Aircraft Accident Report, Explosive Decompression — Loss of cargo door in flight, United Airlines Flight 811, Boeing 747-122, N4713U, Honolulu, Hawaii, February 24, 1989

Investigative Body: National Transportation Safety Board (NTSB), USA

AIRCRAFT ACCIDENT REPORT

EXPLOSIVE DECOMPRESSION--
LOSS OF CARGO DOOR IN FLIGHT
UNITED AIRLINES FLIGHT 811
BOEING 747-122, N4713U
HONOLULU, HAWAII
FEBRUARY 24, 1989

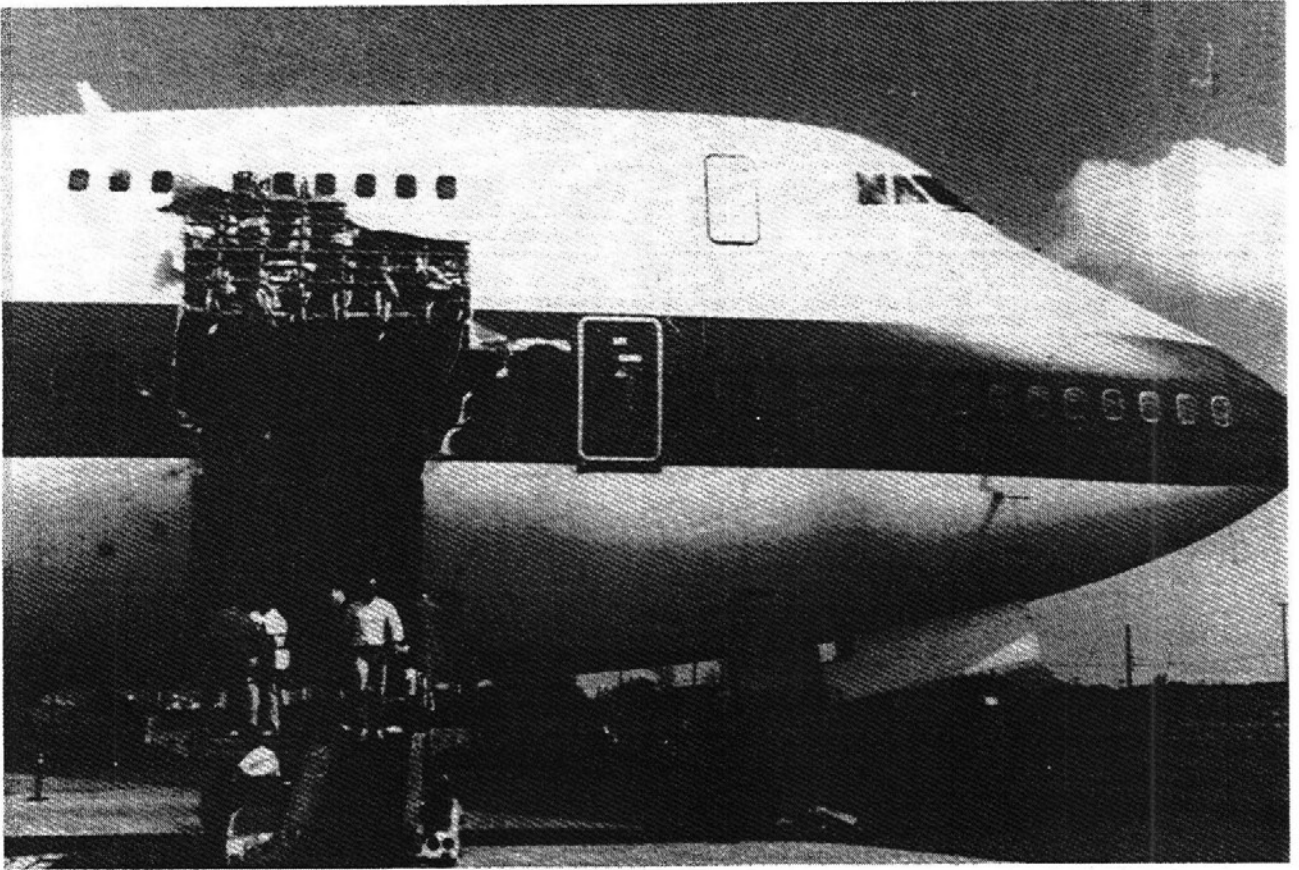
The primary damage to the airplane consisted of a hole on the right side in the area of the forward lower lobe cargo door, approximately 10 by 15 feet large. The cargo door fuselage cutout lower sill and side frames were intact but the door was missing (see figures 1 and 2). An area of fuselage skin measuring about 13 feet lengthwise by 15 feet vertically, and extending from the upper sill of the forward cargo door to the upper deck window belt, had separated from the airplane at a location above the cargo door extending to the upper deck windows. The floor beams adjacent to and inboard of the cargo door area had been fractured and buckled downward.

Examination of all structure around the area of primary damage disclosed no evidence of preexisting cracks or corrosion. All fractures were typical of fresh overstress breaks.

Figure 1.--Overall view of forward cargo door area
on the right side of the aircraft.

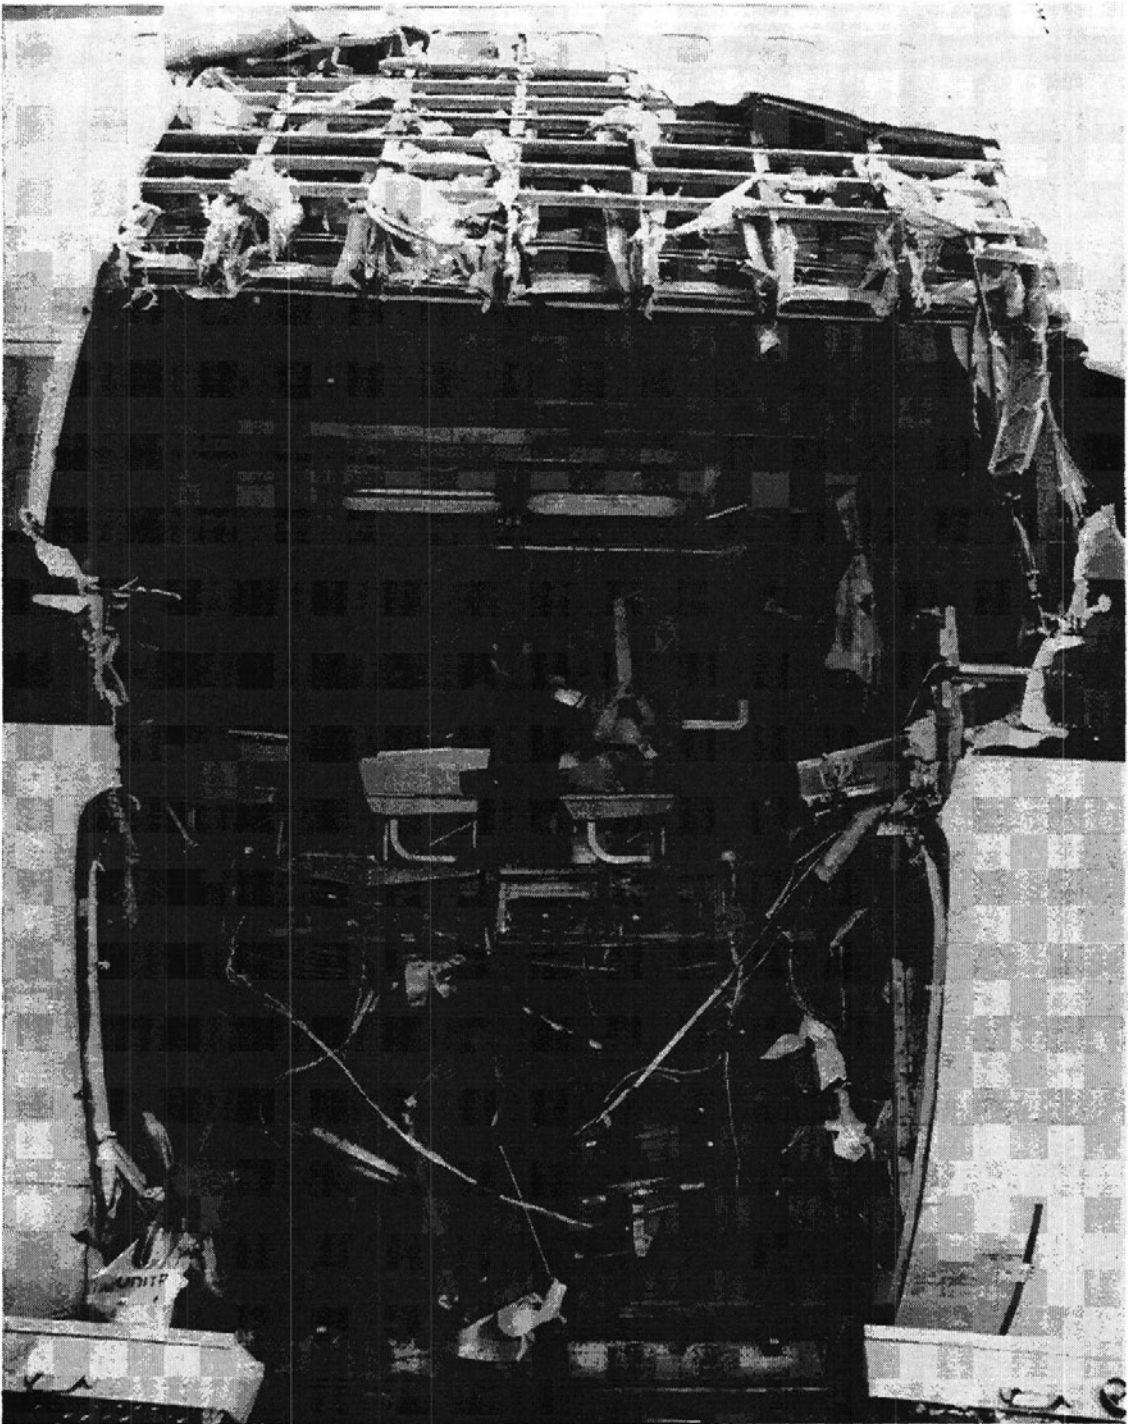
Figure 2.--Close-up view of hole and surrounding structure damage.

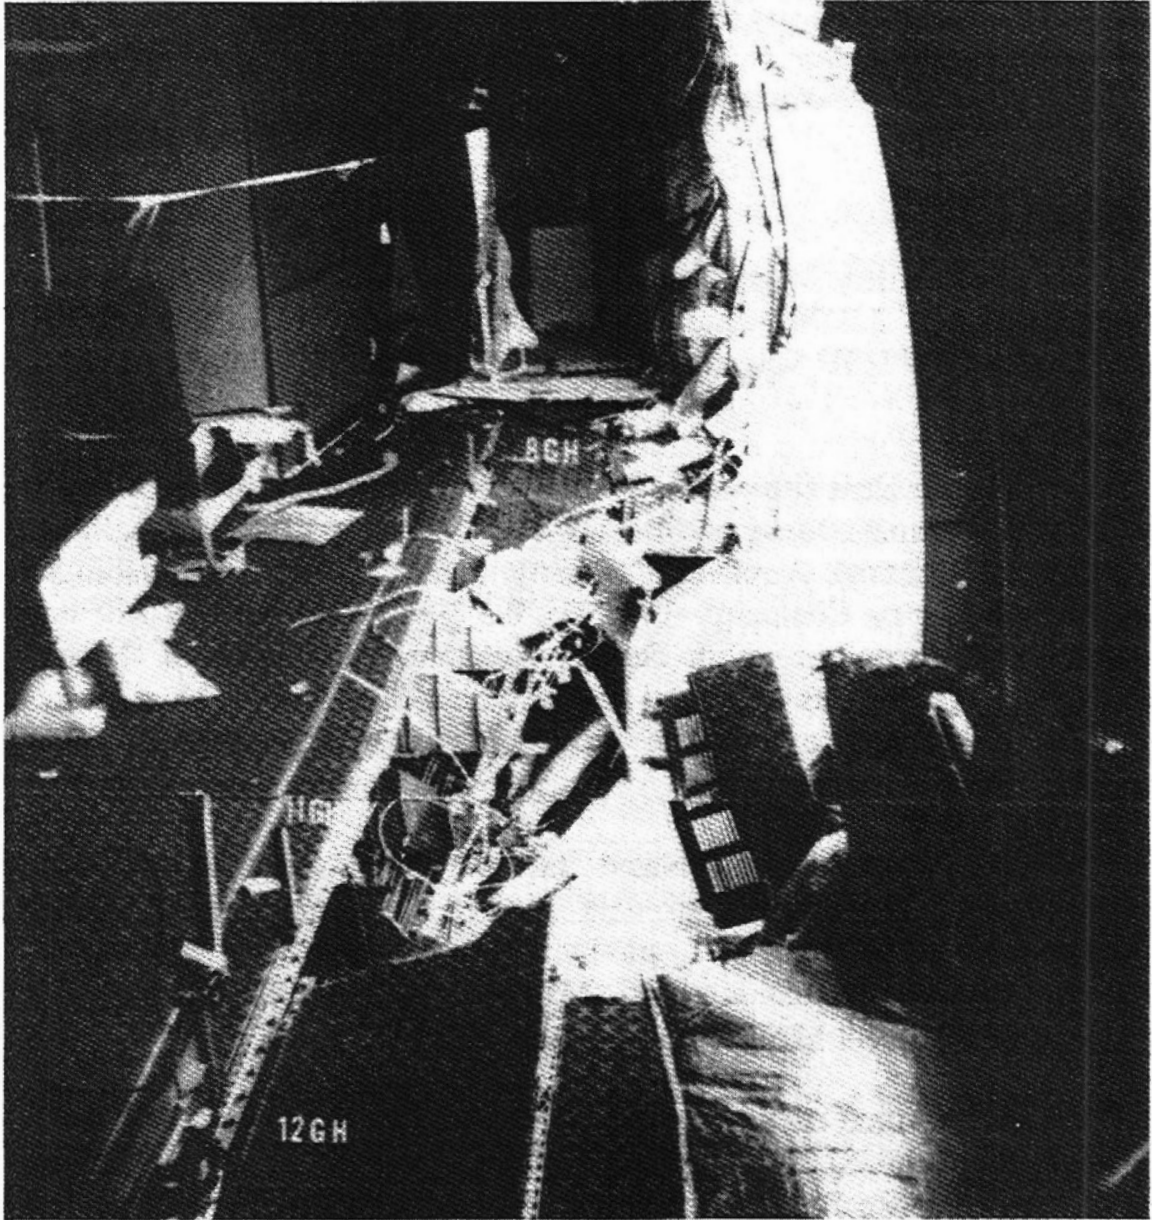
The cargo door separation resulted in the loss of fuselage shell structure above the cargo door, along with main cabin floor structure below seats 8GH through 12GH (see figure 3). The missing floor area extended inboard from the interior of the right side fuselage wall to the inboard seat track of seats 8GH through 12GH.

Figure 3.--Forward view of Cabin Zone B.
Note missing seats 8GH through 12GH.

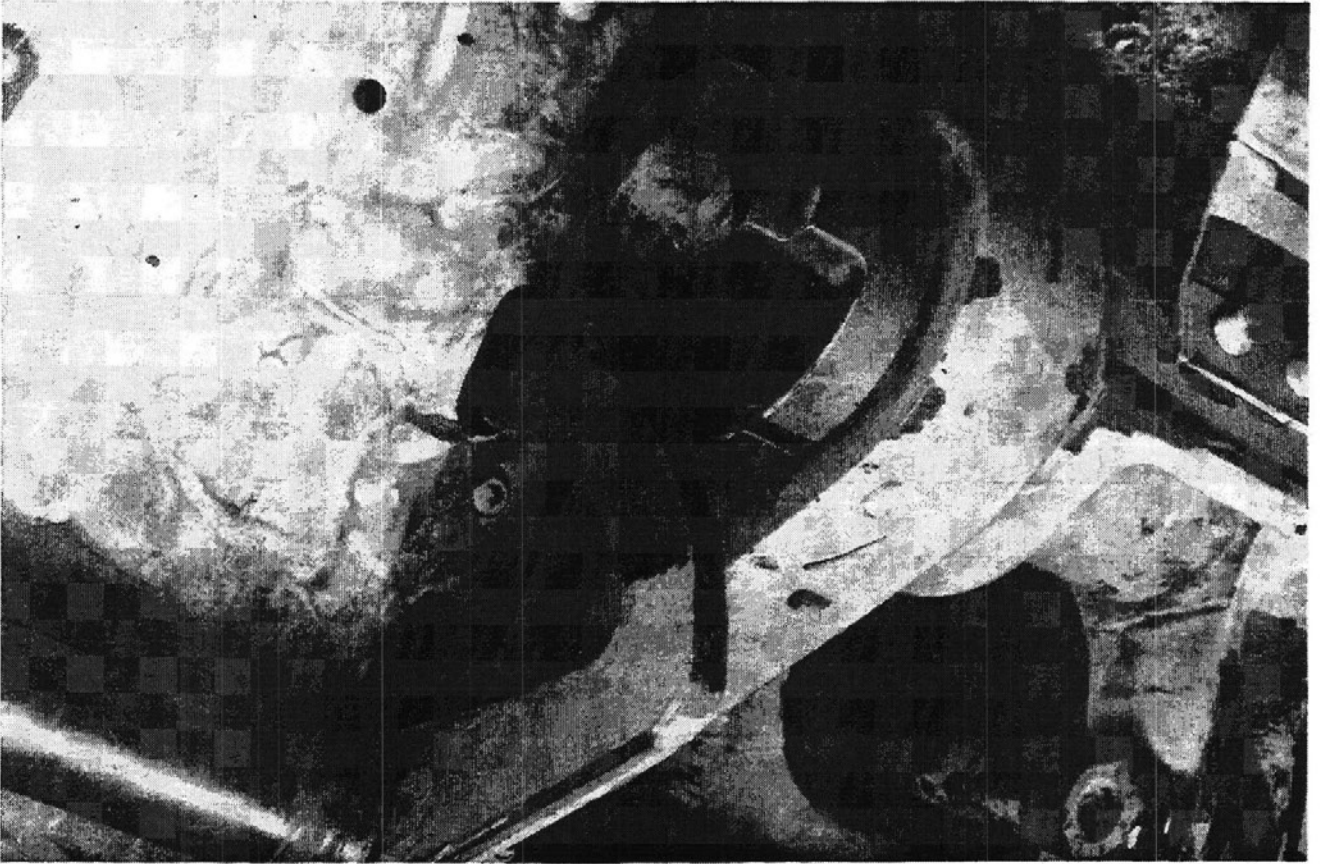
Figure 6.--Recovered lock sectors and cams.

Examination of the lock sectors disclosed that the bottom of the lower arm of each lock sector was gouged. For seven of the eight lock sectors, the distance from the main gouge area to the location of the interference between the latch cam and the lock sector was approximately 0.75 inch. (The No. 2 lock sector was corroded and had fractured at the location of the large gouge common to the other seven lock sectors. Consequently, it was not in contact with the No. 2 latch cam when the door was retrieved).

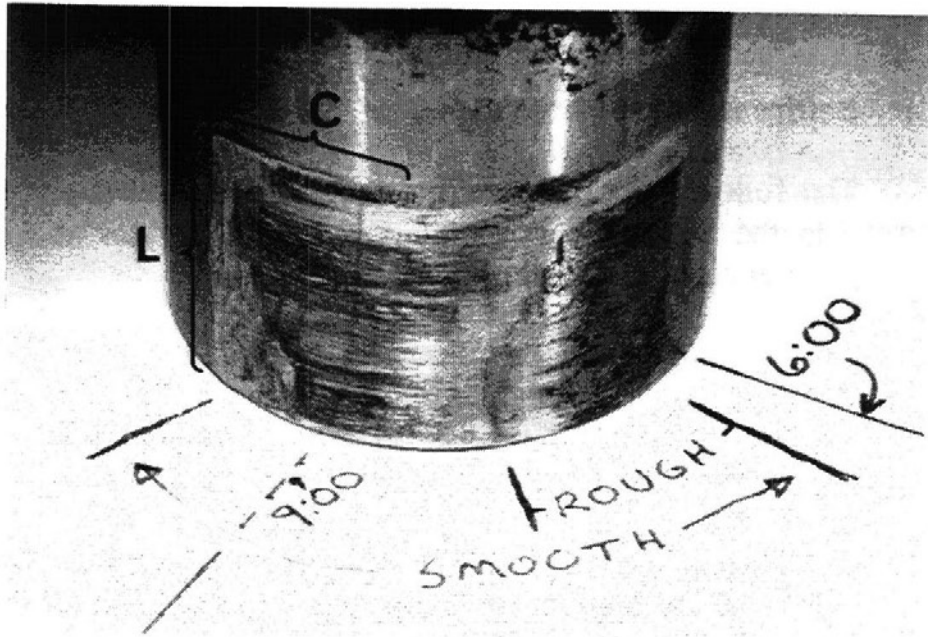
Based on the orientation of the latching mechanisms, the fully unlatched latching cams would first contact the latch pins from about the 1:15 o'clock position to the 7:15 position as the door was closed. As the cams are being latched around the pins, they would rotate approximately 80°, making contact with the pins from about the 4:15 position to the 10:15 position (See figure 7).

Figure 7.--Latch pin number 6. Note the rough and smooth areas and the steps indicating the contact area with the latch cam.

Detailed examination of the exposed surface of the pins (the portion of the pins extending from the housings) revealed various types of wear and damage. In general, all of the forward door cargo latch pins had smooth wear over the entire portion of the pin area contacted by the cams during normal closing and opening of the door. The pins also had distinct roughened (smeared) areas between the 6:15 and the 7:30 positions (See figure 8). The roughened areas had evidence of "heat tinting" and transfer of cam material to the surface of the pins. On pins 1 and 8 the roughened areas extended past the pin bottom to the 5:00 position. The 7:30 position approximately corresponds to the area on the pin where the lower surface of the cam would be relative to the pin when the latch cams are in the unlatched or nearly unlatched position.

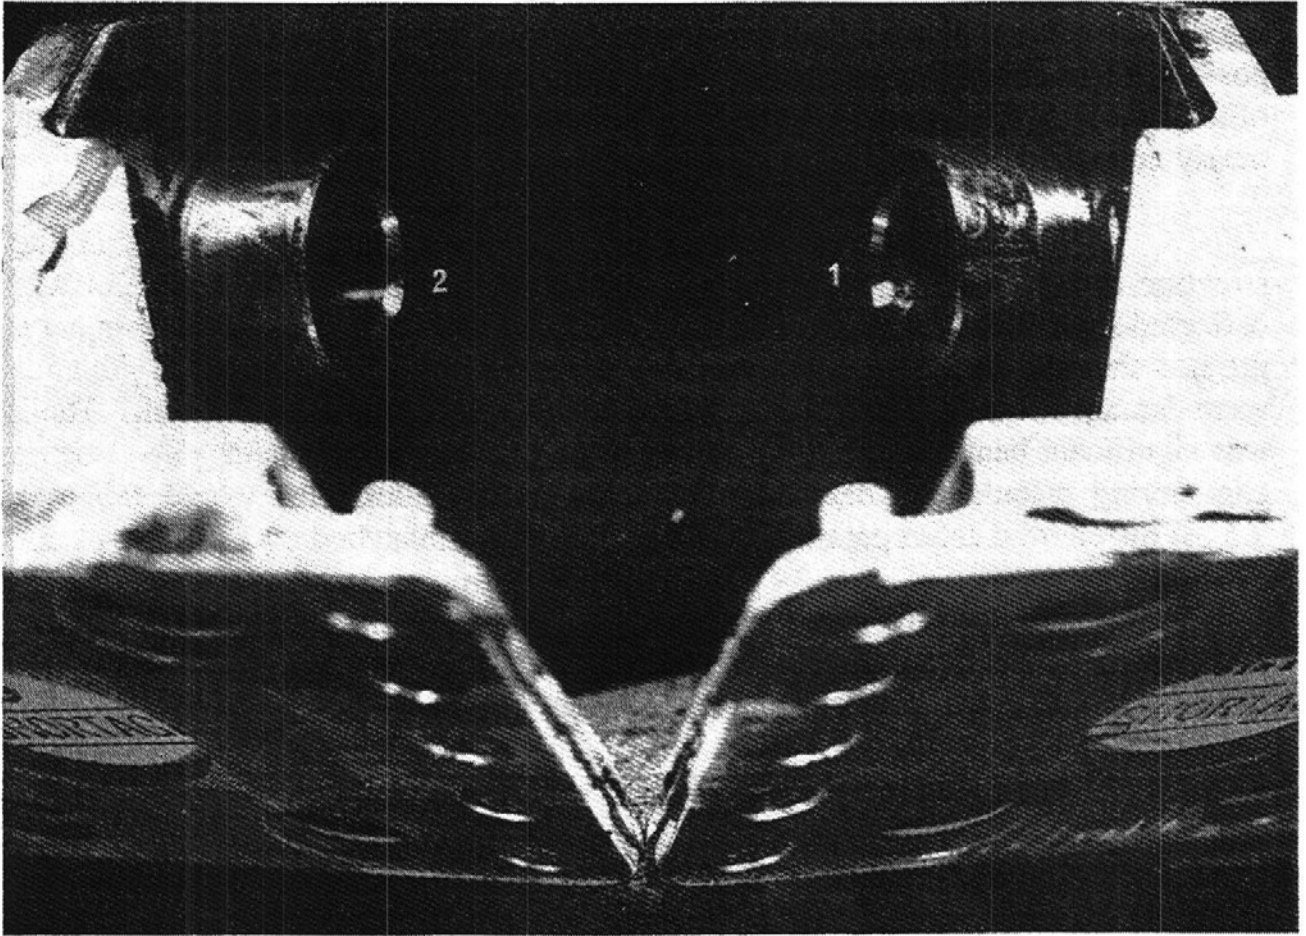
Figure 8.--Lower latch pin and housing assemblies
Nos. 1 and 2 looking up and slightly outboard.

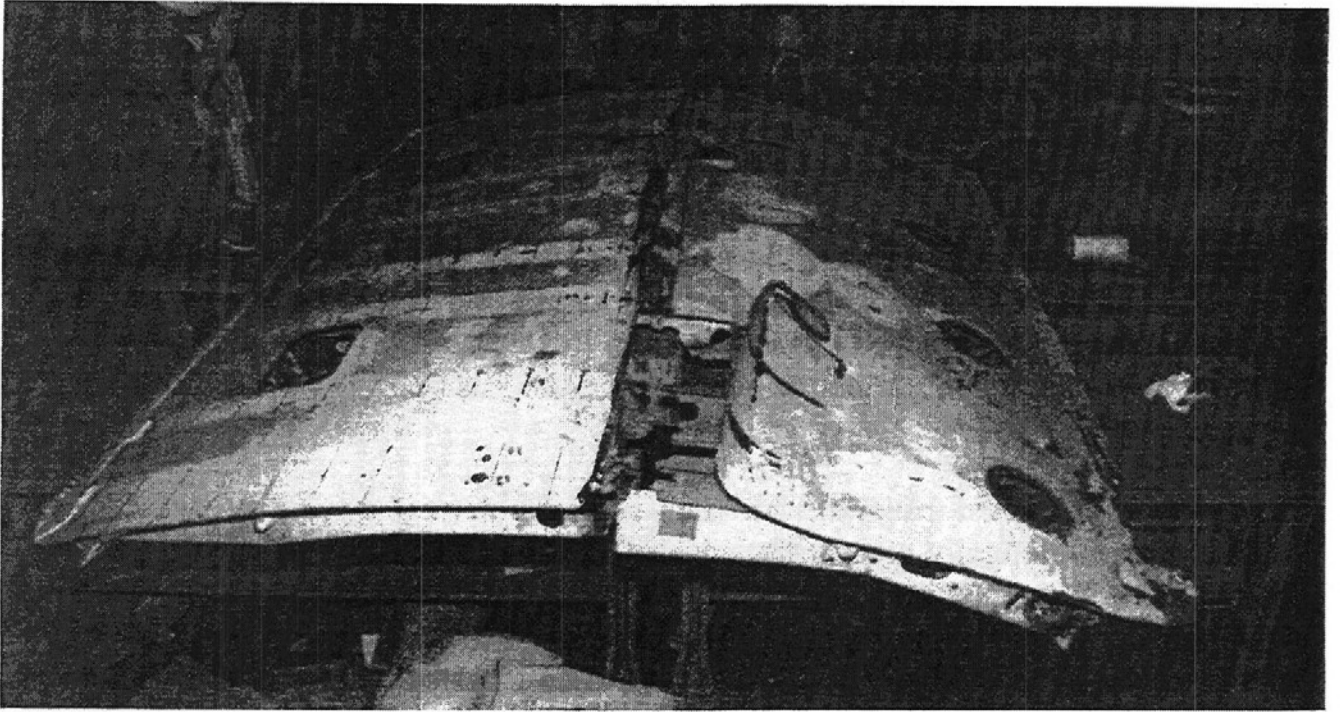
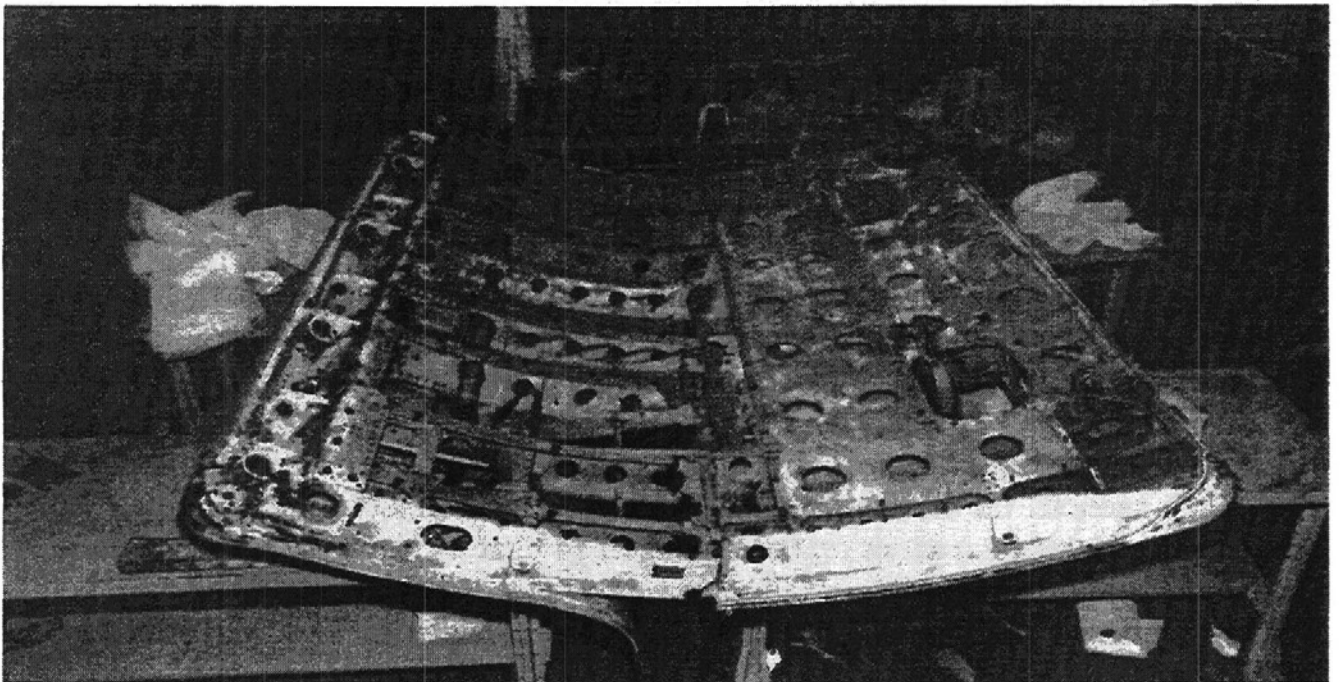
The cargo door had fractured longitudinally near the mid-span lap joint near stringer 34R, just beneath the mid-span torque tubes. Except for an area of missing skin between frames 2 and 3 and a portion of frame webs where the upper latch lock torque tube had torn out, the frames and skin of the upper door

piece mated to the lower door piece.² Several areas of the upper door skin along the longitudinal fracture were bent back. In addition, a large area of lower door skin between frame 6 and the aft door edge had peeled downward from the fracture line. The two door pieces are shown together in Figures 9 and 10. Examinations of the fracture surfaces of the skin and frames revealed no evidence of pre-existing cracks. All fractures were typical of overstress separation.

Figures 9 and 10.--Exterior [top photo] and interior [bottom photo] views of cargo doors after removal of pull-in hooks, latch cams, lock sectors, and actuators

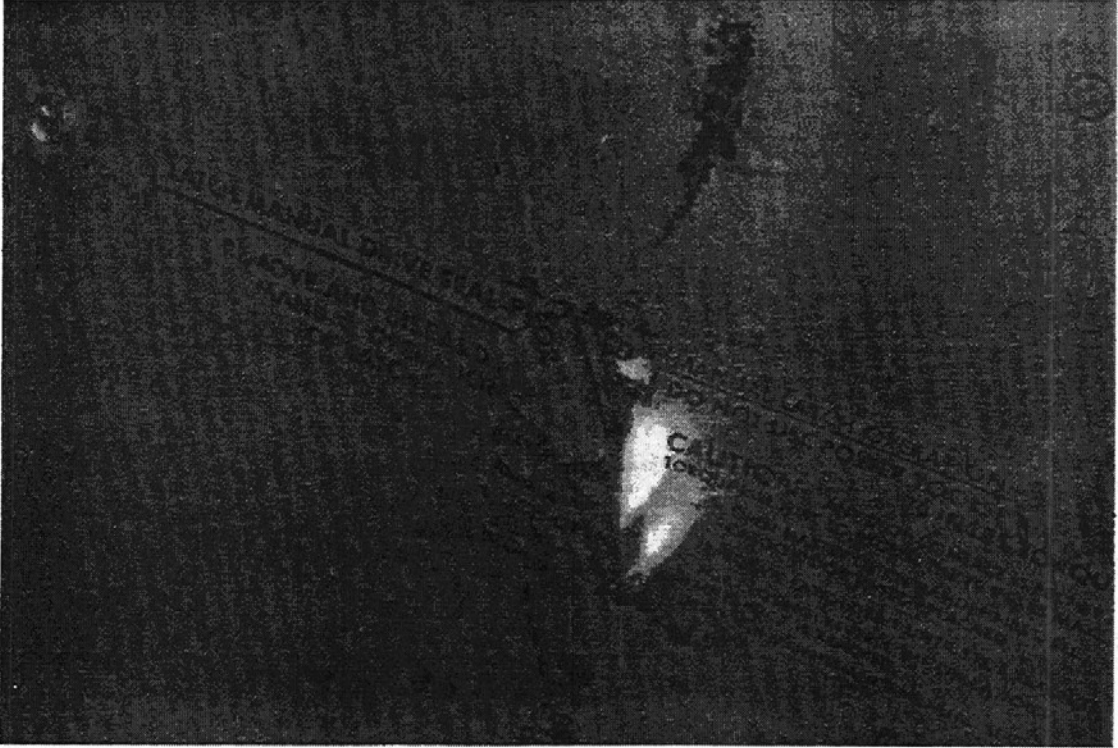
Figure 11.--Decal over latch actuator manual drive port.

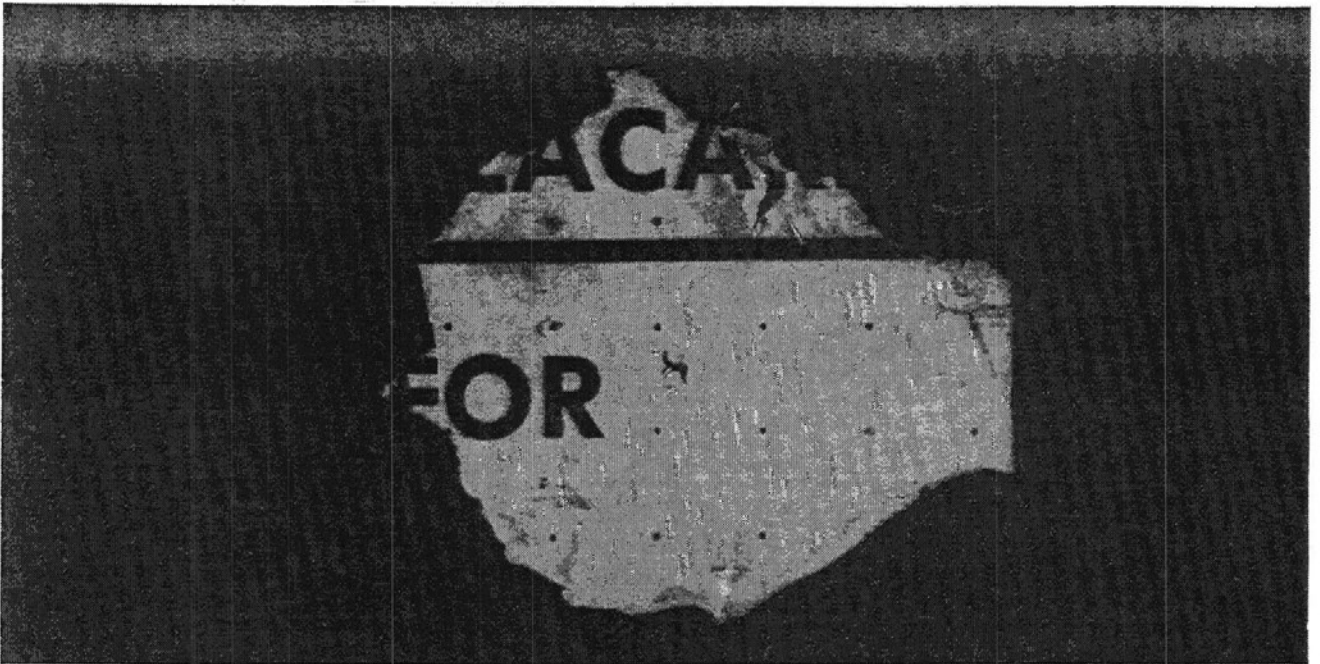
Figure 12.--Decal over latch actuator manual drive port
(2X Magnification).

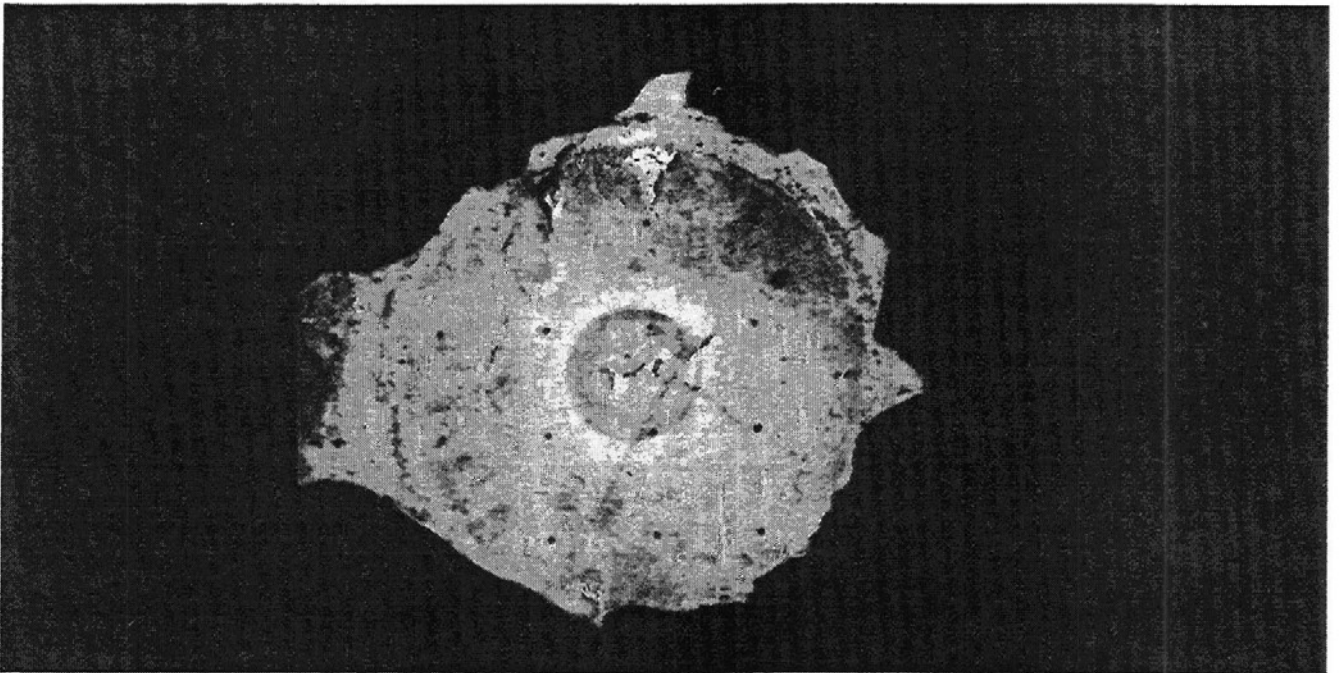
Figure 13.--Underside of decal piece (2X Magnification).

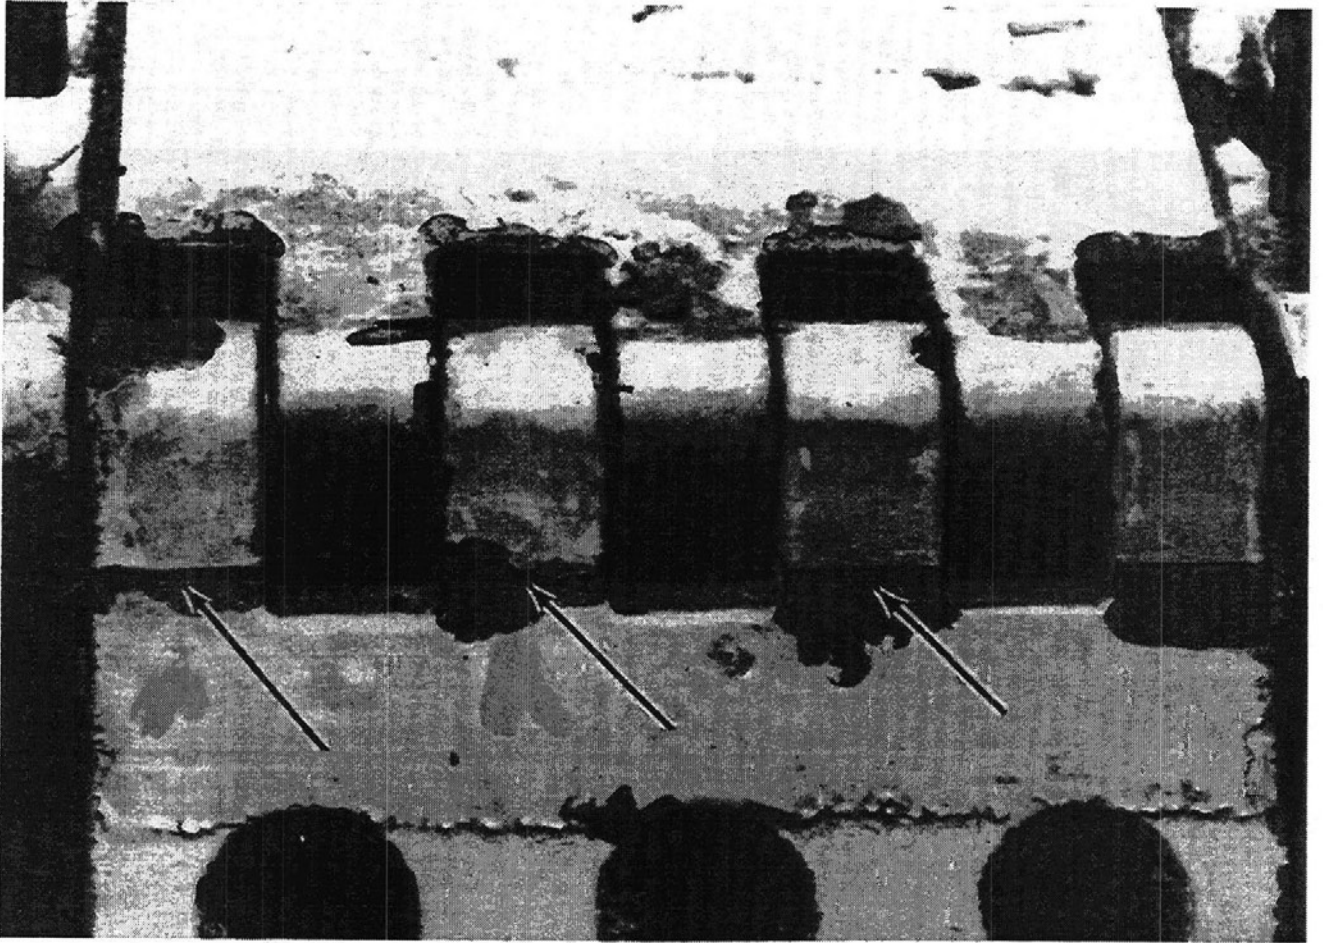
Figure 14.--Close-up view of cargo door hinge section.
Arrows show impressions caused by contact with opposite hinge section.

were slightly bent. The upper flange of the door, to which the door hinges are attached, was not deformed. The forward cargo door can rotate open 143 degrees before the hinge would deform, permitting the door to contact the fuselage above.

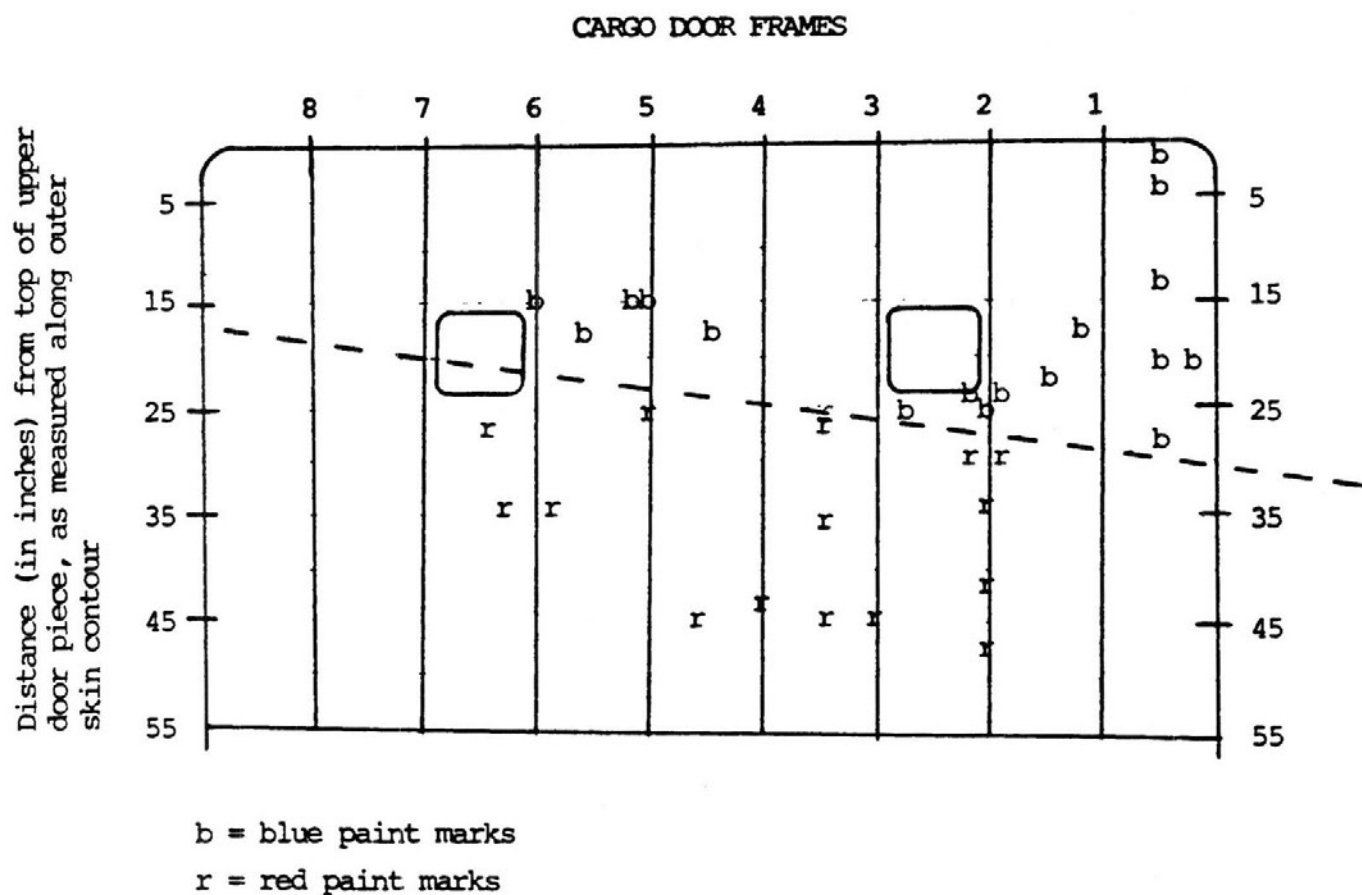
Figure 15.--Documented paint marks on outer skin of upper door piece.
Dashed line is approximately 8 degrees from horizontal.

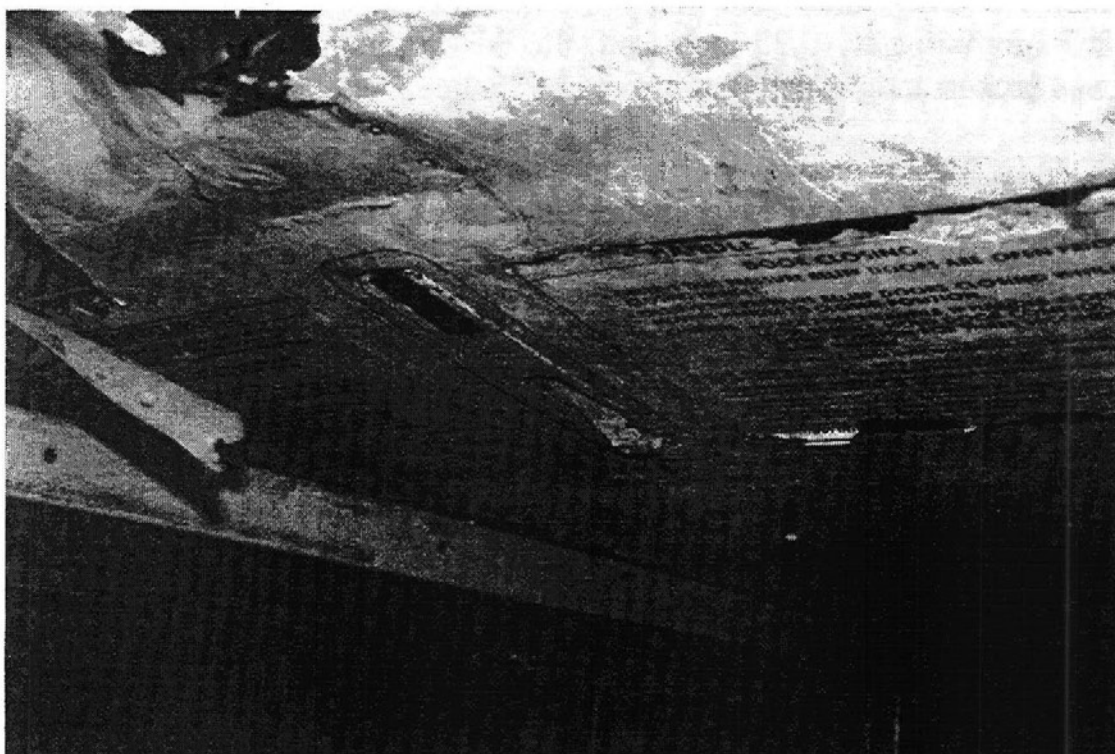
The master latch lock handle housing and trigger were found relatively flush with the door outer skin. The top of the handle was recessed approximately 0.50 inch inward from flush, and the bottom of the handle was protruding approximately 0.40 inch outward from flush (See figure 16). This

Figure 16.--Position of master latch lock handle.

position of the handle indicates that the lock sectors were in a position past fully locked. The fuse pin was found in three pieces but was heavily corroded. The handle housing was undamaged.

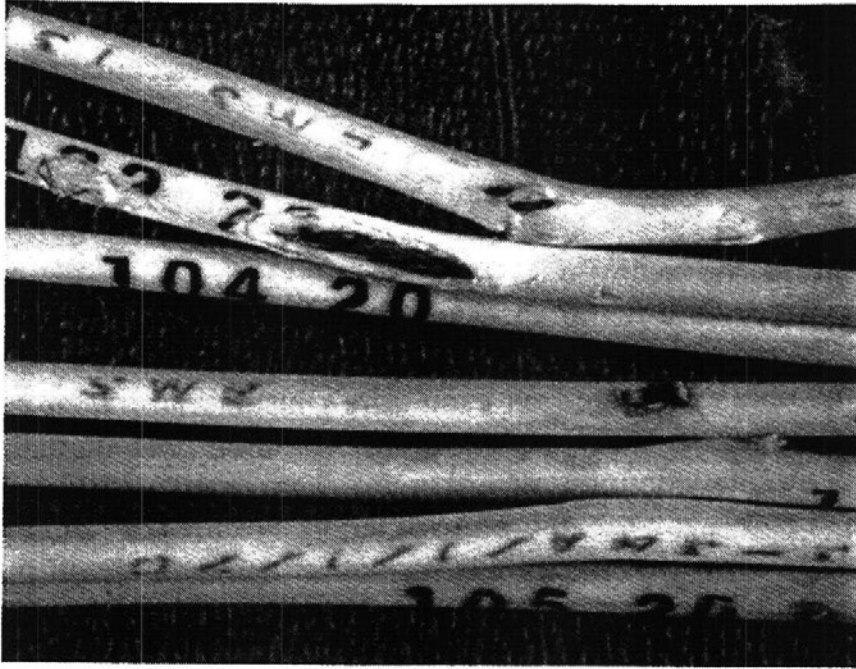
Seven wires numbered 101-20, 102-20, 105-20, 107-20, 108-20, 122-20, and 135-20 had visible damage located near a 3.8 inch position as measured from the P3 plug pin tips. This common position on the wire corresponds to a 360-degree loop in the wire bundle, which is located immediately below the junction box. Figures 18 and 19 show typical wire damage. Wire 122-20 had an open insulation area approximately 0.25 inch long. The other four wires had flattened insulation damage areas.

Figure 18.--Wires (from top to bottom) 101, 122, 104, 107, 110, 108, 105 at 3.8 inches from pin end (4X Magnification).

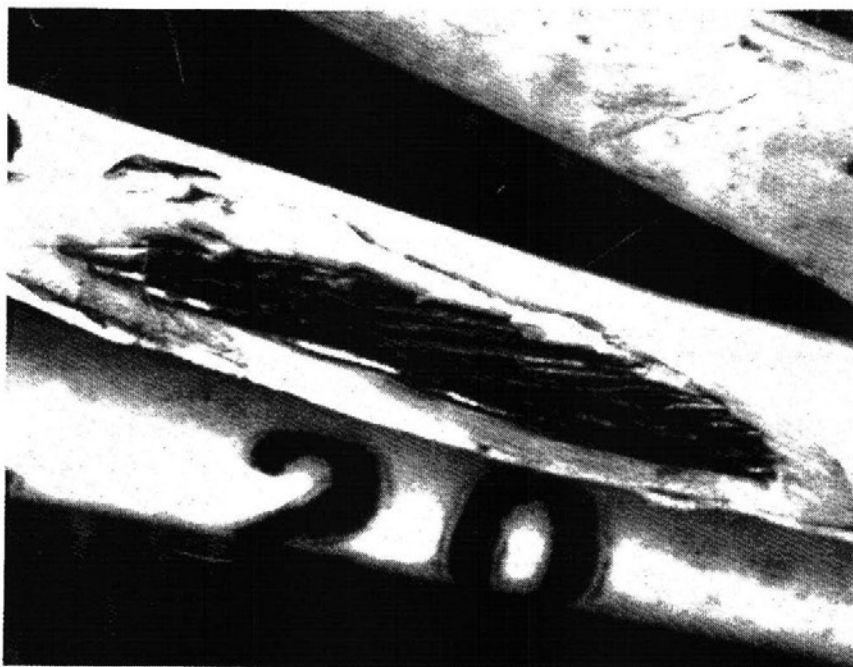
Figure 19.--Wire 122 at 3.8 inches from pin end (4X Magnification).
