Uncontained engine failure, United Airlines Flight 232, McDonnell Douglas DC-10-10, Sioux Gateway Airport, Sioux City, Iowa, July 19, 1989

PB90-910406
NTSB/AAR-90/06

AIRCRAFT ACCIDENT REPORT

UNITED AIRLINES FLIGHT 232
McDONNELL DOUGLAS DC-10-10
SIOUX GATEWAY AIRPORT
SIOUX CITY, IOWA
JULY 19, 1989

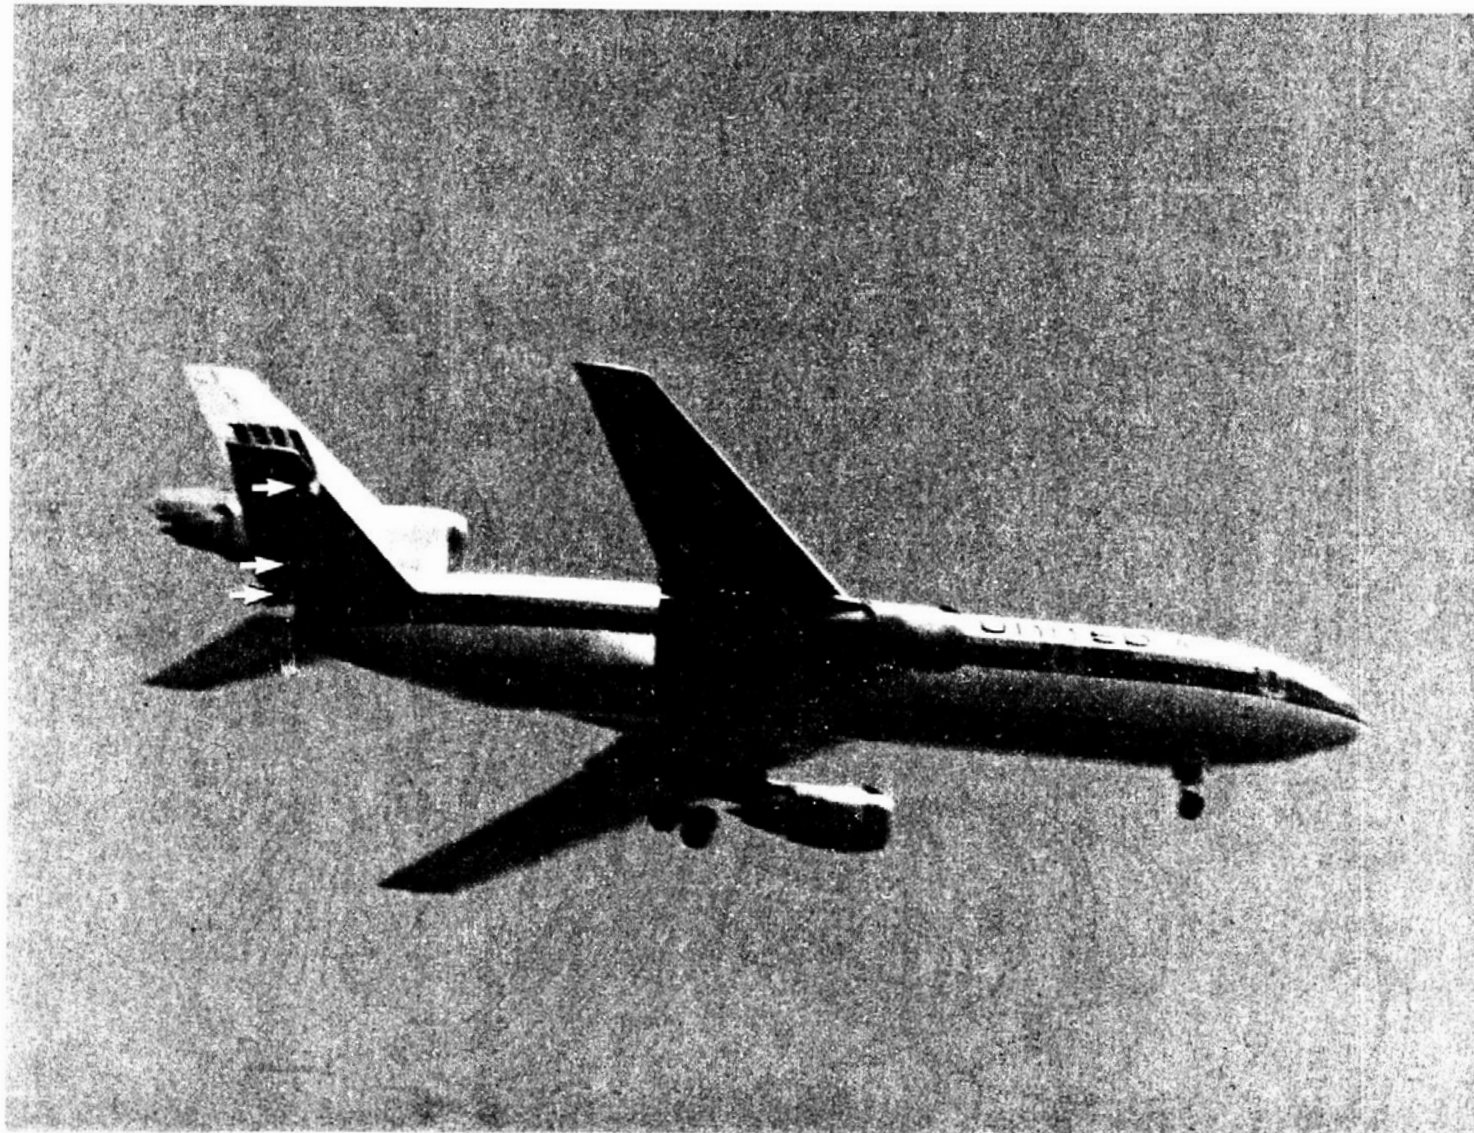
Photographs of the airplane were taken by observers on the ground during its final approach to Sioux Gateway Airport. They showed that the No. 2 engine fan cowling and the fuselage tail cone were missing. The remainder of the No. 2 engine appeared intact. Postcrash examination of the wreckage revealed that the No. 2 engine fan rotor components forward of the fan forward shaft, as well as part of the shaft, had separated from the engine in flight. (See figures 3 through 5).

Figure 3.--Photo (C. Zellmer) taken while flight 232 was approaching Sioux Gateway Airport. Arrows indicate damage to the right horizontal stabilizer. It is also evident that the No. 2 engine fan cowl door and the tail cone are missing.

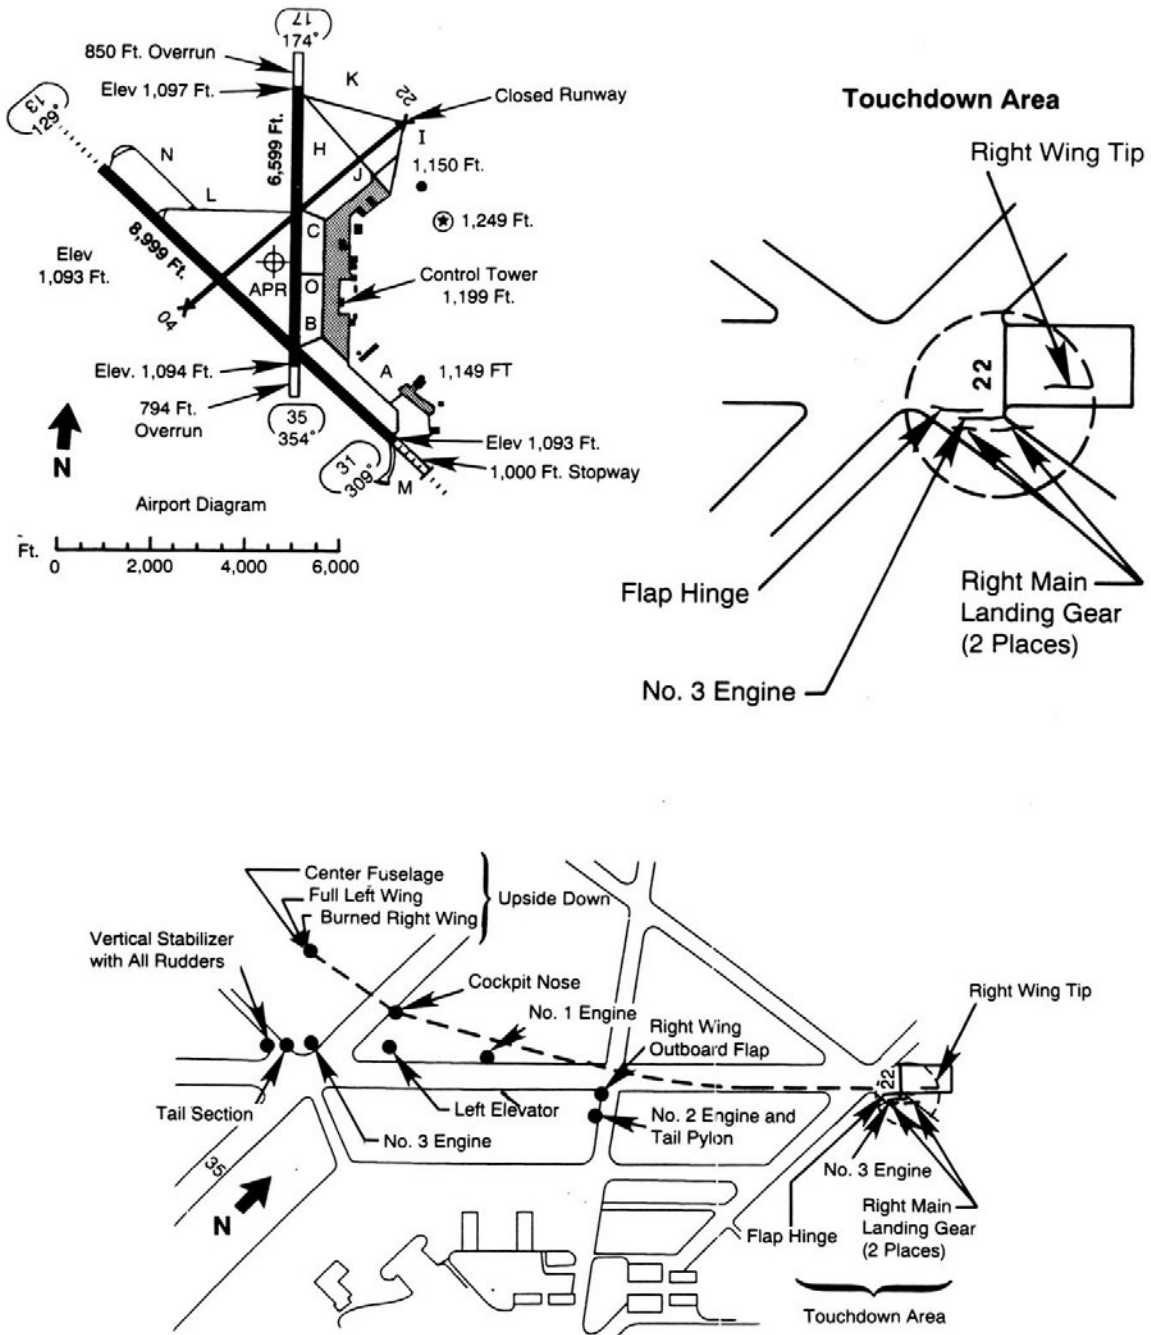
Figure 6.--Sioux Gateway Airport and wreckage path of UA flight 232.

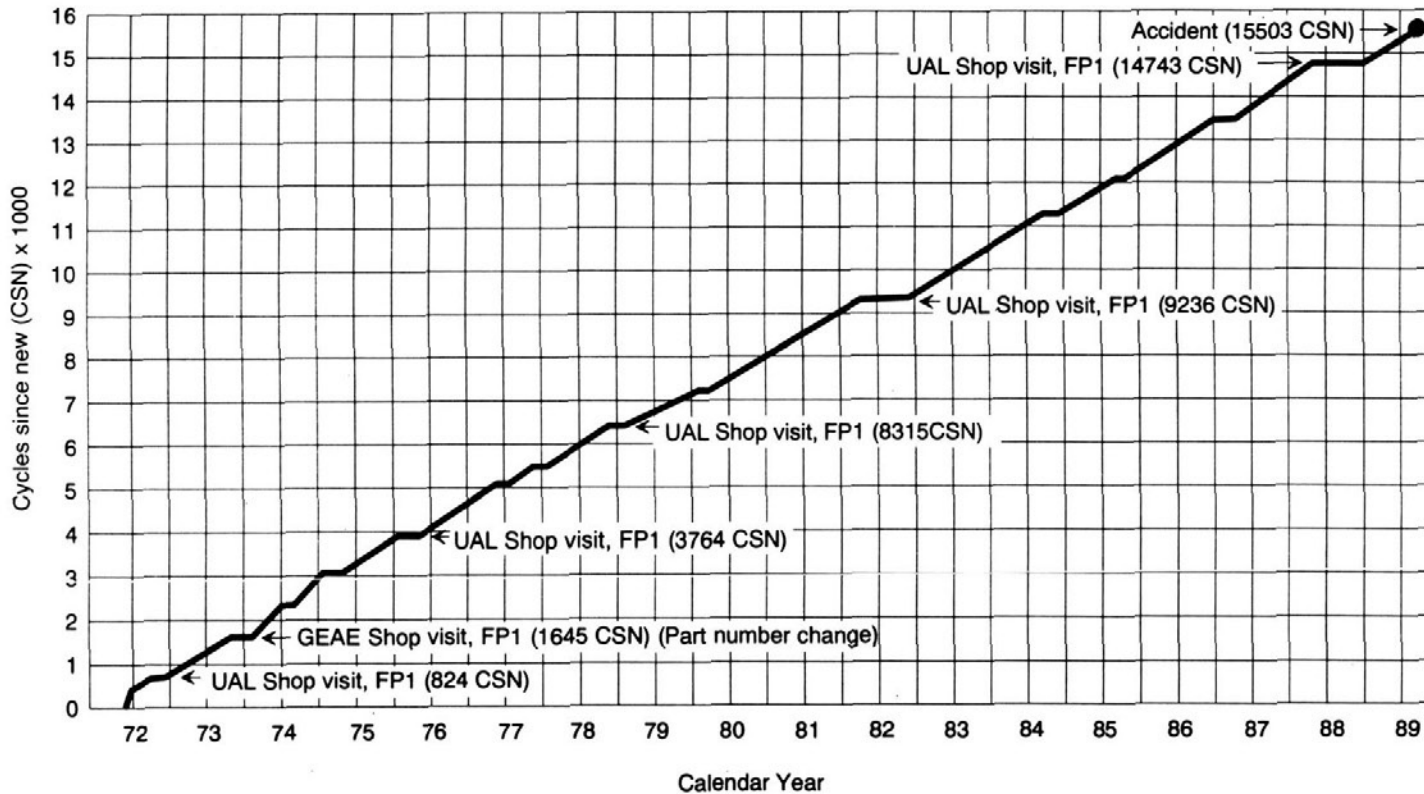
Figure 9.--Inspection history of accident fan disk.
(Data source GEAE)

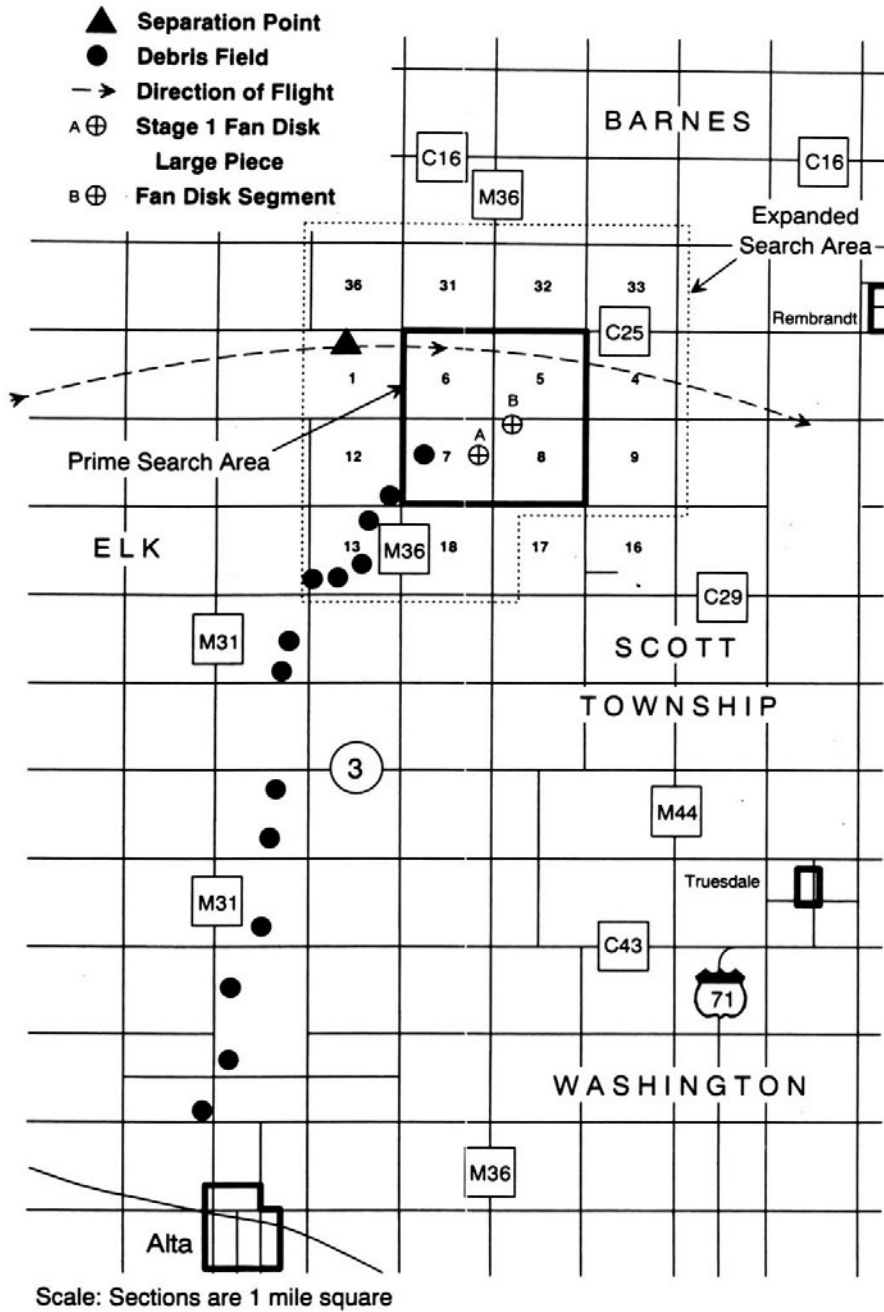
Also found near Alta soon after the accident were parts of the tail engine adapter assembly, consisting of adapter ring and bellmouth assemblies, an anti-ice pneumatic tube, a starter air tube, three cowl hold-open rods, two hydraulic system accumulators from the No. 2 engine-driven hydraulic pumps, fan blade fragments, two pieces of insulated metal braid-covered hydraulic hose clamped together, and a segment of aluminum material broken out of the large structural "banjo" forging from the airplane inlet duct structure.

About 3 months after the accident, parts of the No. 2 engine fan disk were found in farm fields near Alta. There were two sections that constituted nearly the entire disk, each with fan blade segments attached. These parts were initially taken to the GEAE facility in Evandale, Ohio, for examination under the direction of the Safety Board. The small segment was later transported to the NTSB Materials Laboratory in Washington for further evaluation. (See section 1.16, Tests and Research).

Figure 11.--Trajectory information/Alta debris field.

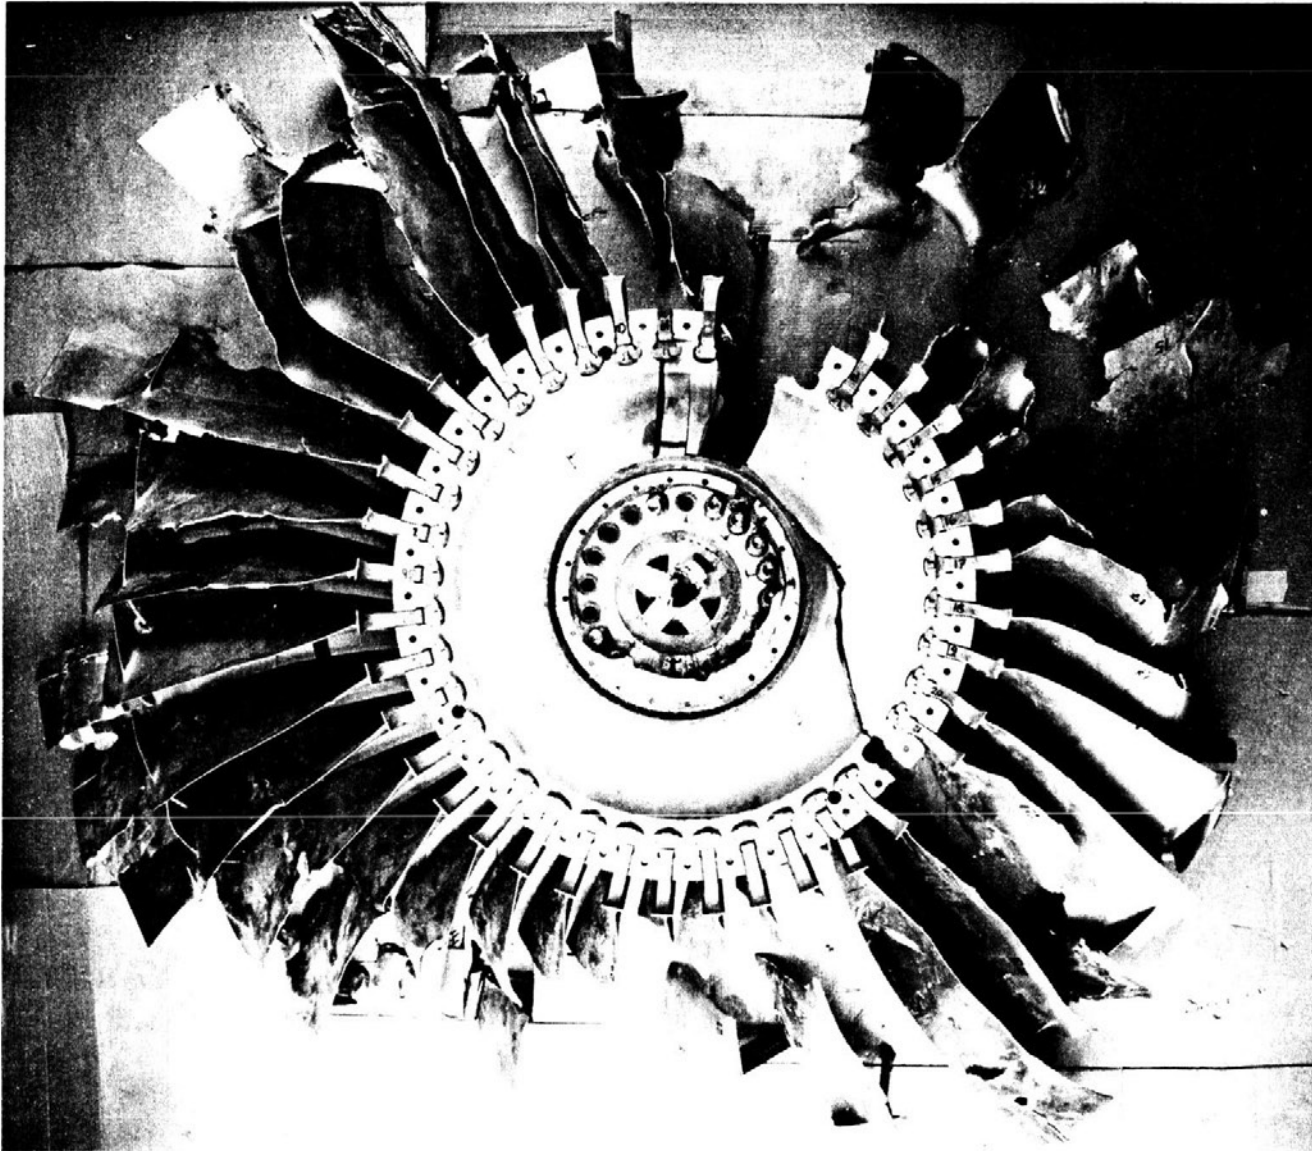
In mid October 1989, about 3 months after the accident, two pieces of the No. 2 engine stage 1 fan disk, with attached blade pieces, were found in corn fields near Alta, Iowa. The two pieces comprised the entire separated disk, with the exception of one dovetail post, which was not recovered. Figure 18 shows the reconstructed pieces of the disk after the larger disk piece had been cut during the metallurgical evaluations. The gap between the smaller and larger piece does not represent missing material but is a result of mechanical deformation that occurred during the disk separation. The disk contained two principal fracture areas, resulting in about one-third of the rim separating from the remainder of the disk. One of the fracture areas progressed largely circumferentially through the web and rim. The other was on a near-radial plane, progressing through the bore, web, disk arm, and rim. Features on the circumferential fracture were

Figure 18.--No. 2 engine stage 1 fan disk (reconstructed with blades).

typical of an overstress separation stemming from multiple origin areas in the radius between the disk arm and the web. The near-radial fracture surface also contained overstress features over most of its surface. However, on this break the overstress features stemmed from a preexisting radial/axial fatigue crack region in the bore of the disk. Figure 19A shows the fatigue region on the bore.

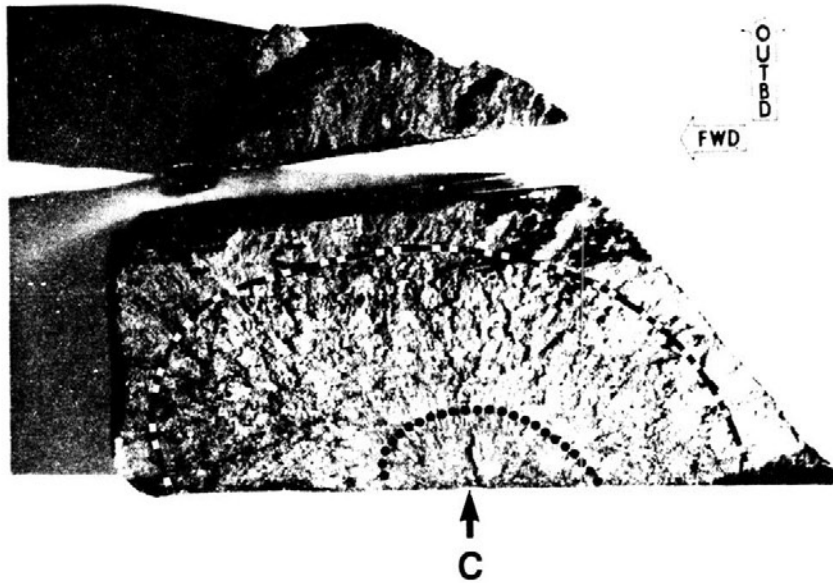
Figure 19A.--Fatigue crack fracture area cut from the bore of the smaller piece of the separated stage 1 fan disk. The fatigue crack extends from the cavity (arrow "C") to the dashed line position. The discolored portion of the fatigue crack is between the cavity and the dotted line. Magnification: 2.26X.

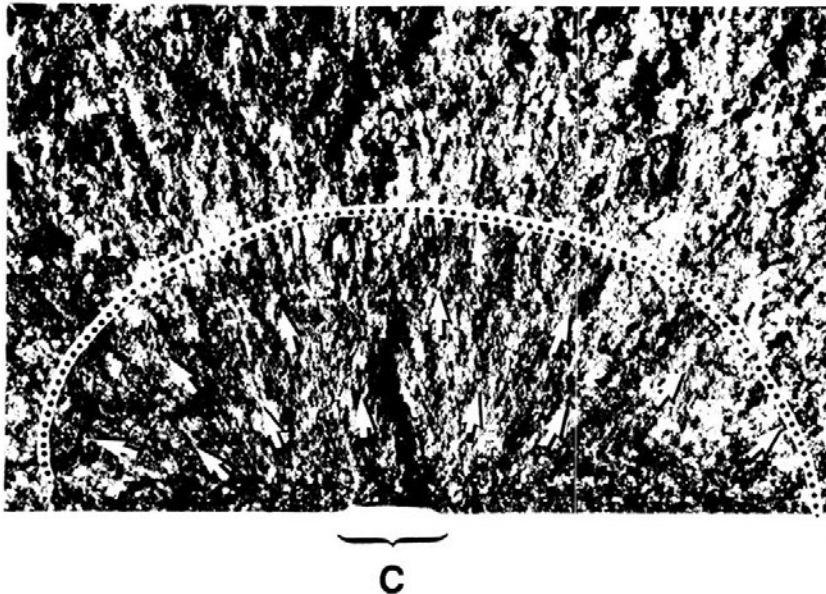
Figure 19B.--Closer view of the discolored area on the fatigue crack. The dotted line in this figure corresponds to the dotted line in figure 19A. Arrowheads on the fracture surface indicate cracking directions away from the cavity. Magnification: 8.6X.

portion of the inclusion at the fatigue origin. However, between the cavity bottom and a radial distance of 0.025 inch outboard of the bore surface, areas with brittle fracture features and a lack of fatigue striations were found intermixed among more ductile-appearing bands with fatigue striations. The zone with a mixture of brittle features and fatigue striation areas correlated with the enriched alpha microstructure surrounding the stabilized-alpha core of the inclusion.

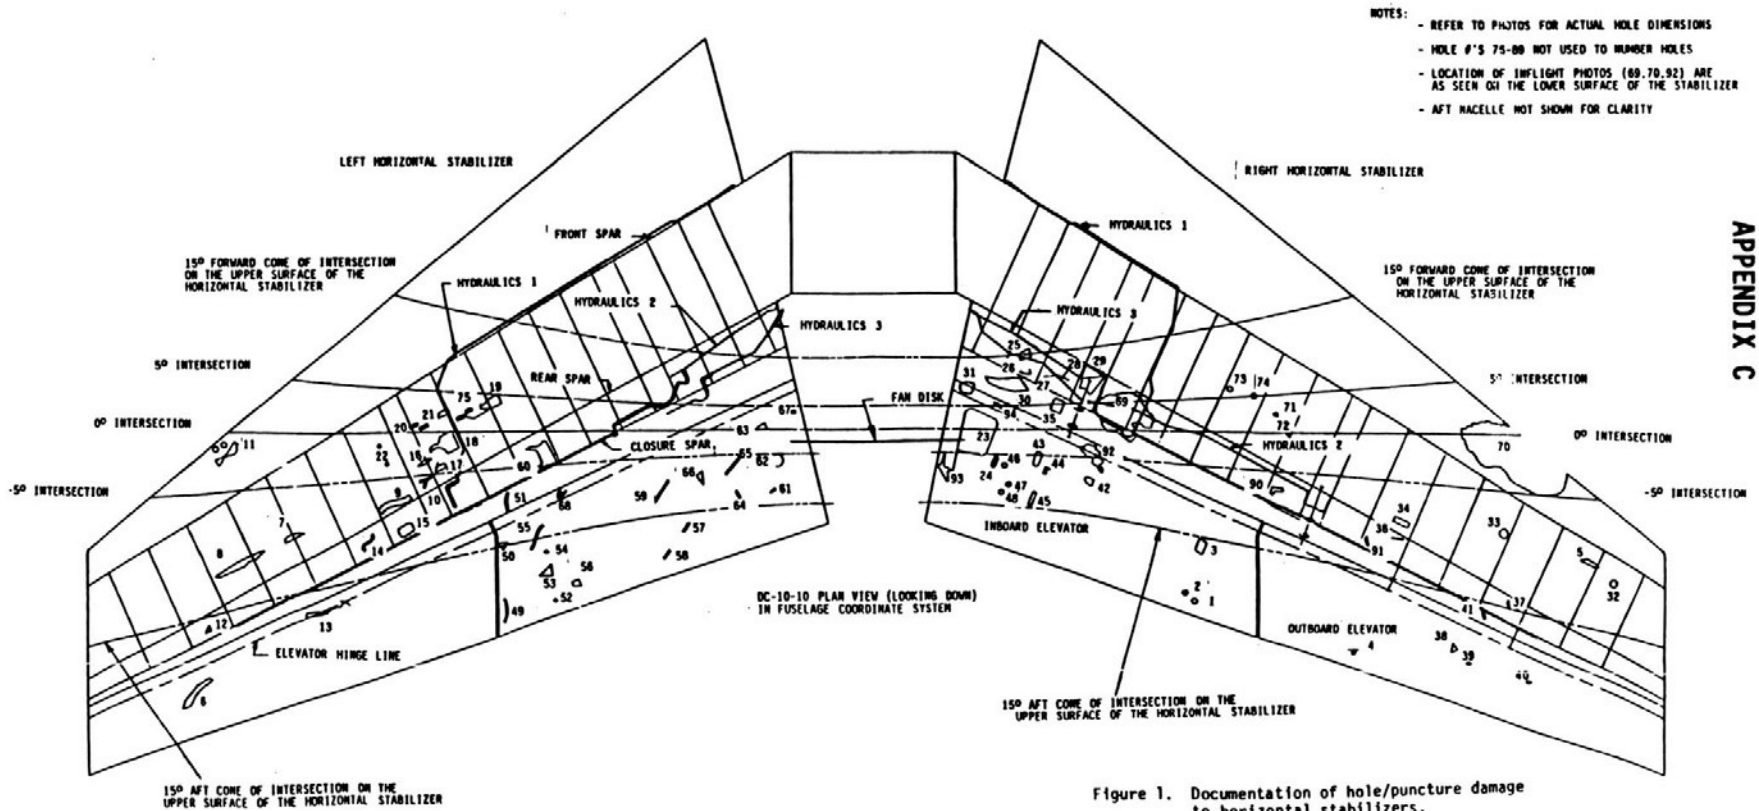
# HORIZONTAL STABILIZER DAMAGE DIAGRAM

Four punctures on the vertical stabilizer were noted as probable fragment damage prior to ground impact. Documentation of hole/puncture damage to the horizontal stabilizers is contained in Appendix C. There were 79 punctures recorded from fragment damage and one large hole, about the same size as the large piece of recovered fan disk. The flight control surfaces were recovered in the aircraft wreckage and had varying degrees of damage that could have occurred before or after impact.

Figure 1. Documentation of hole/puncture damage to horizontal stabilizers.
