Runway overrun, USAir, Inc., Boeing 737-400, Laganrdia Airport, Flushing, New York, September 20, 1989

PB90-910403
NTSB/AAR-90/03

AIRCRAFT ACCIDENT REPORT

USAIR, INC., BOEING 737-400
LAGUARDIA AIRPORT
FLUSHING, NEW YORK
SEPTEMBER 20, 1989

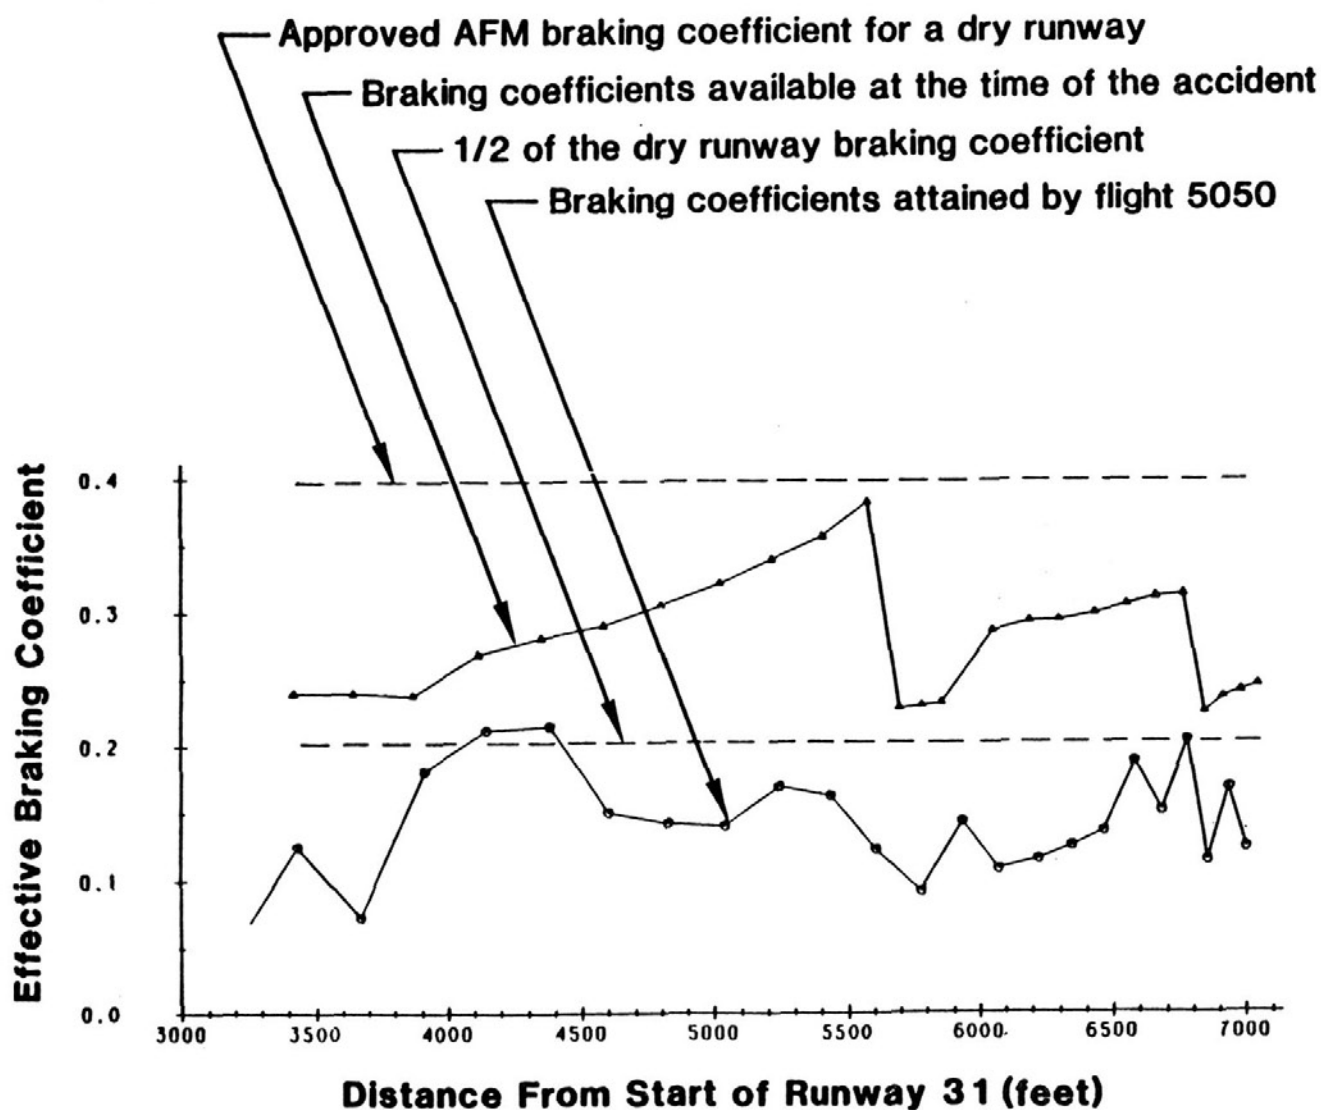
Figure 2.--NASA Evaluation of B-737-400 aircraft rejected takeoff on runway 31 at LaGuardia Airport on September 20, 1989.

runway threshold. About 5,000 feet from the threshold, the two nose gear scrub marks merged into one wider mark for a short distance before they disappeared. The scrub marks on the overrun reappeared at the end of the runway near the centerline and extended onto the overrun. The location of the tire marks is depicted in figure 2.

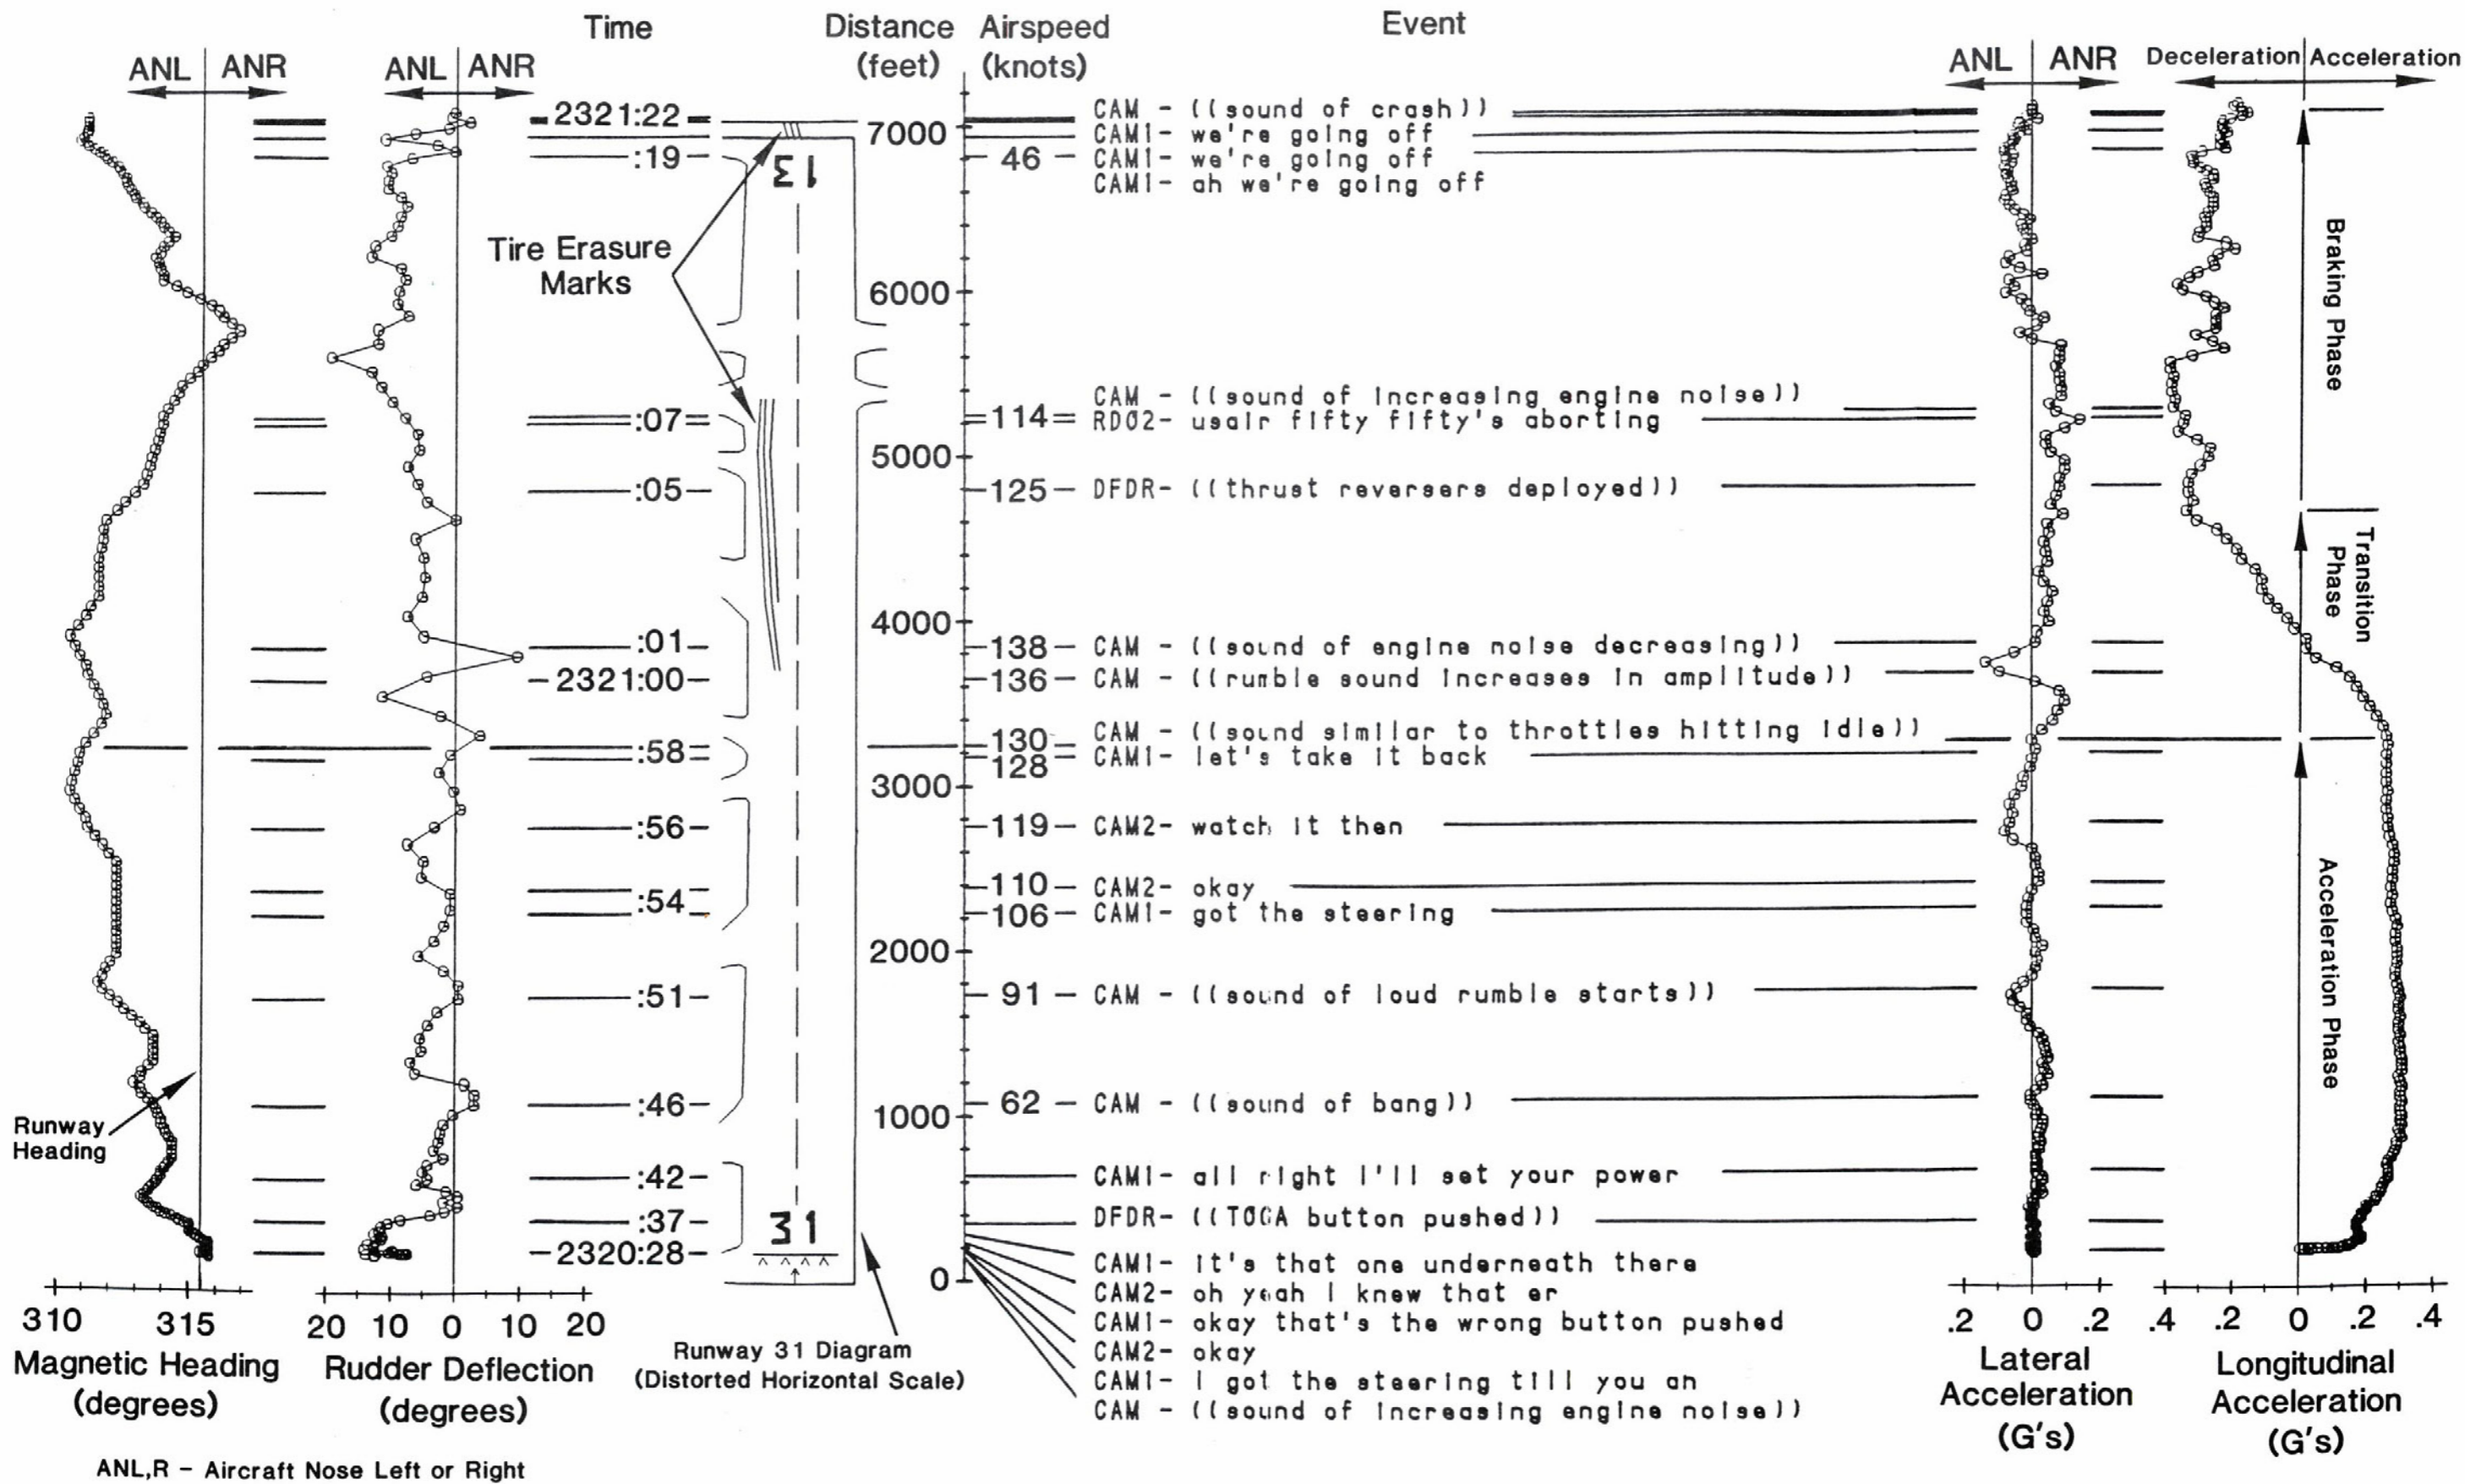
Figure 3.--DFDR/CVR information.

The first indication of the takeoff start was the increasing N1 values for both engines. During the early part of the takeoff, the airplane's heading deviated nearly 2° left of the runway heading, rudder position varied from 0.44° right to 6.9° left, ground speed increased to 91 knots, and N1 values for the left and right engines increased to 91.5 and 94.5 percent, respectively. The airplane's heading was nearly 5° to the left of the runway

heading when an engine power reduction to idle power was recorded. The rudder was nearly centered and the airspeed was about 130 knots.

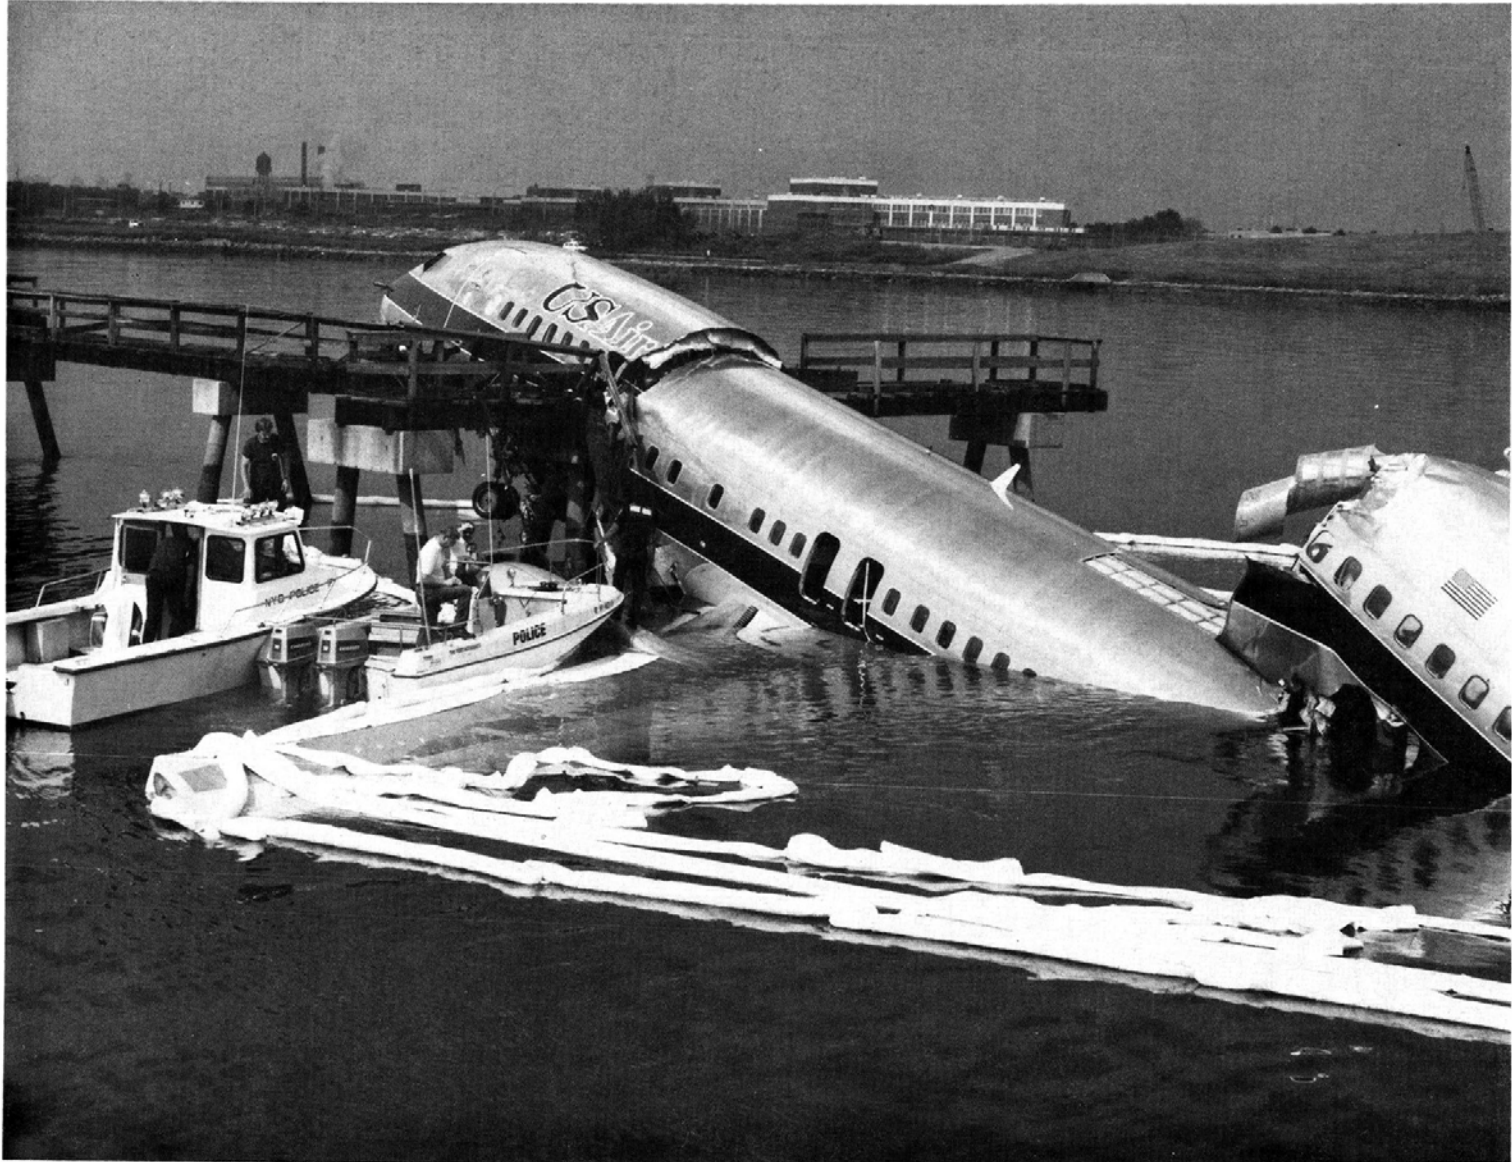
Figure 5.--N416US on lighting stanchion.

The airplane collided with a wooden approach lighting stanchion or pier as it went off the end of the overrun. The fuselage separated into three sections with the forward section resting on part of the elevated light stanchion and the aft section partially submerged (see figures 4 and 5). All fuselage fractures were due to overstress.

The bottom of the nose aft of the nosewheel well had heavy impact damage. Fragments of the pier penetrated the cockpit floor near the captain's rudder pedals. The nose gear was extended, and both nosewheel tires were attached to their wheel rims but were deflated and worn away to expose carcass plies near the center of the tread. More wear was on the left sides of both nose tires.
