Fuel exhaustion, Avianca, The Airline Of Columbia, Boeing 707-321 B, HK 2016, Fuel Exhaustion, Cove Neck, New York, January 25, 1990

AIRCRAFT ACCIDENT REPORT

**AVIANCA, THE AIRLINE OF COLUMBIA
BOEING 707-321B, HK 2016
FUEL EXHAUSTION
COVE NECK, NEW YORK
JANUARY 25, 1990**

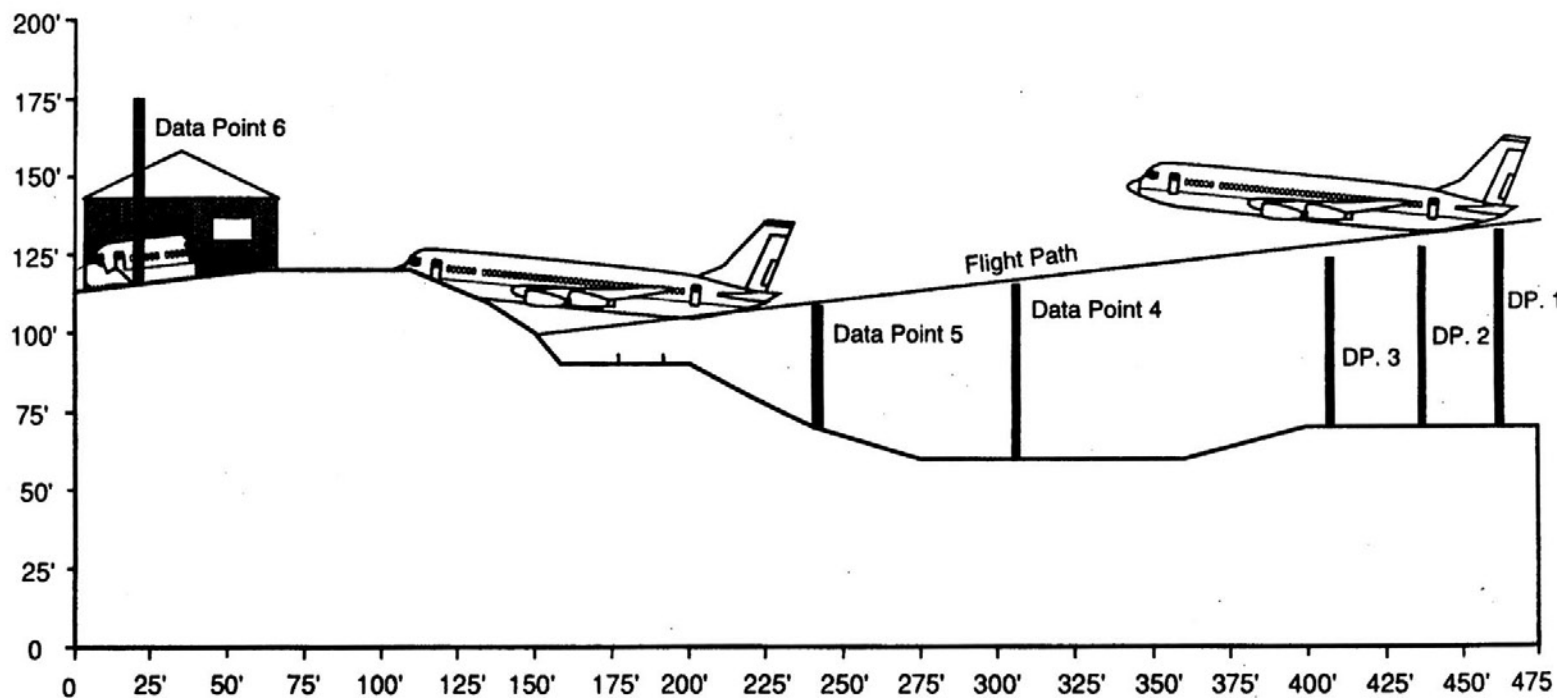
Figure 5.--Terrain impact, AVA052.

Several trees were sheared off just prior to and at the time that the airplane impacted with the ground. The starboard side of the forward fuselage fractured the wooden deck of a residence. Property damage is estimated at approximately \$250,000.

Data Point	Description	Approx. Base Elev.	Measurement	Approx. Top Elev.	Misc. Notes
1	Sheared 17" Hickory Tree	72'	61'	~133'	Measured
2	Sheared 18" Tulp Tree	66'	~61'	~127'	
3	Sheared 10" Unk. Tree	79'	~45'	~124'	
4	Sheared 8" Maple Tree	72'	~36'	~108'	
5	Sheared Telephone Pole	87'	~16'	~103'	
6	24" Oak Tree

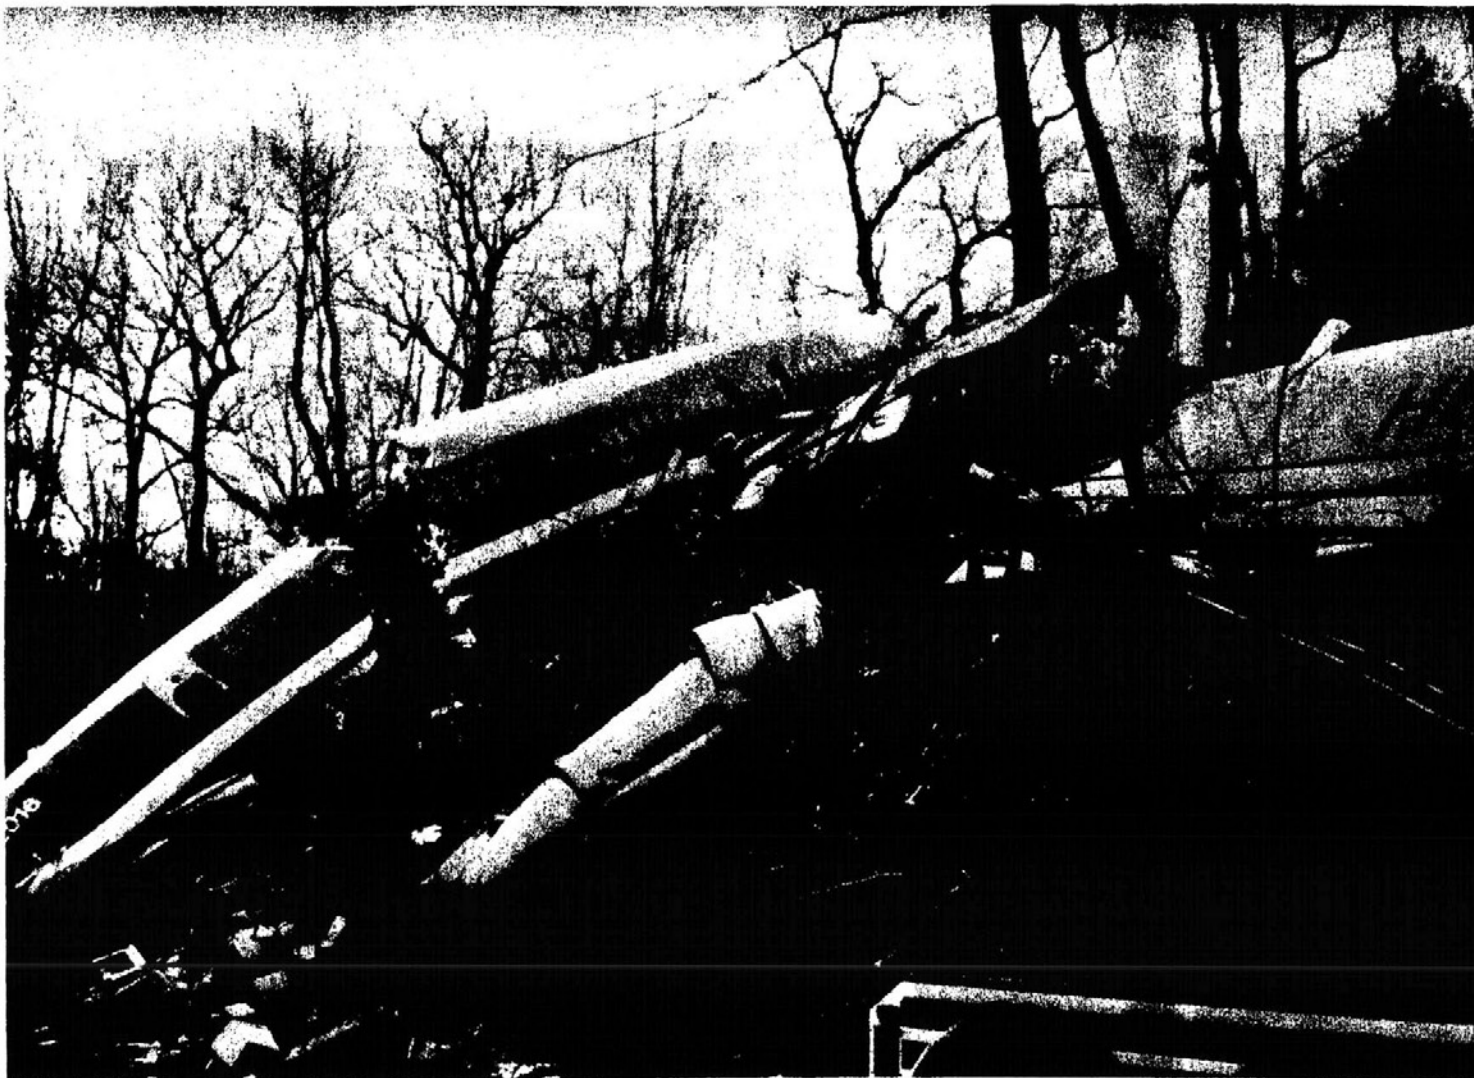
Figure 6.--Wreckage site, AVA052.

The fuselage was found partially separated into three sections. The cockpit and forward cabin had broken away from the rest of the fuselage at the time of terrain impact and had continued to move over the crest of the slope, coming to rest about 90 feet forward of the main wreckage. This section was significantly damaged, with seats and other cabin components lying on the ground, extending back to the main wreckage.

The main fuselage had come to rest, upright, on the upslope of the hill, on a heading of about 182°. The forward end of this section extended over the crest of the slope.
