Controlled Flight into Terrain, MarkAir, Inc. Boeing 737-2X6C, N670MA, Unalakleet, Alaska, June 2, 1990

Investigative Body: National Transportation Safety Board (NTSB), USA

**MARKAIR, INC.,
BOEING 737-2X6C, N670MA
CONTROLLED FLIGHT INTO TERRAIN
UNALAKLEET, ALASKA
JUNE 2, 1990**

**ADOPTED: JANUARY 23, 1991
NOTATION 5358A**

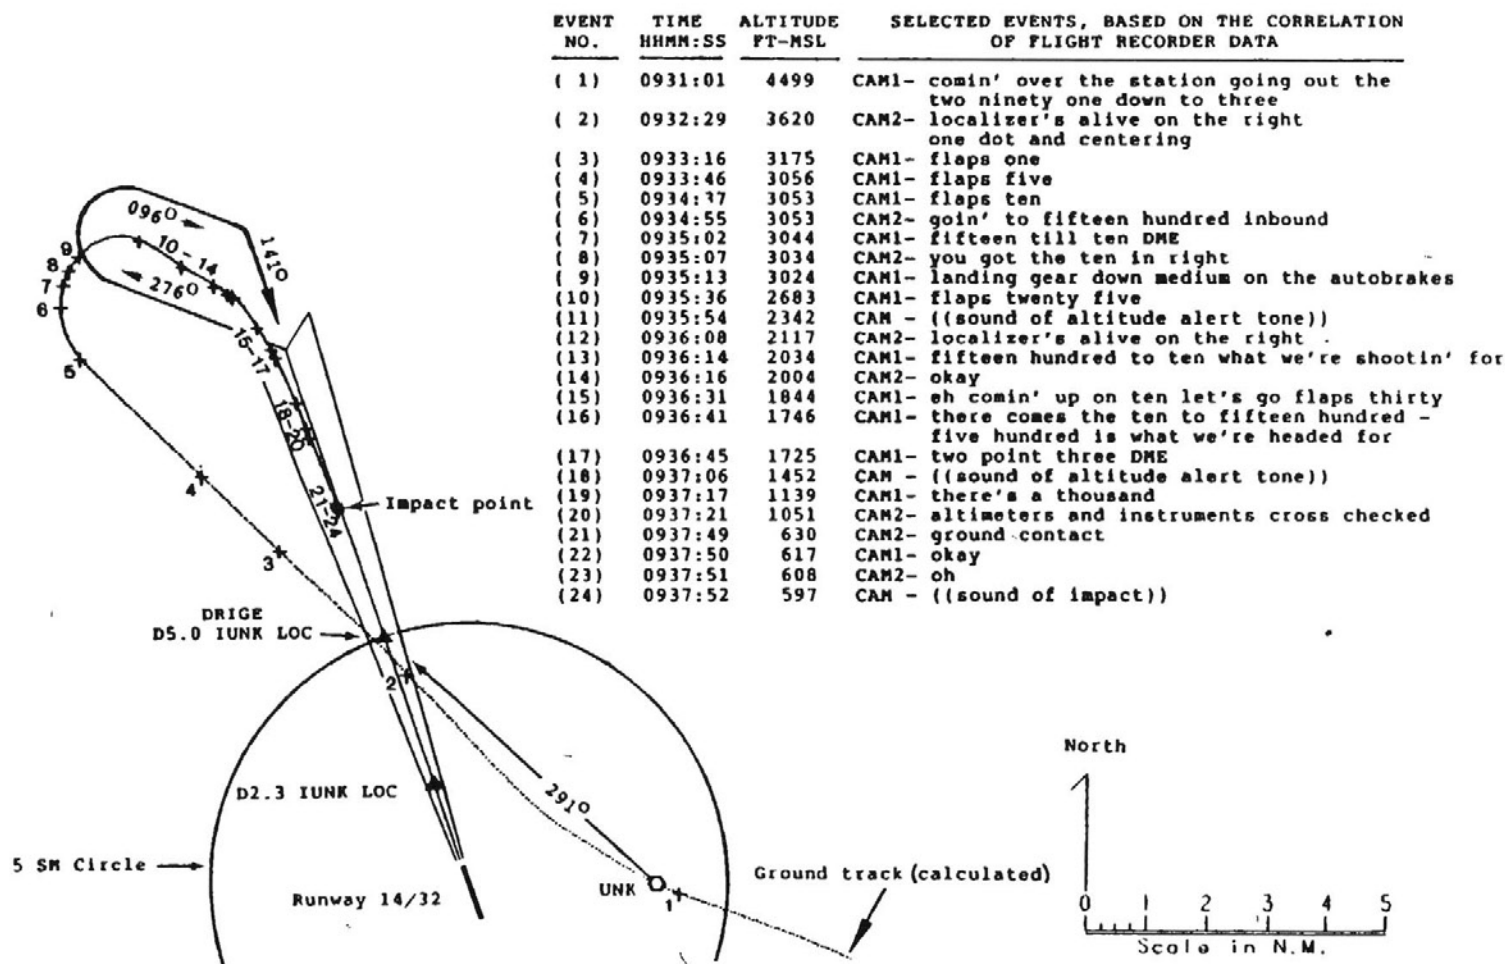
MARKAIR #3087 - LOC RWY 14

Figure 2.--UNK LOC Rwy 14 planview overlaid with MarkAir flight 3087's calculated ground track, selected altitudes, and CVR comments.

At 0936:41, the captain stated, "There comes the 10 to 1,500--500 feet is what we're headed for [lapse of 3 seconds] 2.3 DME." A conversation then ensued about turning the bleed switches off (to aid in avoiding gravel foreign object damage to the engines upon landing) and turning the engine anti-ice system off. This conversation began as the airplane was descending through about 1,700 feet.

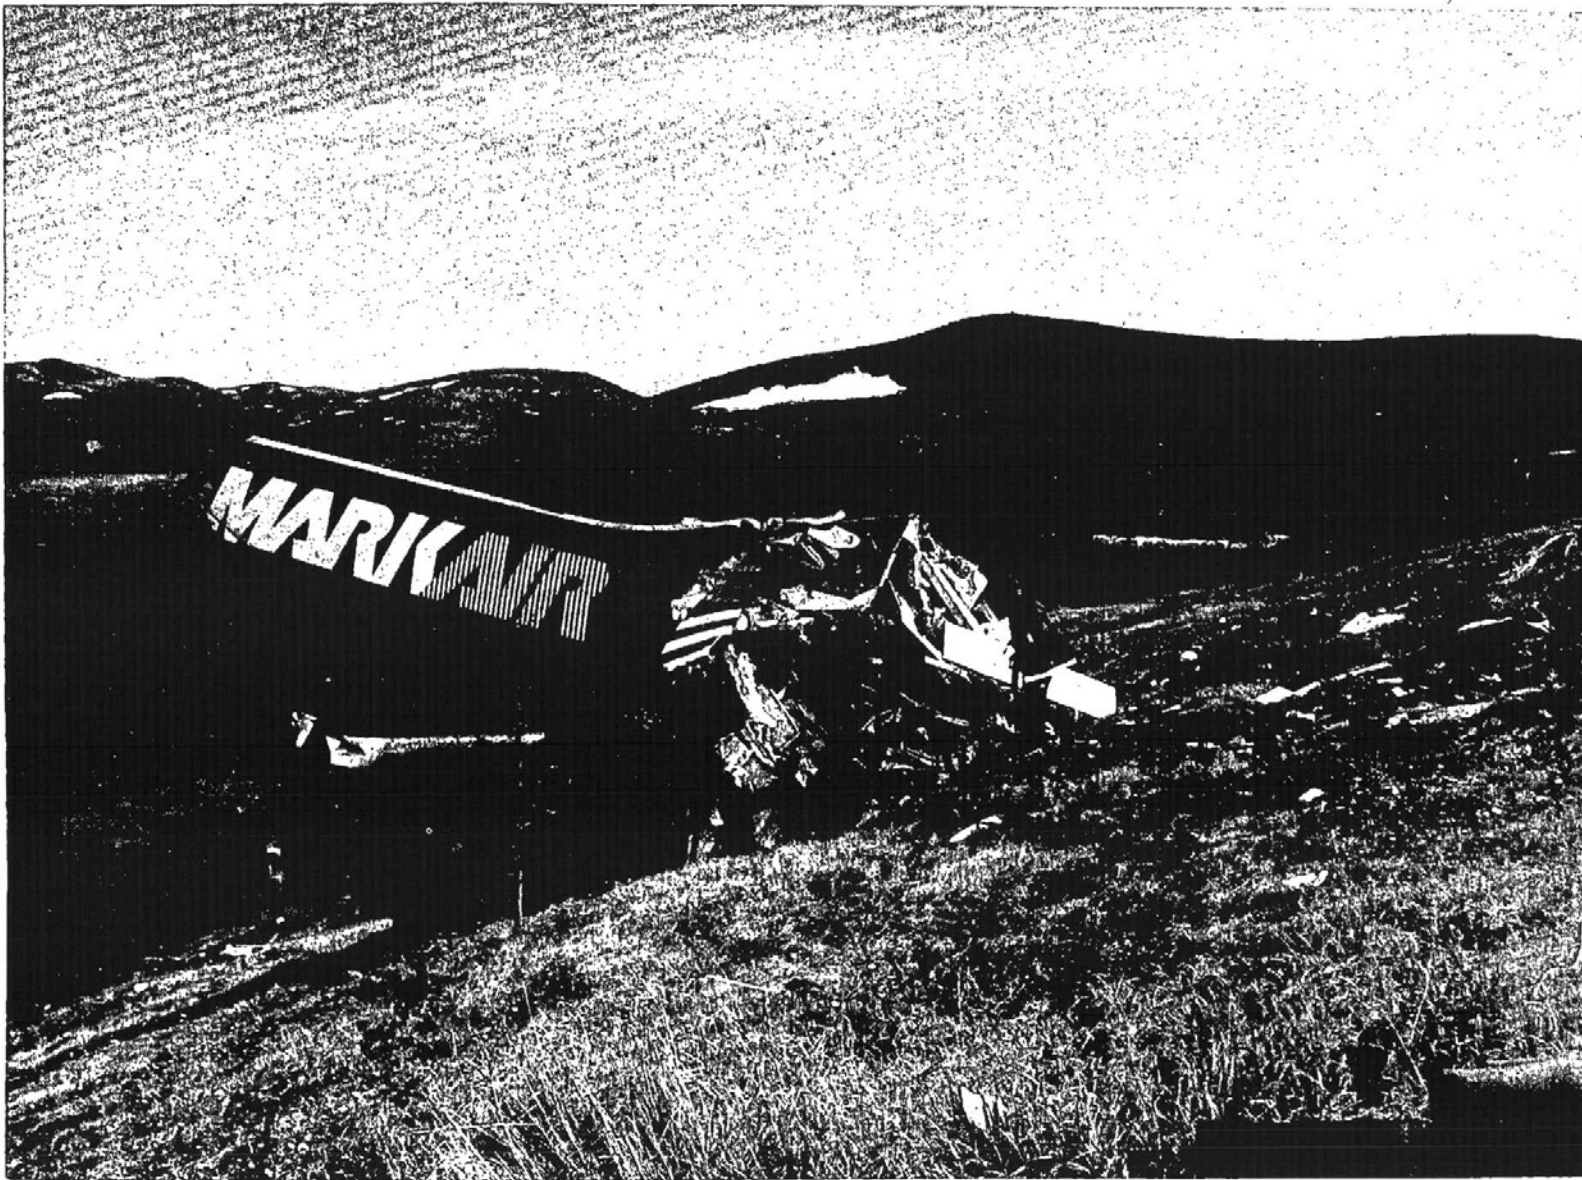
The empennage separated completely from the fuselage just forward of the vertical stabilizer. The empennage was found intact, except for the outboard half of the right horizontal stabilizer and elevator, which separated from the empennage section and was found in many small pieces down the hill. The tips of the left horizontal stabilizer and left elevator were bent upward along the chord line. The upper rear portion of the vertical fin also exhibited sheet metal tearing. The rudder and elevators were constructed of fiberglass and aluminum composite material and the horizontal

Figure 3.--Flight 3087 empennage.

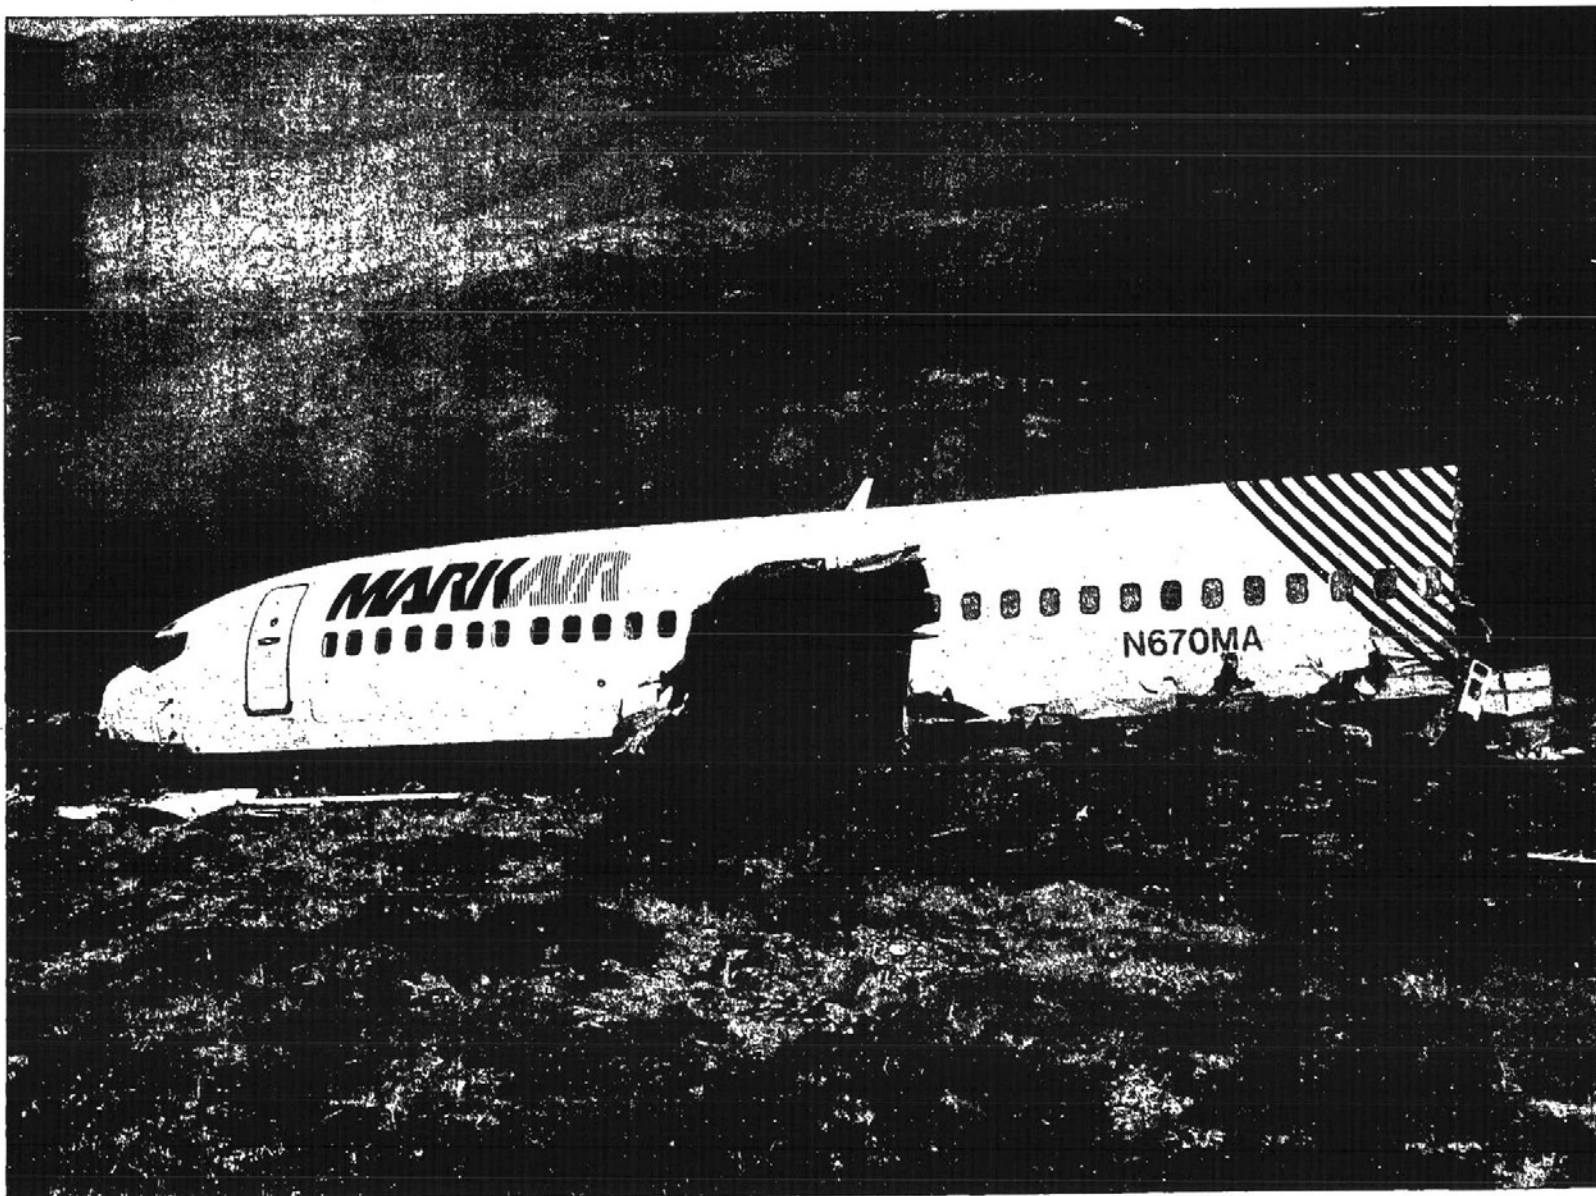
Most of the fuselage below the floor level from the nose of the airplane to the wing center section was destroyed during impact and the slide up the hill. The fuselage had rotated clockwise about 165° before coming to rest on the hill. The nose wheel, well/nose landing gear assembly was dislodged from the fuselage and was found about 20 feet away from the nose of the airplane. The right forward side of the fuselage was cracked and partially separated behind the cockpit, but this separation was only about half the circumference of the fuselage.

Figure 4.--Flight 3087 fuselage.

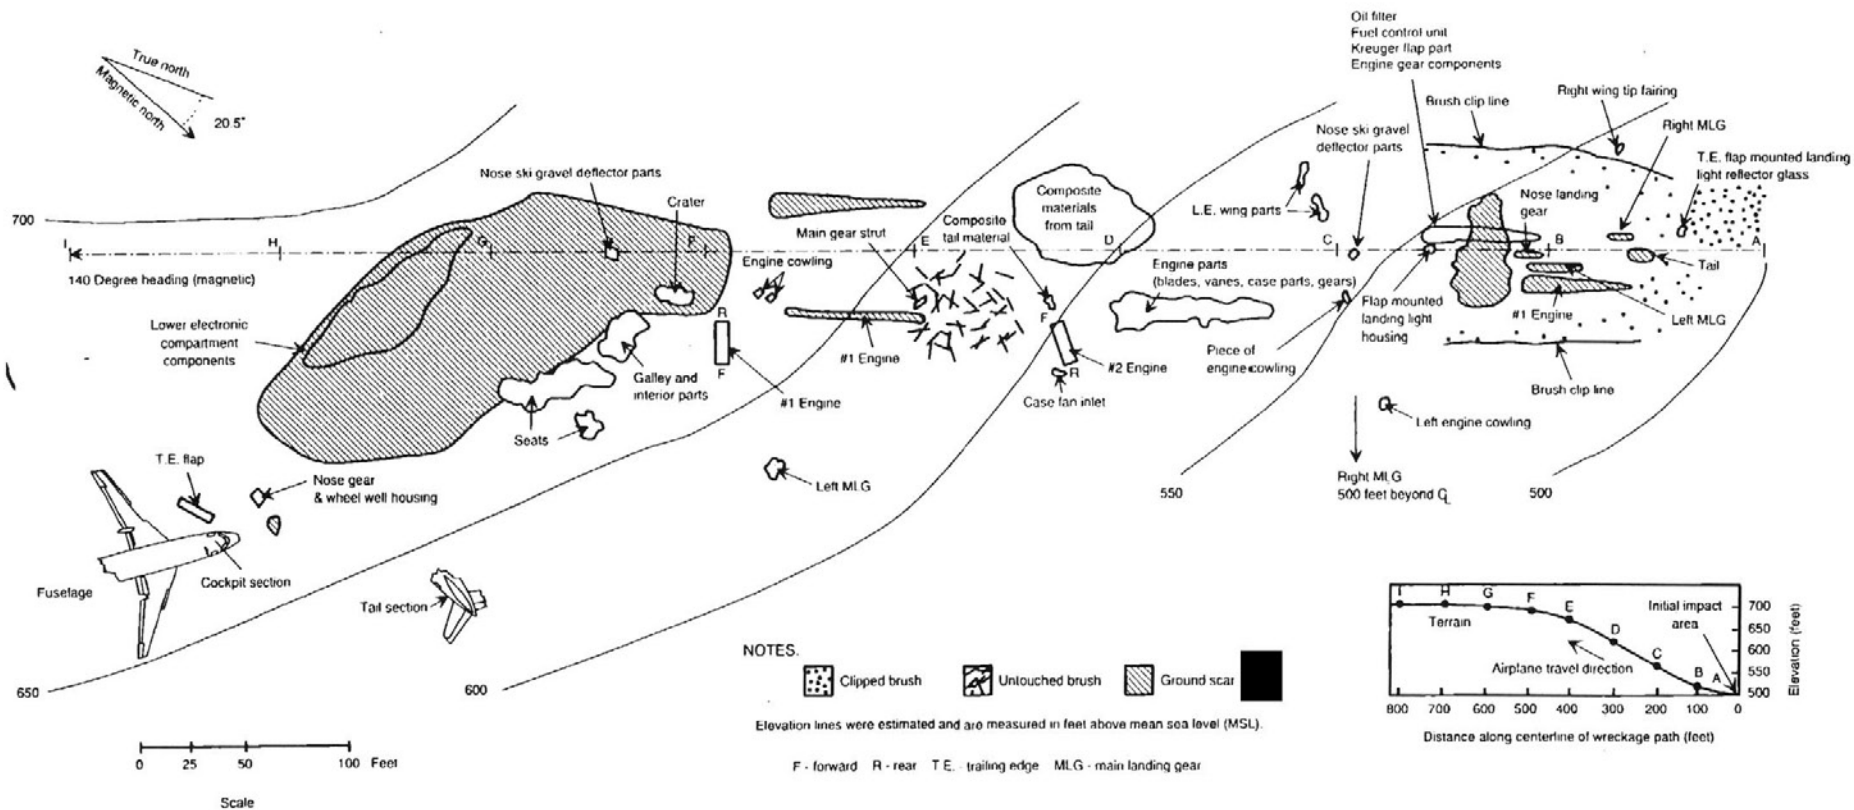
The airplane impacted the ground on a small level area about 530 feet up the northeast slope of Blueberry Hill. The top of Blueberry Hill is about 700 feet. The first indications of impending terrain contact were broken branches on several alder bushes located about 30 feet prior to the first impact mark on the ground. The aircraft began breaking apart upon ground contact and the wreckage scatter pattern extended about 800 feet up the hill on an average magnetic heading of 140° degrees. The width of the wreckage debris field was about 125 feet. The landscape along the wreckage path was typical tundra, small bushes of various kinds, grass, scattered rocks and shale.

Figure 5.-- Wreckage Distribution Diagram.
