Loss of control on takeoff, Ryan International Airlines DC-9-15, N565PC, Cleveland-Hopkins International Airport, Cleveland, Ohio, February 17, 1991

AIRCRAFT ACCIDENT REPORT

DC-9-15, N565PC

LOSS OF CONTROL ON TAKEOFF

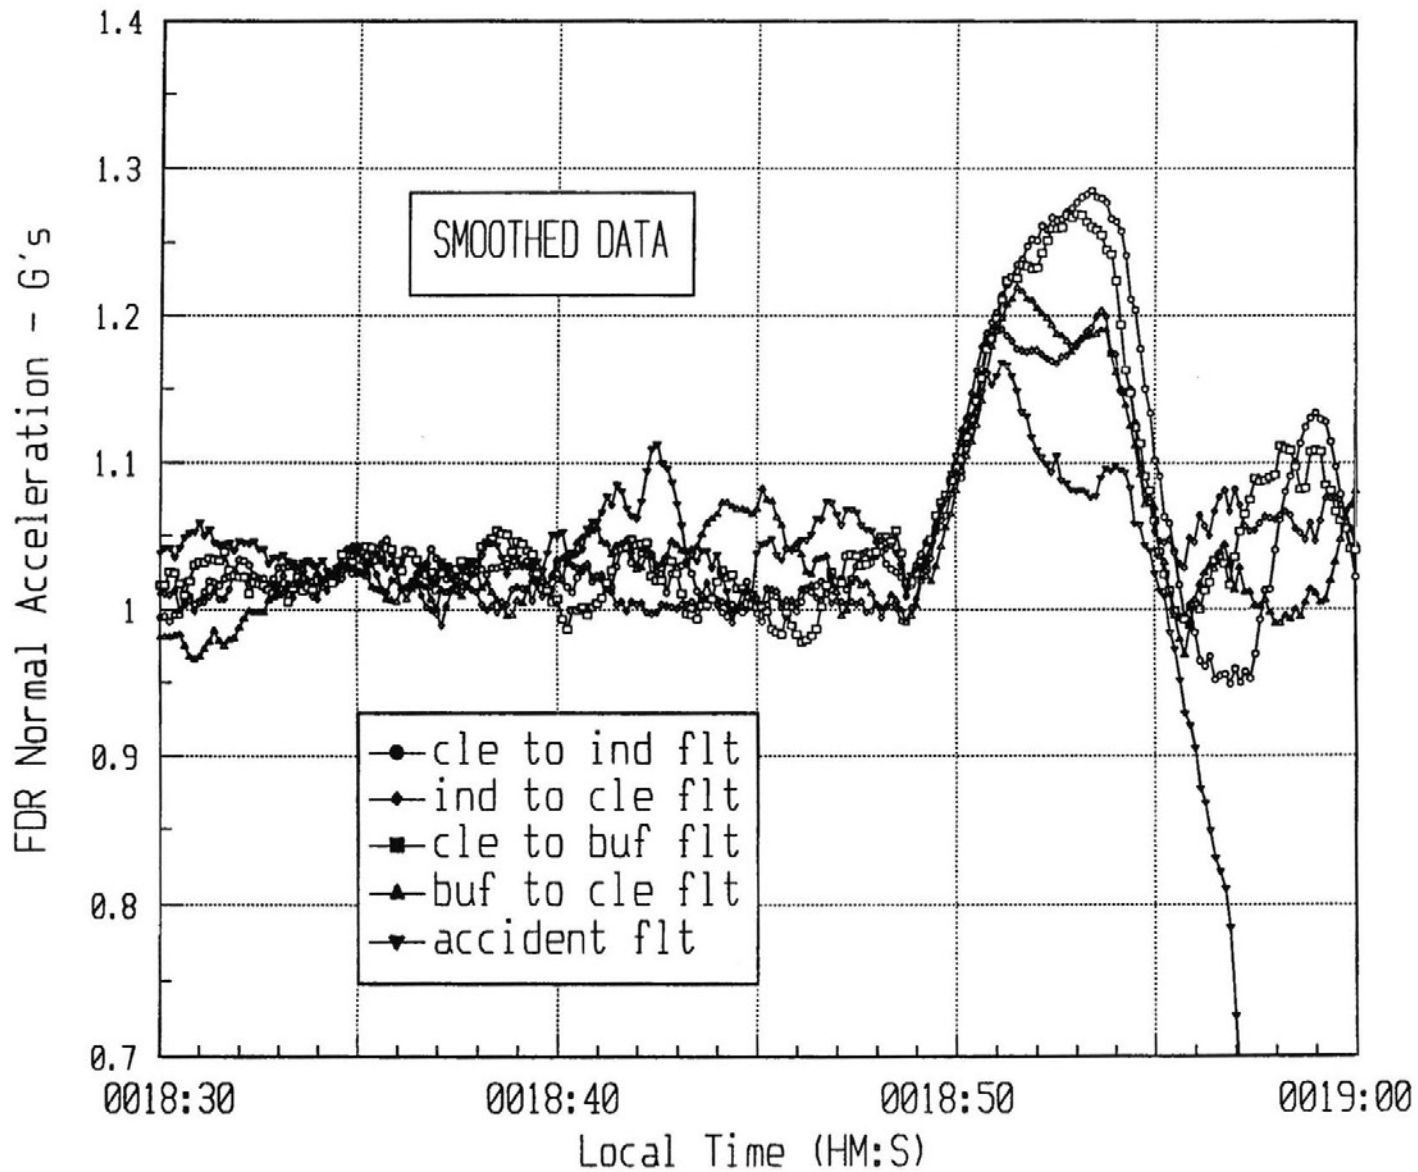
Figure 8.--Normal acceleration data for previous takeoffs.

As the airplane transitioned to climbing flight on previous takeoffs, there was a buildup in normal acceleration, followed by a return to near 1 g values. A comparison of the accident takeoff to the previous four takeoffs is plotted in figure 8. Smoothed acceleration curves for the previous takeoffs were offset so that the beginning of each buildup coincides with that of the accident flight. All five takeoffs display an increase in normal acceleration early in the transition phase, except that the buildup in g values during the accident takeoff abruptly ended after reaching about 1.17 g, and then decreased prematurely. On the previous flights, the positive normal accelerations were sustained for 3 to 5 seconds reaching peak values between 1.2 g and 1.3 g.

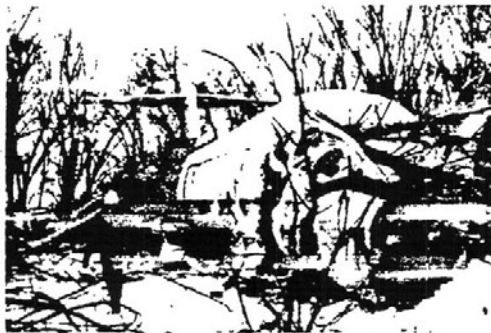
A somewhat in-between case is shown in Figure 1. This airplane made a normal approach into Sioux City, Iowa, in 1968. Mild icing was encountered during the approach, but the flight crew elected not to turn on the airfoil ice protection. During the turnaround, a light freezing drizzle was falling. The flight crew

Figure 1. There Is No Such Thing as "A Little Ice"

was advised by ground maintenance personnel that there was ice on the wing and asked if the airplane should be de-iced. The flight crew declined the offer and proceeded with the takeoff. As the landing gear began to retract, the aircraft rolled violently to the right. Rudder and aileron application brought the right wing up; however, the roll continued to the left until the left wing contacted the runway. The captain succeeded in leveling the aircraft before it hit the ground about 110 feet beyond the end of the runway and skidded into a grove of trees where it came to rest, as shown in the figure.
