**In-flight upset, United Airlines Flight 585, Boeing 737-291, N999UA,
Uncontrolled Collision with Terrain for Undetermined Reasons, 4 Miles
South Of Colorado Springs Municipal Airport, Colorado Springs,
Colorado, March 3, 1991**

Uncontrolled Descent and Collision With Terrain
United Airlines Flight 585
Boeing 737-200, N999UA
4 Miles South of Colorado Springs
Municipal Airport
Colorado Springs, Colorado
March 3, 1991

**NTSB/AAR-01/01
PB2001-910401
Notation 5498C
Adopted March 27, 2001**

The National Transportation Safety Board determines that the probable cause of the United Airlines flight 585 accident was a loss of control of the airplane resulting from the movement of the rudder surface to its blowdown limit. The rudder surface most likely deflected in a direction opposite to that commanded by the pilots as a result of a jam of the main rudder power control unit servo valve secondary slide to the servo valve housing offset from its neutral position and overtravel of the primary slide.

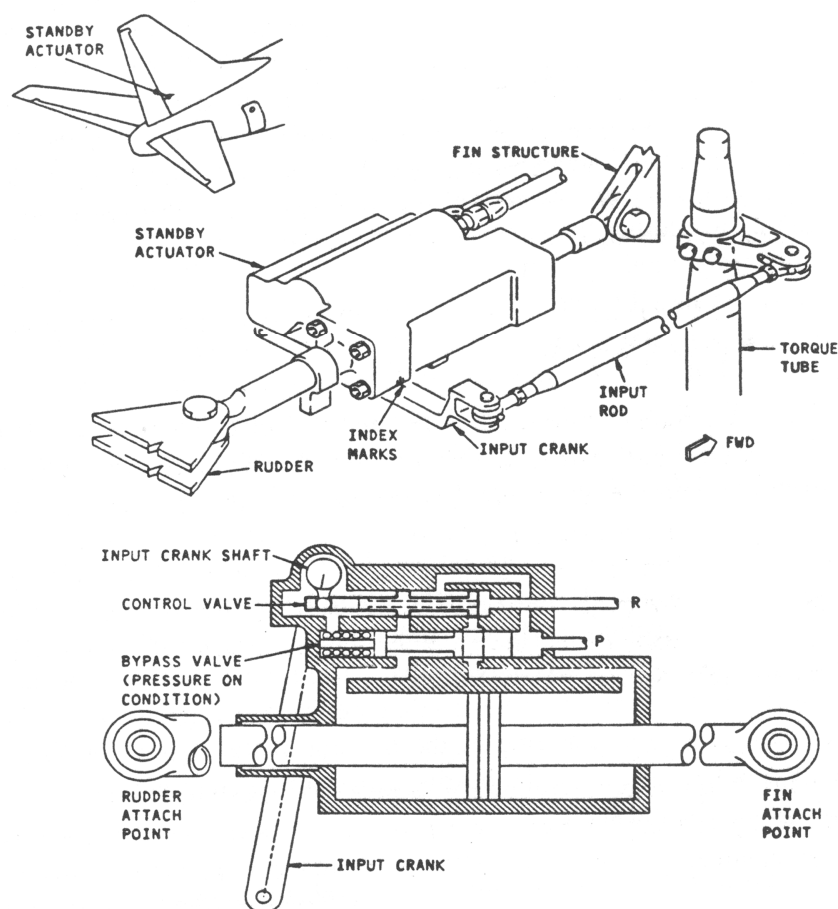
A review of the design of the B-737 rudder control system revealed that binding of the input shaft to the bearing that is threaded in the actuator body could potentially cause flight control problems even though the standby rudder hydraulic system is not pressurized. In the rudder control system, the pilot pedal movement is applied through a mechanical control system to a lever arm to rotate a torque tube in the empennage. Other lever arms attached to the torque tube transmit linear motion to the ends of the input cranks for both the MPCU and the standby rudder actuator. (See figure 11).

Figure 11. Standby rudder actuator.

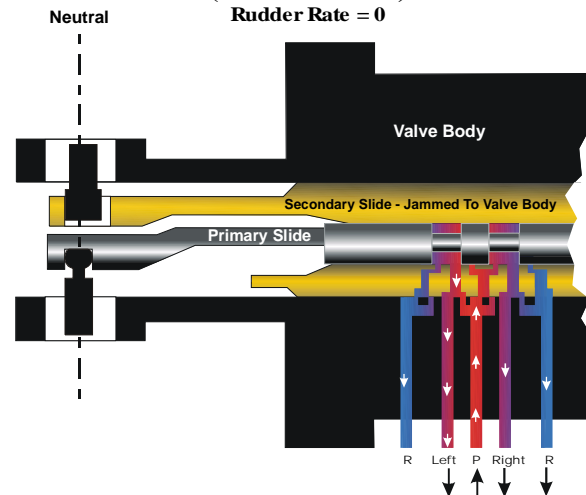
Intended Operation:
Secondary Slide Jammed Full Open, Primary Slide Opposing
(Full Cross Flow)
Rudder Rate = 0

Figure 14. PCU servo valve intended operation with the secondary slide jammed to the servo valve housing and primary slide opposing.

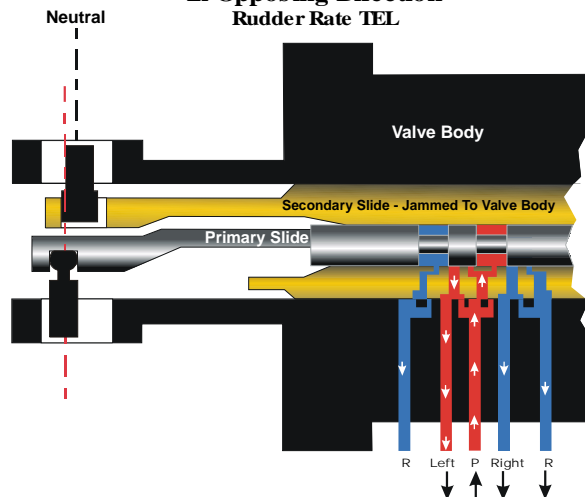
Newly Discovered Failure Effect:
Secondary Slide Jammed Full Open, Primary Slide Over-Stroke
In Opposing Direction
Rudder Rate TEL

Figure 15. PCU servo valve with the secondary slide jammed to the servo valve housing and the primary slide in the overtravel condition.

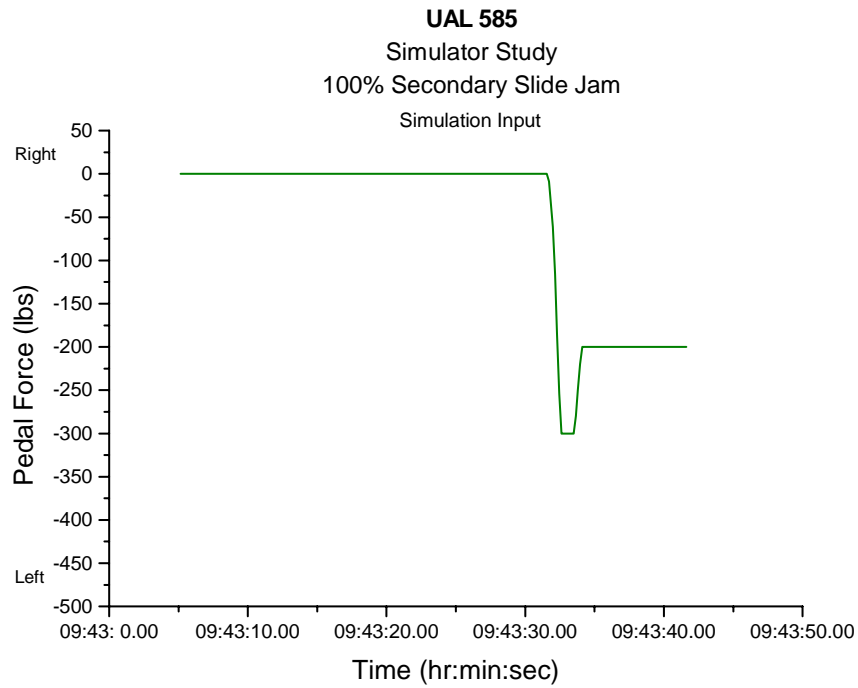
Figure 16. Pilot rudder pedal force positions for United flight 585.

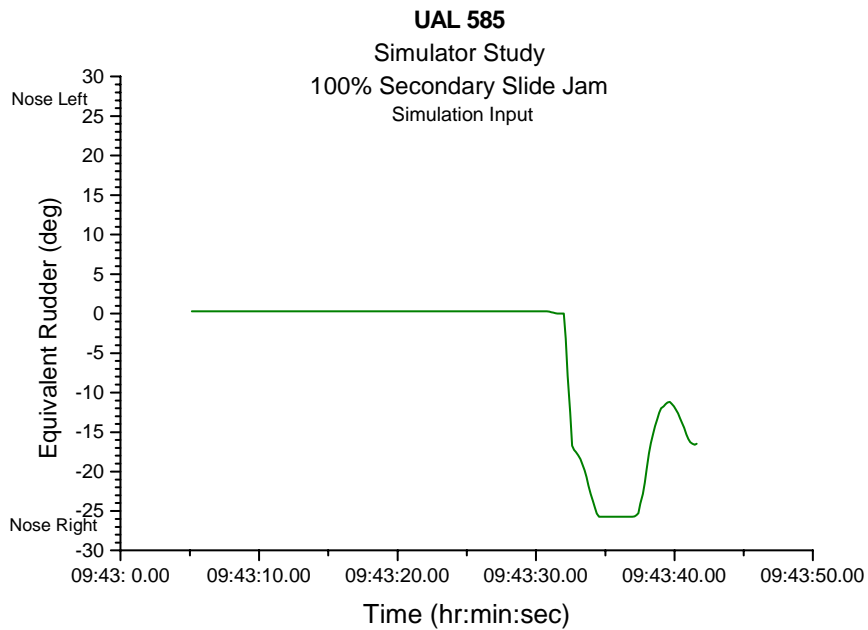
Figure 16a. Rudder surface positions for United flight 585.

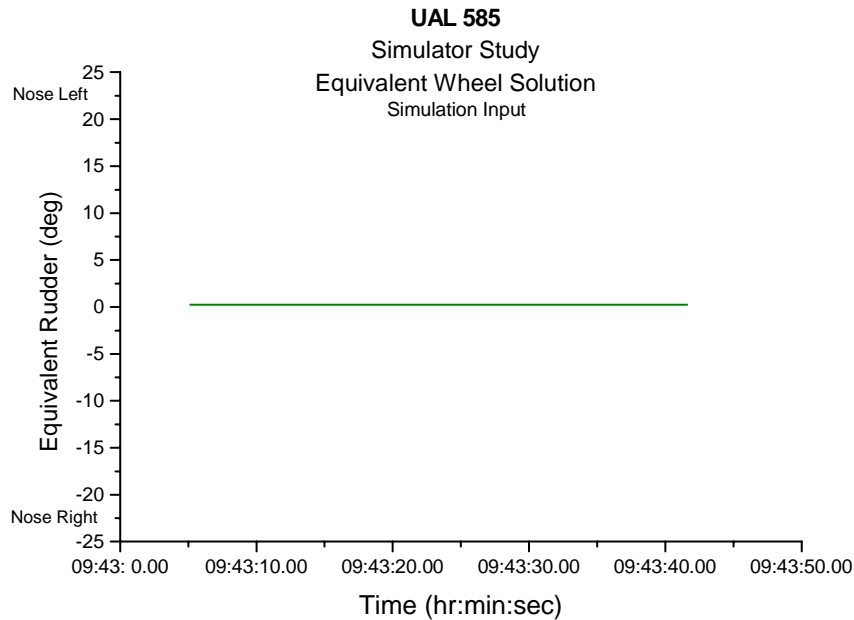
to the right with no rudder input. The equivalent control wheel input could represent a pilot command, a rotational wind, or a combination of the two. Figures 17 through 17f show the resultant data for rudder surface and control wheel positions and heading, normal load factor, calibrated airspeed, pitch angle, and bank angle data, respectively. Figures 17e and 17f also show CVR data.

Figure 17. Rudder surface positions for United flight 585 assuming a sustained equivalent control wheel input.

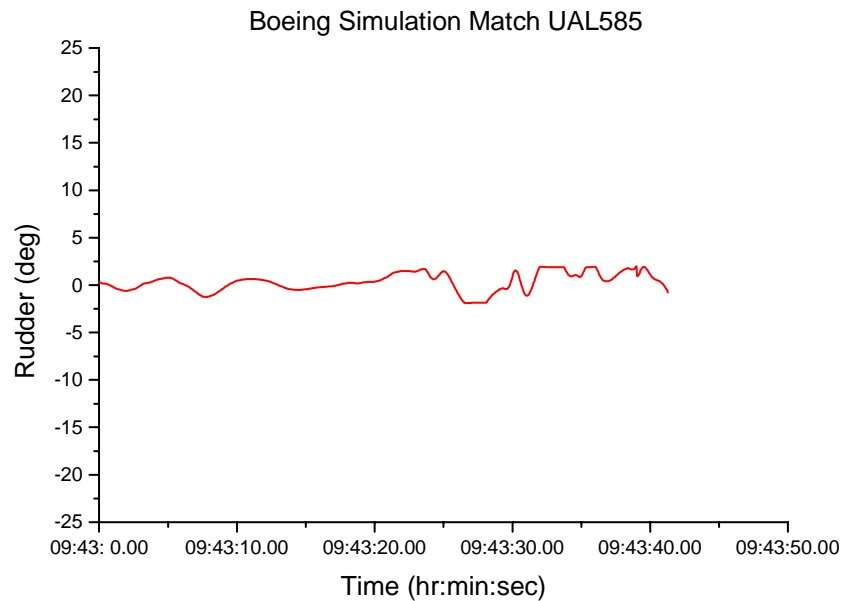
In a June 23, 1997, letter to the Safety Board, Boeing provided its analysis of the United flight 585 accident.⁷³ Boeing's analysis concluded that a rudder hardover scenario did not fit the FDR data and that a "new rotor model" did match the data.⁷⁴ Further, Boeing derived this new rotor model to match the available data and introduced a rotational effect of near zero just before 0943:28, which increased linearly to about 0.4 radians per second just before 0943:29 and then increased linearly to about 1.8 radians per second about the time the airplane impacted the ground (just before 0943:42).

Figure 18. United flight 585 rudder surface positions according to Boeing's new rotor model.
