Uncontrolled Descent and Collision With Terrain, United Airlines Flight 585, Boeing 737-200, N999UA, 4 Miles South of Colorado Springs Municipal Airport, Colorado, Springs, Colorado, March 3, 1991

AIRCRAFT ACCIDENT REPORT

UNITED AIRLINES FLIGHT 585
BOEING 737-291, N999UA
UNCONTROLLED COLLISION WITH TERRAIN
FOR UNDETERMINED REASONS
4 MILES SOUTH OF
COLORADO SPRINGS MUNICIPAL AIRPORT
COLORADO SPRINGS, COLORADO
MARCH 3, 1991

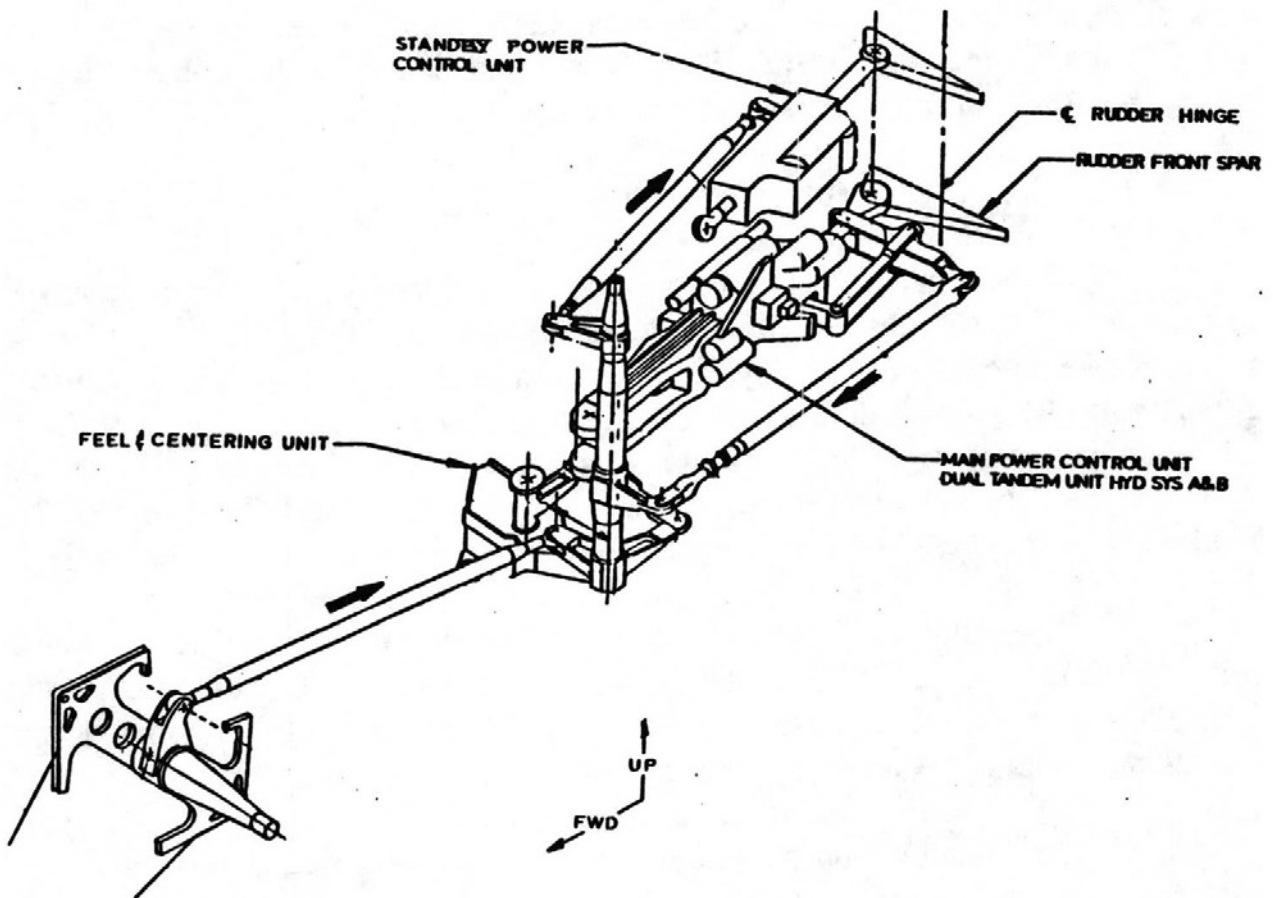
The standby rudder actuator is not normally powered. When operation is selected by the "A" or "B" flight control switches (either switch positioned to STBY RUD), the actuator is powered through the standby rudder system. At least one side of the main power control unit is not powered when the standby actuator is powered. No more than two hydraulic systems can be used to operate the rudder.

Inputs from the rudder pedals or trim actuator are simultaneous to the main (MPCU) and the standby actuator. When pressure is not available for any system, a bypass valve is positioned to connect both sides of the piston in that system's actuator to the same port of the control valve to prevent a hydraulic lock.

Figure 1.--B-737 rudder control system
main power control unit and standby actuator.

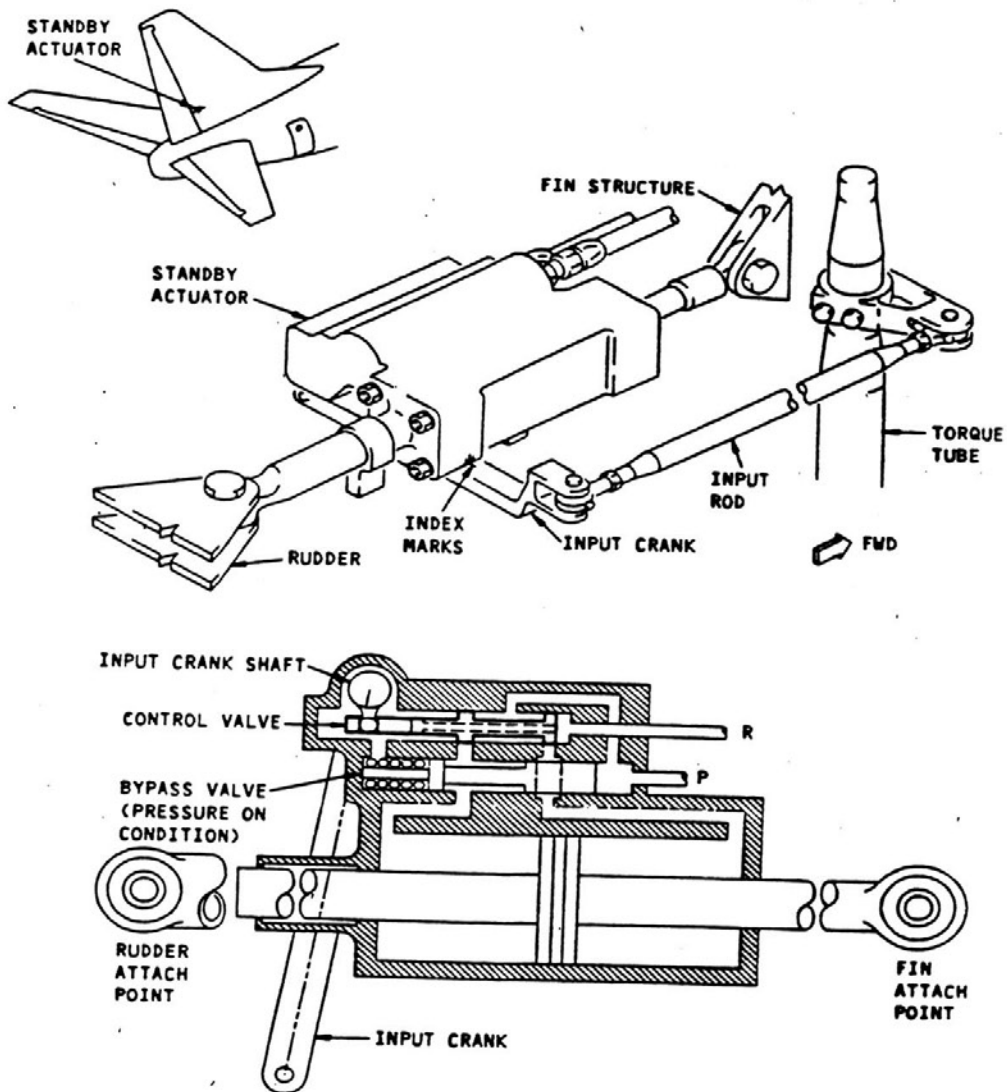
A review of the design of the B-737 rudder control system revealed that binding of the input shaft to the bearing that is threaded in the actuator body could potentially cause flight control problems even though the standby rudder hydraulic system is not pressurized. In the rudder control system, the pilot pedal movement is applied through a mechanical control system to a lever arm to rotate a torque tube in the empennage. Other lever arms attached to the torque tube transmit linear motion to the ends of the input cranks for both the MPCU and the standby rudder actuator. (See figure 5).

Figure 5.--Standby rudder actuator.

change the length of this link by rotation of the standby rudder actuator input crank within the actuator housing will affect the feedback mechanism between the rudder position and the MPCU input crank. This condition can result in problems ranging from high pilot control force necessary to move the rudder to uncommanded rudder deflections.

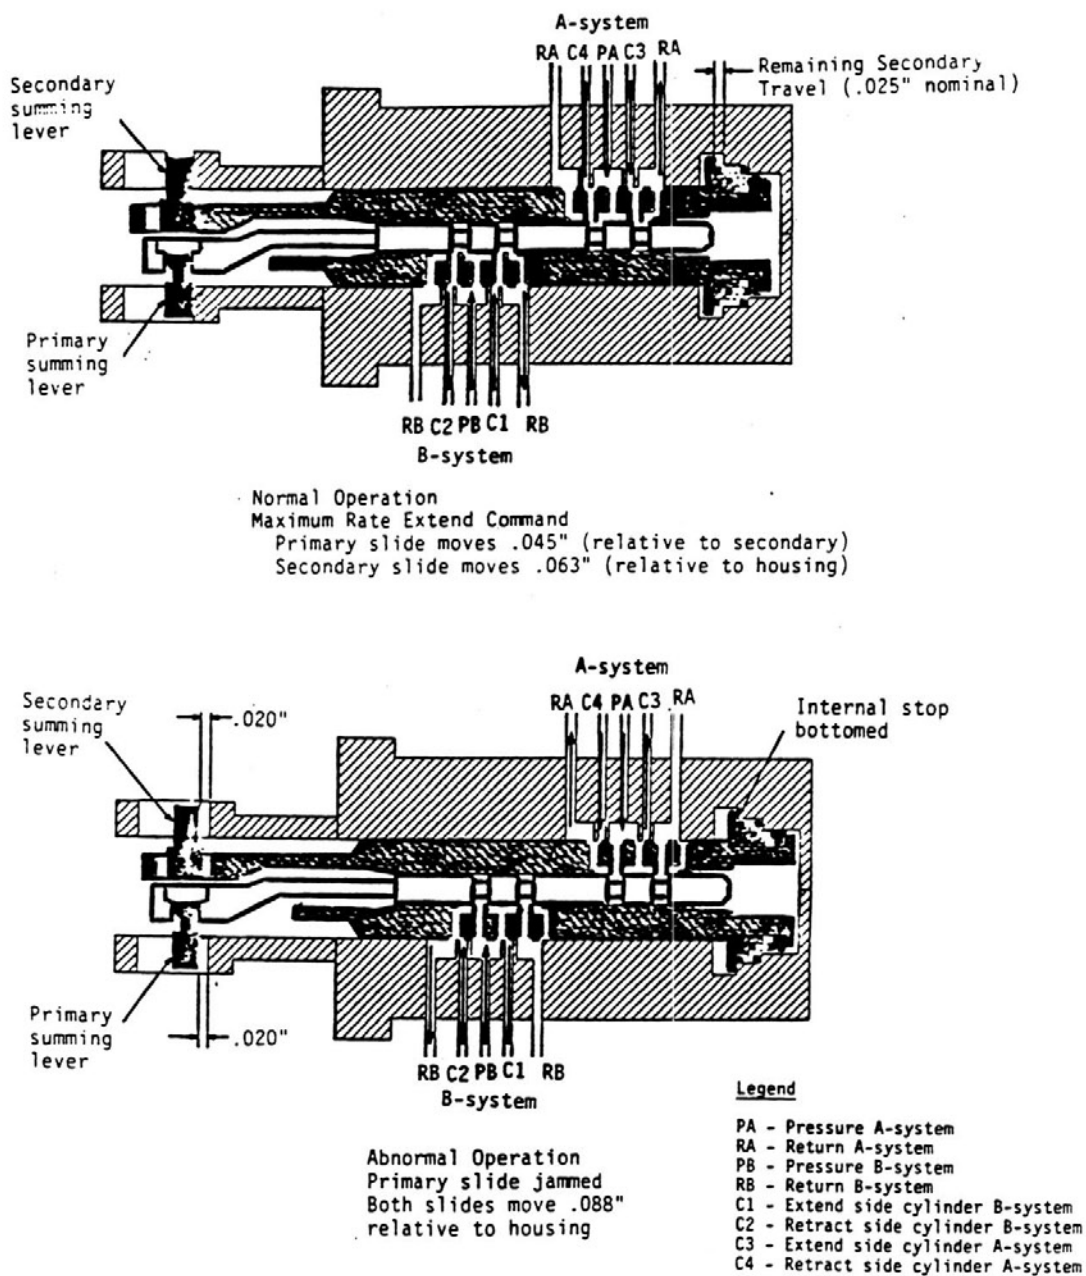
Figure 7.--B-737 Rudder power control unit servo valve schematic of normal and abnormal operation.
