In-Flight Structural Breakup, Britt Airways, Inc. dba Continental Express Flight 2574, EMB-120RT, N33701, Eagle Lake, Texas, September 11, 1991

NTSB/AAR-92/04

BRITT AIRWAYS, INC., d/b/a CONTINENTAL EXPRESS FLIGHT 2574 IN-FLIGHT STRUCTURAL BREAKUP EMB-120RT, N33701 EAGLE LAKE, TEXAS SEPTEMBER 11, 1991

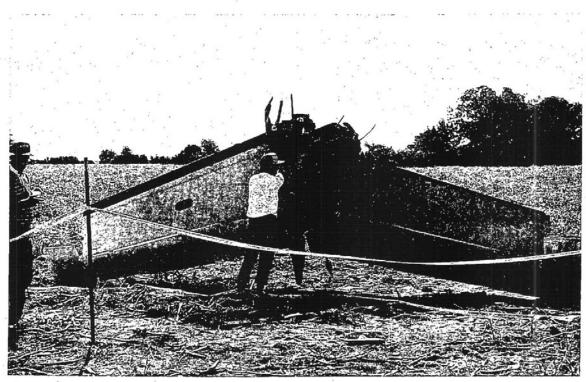
During the Safety Board's examination of the wreckage, none of the 47 screws that would have attached the upper surface of the leading edge assembly for the left side of the horizontal stabilizer was found. There was no evidence of distress in the upper attachment holes for the left side leading edge assembly or indication that the attaching screws were installed when the left side leading edge assembly separated from the horizontal stabilizer. In addition, a "lip" was formed on the forwardmost frame on the left lower side of the horizontal stabilizer spar cap. That frame (spar cap), with receptor holes for the lower attaching screws, was the area into which the screws mounted the underside of the left side leading edge assembly to the stabilizer. This lower frame area showed signs of distress. Figures la through 1d show the condition of the left horizontal stabilizer leading edge.

The lower attachment screws remained installed, but the leading edge assembly had separated from the stabilizer, with the exception of a small portion of composite structure remaining below the two farthest inboard screw heads. The spar cap on the lower left side of the horizontal stabilizer showed evidence of being pulled down so that it would project into the wind stream along with the leading edge. This pulling damage is consistent with the left side leading edge assembly having been ripped down and away from the lower attaching screws as it separated from the horizontal stabilizer. This evidence was consistent with screws missing on the top side of the left leading edge assembly, and the lower attaching screws holding fast, pulling down the frame (spar cap) on the lower side of the stabilizer, and thereby forming the lip.

Figure 1a.--View of horizontal stabilizer from underside.

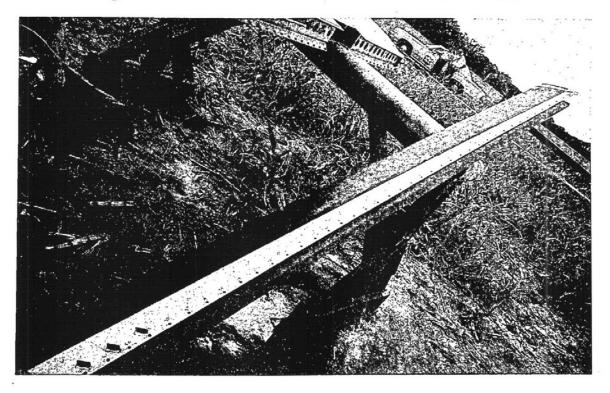
Figure 1b.--Leading edge assembly and outboard portion of left side of horizontal stabilizer.

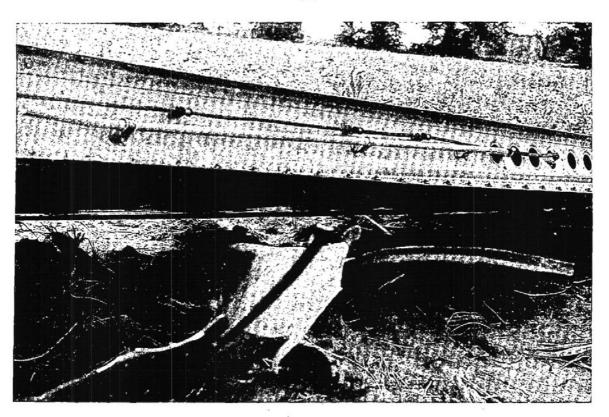
Figure 1c.--Front frame of left side of horizontal stabilizer with lower screw attaching area angled downward.

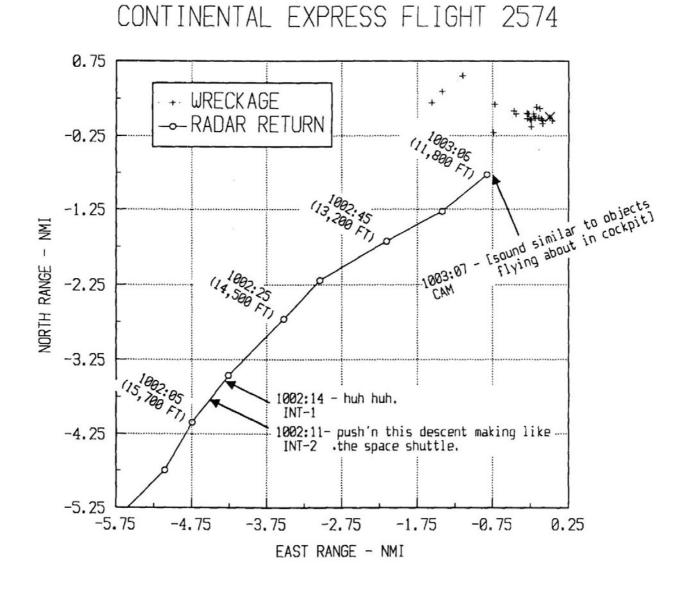
The airplane was flying to the northeast on a 44-degree heading at the time radar contact was lost at 1003:06 CDT. Figure 2 shows the radar-derived ground track of flight 2574, selected sounds from the CVR, and the wreckage distribution.

Figure 2.--Radar-derived ground track, CVR sounds, and wreckage distribution.

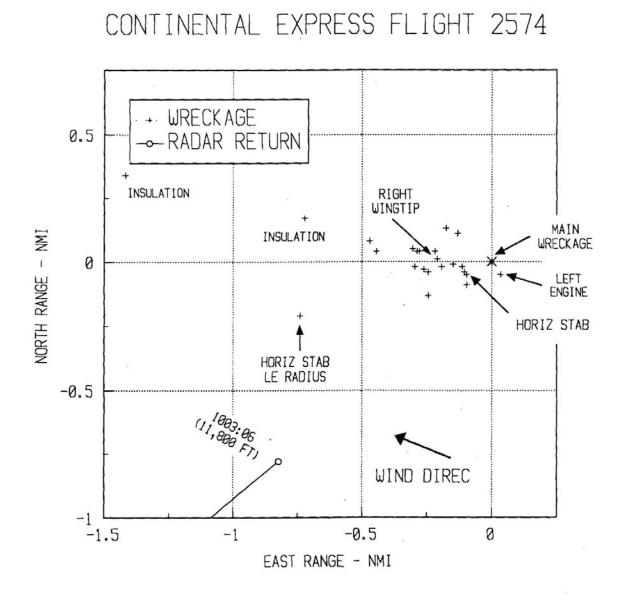
Figure 3 provides a closeup view of part of the ground track and wreckage distribution. The piece of airplane structure farthest from the main wreckage was the left side leading edge (LE) of the horizontal stabilizer. The LE

Figure 3.--Closeup view of part of ground track and wreckage distribution.

was the first piece of structure along the flight's northeasterly ground track, preceding the next piece by roughly 1/2 of a nautical mile.

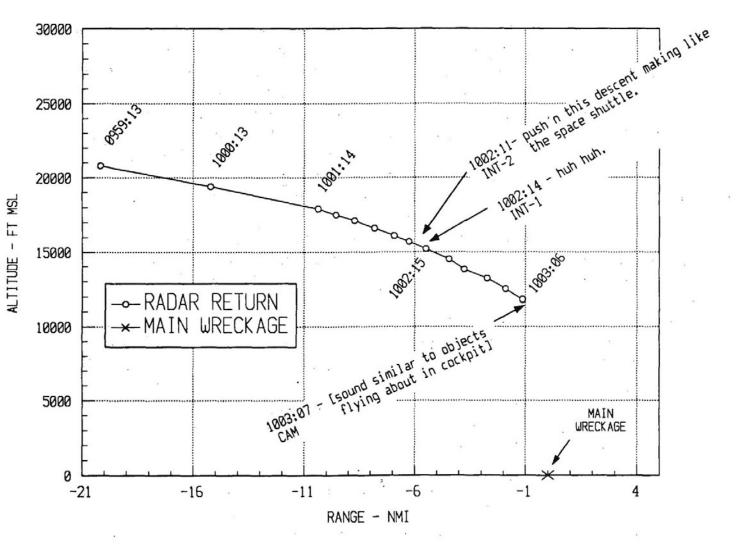
Figure 4.--Radar-derived descent profile.
