Loss of control and crash, Air Transport International, Inc. Flight 805, Douglas DC-8-63, N794AL, Swanton, Ohio, February 15, 1992

Investigative Body: National Transportation Safety Board (NTSB), USA

AIR TRANSPORT INTERNATIONAL, INC., FLIGHT 805
DOUGLAS DC-8-63, N794AL
LOSS OF CONTROL AND CRASH
SWANTON, OHIO
FEBRUARY 15, 1992

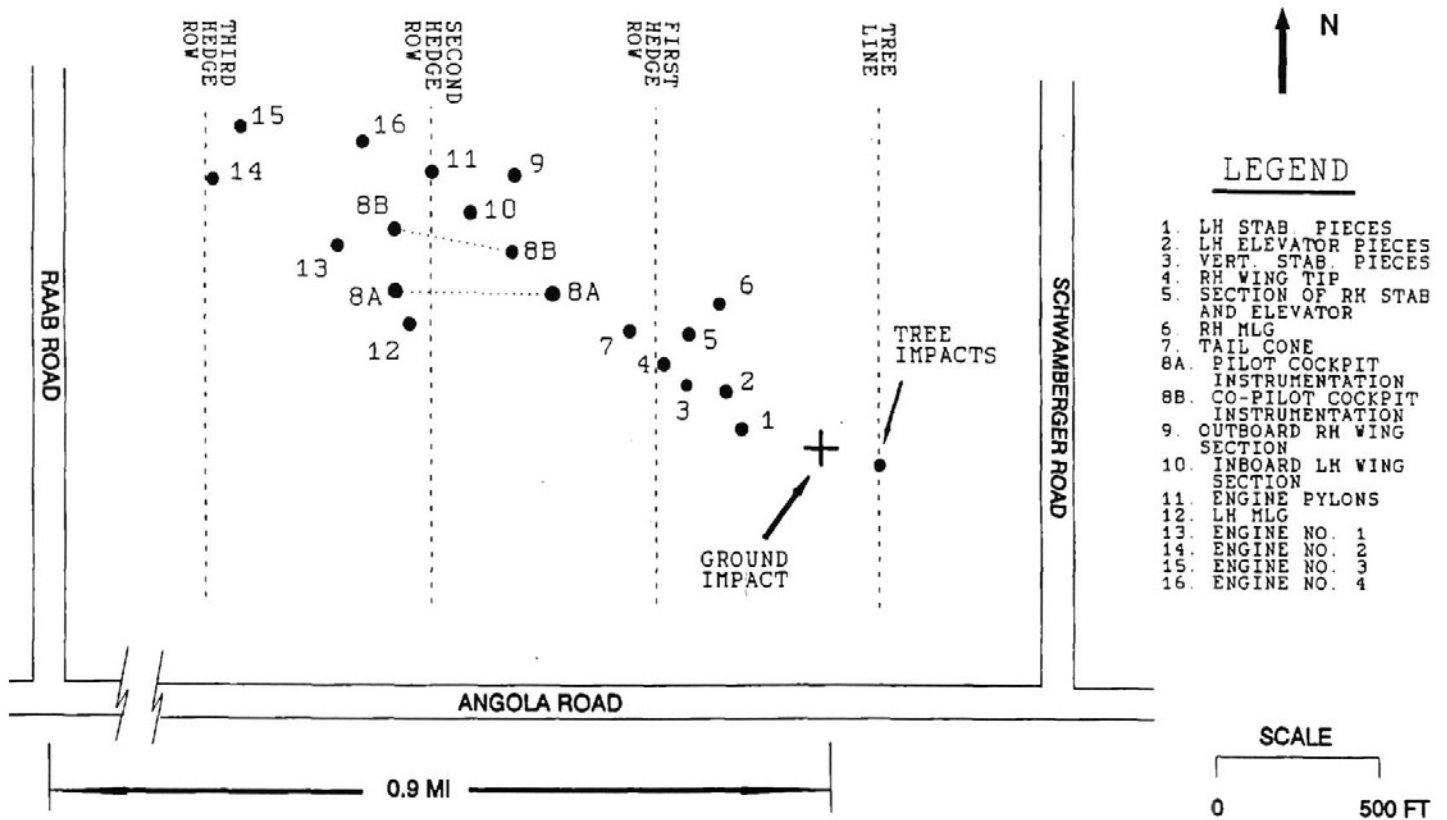
Figure 3.--Wreckage distribution diagram.

Several tree strikes were documented near the location of the initial ground impact site. In the area of the tree impacts, only a few small pieces of wing skin and engine cowling were found. A piece of one of the trees measuring 2 feet in length was found toward the west end of the debris field and was imbedded with several pieces of thick wing skin.

At the initial ground impact site, several ground scars were observed that were consistent with the size and spacing of the left wing tip, No. 1 engine, No. 2 engine, fuselage, No. 3 engine, and No. 4 engine. No initial ground scars were observed outboard of the No. 4 engine indentation. Based on the tree strikes, ground scars, and airplane dimensions, the flightpath angle was estimated at 17 degrees down, and the airplane roll was approximately 15 degrees left wing down.

The tail cone was found approximately 600 feet from the initial ground impact site. The bottom was not crushed and the tail light and lens, which are located on the bottom of the tail cone, were intact.

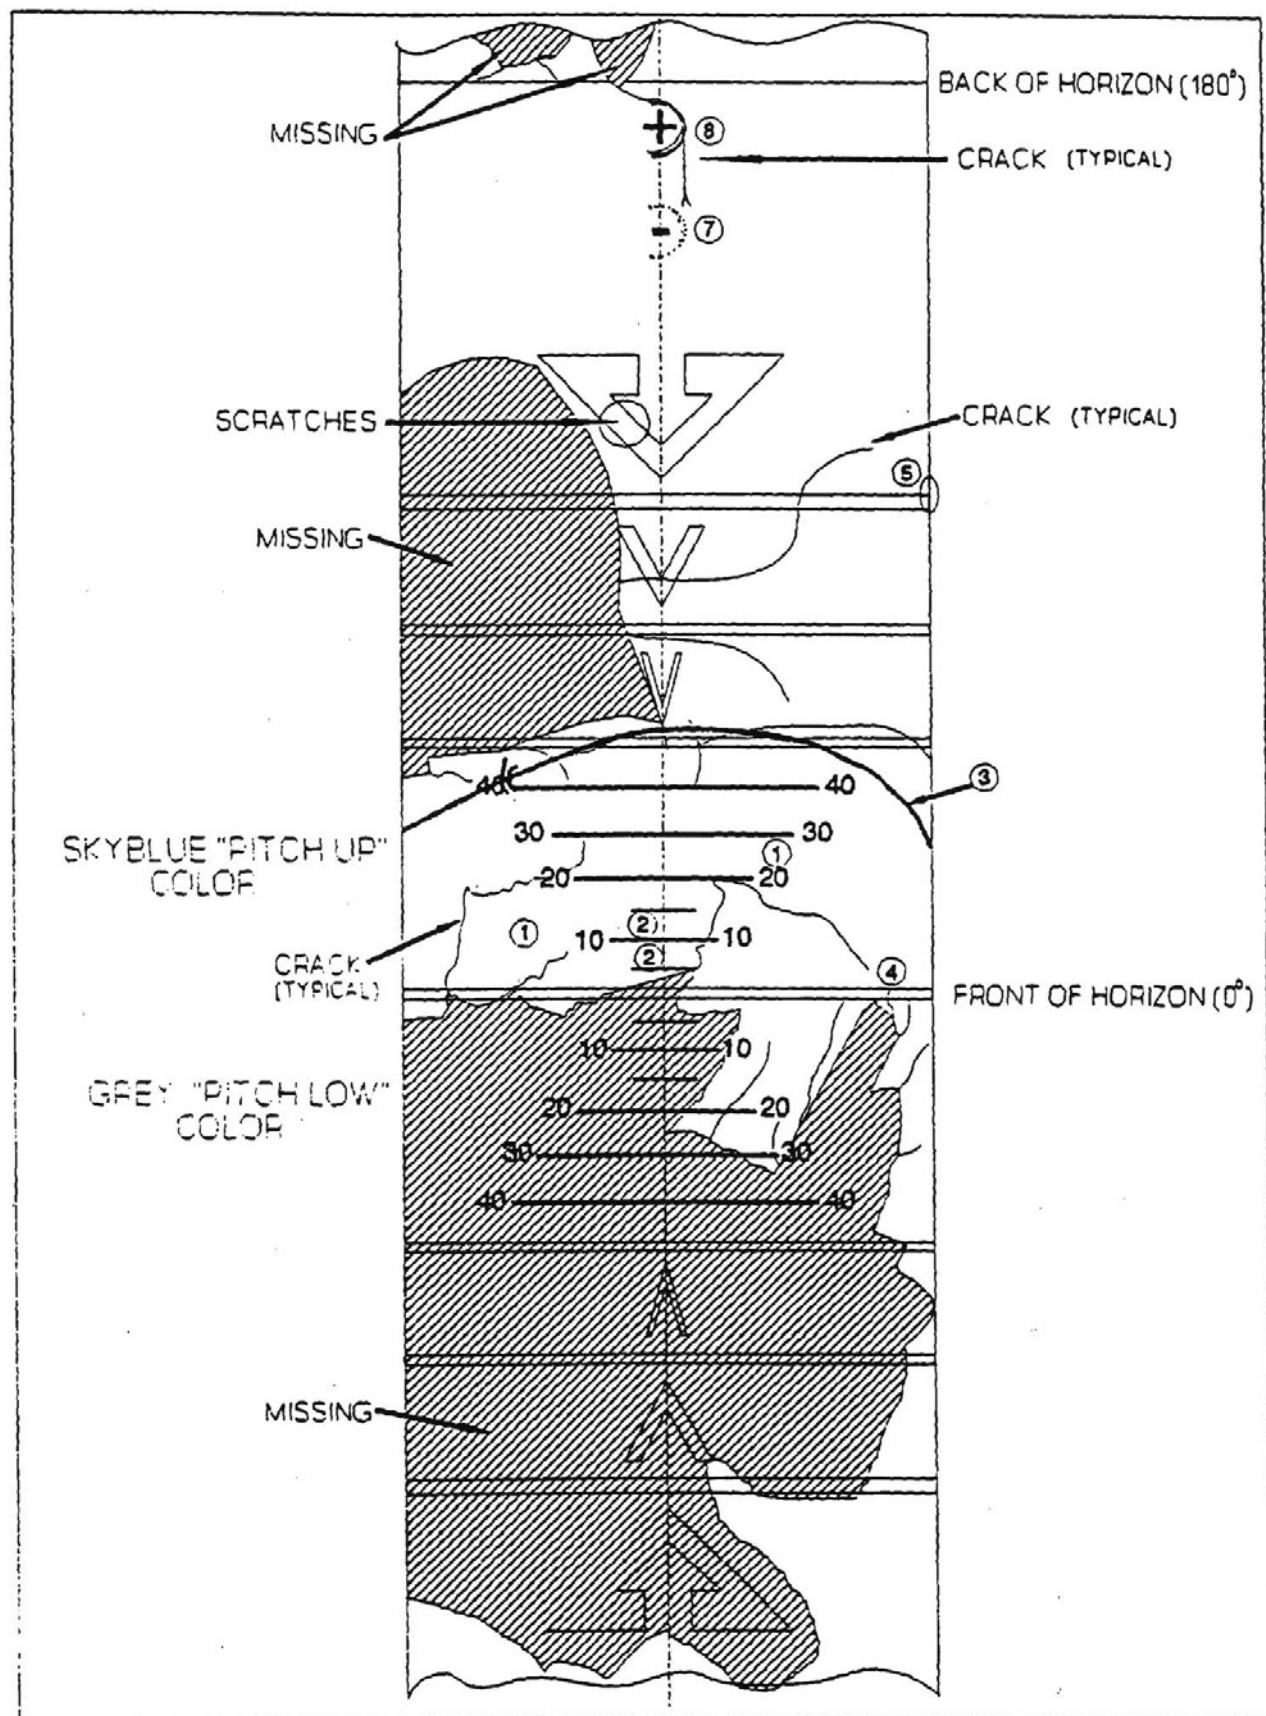
**ADI HORIZON BALL MARKINGS AND DAMAGE
(AS UNWRAPPED FROM BALL SURFACE)**

12. (Not shown in illustrations) Douglas documents show that the airplane uses internal resolvers within each ADI to compare pitch data. The March 4, 1992, group recorded the resolver position as seized at 53 degrees, 29 minutes A.N.D., which was noted by that group as placing the resolver 90 degrees out of phase with a 36 degree 71 minute A.N.D. electrical position. At the September 9, 1992 meeting, Honeywell personnel stated that in subsequent review, it was realized that the measurement should have been described by the inverse phase, therefore, an indication of 26 degrees, 31 minutes A.N.D. was given as the correct measurement.

Note: Two remaining instrument light filaments were fused to the glass and exhibited massive stretching of individual coils and of the general coil.
