**Aborted Takeoff Shortly after Liftoff, Trans World Airlines Flight 843  
Lockheed L-1011, N11002, John F. Kennedy International Airport,  
Jamaica, New York, July 30, 1992**

## AIRCRAFT ACCIDENT REPORT

ABORTED TAKEOFF SHORTLY AFTER LIFTOFF  
TRANS WORLD AIRLINES FLIGHT 843  
LOCKHEED L-1011, N11002  
JOHN F. KENNEDY INTERNATIONAL AIRPORT  
JAMAICA, NEW YORK  
JULY 30, 1992

The National Transportation Safety Board determines that the probable causes of this accident were design deficiencies in the stall warning system that permitted a defect to go undetected, the failure of TWA's maintenance program to correct a repetitive malfunction of the stall warning system, and inadequate crew coordination between the captain and first officer that resulted in their inappropriate response to a false stall warning.

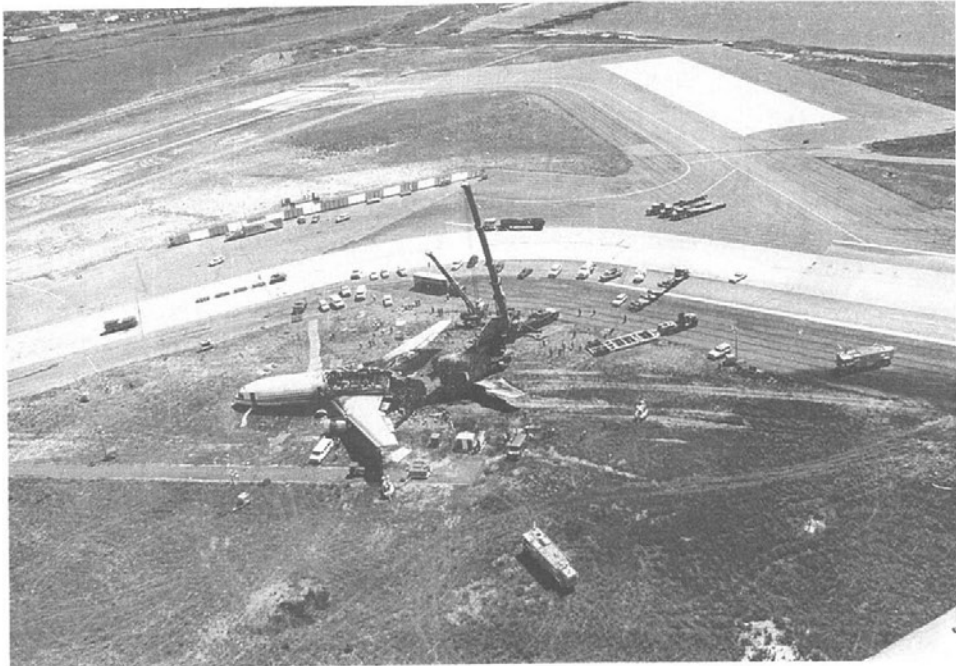
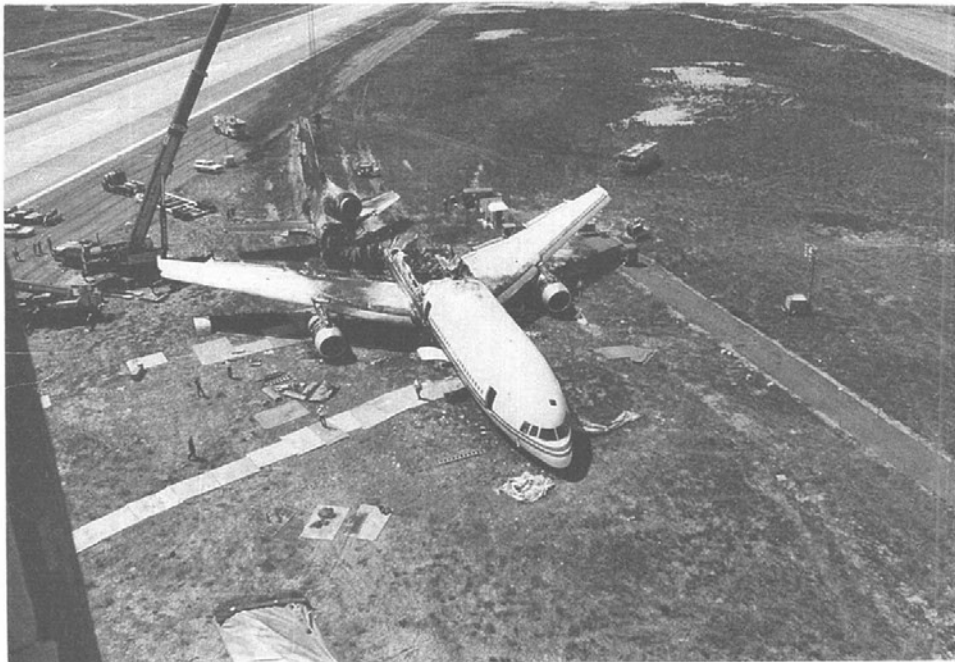
Figure 3.--Airplane wreckage.

Within 2 minutes of the time the airplane came to rest, airport rescue and fire fighting (ARFF) trucks arrived at the site. However, the airplane continued to burn. Before the fire could be extinguished, it consumed the entire aft fuselage, in the area behind the wings and above the cabin floor. The fire also burned through the lower fuselage in two places, so that two sections fell separately to the ground. After the fire was extinguished, the airplane rested on the wheels from the two main landing gear and the structure and skin beneath the forward cockpit and nose. Figures 3 and 4 are photographs of the wreckage.

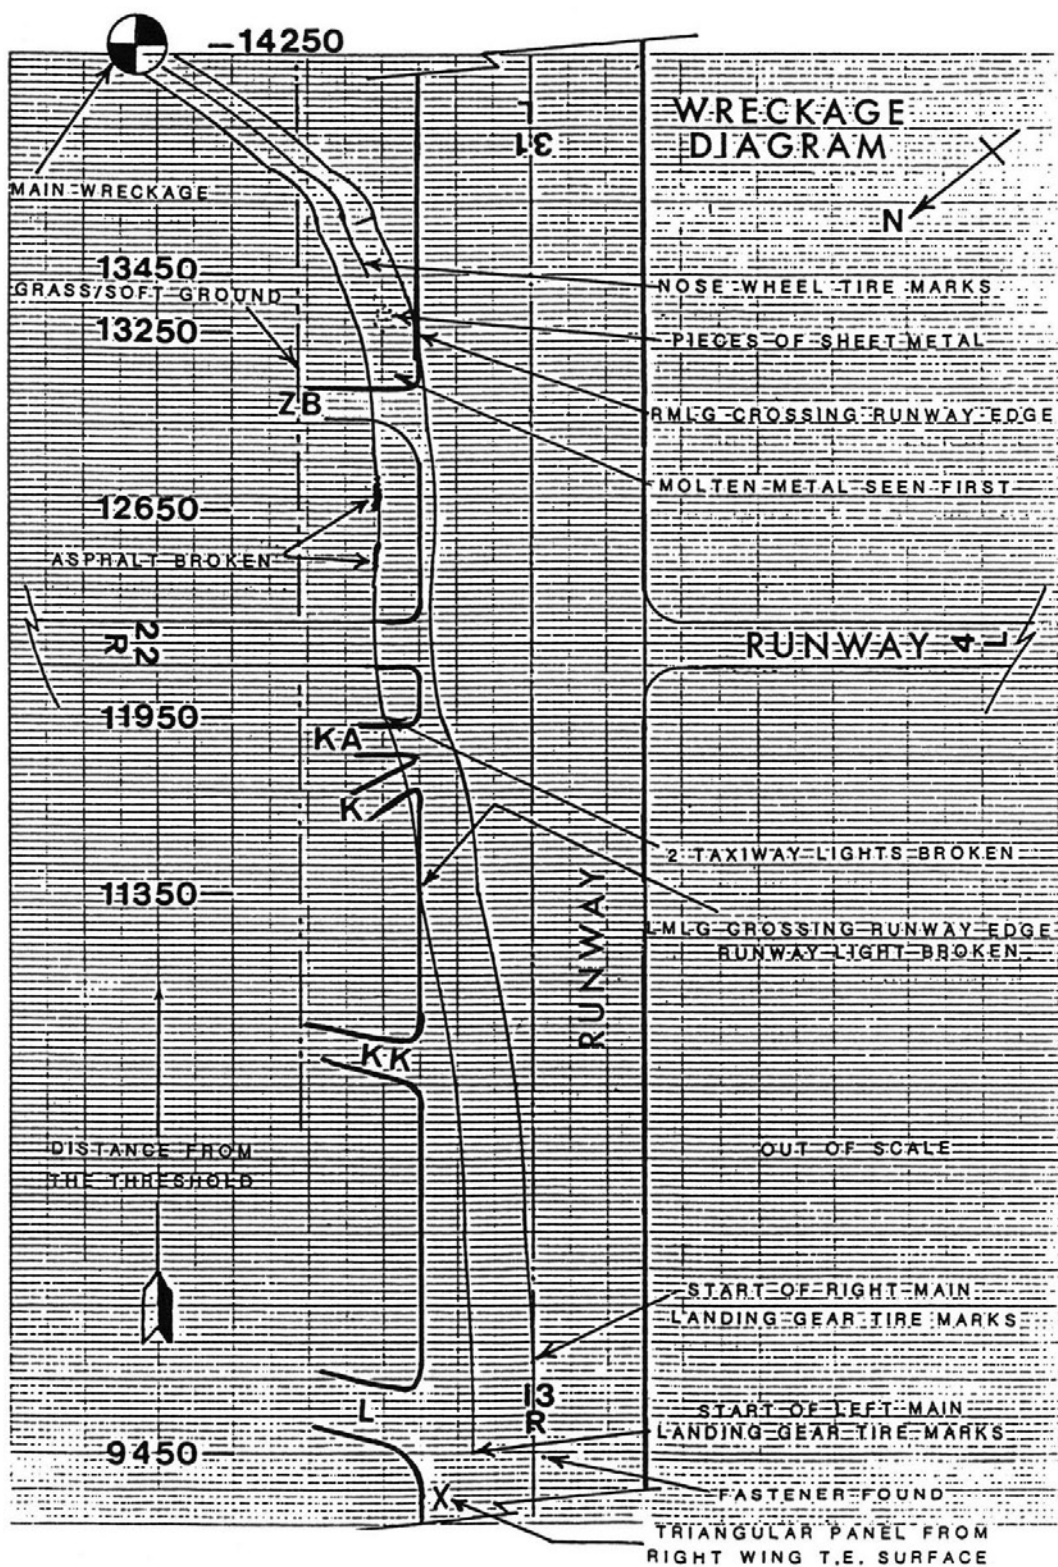
Figure 5.--Wreckage diagram.

Initial contact marks found on runway 13R were a pair of tire marks from the left main landing gear, starting about 9,418 feet from the beginning of the takeoff runway. (See figure 5). They started about 39 feet to the left of the runway centerline and ran approximately parallel to the centerline and later angled off the left shoulder of the runway.

A large darkened area on the runway, which progressively widened, was found beginning about 13,250 feet from the threshold of takeoff runway 13R. The right main landing gear skid marks ran through the darkened area. These marks increased in intensity and width until they departed the shoulder on the left side of the runway. The darkened area continued to where the airplane came to rest.

The main gear tire marks departed the asphalt on the left side of the runway at 13,918 and 14,068 feet, respectively, from the beginning of the runway. The ruts continued to where the airplane came to rest. The main wreckage came to rest, burning, 14,368 feet from the beginning of runway 13R, about 296 feet to the left of the centerline at the departure end of the runway.

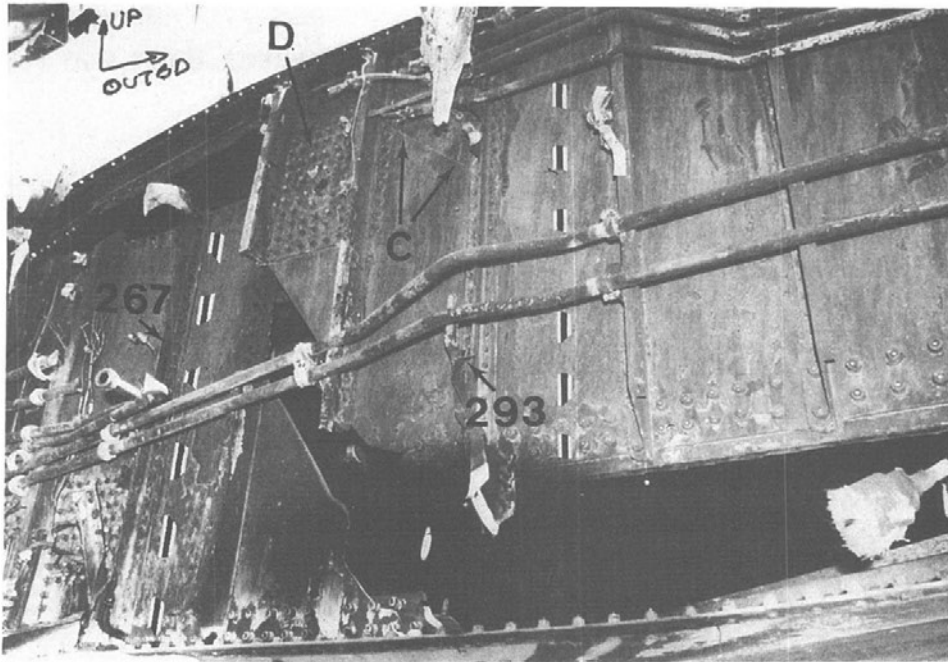
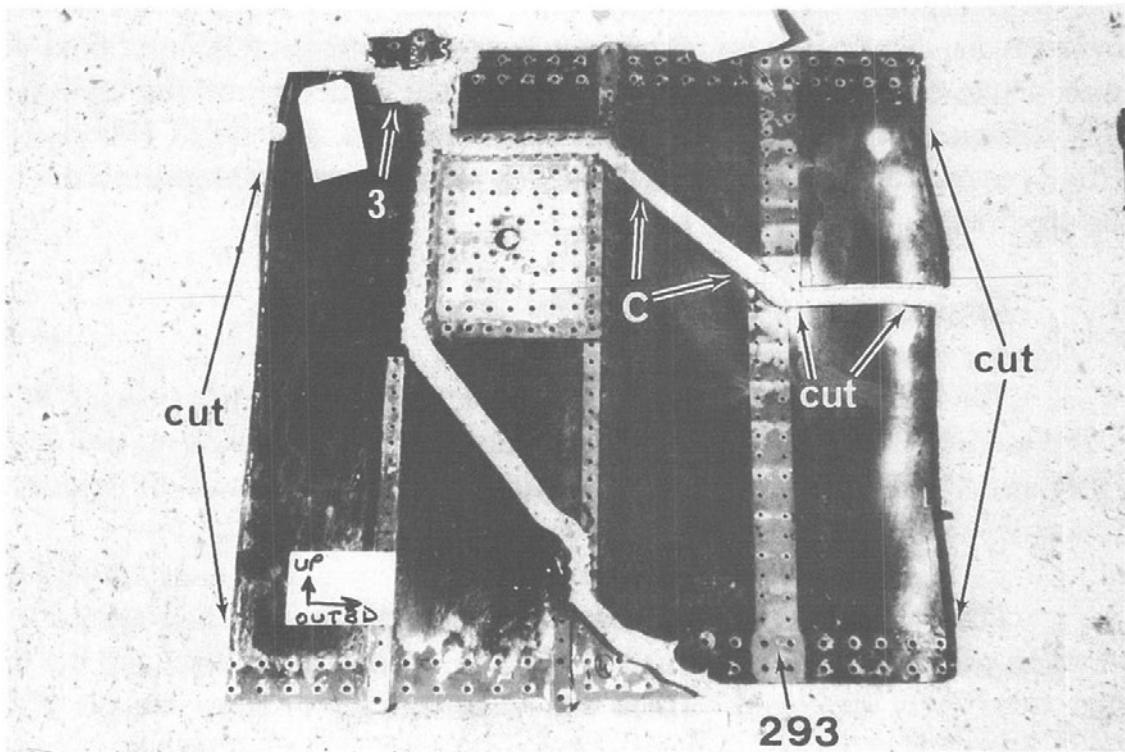
Figure 6.--Right wing spar damage.

The right inboard wing rear spar, which also formed part of the fuel cell wall, was fractured between the right side of the fuselage and the right main landing gear. (See figure 6). After the fire was extinguished, fuel continued to drip out of this fracture. The fractures in the right wing rear spar were examined in the field by structural engineers and metallurgists; portions of the spar web were brought to the Safety Board's Materials Laboratory in Washington, D.C., for detailed metallurgical examinations.<sup>2</sup>

The detailed examinations of the right wing rear spar revealed no evidence of preexisting fatigue damage. All fractures were found to be caused by overstress forces. There was no fatigue cracking or progressive failure found in the spar web fracture, or in any other fracture in the structure of the right wing, including stiffeners, upper and lower spar caps, stringers, and skin. Hardness and conductivity measurements of the fractured web material produced results consistent with the specified material.

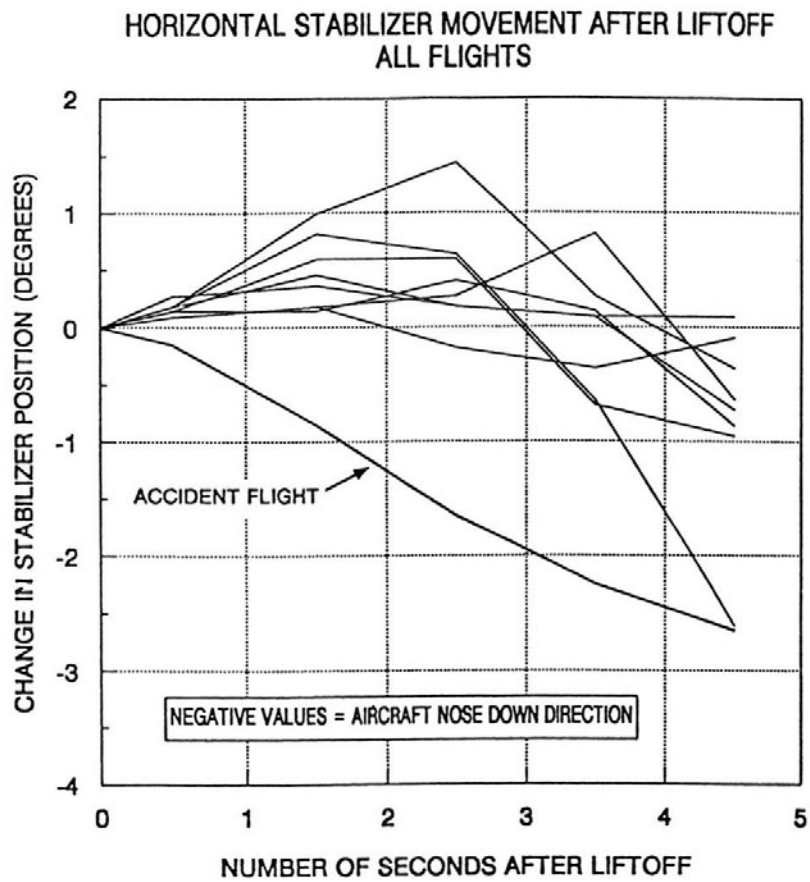
Figure 10.--Horizontal stabilizer movement after liftoff.

Figure 10 shows the horizontal stabilizer movement after liftoff for the accident and eight previous takeoffs. This figure shows the change in horizontal stabilizer position with respect to its position at liftoff.

During the first 3 seconds after liftoff, the previous takeoffs show a positive trend (airplane nose up, A.N.U.) of horizontal stabilizer movement during the initial climbout. Stabilizer positions for the accident flight reveal a negative (airplane nose down, A.N.D.) rotation of the horizontal stabilizer during the first 3 second time period.

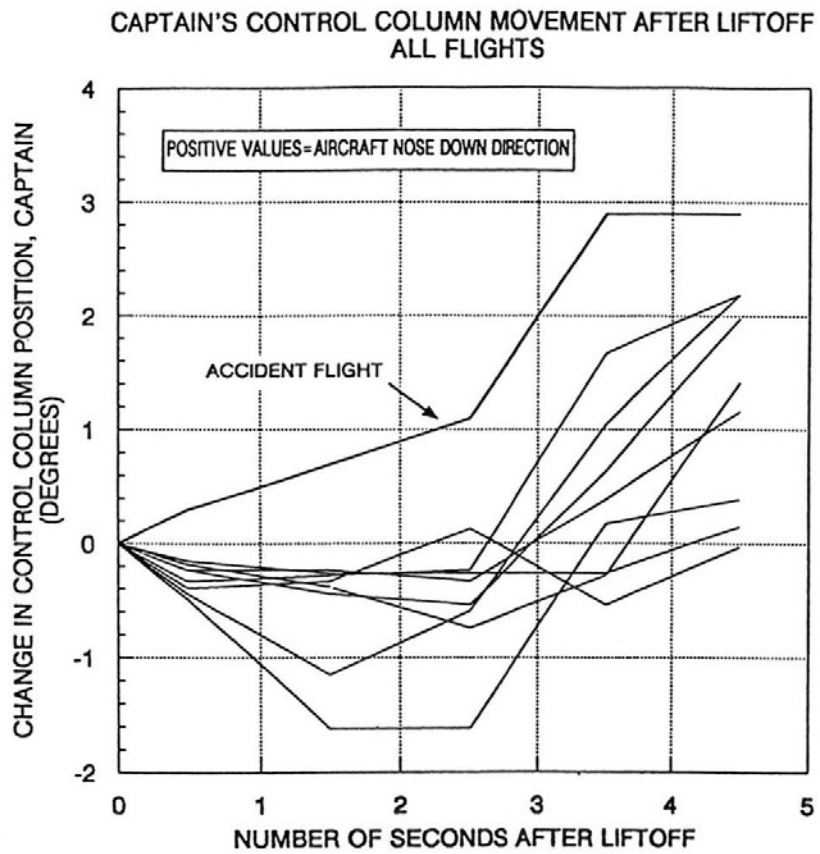
Figure 11.--Captain's control column movement after liftoff.

Figures 11 and 12 show the pilots' control column movements after liftoff. These plots show the change in control column position with respect to the control column position at liftoff. During the first 2 to 3 seconds after liftoff, the previous takeoffs show a negative, or aft control column trend (aft A.N.U.) during the initial climbout. The accident flight control column positions reveal a positive, or forward control column movement (forward A.N.D.) during the first 3 seconds.
