In-flight turbulence encounter and loss of portions of the elevators, China Airlines Flight CI-012, McDonnell Douglas MD-11-P, Taiwan registration B-150, About 20 miles east of Japan, December 7, 1992

AIRCRAFT INCIDENT REPORT

IN-FLIGHT TURBULENCE ENCOUNTER AND
LOSS OF PORTIONS OF THE ELEVATORS
CHINA AIRLINES FLIGHT CI-012
McDONNELL DOUGLAS MD-11-P
TAIWAN REGISTRATION B-150
ABOUT 20 MILES EAST OF JAPAN
DECEMBER 7, 1992

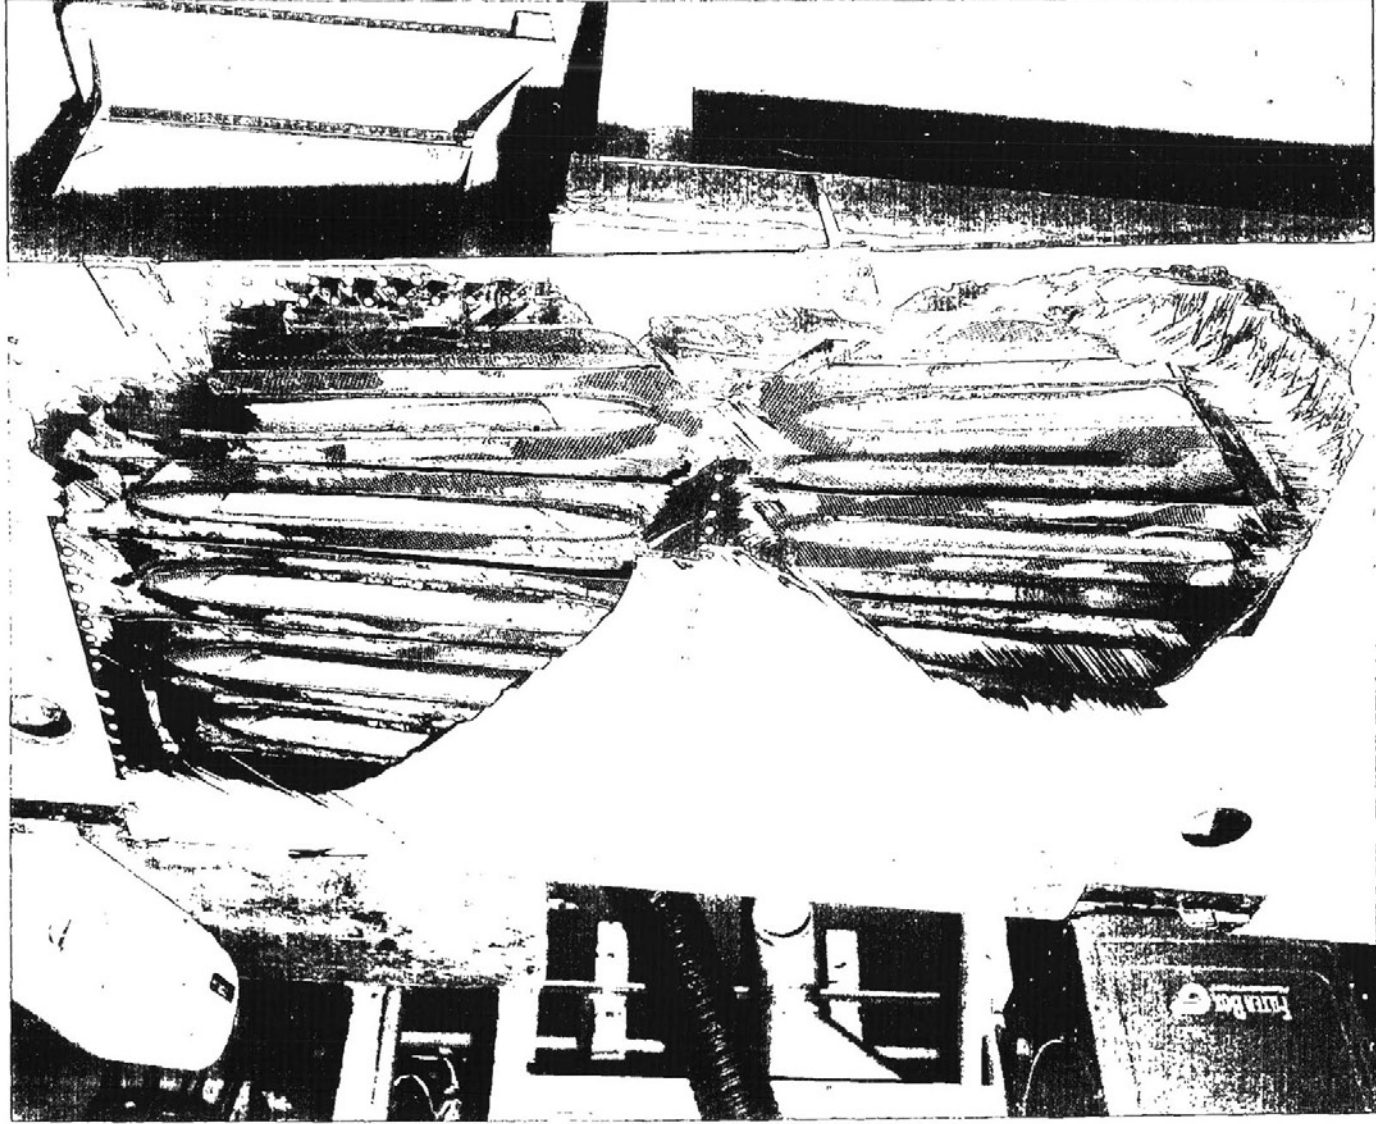
Large areas of composite skin and several pieces of internal composite structural members had separated from the left and right outboard elevators (see figures 1a and 1b). The lower skin panel assembly of the left outboard elevator, measuring approximately 28 inches by 46 inches, and the right outboard elevator

Figure 1a.--Damage on left elevator lower surface, view looking down.

The elevator, as received, exhibited fracture, delamination, and disbonding of the lower skin panel assembly, extending from inboard to outboard

between the rib located at station XE-326.5 and the hinge rib located at station XE-374.84 (see figure 2). The damage extended from the leading edge to the trailing edge of the lower skin panel assembly. A section approximately 28 inches by 46 inches of the first and second outboard bay, connected at the stiffener rib, station XE-350.67, had separated from the airplane and was not recovered. The leading edge skin had delaminated 8 inches inboard from the outboard edge.

Removal of the lower skin assembly revealed damage to the stiffener rib, located at station XE-350.67. A 3-inch-long transverse fracture, which was oriented in the downward direction and located 14 inches aft of the front spar, extended through the section thickness. Several upper and lower skin assembly bead stiffeners were found disbonded. The upper skin assembly had a cracked bead stiffener, located just aft of the front spar in the first outboard bay.

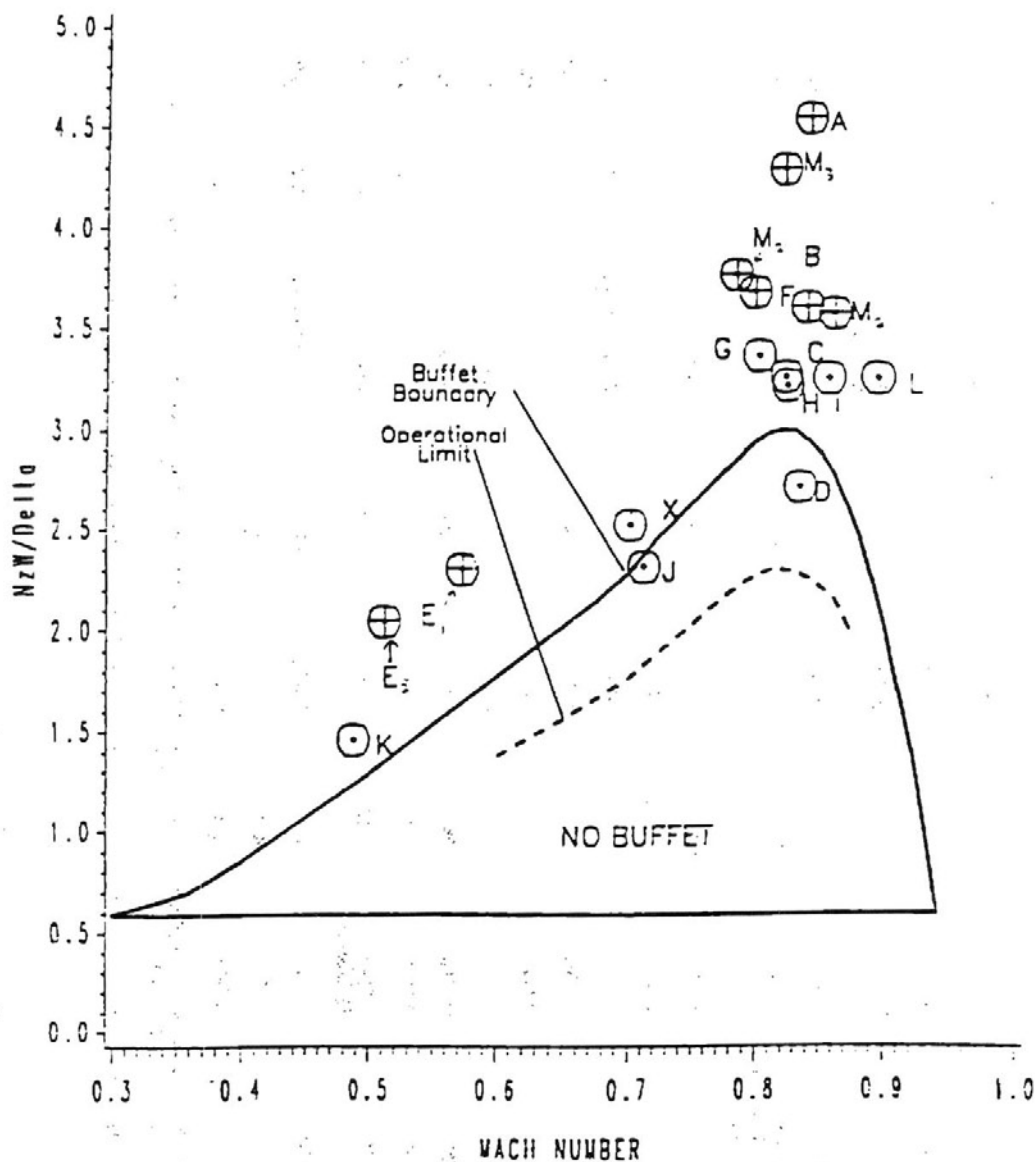
Figure 3.--MD-11 cruise buffet onset boundary.

The graph revealed that in two of these incidents, the buffet boundary was not exceeded. The buffet boundary, however, was exceeded in each of 11 other incidents. In 5 of these 11 cases, there was elevator damage; further, in 4 of these 5 incidents, the airplane speeds were between Mach 0.75 and 0.86. The airplanes were operating at normal load factors (N_z W/S) of 3.5 units (in units of millions) or greater. Only the China Airlines incident resulted in damage from normal forces of less than 3.5 units. The remaining six incidents that exceeded the buffet boundary occurred at speeds from Mach 0.49 to Mach 0.89 and normal load factors of less than 3.5 units, but incurred no damage to the airplane elevators. Analysis of this study revealed that the incidents that resulted in damaged elevators involved airplanes operating at 20 percent or more above the buffet limit. The Safety Board concluded that the resultant loads induced on the elevators were above the ultimate loads for the MD-11 elevators.

DAC engineers believe that an MD-11 needs to exceed its buffet boundary by a margin of 20 percent or more in order to sustain elevator damage. The extent of elevator damage is believed by DAC to be related to some combination of the degree of exceedence above the 20 percent margin and length of time exposed to buffet. DAC has been unable to determine the exact relationship.

The positions relative to the cruise buffet onset boundary based on recorded flight data for 13 different flights (points A through M) are shown above. The symbols containing a cross represent flights during which damage occurred. The open symbols represent both service and test flights for which no damage occurred. The flight test points represent a sample of test flights during which elevator buffet response was measured. The point labeled 'X' is a sample calculation shown in figure 11.

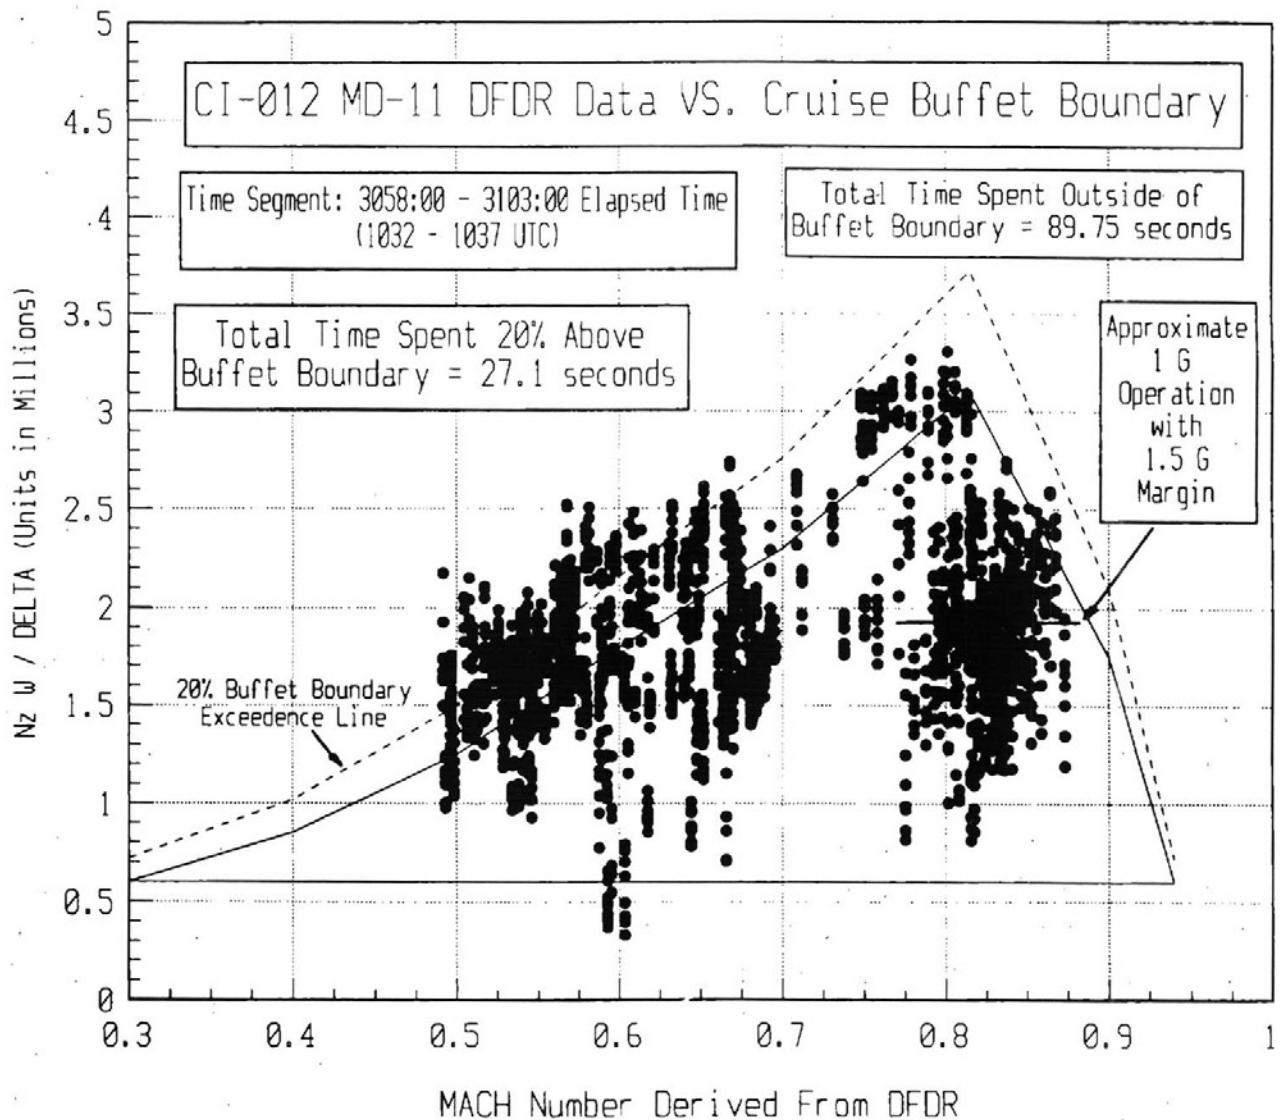
Figure 5.--CI-012 MD-11 DFDR data vs. cruise buffet boundary.

To observe the incident aircraft's boundary buffet time history, FDR data from 1032 to 1037 UTC were used to generate a comparison plot of the MD-11's cruise buffet boundary, a 20 percent boundary exceedence line, and FDR-derived operational data (see figure 5). The airplane was operating at a 1.5 G stall margin, which helped keep the initial excursion below the 20 percent exceedence level.

However, the separation of the elevator skin most likely occurred during the stall buffet when the elevators were loaded above the design limit load.

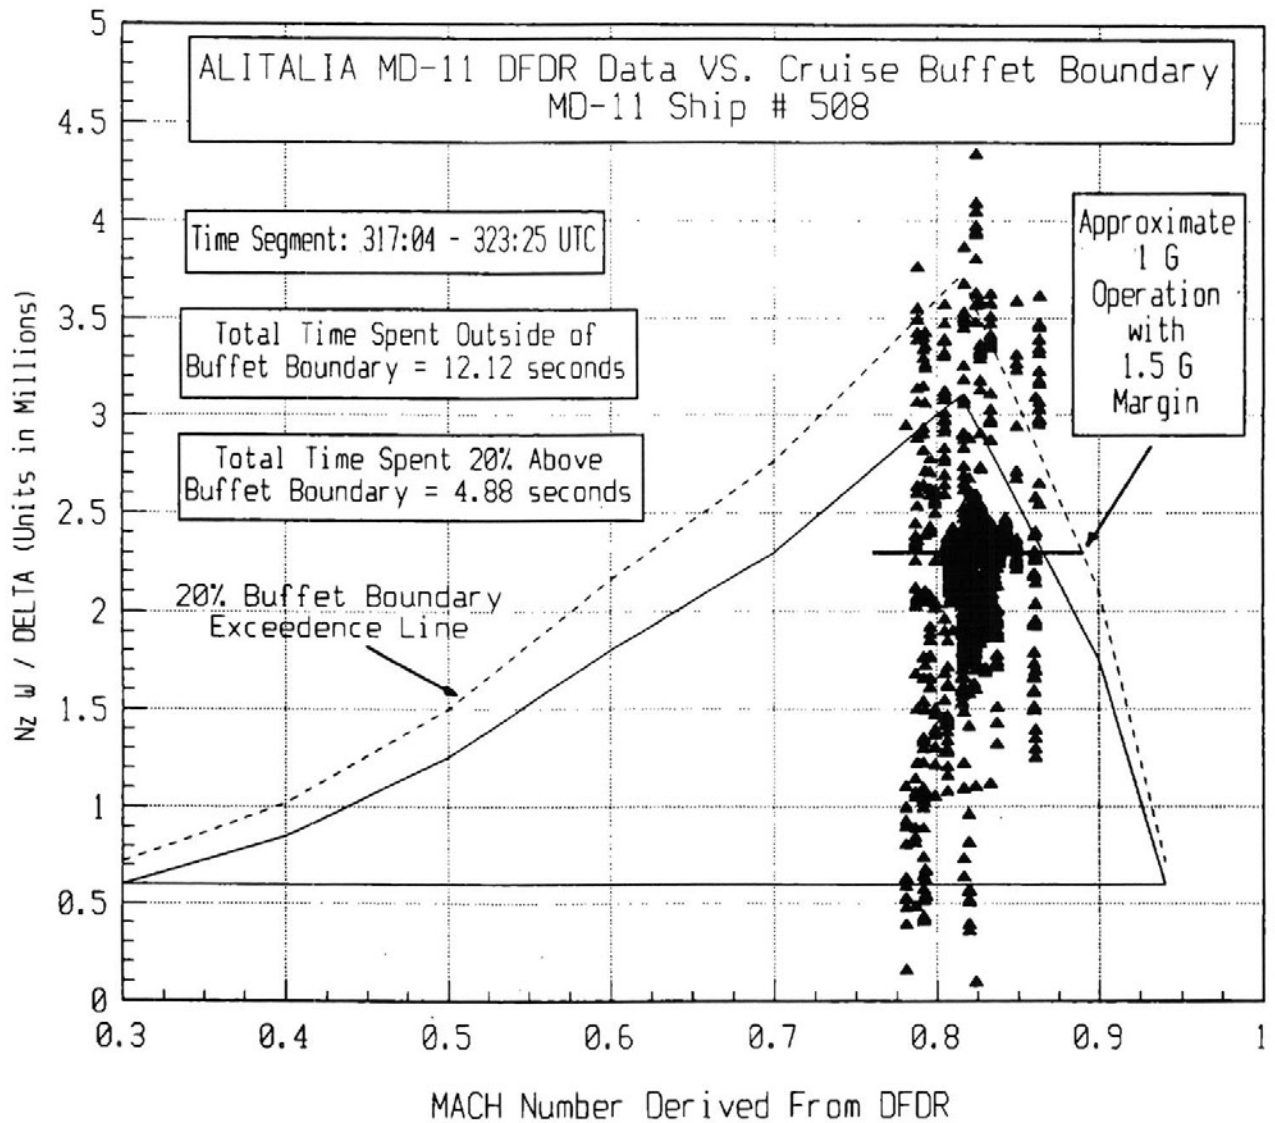
Figure 6.--Alitalia MD-11 DFDR data vs. cruise buffet boundary.

A second plot (see figure 6) shows the buffet boundary calculations of an Alitalia MD-11 that sustained elevator damage similar to the China Airlines airplane. However, the Alitalia MD-11 exceeded the 20 percent boundary margin at speeds greater than Mach 0.8 (467 KTAS). The airplane was outside the buffet boundary for 12.12 seconds, and greater than 20 percent above the limit for 4.88 seconds. The airplane was operating at a 1.3 G buffet margin. If the airplane had been operating at a 1.5 G margin, as was the China Airlines airplane, most of the data points would have fallen below the 20 percent buffet margin curve. The Safety Board concluded in its report on the China Eastern accident that MD-11 airplanes should operate at stall margins greater than 1.3. The Board had previously issued Safety Recommendation A-93-145 to address this issue (see section 4).
