Uncontrolled Collision with Terrain, American International Airways Flight 808, Douglas DC-8-61, N814CK, US Naval Air Station Guantanamo Bay, Cuba, August 18, 1993

UNCONTROLLED COLLISION WITH TERRAIN
AMERICAN INTERNATIONAL AIRWAYS FLIGHT 808
DOUGLAS DC-8-61, N814CK
U.S. NAVAL AIR STATION
GUANTANAMO BAY, CUBA
AUGUST 18, 1993

Abstract: This report explains the crash of American International Airways Flight 808, a DC-8-61, about 1/4 mile from the approach end of runway 10 at Leeward Point Airfield, U.S. Naval Air Station, Guantanamo Bay, Cuba, on August 18, 1993. The safety issues discussed in the report include flightcrew scheduling, the effects of fatigue on flightcrew performance, training on special airports, and the dissemination of information about special airports. Safety recommendations concerning these issues were made to the Federal Aviation Administration, American International Airways, Inc., and the Department of Defense.

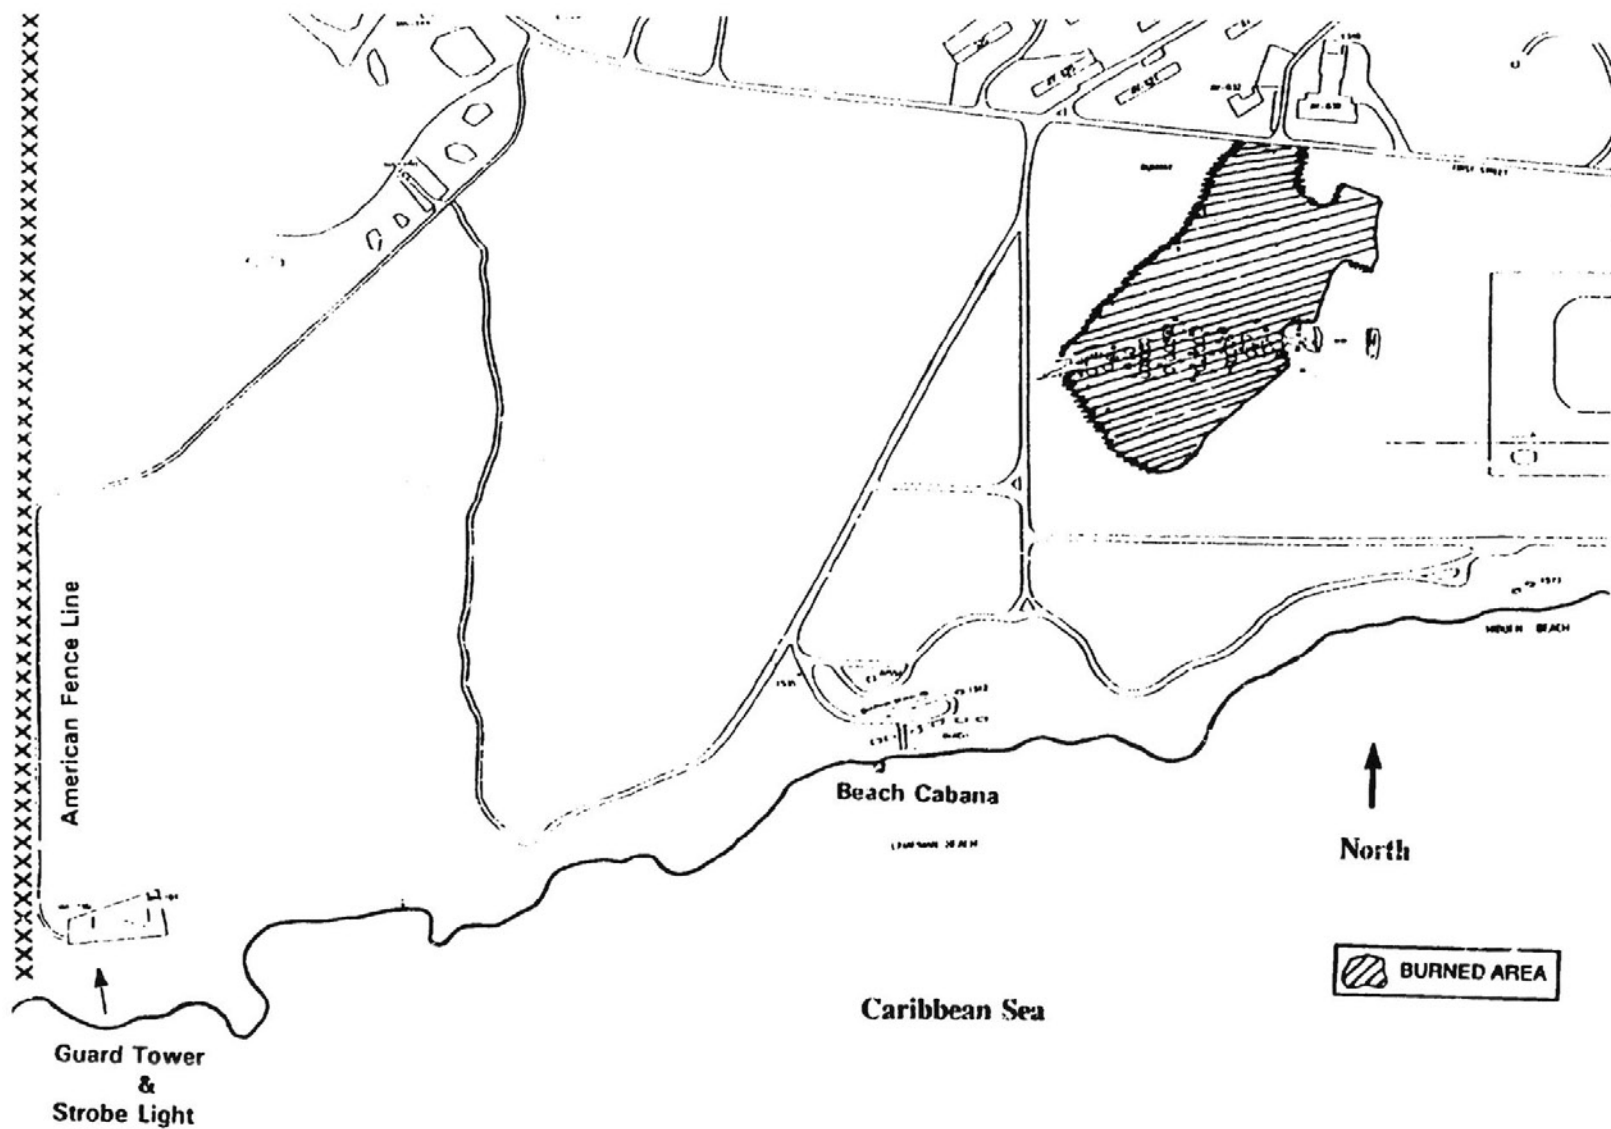
Figure 2.--Location of airplane wreckage.

The airplane initially struck the ground 200 feet north of the extended runway centerline and 1,400 feet west of the runway 10 threshold (see figure 2). The wreckage debris was oriented on a magnetic heading of approximately 100 degrees and extended for a distance of about 1,000 feet from the initial impact point. The debris found at the farthest point from the runway consisted primarily of right wing structure and skin, as well as parts from the Nos. 3 and 4 engines.

The initial impact mark was a thin, shallow trough that fanned outward to about 25 feet wide and extended 150 feet in the direction of flight. The right wing tip, found 200 feet north of the first impact point, exhibited compression damage and scratch marks that were consistent with the airplane in a roll attitude of 51 degrees at the point of initial ground impact.

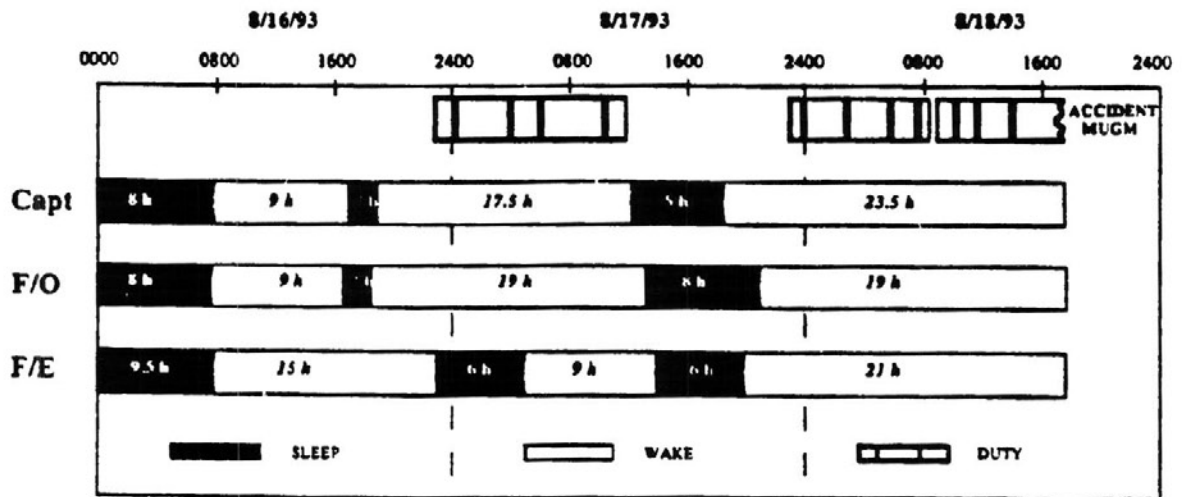
Figure 3.--Flightcrew sleep/wake histories.

The researchers found in their study of the crewmembers' sleep/wake periods that in the 28.5 hour period prior to the accident, the cumulative totals for sleep and wakefulness for the captain, first officer, and flight engineer were: 23.5 hours awake with 5 hours of sleep, 19 hours awake with 8 hours of sleep, and 21 hours awake with 6 hours of sleep, respectively. (See figures 3 and 4).

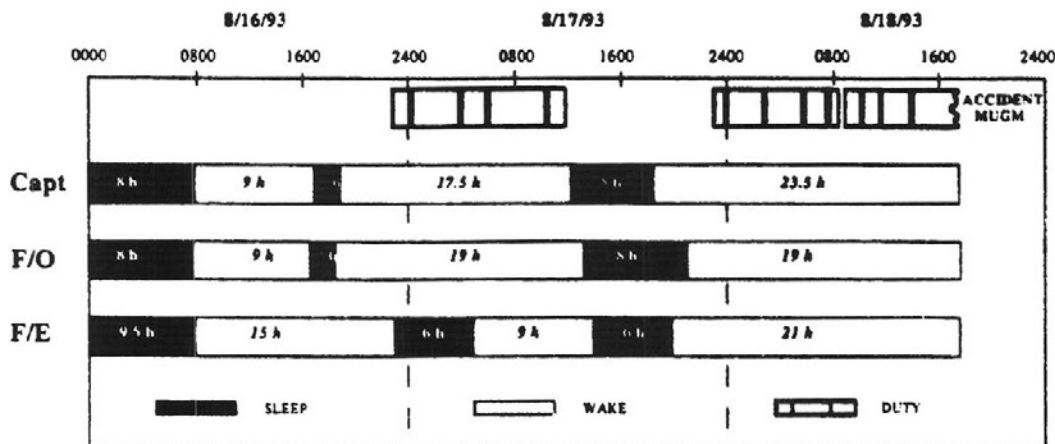
Figure 1. AIA Flight 808 Crew Sleep/Wake Histories

The first horizontal bar in Figure 1 displays the sleep/wake history of the Captain. He reported a typical sleep requirement of 8 hours. The Captain awakened on 8/16/93 after 8 hours of sleep and was awake for 9 hours before taking a 2-hour nap prior to his all-night duty period. Following his nap, the Captain was awake for 17.5 hours. He reported a 5-hour sleep period during a daytime sleep opportunity in a Dallas-Ft. Worth Airport hotel during layover. The Captain was then awake for 23.5 hours until the accident occurred at Guantanamo Bay. This 23.5 hour period included an all-night duty period after which the Captain was released from duty. However, he was called back to operate Flight 808 prior to his return home, and therefore was continuously awake until the accident.

Overall, this information demonstrates that the entire crew displayed cumulative sleep loss and extended periods of continuous wakefulness. It should be noted that the cumulative sleep loss can be partially attributed to the reversal of the circadian pattern, with nighttime sleep periods at home followed by daytime sleep periods due to all-night duty periods. Sleep obtained in opposition to the body's circadian rhythms is more disturbed than sleep that coincides with times when the body is programmed for sleep. The time of day factor also played a role. Also, the accident occurred at about 4:56 PM in the 3-5 PM window of sleepiness.

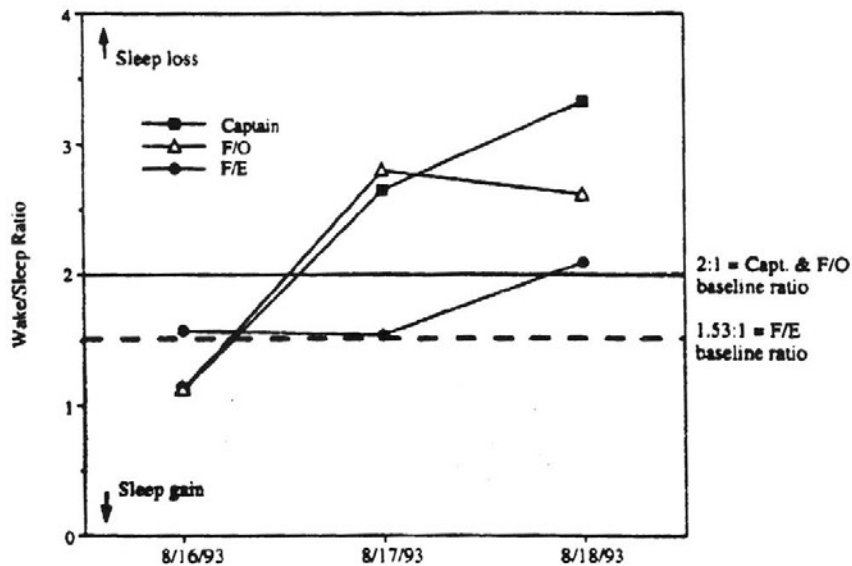
Figure 2. Cumulative Sleep/Wake Debt

The Captain and First Officer reported a usual sleep requirement of 8 hours and therefore, a wake/sleep ratio of 2 would be their appropriate self-defined norm. As evidenced in Figure 2, the wake/sleep ratio for both the Captain and First Officer is greater than 2 (indicated by the solid line) over the two days prior to the accident, reaching greater than 3 for the Captain. The Second Officer reported a usual sleep requirement of 9.5 hours. This represents a wake/sleep ratio of 1.53 as his self-defined norm (indicated by the dashed line). He approximates this on 8/16 and 8/17 and exceeds a ratio of 2 prior to the accident.
