Overspeed And Loss Of Power On Both Engines During Descent And Power-Off Emergency Landing, Simmons Airlines, Inc., D/B/A American Eagle Flight 3641, N349SB False River Air Park, New Roads, Louisiana, February 1, 1994

AIRCRAFT ACCIDENT REPORT

OVERSPEED AND LOSS OF POWER
ON BOTH ENGINES DURING DESCENT AND
POWER-OFF EMERGENCY LANDING
SIMMONS AIRLINES, INC., d/b/a
AMERICAN EAGLE FLIGHT 3641, N349SB
FALSE RIVER AIR PARK, NEW ROADS, LOUISIANA
FEBRUARY 1, 1994

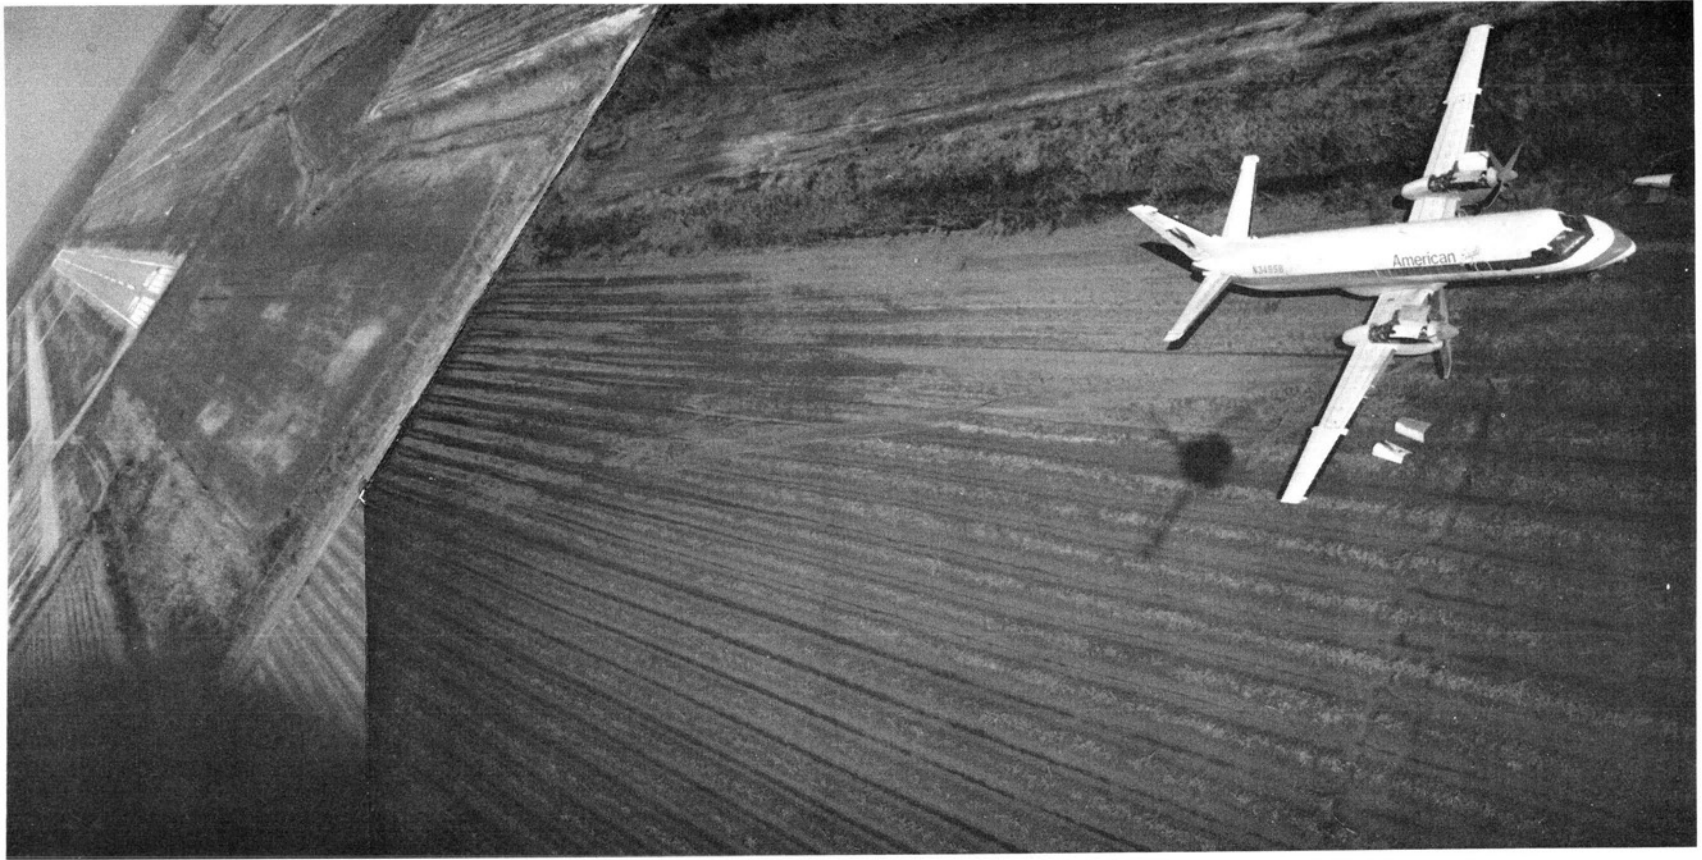
Figure 1.--Resting position of airplane.

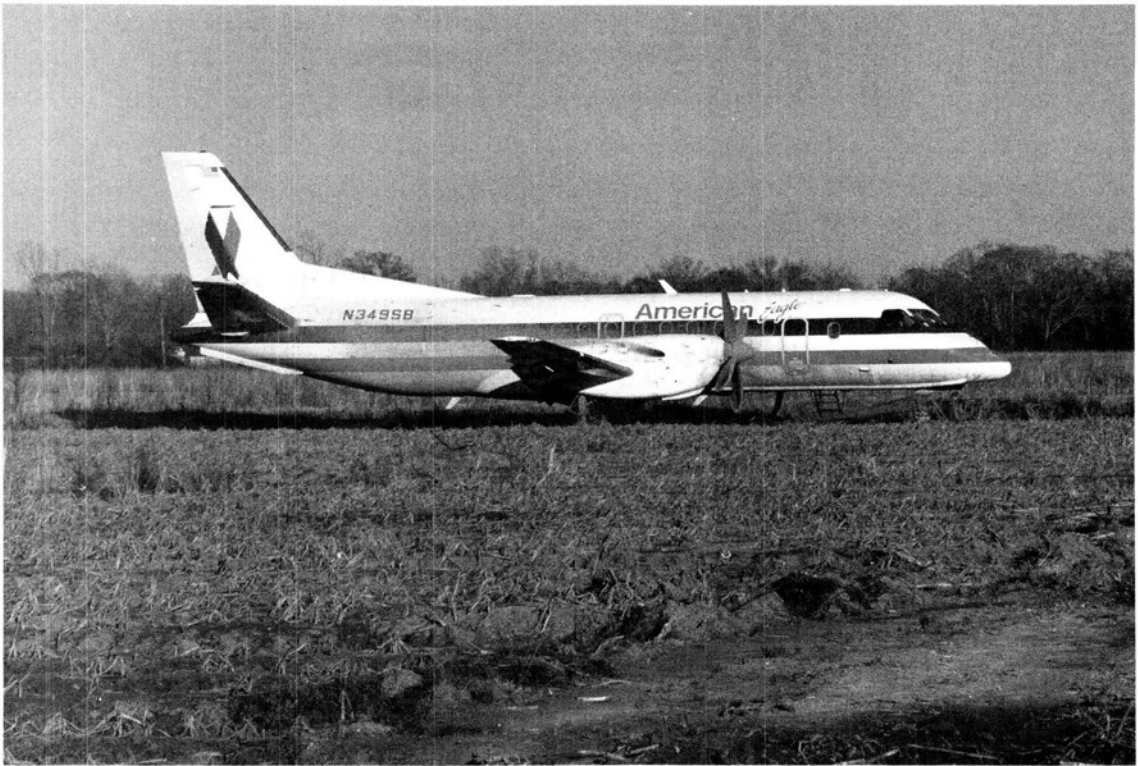
Figure 2a.--Airplane in sugar cane field with fence visible on landing gear.

After the airplane came to a stop, the first officer exited the cockpit. After he observed fencing materials wrapped around the landing gear, he lowered the airstair door to assist passengers exiting the cabin so that they would not jump

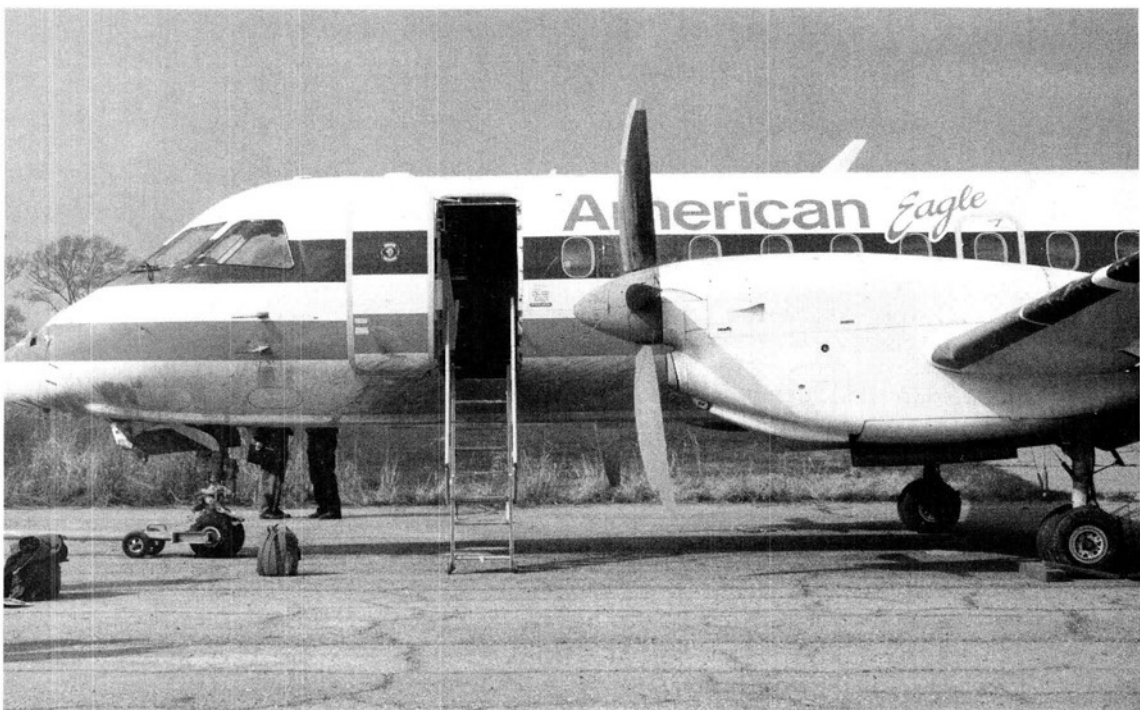
Figure 2b.--Airplane after recovery showing radome, puncture (in front of logo), and dented leading edge of wing.

Structural damage to the airplane included dents and punctures in wing leading edge panels and flap panels, a horizontal crease in the left nose structure at the radome, and crushing of the composite radome. There was a 2- by 3-inch hole surrounded by a 6- by 12-inch dent in the fuselage aft of the main cabin door upper edge. Also, there was a 3-inch tear near the forward hinge point for the right nose landing gear door, a buckled skin and former section on the left side of the left nacelle, and a bend in the lower forward spar cap at the root of the left wing. Figures 4a and 4b illustrate the wreckage site and damage to the airplane.

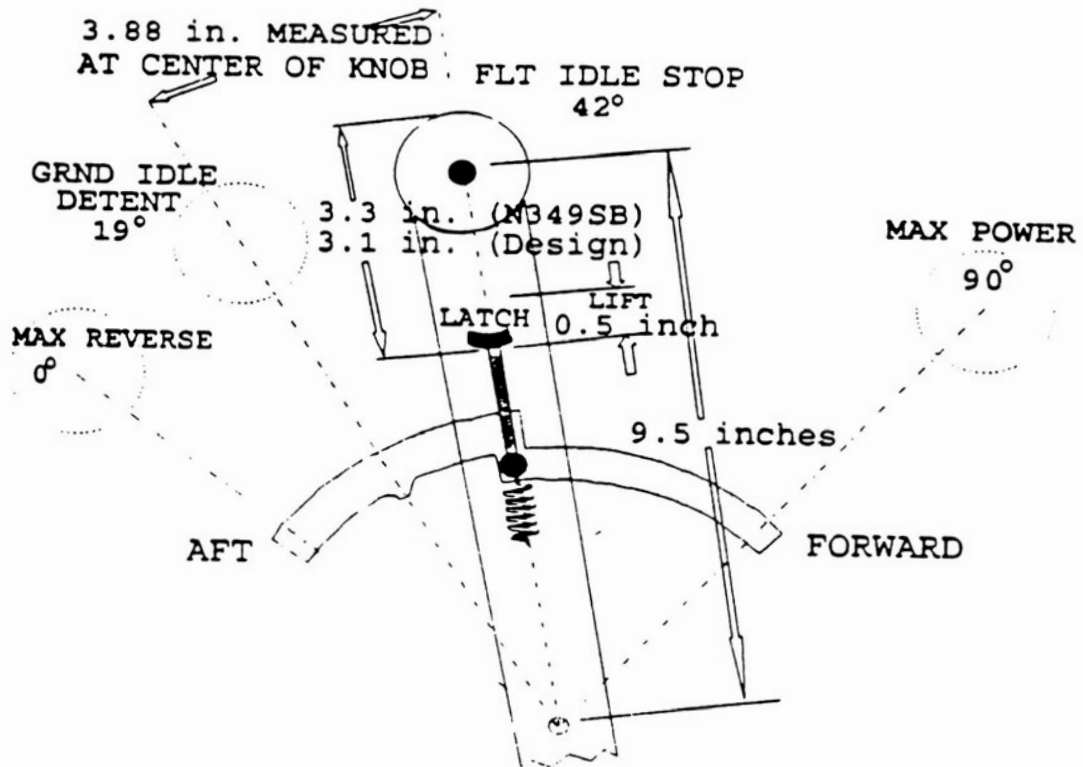
1. Left latch movement began with 3.0 pounds of lift and topped at 7.0 pounds.
Right latch movement began with 3.0 pounds of lift and topped at 5.5 pounds.
Saab design calls for beginning of 2.5 pounds and 7.0 pounds at .5 inch lift.
2. Dimensions measured on N349SB and confirmed with Saab documents.

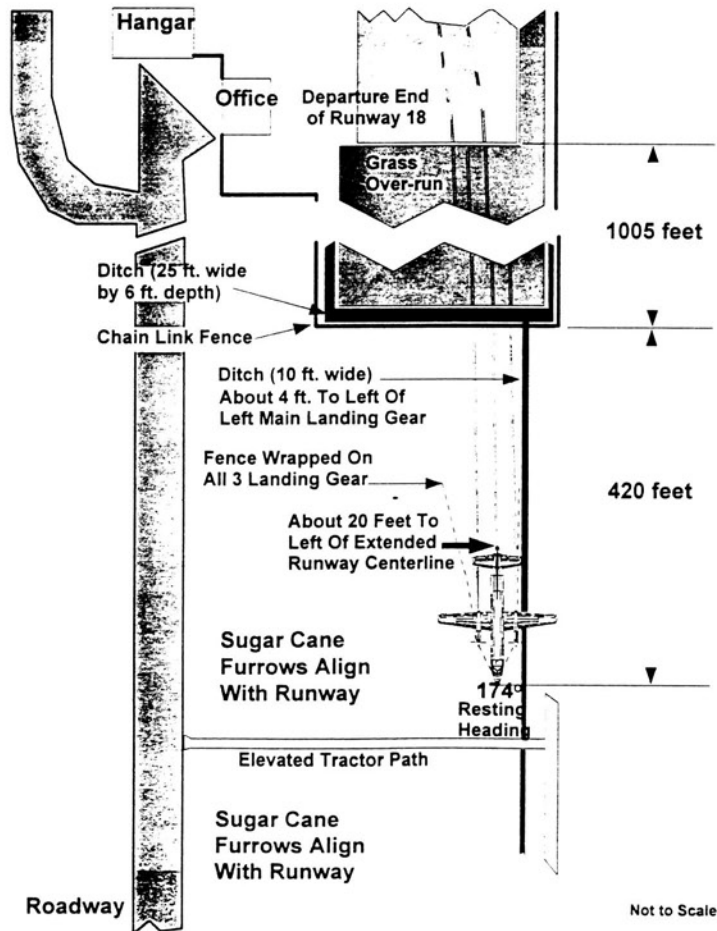
Figure 4a.--Wreckage site and airplane damage.

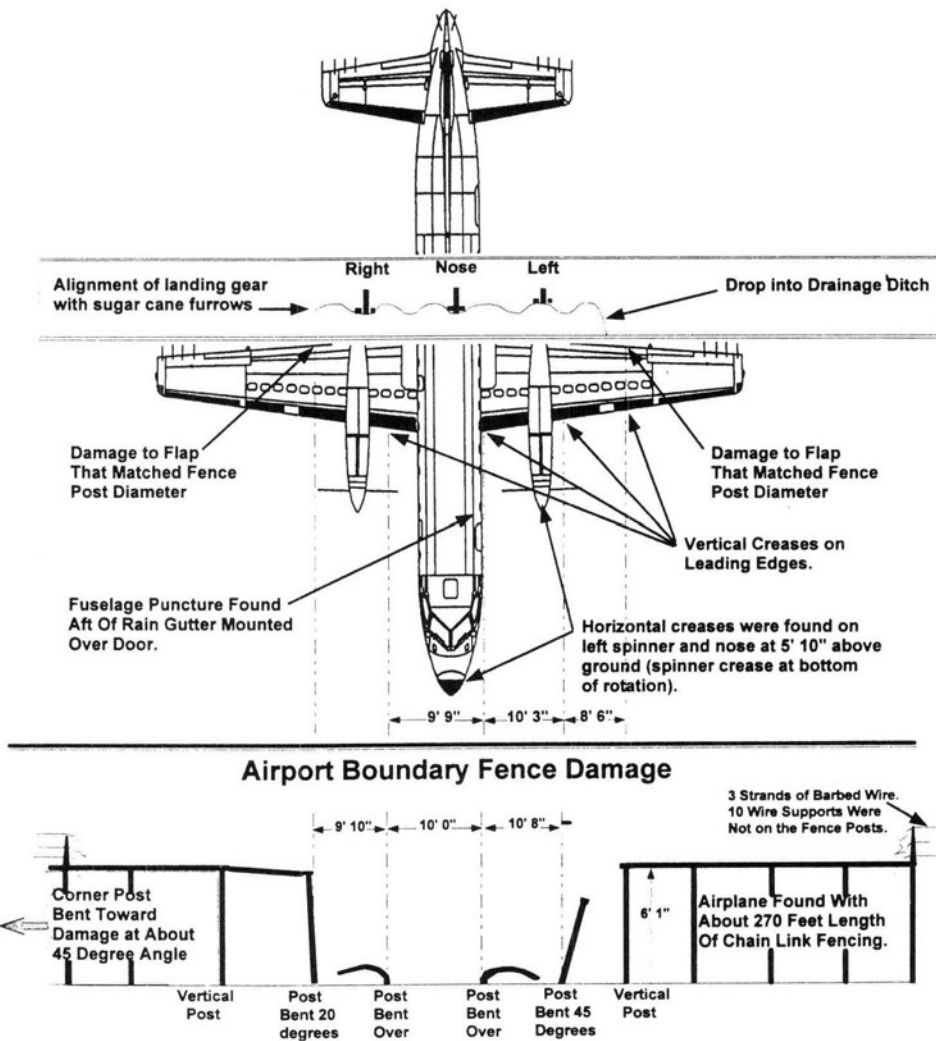
Figure 4b.--Wreckage site and airplane damage.
