Runway overrun during rejected takeoff, McDonnell Douglas MD-80, March 2, 1994

AIRCRAFT ACCIDENT REPORT

RUNWAY OVERRUN FOLLOWING REJECTED TAKEOFF
CONTINENTAL AIRLINES FLIGHT 795
McDONNELL DOUGLAS MD-82, N18835
LaGUARDIA AIRPORT
FLUSHING, NEW YORK
MARCH 2, 1994

Abstract: This report explains the accident involving Continental Airlines flight 795, an MD-82 airplane, which experienced a runway overrun following a rejected takeoff from runway 13 at LaGuardia Airport, Flushing, New York, on March 2, 1994. Safety issues discussed in the report include the availability of takeoff performance data for flightcrews, the proper functioning of pitot/static heat systems, the duration of cockpit voice recordings, and problems associated with passenger evacuations from airplanes. Safety recommendations concerning these issues were addressed to the Federal Aviation Administration and to Continental Airlines, Inc.

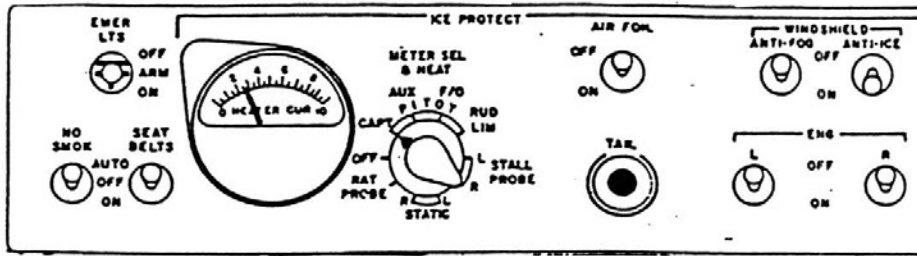
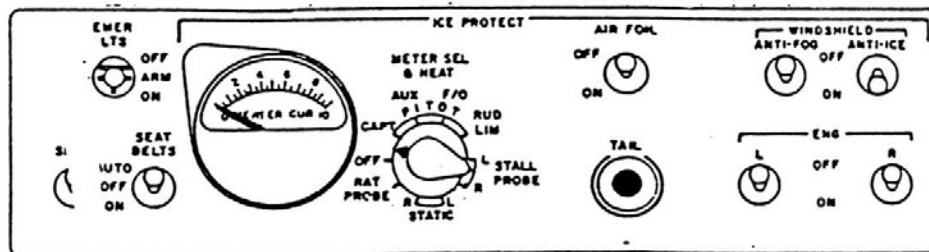
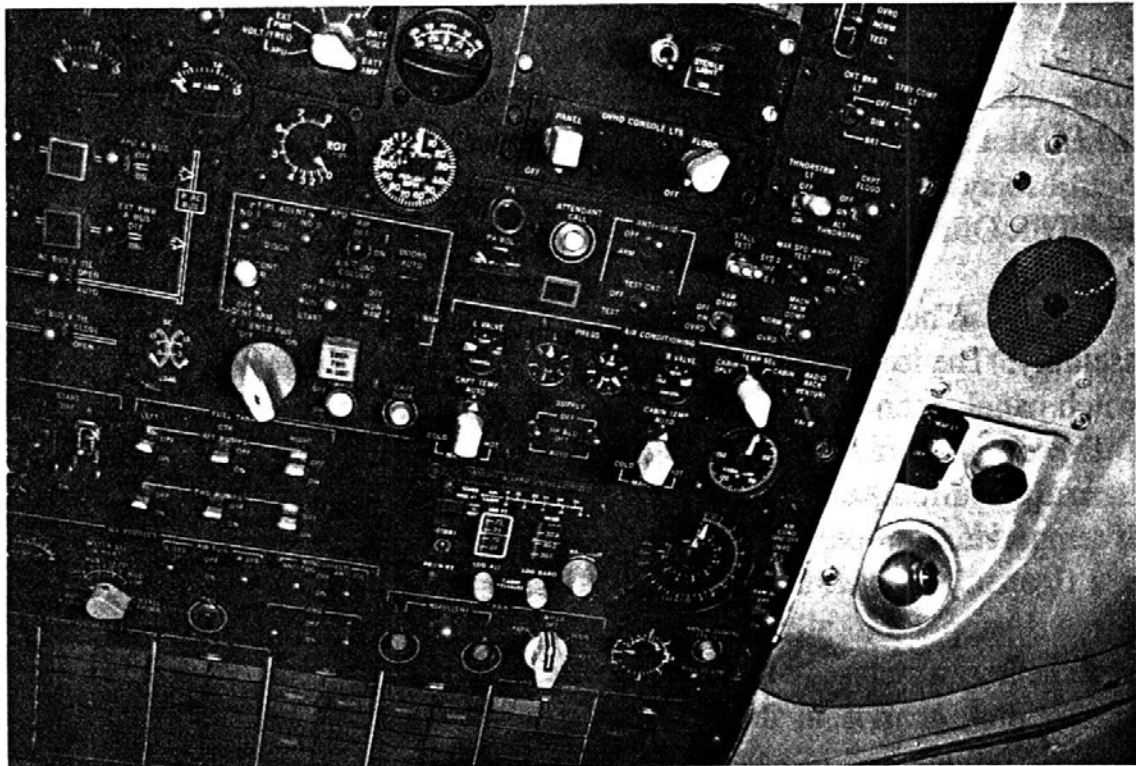
Figure 1.--Pitot/static/stall heater selector switch.

Upper Illustration-Normal position for system ON and reading CAPT Heater current.

Middle Illustration-Approximate alignment of accident airplane's switch in OFF detent.

Bottom Photo-Photo of accident airplane's METER SEL & HEat switch in OFF position. See arrow: ➤

The METER SEL & HEAT, which controls heat to the pitot tubes/static ports, RAT probe, and AOA [angle of attack] was found to be slightly misaligned. When the switch was set to the OFF position, the switch "pointer" indication was approximately 1/3 of the distance toward the CAPT position. The misalignment of the switch existed as it was rotated throughout each position. Each position was clearly identified by a detent. The switch rotated freely without apparent binding or malfunction.

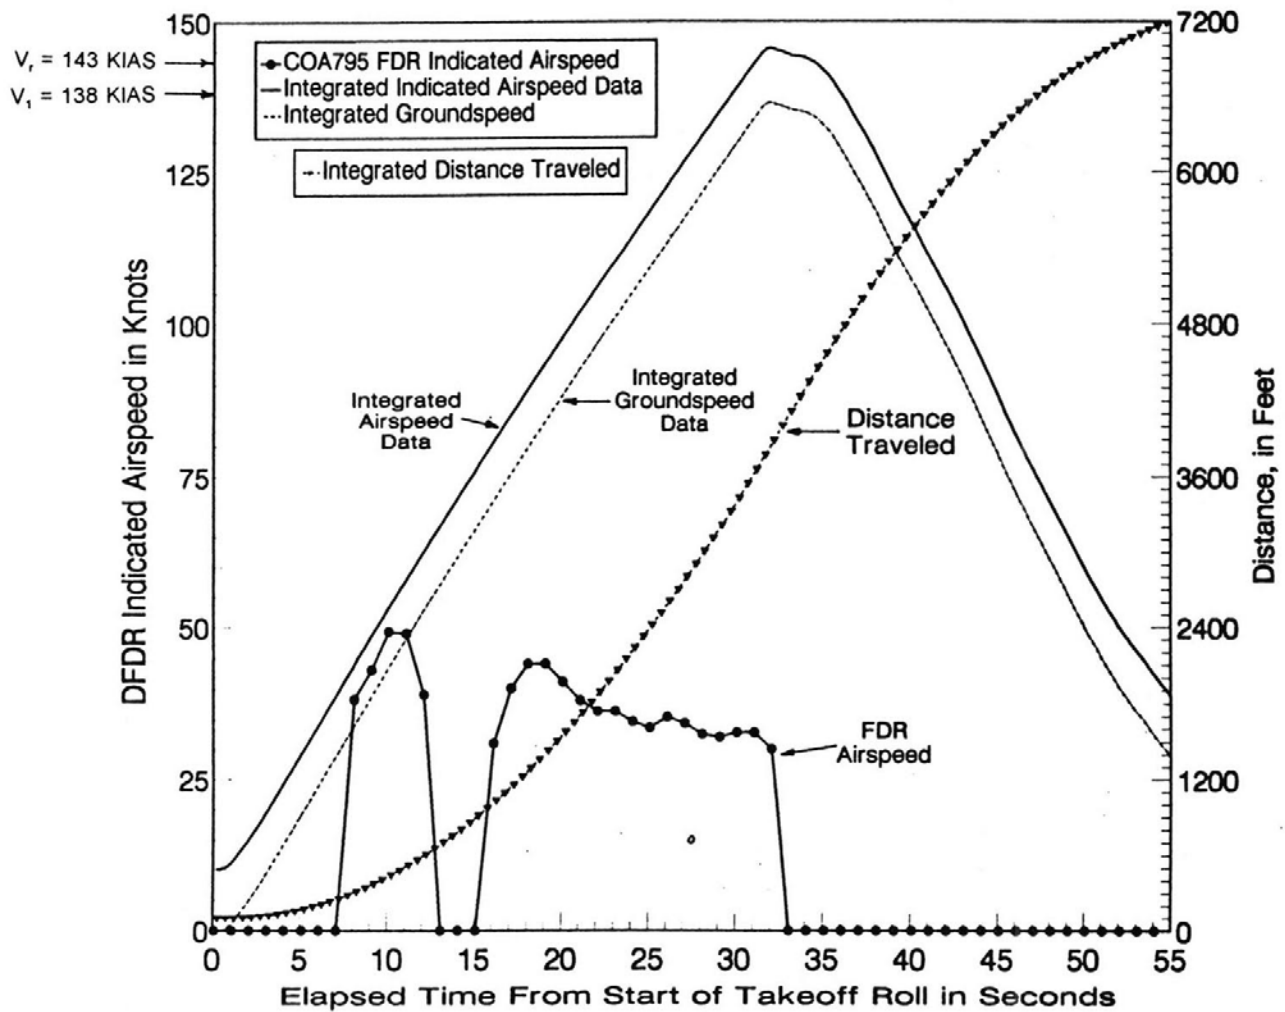
Figure 5.--Comparison of FDR airspeed and integrated airspeed.

1. The accelerations and decelerations were consistent with expected airplane performance for the conditions present.
2. The takeoff was rejected at a computed indicated airspeed of 143 KIAS. (See figure 5).
3. The maximum computed indicated airspeed during the takeoff was 145.5 KIAS.
4. The airplane departed the end of runway 13 at a computed indicated airspeed of 53 KIAS.
5. The airplane struck the dike at a computed 39 KIAS.
6. The time between 60 KIAS and the start of the abort (as determined by the performance evaluation, not the cockpit indicators) was 19.25 seconds.

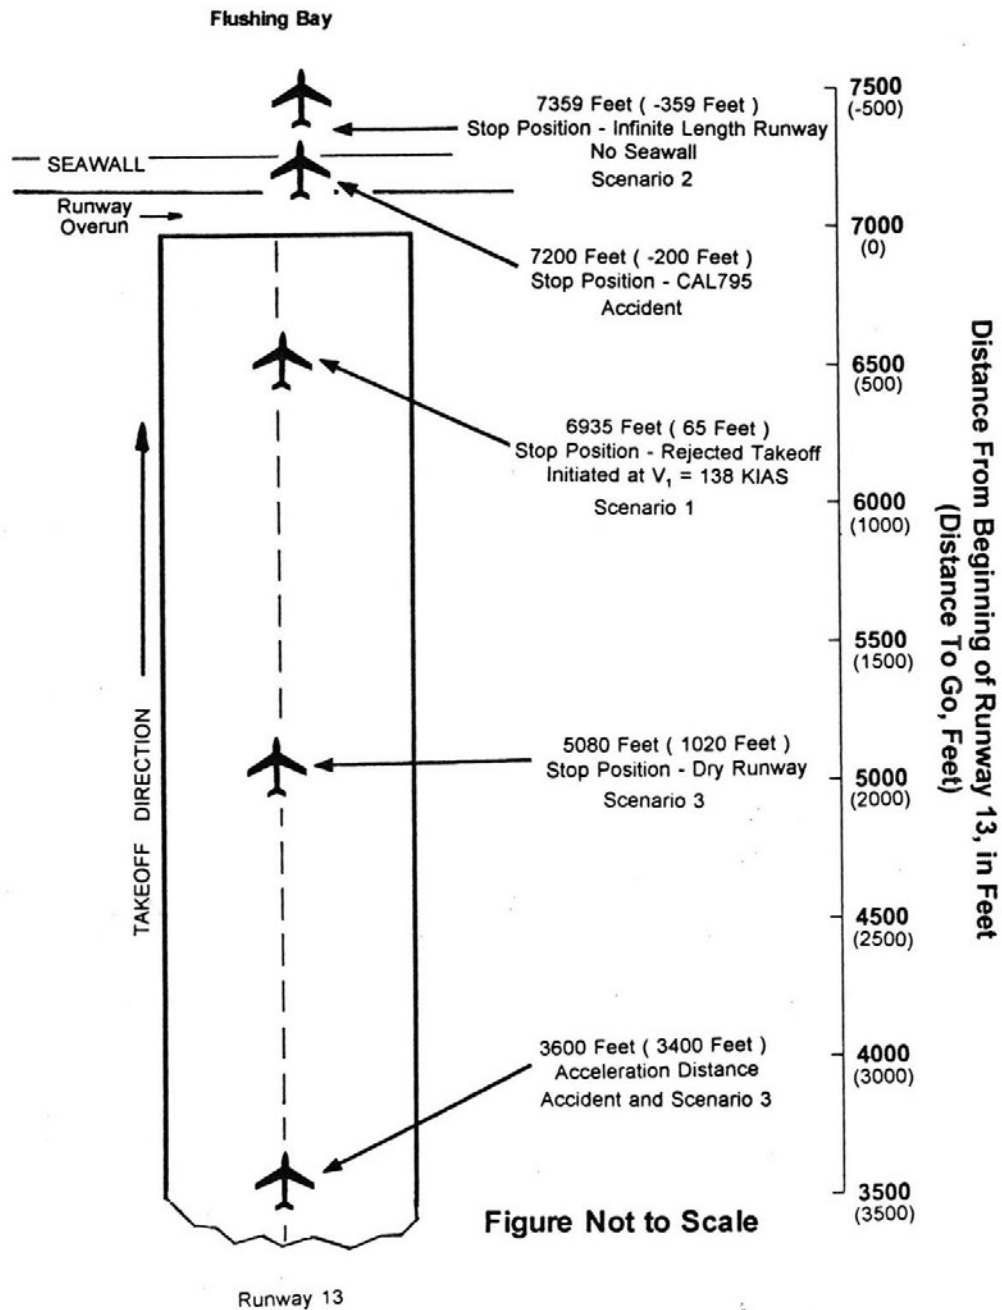
Figure 6.--Results of takeoff/stop scenarios.

The airplane performance study also revealed that the airplane should have been able to stop 1,320 feet from the end of the runway, if the runway surface were dry. (See figure 6, scenario 3). These computations assumed weight, thrust, and environmental conditions for the accident flight. The study also determined that the acceleration of the airplane, as compared to the nominal performance data for the airplane, was consistent with that for an uncontaminated runway, and the deceleration values were consistent with a slippery runway. (A Mu of 0.2 was used in these calculations).
