## Runway Collision involving Trans World Airlines Flight 427 and Superior Aviation Cessna 441, Bridgeton, Missouri, November 22, 1994

**Micro-summary: An MD-82 collides with a Cessna 441 on the active runway, destroying the Cessna.**

**Investigative Body: National Transportation Safety Board (NTSB), USA**

RUNWAY COLLISION INVOLVING  
TRANS WORLD AIRLINES FLIGHT 427  
AND SUPERIOR AVIATION CESSNA 441  
BRIDGETON, MISSOURI  
NOVEMBER 22, 1994

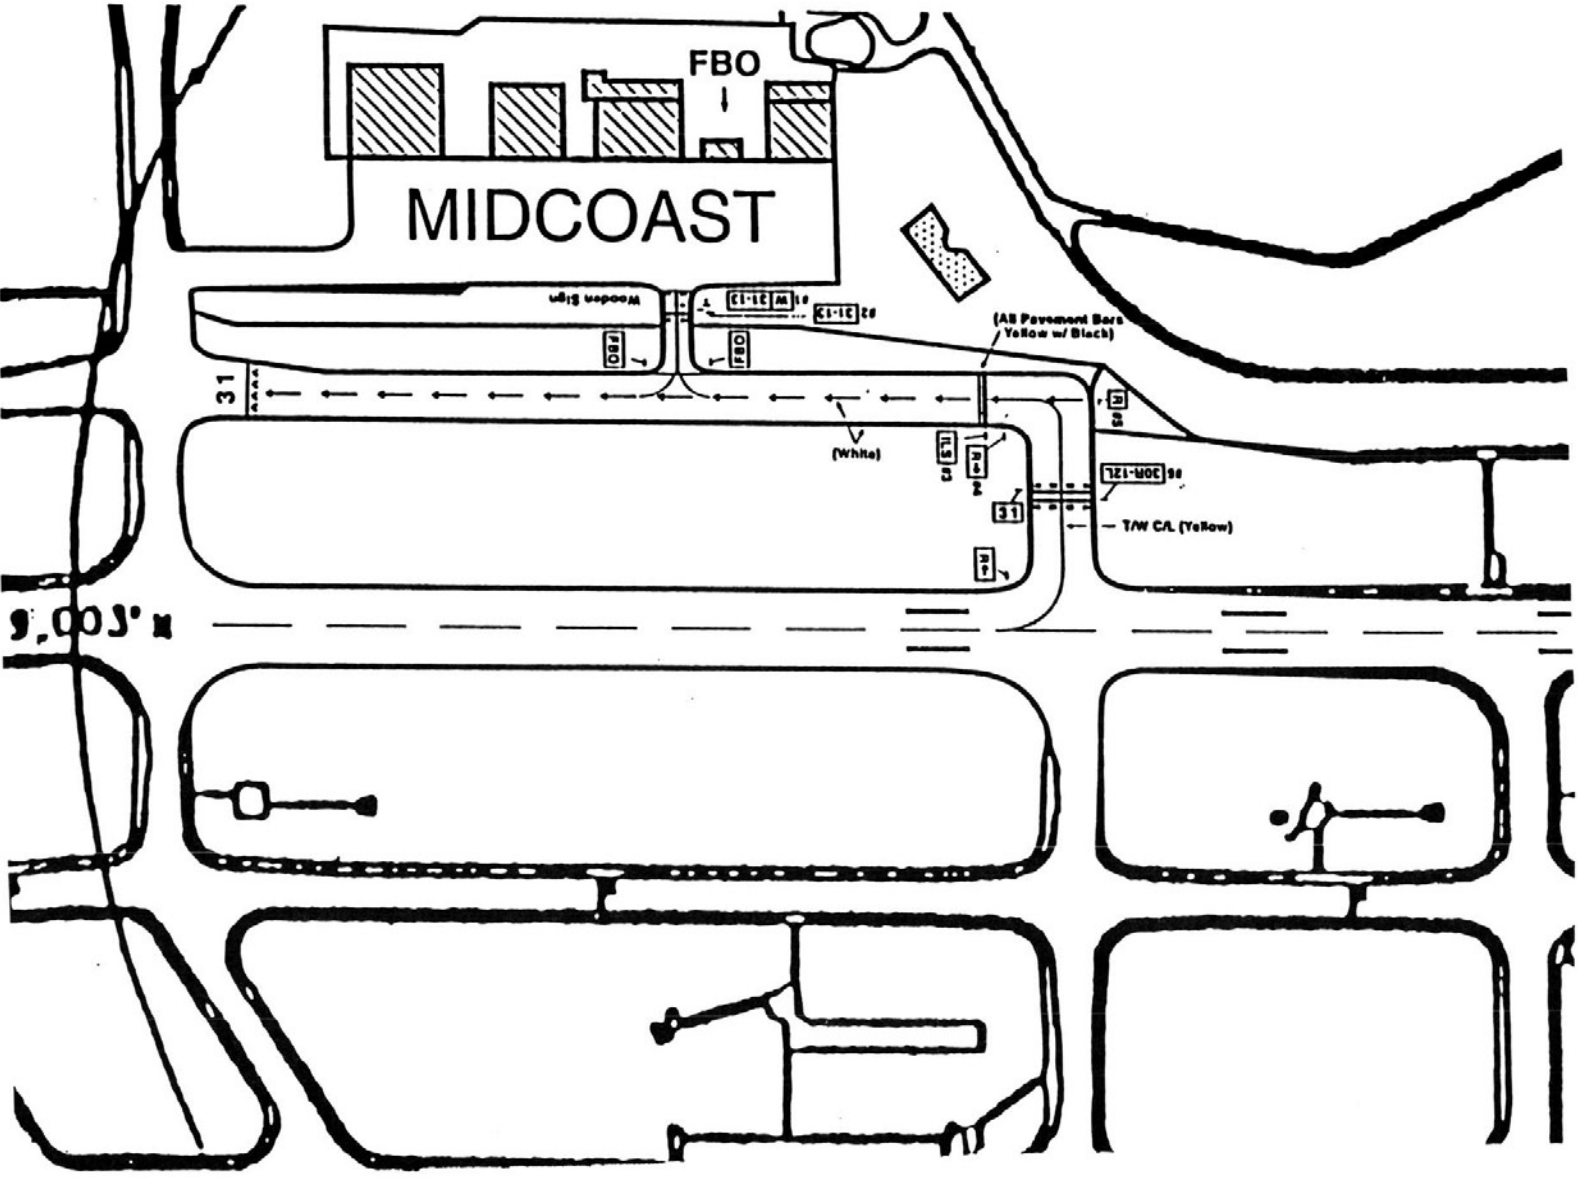
Figure 3--Airfield Signs Near and Along Midcoast Ramp and Taxiways Whiskey and Romeo

The Safety Board's examination of the airfield signs, markings, and lighting near and along the taxi route taken by the Cessna 441 revealed that they conformed to FAA standards. The Safety Board noted that upon exiting the Midcoast ramp area, there were three signs indicating runway 31 on the left side of the entrance to taxiway Whiskey. The furthest sign on the left side of the taxiway was installed in compliance with the FAA's revised (July 31, 1991) signage requirements, but was not yet in full service and was not lit. Behind this sign and slightly to its left was the in-service hold position sign. To the right of the two hold position signs was a wooden sign that read "ACTIVE RUNWAY CONTACT TOWER 121.9." (See Figure 3.)

Airport personnel told Safety Board investigators that the hold position signs for runway 13/31 were observed to be not internally illuminated during the hours following the accident: one sign had an inoperative light bulb, and one sign hadn't been hooked up to power. To simulate the signage conditions that the pilot of the Cessna 441 may have encountered the night of the accident, the Safety Board observed the signs at night, without internal illumination. Investigators noted that the three signs were clearly visible in the ambient light from the Midcoast ramp flood lights.

Investigators also noted that all taxiway markings, hold position markings, and displaced threshold markings for runway 31 were visible as they traveled from the Midcoast ramp to runway 30R, via taxiway Romeo. The yellow hold position markings on taxiways Whiskey and Romeo were highlighted in black to enhance the visibility of the markings. The runway 12L/30R hold position sign at taxiway Romeo had one inoperative light bulb on the right side of the sign. Investigators noted that the sign was clearly visible.

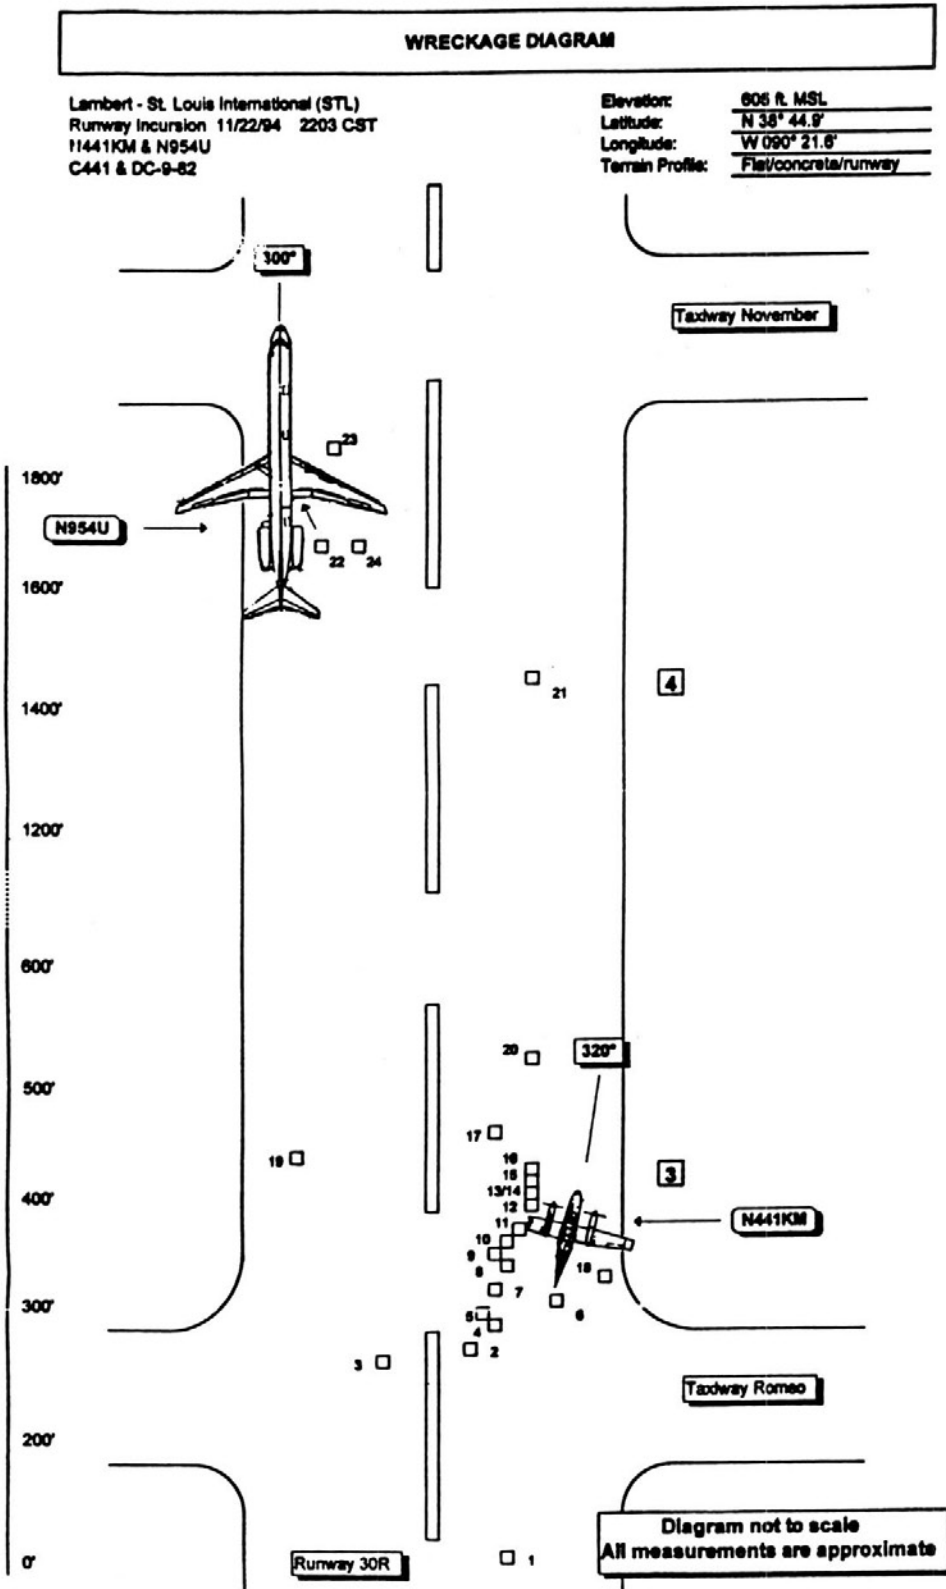
Figure 4--Wreckage Diagram

The upper fuselage was sheared off approximately 2 inches above the bottom of the cabin windows from the tail section to the windscreen. The outboard 7 1/2 feet of the left wing had separated. Separations at the left wing, all window frames, and cabin structure exhibited forward bending. Scrapes and indentations across the upper surface of the left wing, the left engine nacelle, and the instrument panel were angled 14 to 15° from the longitudinal axis of the airplane.

19. [N441KM] Cabin door actuator
20. [N441KM] Magnetic compass
21. [N954U] Number three leading edge slat
22. [N441KM] Left horizontal stabilizer section
23. [N441KM] Left outboard wing section (fractured 7.5 feet outboard of the number one engine nacelle) found wrapped around right main gear of N954U

The aft empennage was buckled and bent to the right; the entire empennage showed compression damage from the aft direction. The rudder was separated from the airplane. The vertical and horizontal stabilizers were fractured at their main attach points.

The right main landing gear, the right lower fuselage, and the number two engine were also damaged. Plexiglass and metal debris from the Cessna was embedded in the MD-82. The largest piece of Cessna debris directly associated with the MD-82 was the outboard section of the left wing, which was wrapped around the right main landing gear strut.
