In-flight loss of propeller blade, forced landing, and collision with terrain, Atlantic Southeast Airlines, Inc., Flight 529, Embraer EMB-120RT, N256AS, Carrollton, Georgia, August 21, 1995

AIRCRAFT ACCIDENT REPORT

IN-FLIGHT LOSS OF PROPELLER BLADE
FORCED LANDING, AND COLLISION WITH TERRAIN
ATLANTIC SOUTHEAST AIRLINES, INC., FLIGHT 529
EMBRAER EMB-120RT, N256AS
CARROLLTON, GEORGIA
AUGUST 21, 1995

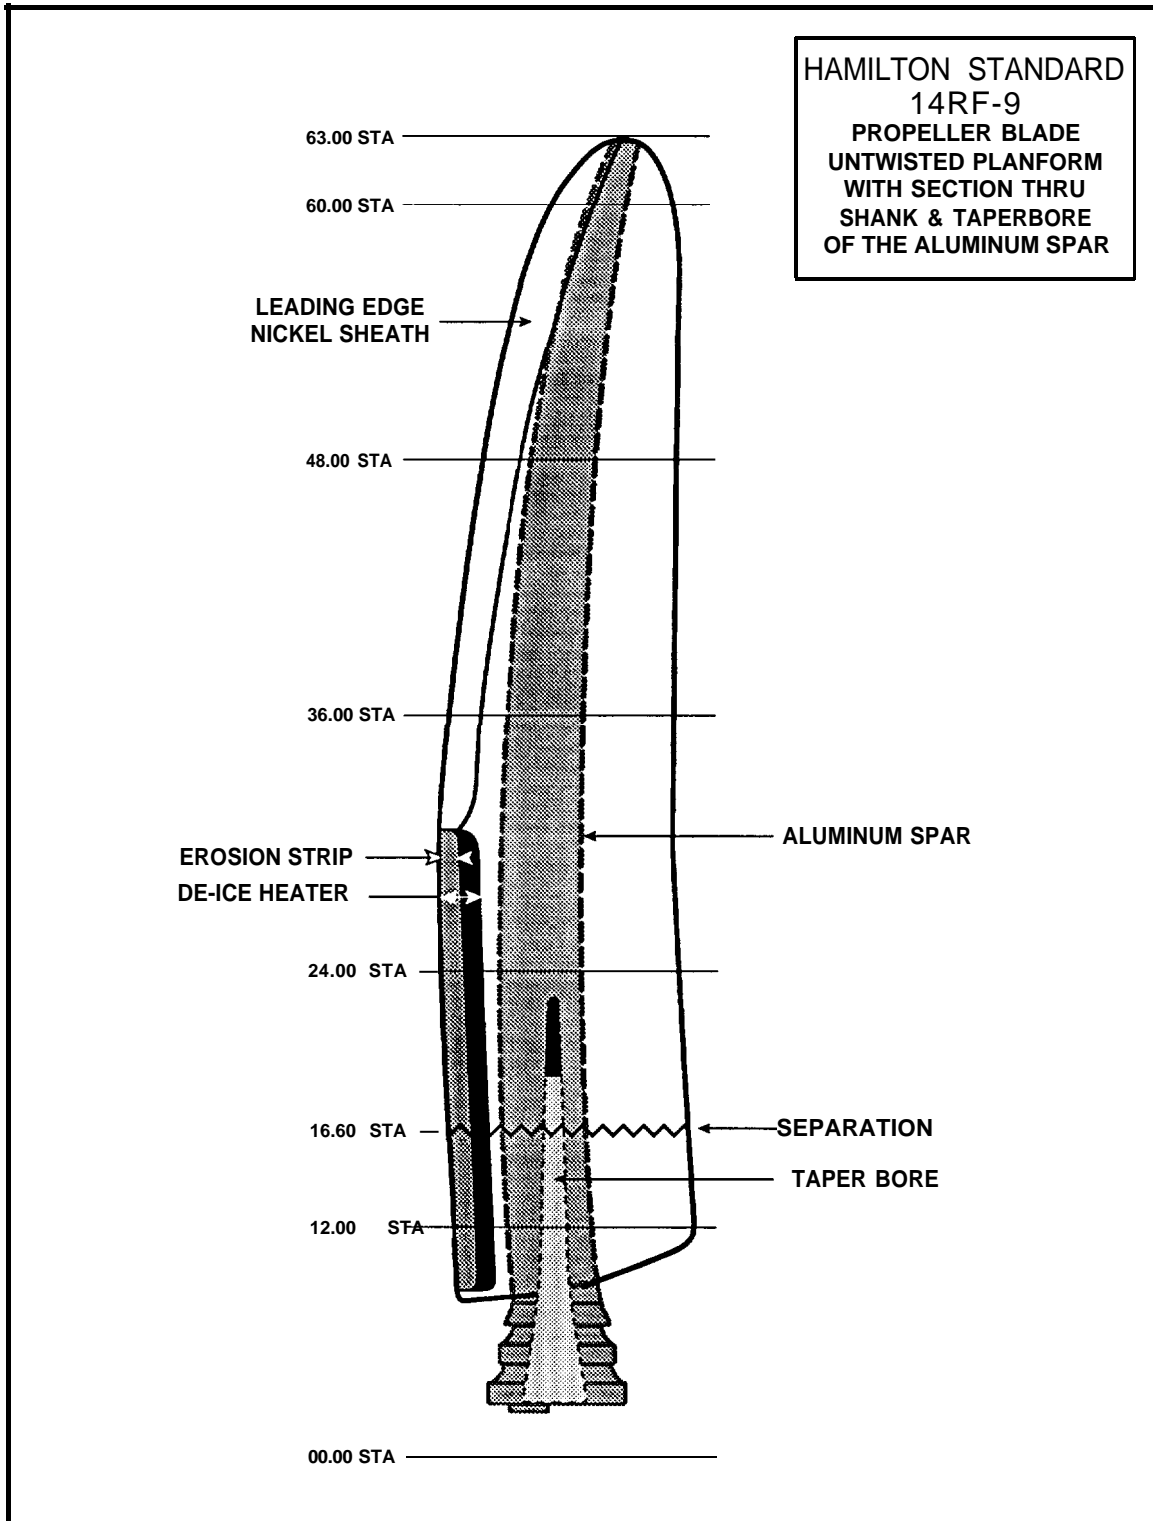
Figure 2.--Illustration of a 14RF-9 propeller blade.

bellmouth shape (known as the “N” style). Also, during very early production, the taper bore was shotpeened.¹⁴ However, early in the production run, Hamilton Standard reviewed the production process, deemed shotpeening unnecessary, and, with FAA approval, it was discontinued. The accident blade was originally an N style blade, but it was rebalanced on customer request for ASA fleet standardization to the M style and reidentified as an M blade. The accident blade taper bore was not shotpeened during production.

The taper bore provides space for a measured amount of lead wool to be inserted for blade balancing. Until April 1994, a cork was used to retain the lead wool in the taper bore; however, it was later eliminated¹⁵ because it was found to be a source of chlorine (and potential corrosion) in the taper bore, as well as unnecessary to retain the lead wool. The model 14RF, 14SF and 6/5500/F propellers, which vary in length from 10.5 to 13 feet, operate at a maximum of 1,200 to 1,384 rpm. As of July 1996, the 14RF, 14SF and 6/5500/F propeller assemblies were installed on 9 types of commuter aircraft, operated by 143 operators, on approximately 1,300 aircraft, for an industry total of about 15,000 blades worldwide.

According to information provided to the Safety Board in February, 1995, Hamilton Standard statistical data from field service experience indicate that blades without shotpeened taper bores are susceptible to earlier corrosion and cracking.

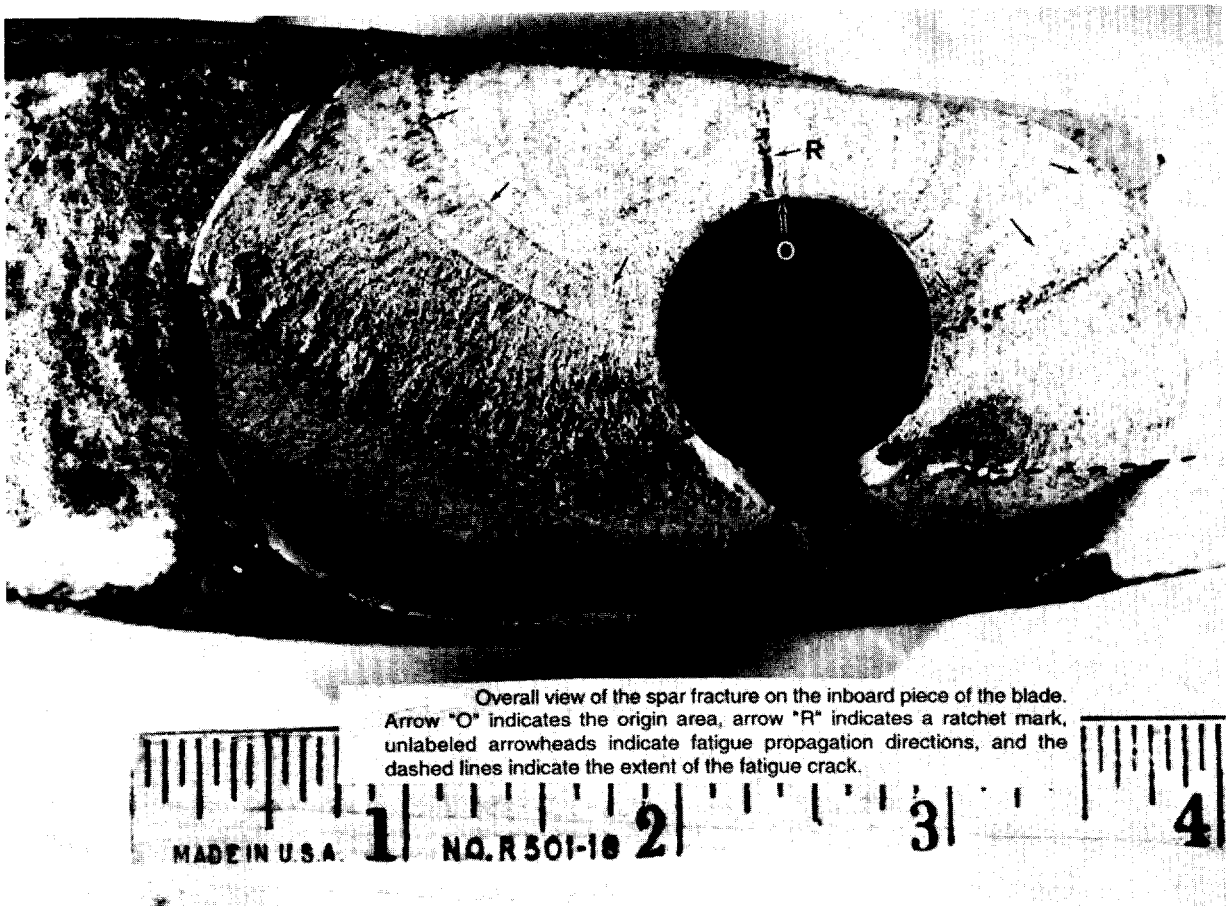
Figure 3.--Photo of the blade fracture surface.

The inboard piece of the fractured blade, serial number 861398, was retained in the left engine propeller hub, which was recovered at the accident scene on August 21, 1995. The outboard piece of the blade was recovered on September 15, 1995, after it was discovered by a farmer on property about 35 miles west of the accident site adjacent to an area that had previously been searched by helicopter. Both portions of the blade were examined at the Safety Board's Materials Laboratory. The blade spar²⁵ was separated at blade station 16.6 (about 13.2 inches outboard of the blade pin platform). Initial visual examination revealed that a portion of the spar fracture was on a flat transverse plane and contained crack arrest positions, typical of fatigue cracking (see Figure 3). The fatigue cracking appeared to initiate from at least two adjacent locations on the taper bore surface. Below the taper bore surface, the individual cracks joined to form a single crack that propagated toward the face side²⁶ of the blade and progressed circumferentially around both sides of the taper bore. The extent of the fatigue cracking progressed through about 75 percent of the spar cross section. The fracture surface in areas beyond the terminus of the fatigue region contained rough features with a matte appearance, typical of an overstress separation area.

The origin areas on both the inboard and outboard faces of the fracture were examined with a scanning electron microscope (SEM) before the faces of the fracture were cleaned. The fracture surface near the origin area on both faces of the fracture contained a layer of heavy oxide deposits that had a mud-cracked appearance. These deposits extended to a maximum depth of 0.049 inch from the taper bore surface. Their maximum circumferential width was 0.130 inch, based on the examination of the damaged outboard fracture face. X-ray energy dispersive spectroscopy (EDS) of the deposits of both faces generated similar spectra with a major peak for aluminum, a substantial peak for oxygen, and a minor peak for zinc.²⁷ EDS of the deposit area on the inboard fracture face also revealed the presence of chlorine.

After the fracture surface had been cleaned, additional SEM examination revealed that the fatigue cracking initiated from several corrosion pits in a line of pits in the taper bore that extended over a distance of about 0.070 inch. The maximum depth of the corrosion pitting at the fatigue origin area was measured as slightly less than 0.006 inch below the taper bore surface.

The taper bore surface, including the area adjacent to the fatigue initiation area, contained a series of nearly circumferential sanding marks. The marks extended over about 180 degrees of the circumference of the taper bore and to a maximum distance of about 1.5 inches inboard of the fracture surface. Outboard of the fracture, the sanding marks extended about 2 inches from the fracture surface.

The investigation revealed that sanding rework of the area had been accomplished using the blending repair procedures contained in PS960A.²⁸ The procedures required that the surface finish of the blended area should be restored to the original surface finish. Postaccident surface profilometer measurements conducted on the taper bore sanding marks indicated that the surface finish was much rougher than the manufactured surface not disturbed by the rework process.²⁹ Measurements also indicated that the nondisturbed surface met the manufacturing specifications.

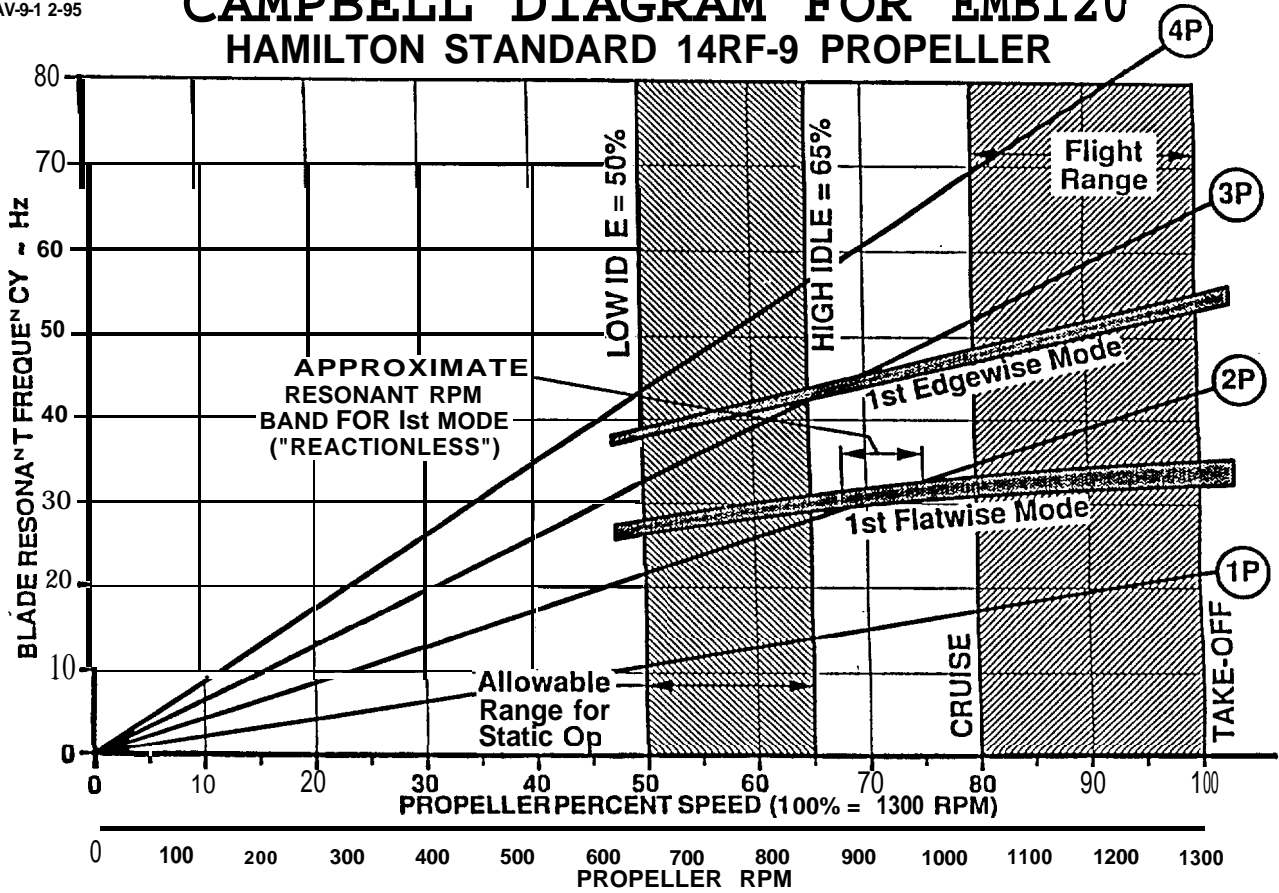
Figure 4.--Vibratory modes of the 14RF-9 propeller.

When the first flat-wise vibration frequency and the 2P excitation frequency coincide, a four-bladed propeller, such as the 14RF-9, vibrates in the reactionless⁴⁹ mode. The reactionless mode of vibration is characterized as when two blades of a four-bladed, rotating propeller, 180 degrees apart, reach a negative stress peak at the same time that the other two blades reach their positive stress peak. This type of propeller vibration is called reactionless because the bending loads of the four blades are canceled at the propeller hub which consequently transmits little or no vibratory loading to the propeller mounting structure.
