## **Collision with Trees on Final Approach, American Airlines Flight 1572, McDonnell Douglas MD-83, N566AA, East Granby, Connecticut, November 12, 1995**

**Investigative Body:** National Transportation Safety Board (NTSB), USA

## AIRCRAFT ACCIDENT REPORT

COLLISION WITH TREES ON FINAL APPROACH  
AMERICAN AIRLINES FLIGHT 1572  
McDONNELL DOUGLAS MD-83, N566AA  
EAST GRANBY, CONNECTICUT  
NOVEMBER 12, 1995

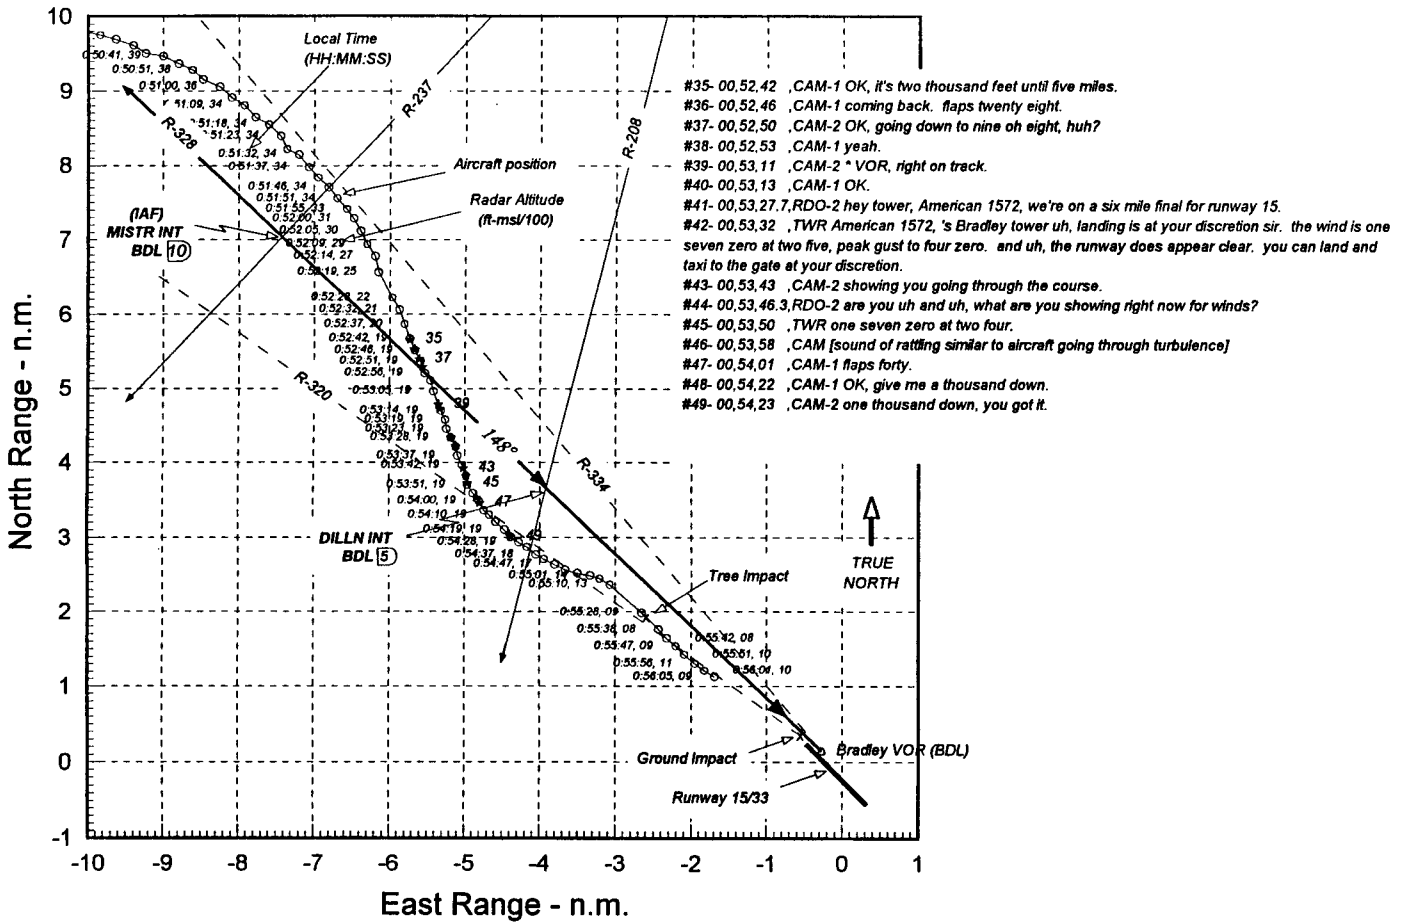
Figure 2a.—Plan view of the approach.

<sup>11</sup>Investigators determined that the first impact point was with trees on the top of a ridge line approximately 2.54 nautical miles northwest of the approach end of runway 15.
