Runway excursion during takeoff, Boeing 747-136, December 20, 1995

AIRCRAFT ACCIDENT REPORT

**RUNWAY DEPARTURE DURING ATTEMPTED TAKEOFF
TOWER AIR FLIGHT 41
BOEING 747-136, N605FF
JFK INTERNATIONAL AIRPORT, NEW YORK
DECEMBER 20,1995**

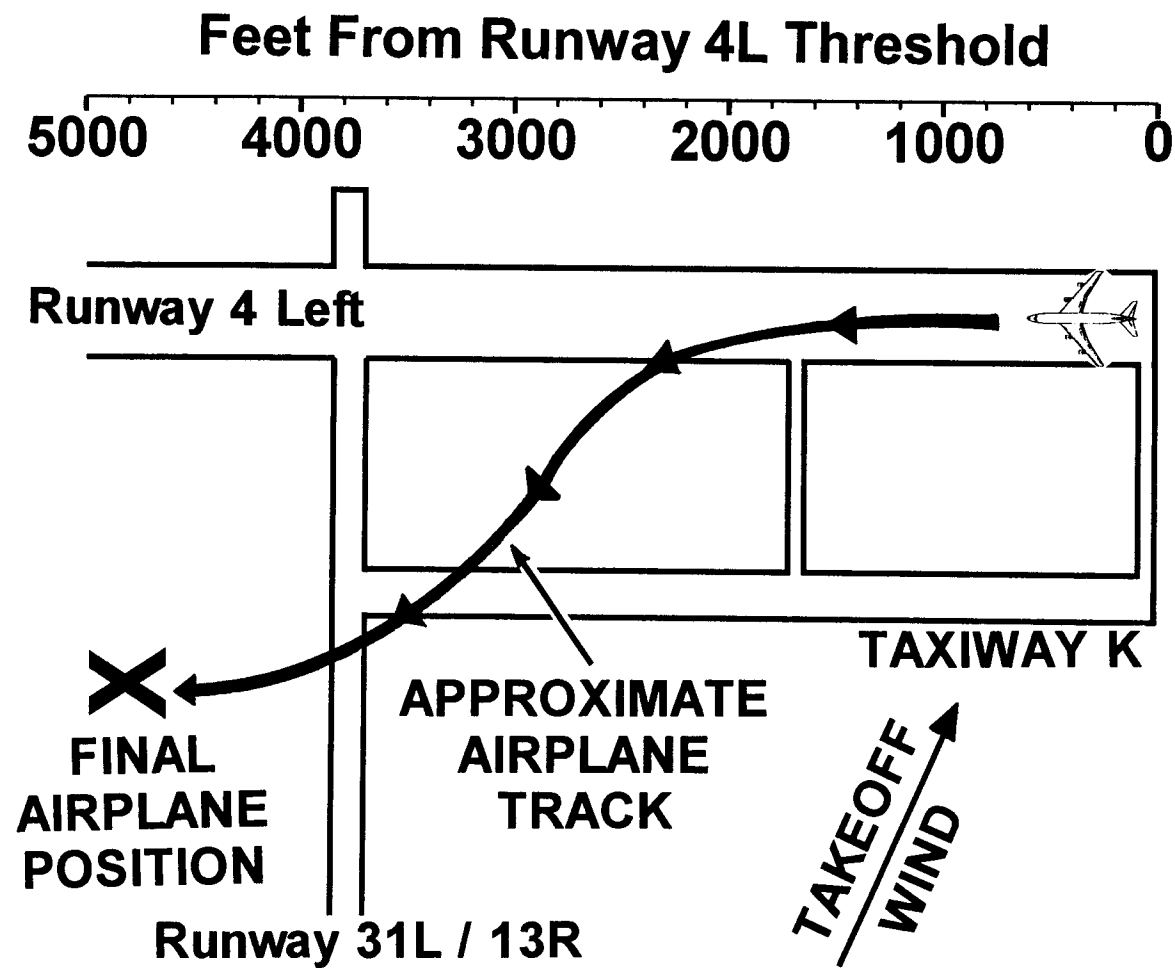
Figure 2—Airplane's Location After Skid

The first marks on the runway attributed to N605FF consisted of four pairs of black marks located approximately 2,000 feet from the threshold of runway 4L, and centered approximately 40 feet left of the runway centerline (see figure 2). The four pairs of tire marks were consistent with the tires of the airplane left main wing landing gear (LMWLG), left body landing gear (LBLG), right body landing gear (RBLG), and right main wing landing gear (RMWLG). The tire marks on the runway were continuous, and each mark was approximately 8 inches wide. No tire marks were found from the nose landing gear either on the runway or on the ground.

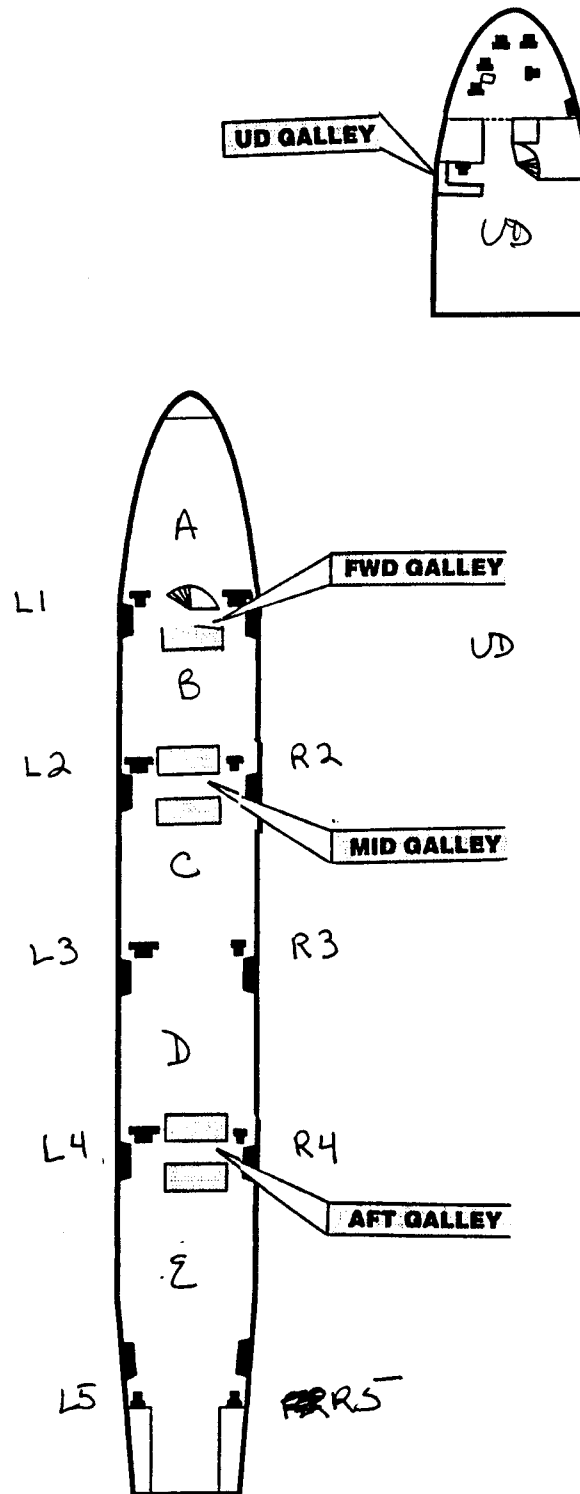
Figure 3—Cabin Layout

The cabin floor sustained substantial damage in Zone A. The floor was displaced upward approximately 2 feet in the center of the cabin at seat rows 6, 7, and 8. At least three of the four attach points for each of the seats in this area remained secured to the seat tracks, and no injuries were reported in this area.

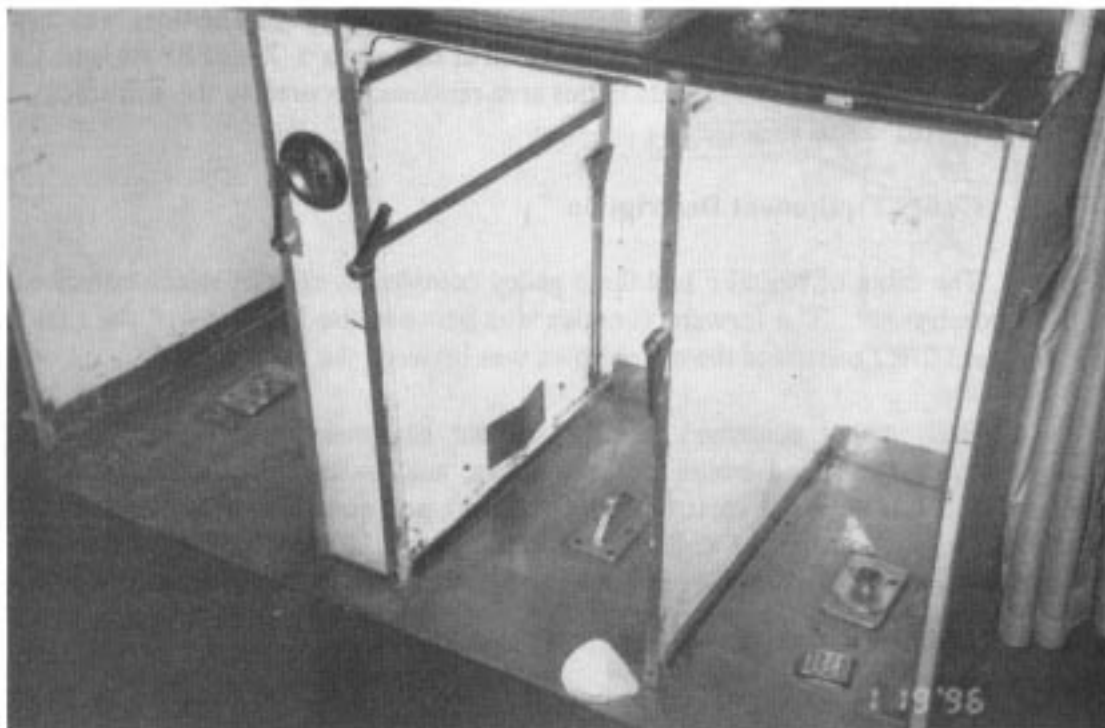
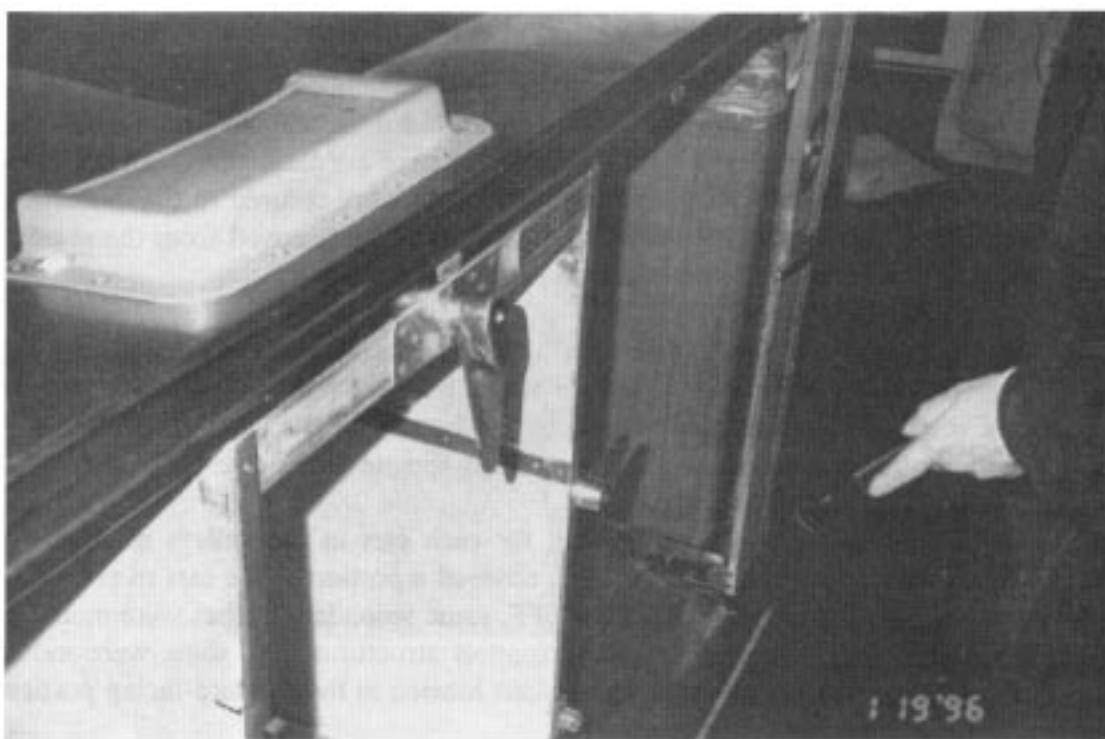
Figure 4—Galley Cart Primary and Secondary Securing Mechanisms

In contrast to the "mushroom" locking mechanism used to secure meal and beverage carts, the ice cart in each galley area of N605FF locked onto a retaining tongue mounted on the floor of the galley with a lever located on the bottom of the cart. The lever movement inserted a pin through a circular opening in the retaining tongue (see figure 4).

Secondary latches were installed for each cart in the galleys of N605FF. The secondary latches were levers that when rotated, covered a portion of the cart to prevent the cart from moving from its stowage location. In N605FF, some secondary latches were mounted to the galley counter, some were mounted on galley support structures, and some were mounted on trash bin doors. The secondary latch for the ice cart located in the forward-facing portion of the aft galley was mounted on the galley counter.
