In-Flight Fire And Impact with Terrain, ValuJet Airlines Flight 592, DC-9-32, N904VJ, Everglades, Near Miami, Florida, May 11, 1996

AIRCRAFT ACCIDENT REPORT

**IN-FLIGHT FIRE AND IMPACT WITH TERRAIN
VALUJET AIRLINES FLIGHT 592**

DC-9-32, N904VJ

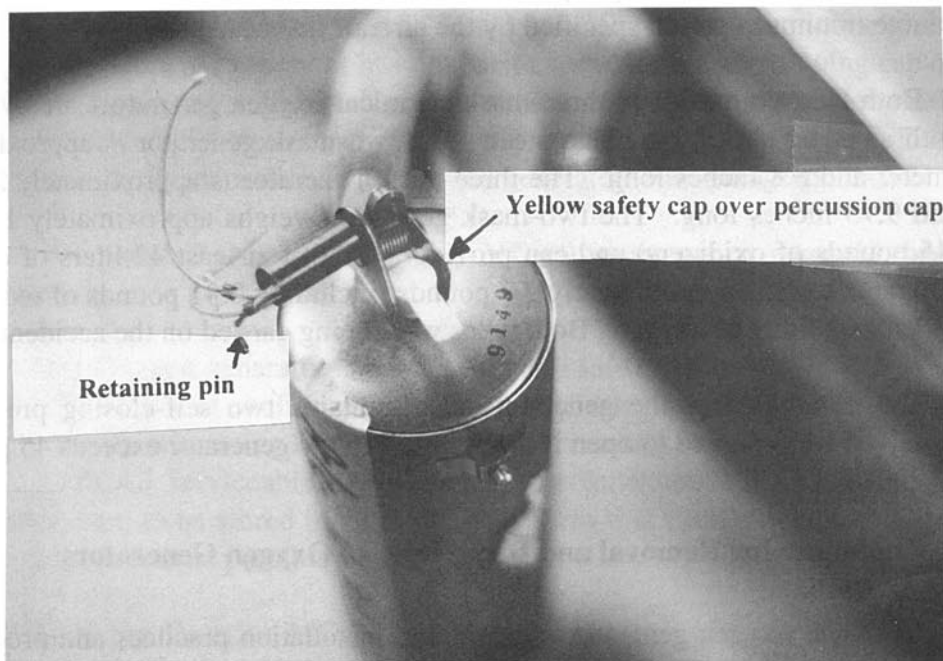
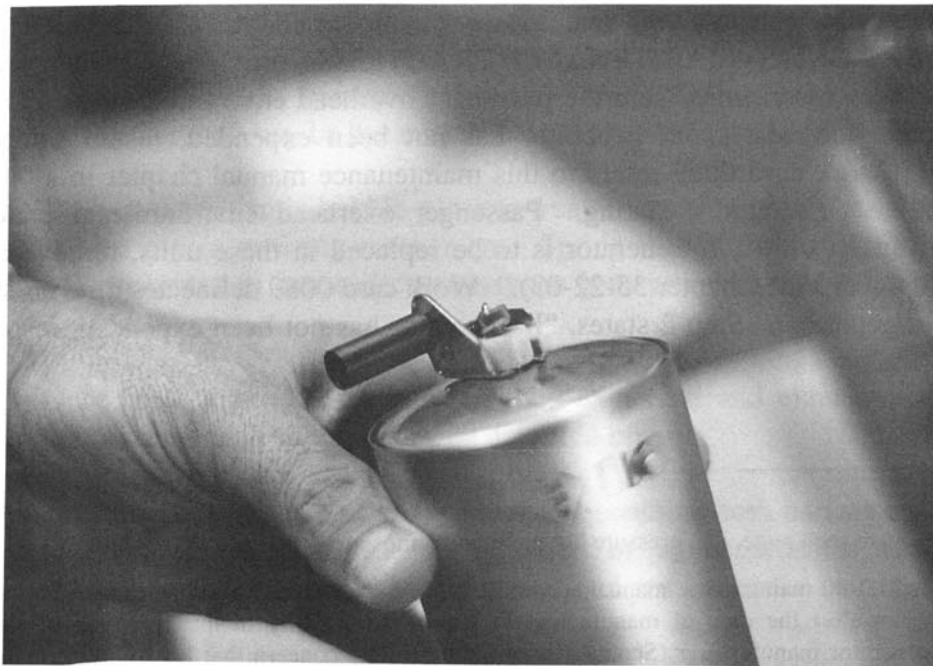
Figure 2b—Photographs of passenger oxygen generator unit

The chemical reaction is exothermic, which means that it liberates heat as a byproduct of the reaction. This causes the exterior surface of the oxygen generator to become very hot; the maximum temperature of the exterior surface of the oxygen generator during operation is limited by McDonnell Douglas specification to 547 °F when the generator is operated at an ambient temperature of 70 to 80 °F. Manufacturing test data indicate that when operated during tests, maximum shell temperatures typically reach 450 to 500 °F.

Both the two-mask and three-mask chemical oxygen generators are cylindrical in appearance with an outer skin of stainless steel. The two-mask generator is approximately 2.5 inches in diameter and 8.8 inches long. The three-mask generator is approximately 2.75 inches in diameter and 9.75 inches long. The two-mask generator weighs approximately 1.25 pounds (including 0.45 pounds of oxidizers) and can provide a total of at least 42 liters of oxygen; the three-mask generator weighs approximately 1.7 pounds (including 0.81 pounds of oxidizers) and can produce at least 62 liters of oxygen. Both types were being carried on the accident airplane.

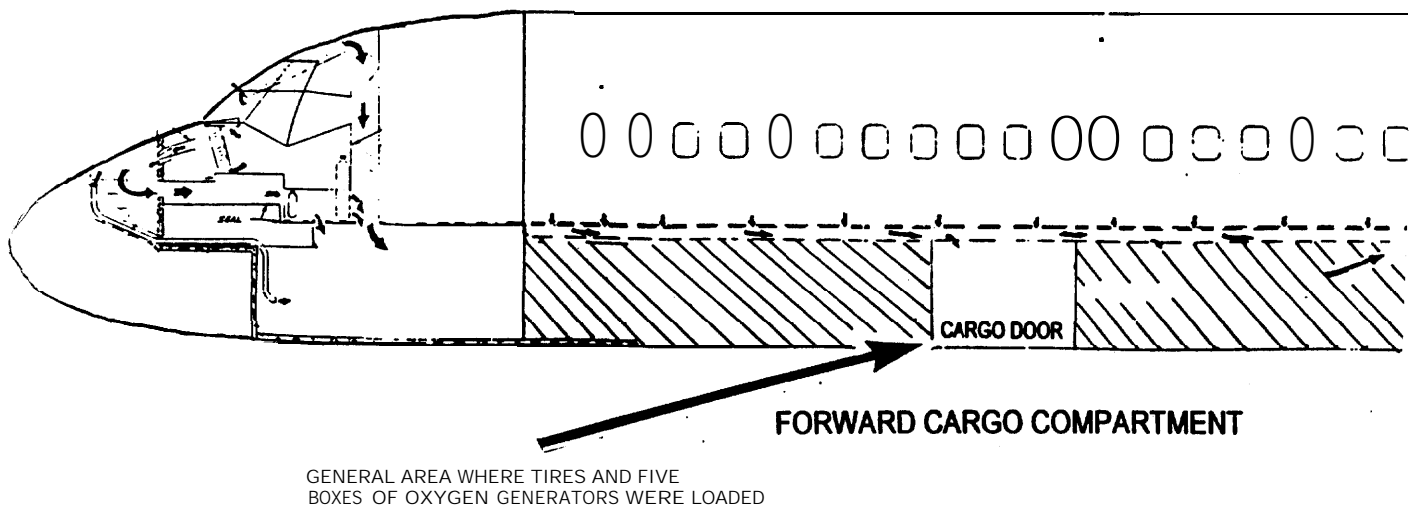
Figure 3—Forward cargo compartment

The accident airplane was equipped with two class D cargo compartments. (See figure 3—forward cargo compartment.) The volume of the forward cargo compartment in the DC-9 airplane is about 560 cubic feet.

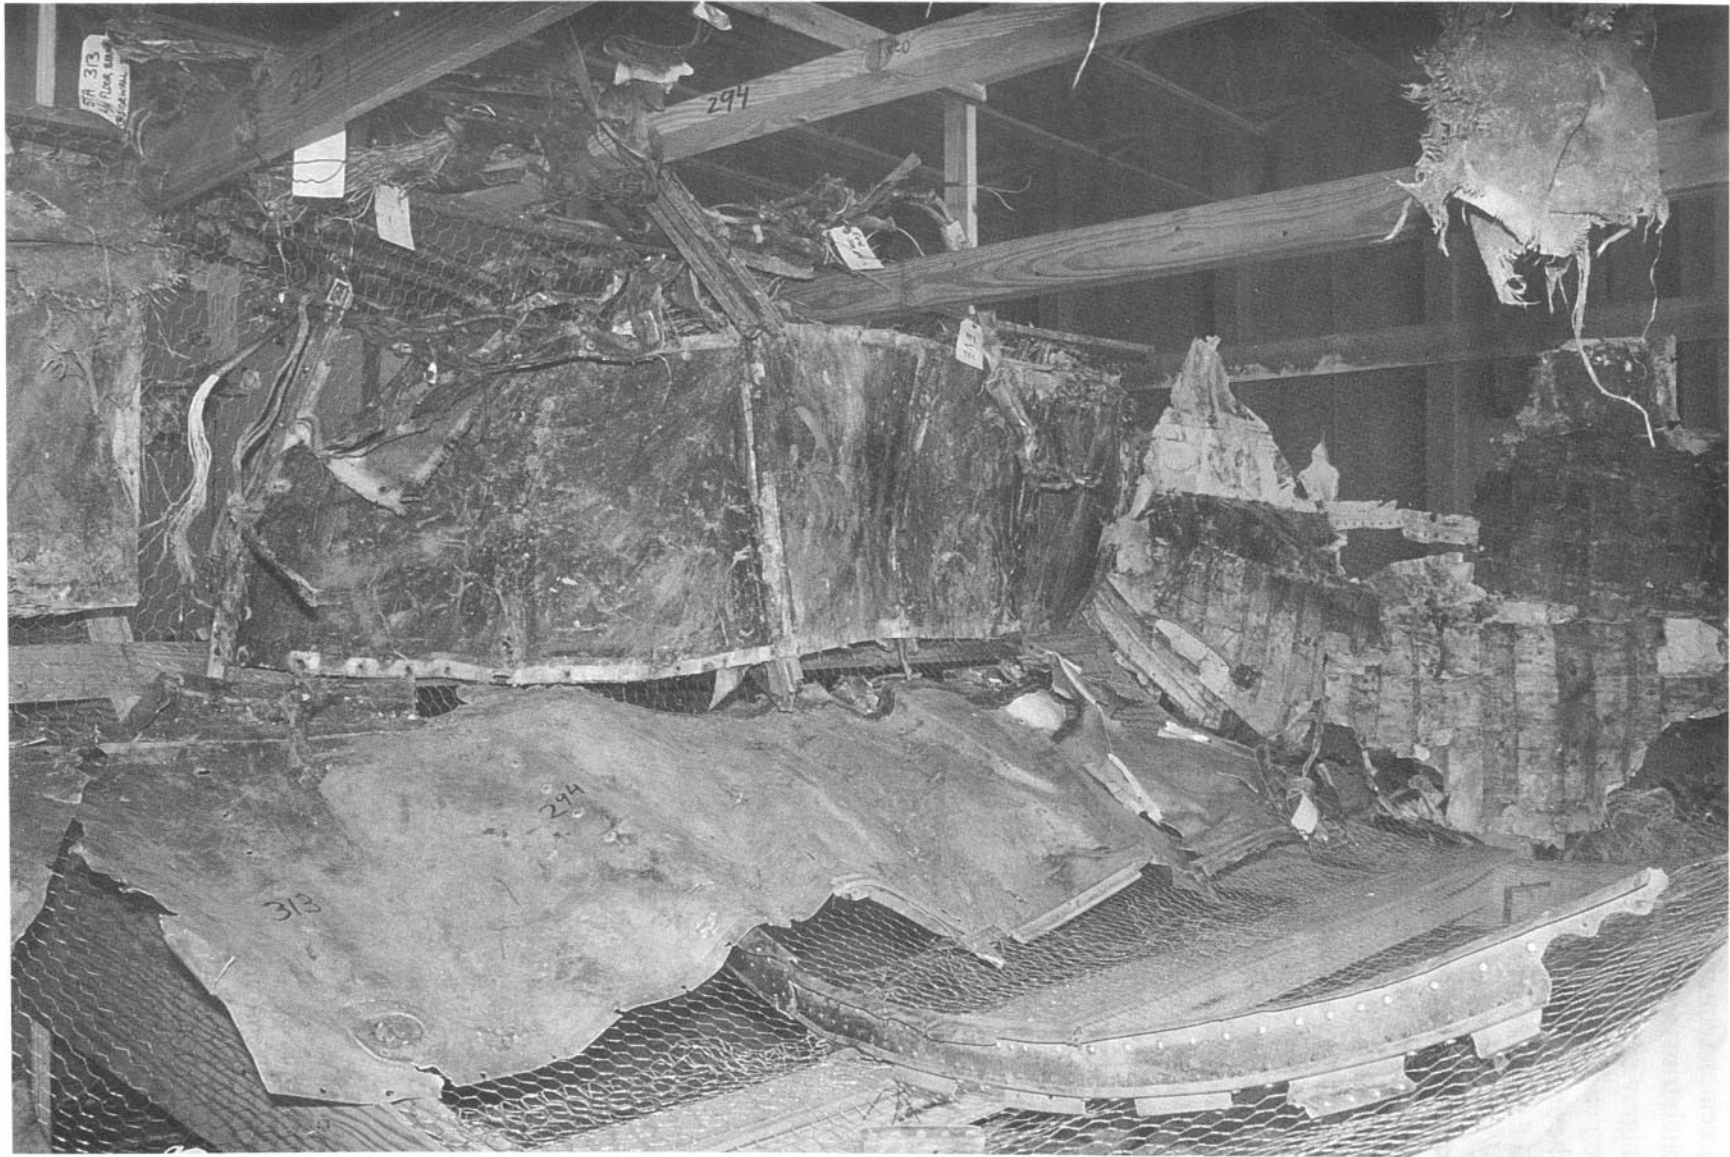
Figure 5—Cargo compartment mockup

All recovered wreckage identified as being from the area of the forward cargo compartment was assembled into a full-scale, three-dimensional mockup. (See figure 5.) The forward cargo compartment extended from fuselage station (FS) 218 to 581. The forward edge of the forward cargo door was located at FS 373 and the aft edge was located at FS 425. Most of

these pieces, which included the cargo floor, cargo liners, and fuselage structure, exhibited soot and heat damage.
