## **Descent Below Visual Glidepath and Collision with Terrain, Delta Air Lines Flight 554, McDonnell Douglas MD-88, N914DL, LaGuardia Airport, New York October 19, 1996**

PB97-910403  
NTSB/AAR-97/03  
NYC97MA005

## AIRCRAFT ACCIDENT REPORT

DESCENT BELOW VISUAL GLIDEPATH  
AND COLLISION WITH TERRAIN  
DELTA AIR LINES FLIGHT 554  
MCDONNELL DOUGLAS MD-88, N914DL  
LAGUARDIA AIRPORT, NEW YORK  
OCTOBER 19, 1996

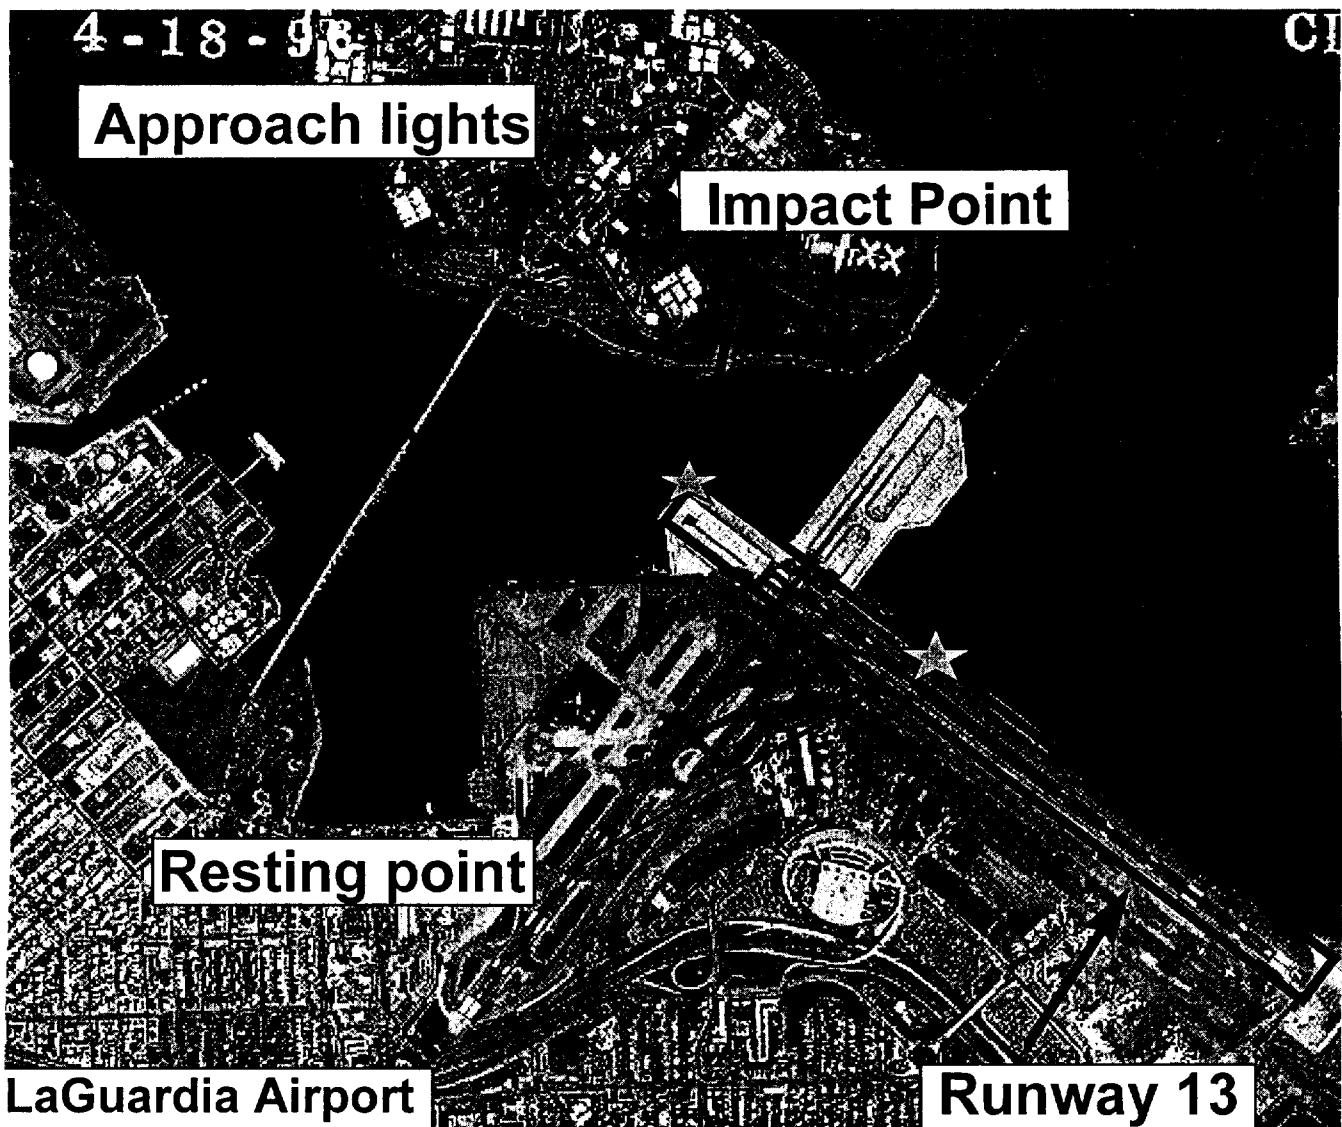
Figure 2—LaGuardia Airport, with runway 13 approach lights, the point of initial impact, and the point where the airplane came to rest on runway 13 depicted

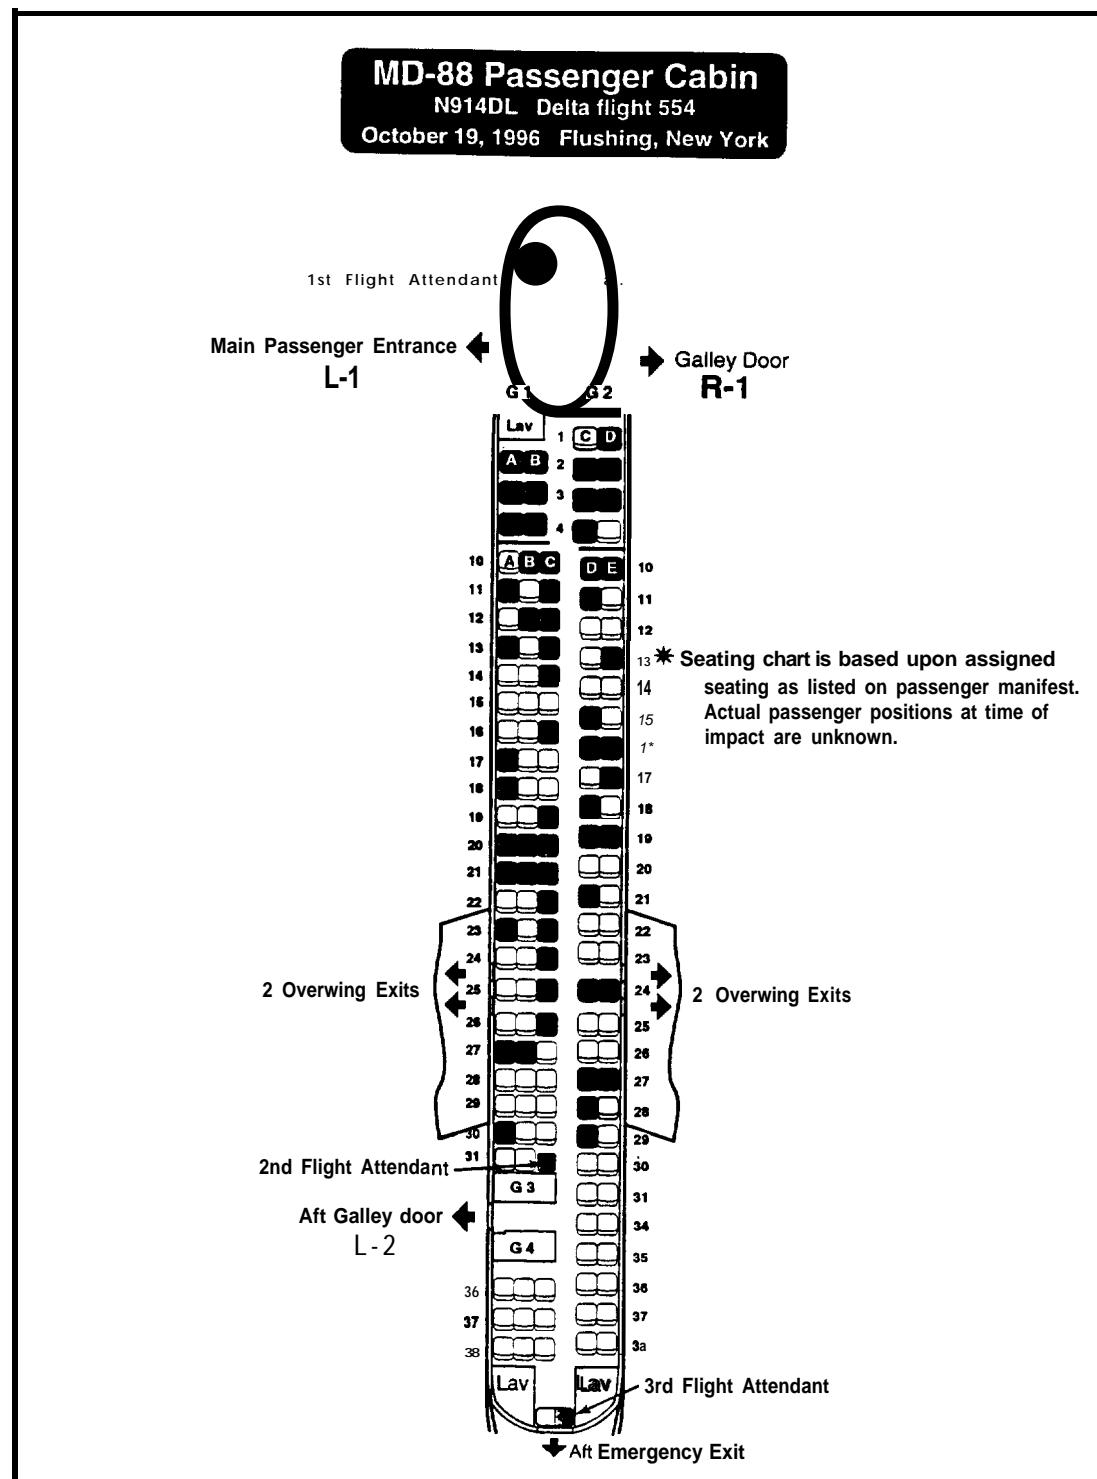
Figure 4—Airplane diagram and seating chart

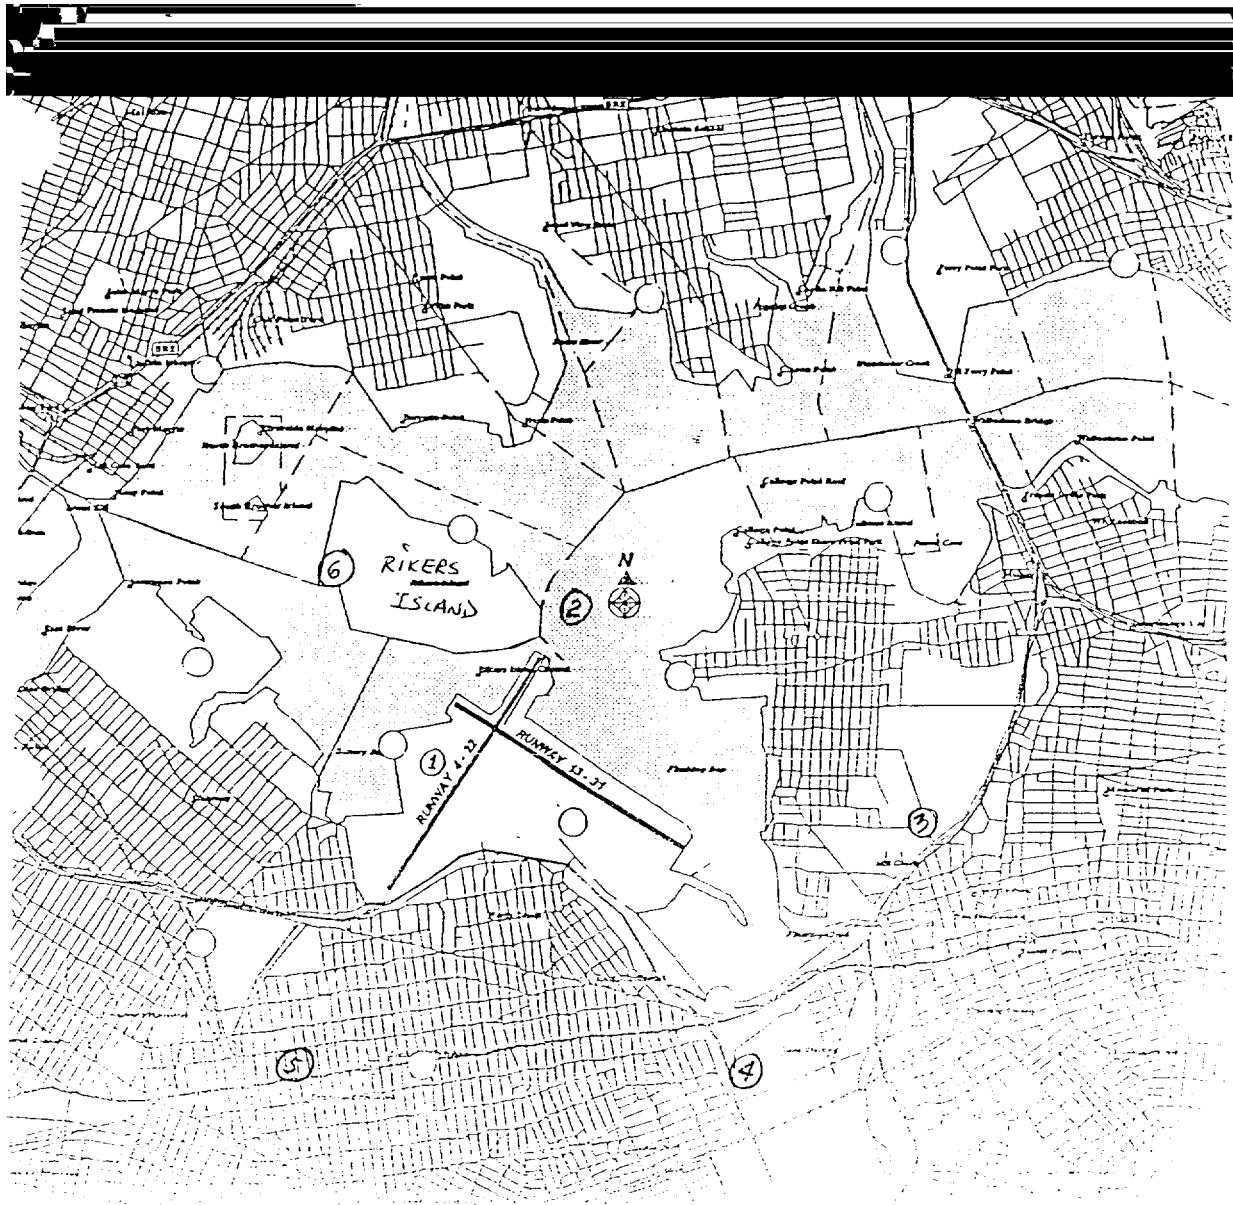
### LLUVAS Sensor Locations

After the accident, the FAA performed a site performance evaluation system of the LLWAS archived data. The examination revealed that three of the six sensors (sensors 3, 4, and 5) appeared to have problems. According to the FAA, the sensor problems might have resulted in the system's failure to detect existing windshears, or the system producing false windshear warnings.

- STATION #1: CENTERFIELD @ LGA RTR SITE
- #2: NORTH @ MM-22 PIER
- #3: NORTH-EAST @ FLUSHING AIRPORT
- #4: SOUTH-EAST @ WORLD'S FAIR
- #5: SOUTH-WEST @ MM-4 JACKSON HEIGHT
- #6 : NORTH-WEST @ RIKERS ISLAND  
EAST ELMHURST
