# In-Flight Icing Encounter And Uncontrolled Collision With Terrain, Comair Flight 3272, Embraer EMB-120RT, N265CA, Monroe, Michigan January 9, 1997

PB98-910404 NTSB/AAR-98/04 DCA97MA017

# AIRCRAFT ACCIDENT REPORT

IN-FLIGHT ICING ENCOUNTER AND UNCONTROLLED COLLISION WITH TERRAIN COMAIR FLIGHT 3272 EMBRAER EMB-120RT, N265CA MONROE, MICHIGAN JANUARY 9, 1997

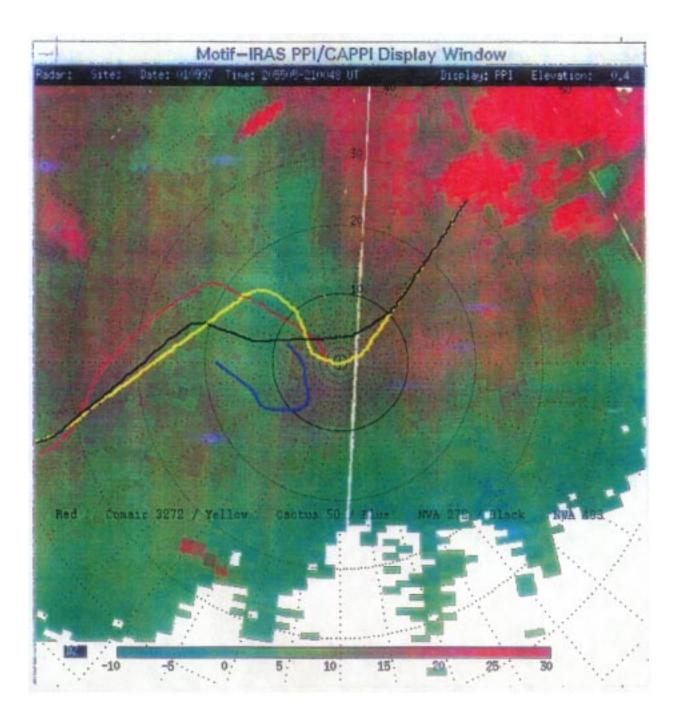
Figure 8.--Flightpath and weather radar echo information.

meteorologists further concluded that it was unlikely that freezing rain-size droplets (greater than 400 microns) were present.

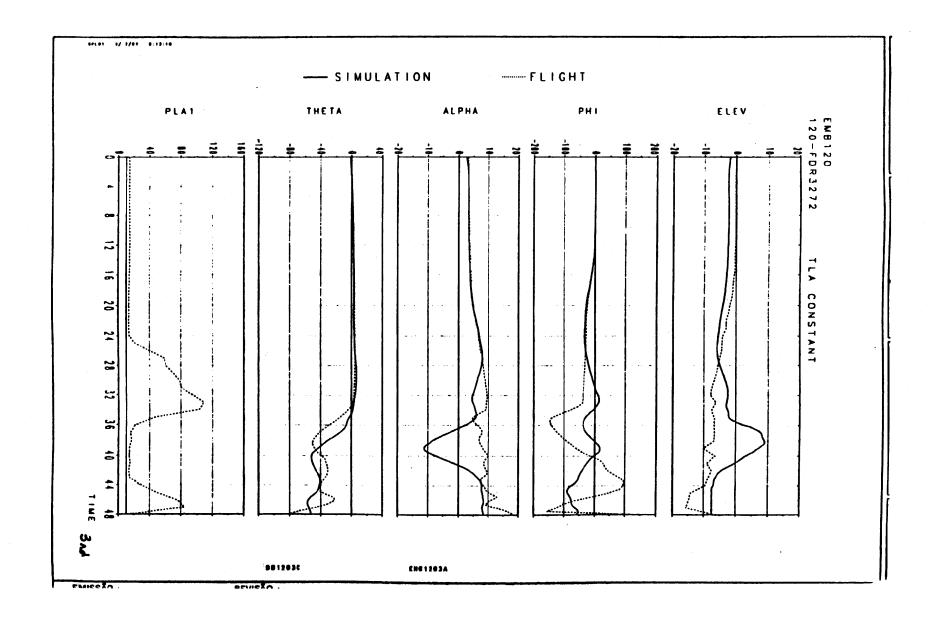
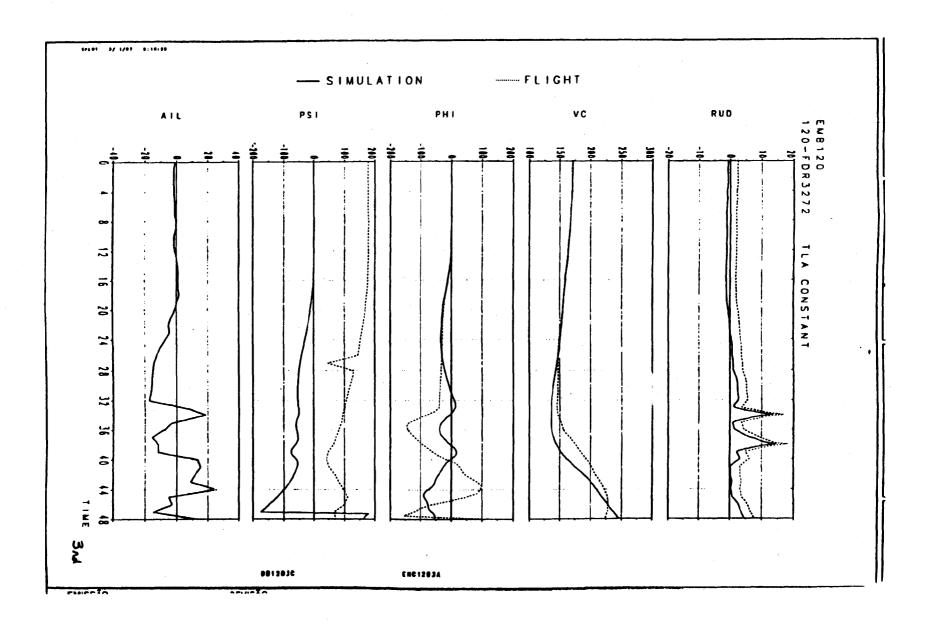
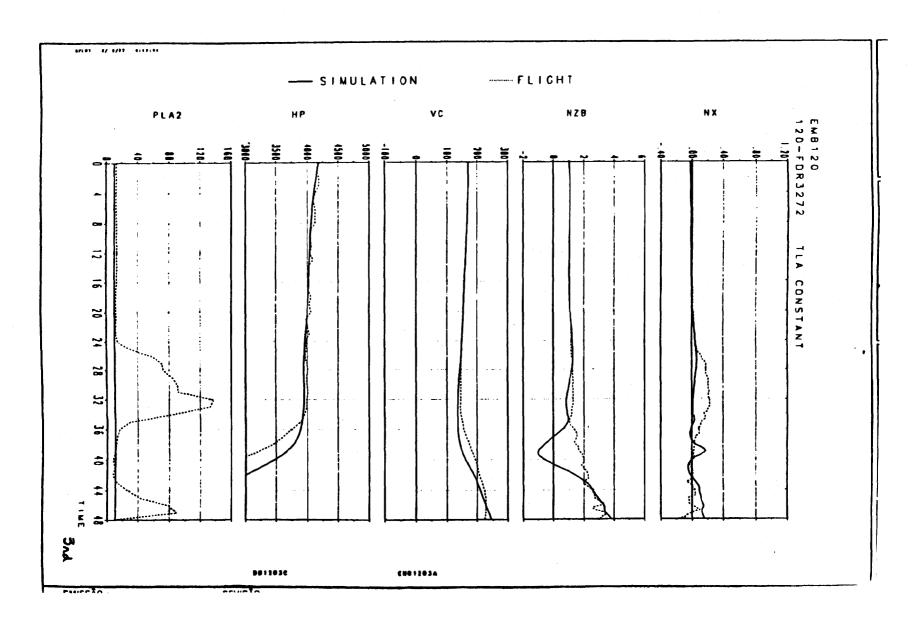
The attached figures (3 pages) shows the airplane response without power increase from the simulation and the DFDR readings. In figure 2 we notice that the airspeed that in the DFDR readings shows a flattening around 150 Kcas, but in the simulation it has a constant decrease up to a minimum of around 135 Kcas. It is important to notice that at this moment the angle of attack (AOA) of the DFDR is increasing rapidly and the drag variation that was introduced in the simulation is also increasing from a value of zero for one degree of AOA to a value of DCD = + 0.040 (400 drag counts) for 10 degrees of AOA. This value of 400 drag counts is almost twice the drag of the airplane landing gears. For those reasons (the fact that without increasing the torque the airspeed would constantly decrease and the drag was increasing with the AOA) the airspeed did not show an increase in the DFDR.

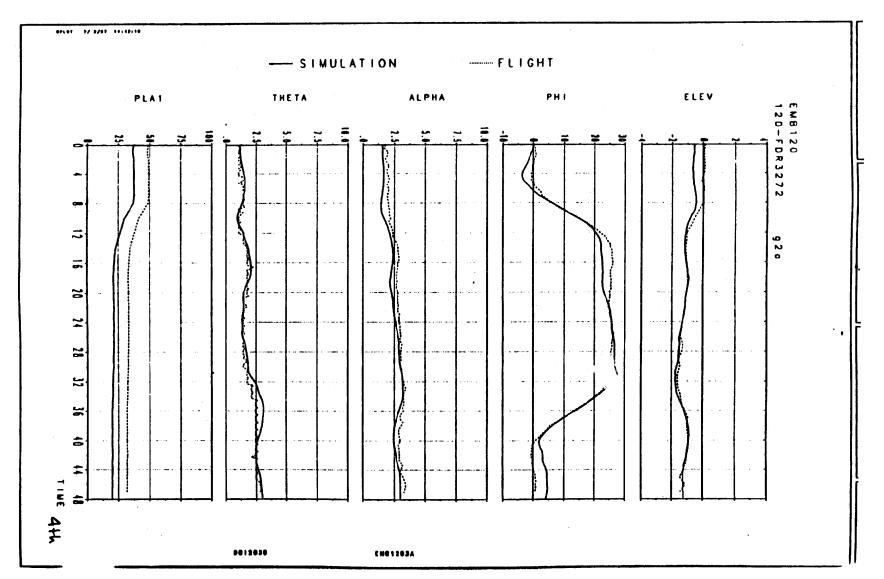
The obtained simulation roll angles have some small differences at the beginning and the end of the turn, but the average value is very close to the DFDR. is important to notice that the simulation does not take in consideration several effects like atmosphere disturbances, control cable elasticity, airplane flexibility among others. The accuracy of the DFDR readings and calibration must also be taken in consideration.

We notice, however, that the general response of the simulation is very close to the DFDR readings, suggesting that the aerodynamic data bank is representative of the airplane and, at that moment, no aerodynamic degradation was evident.

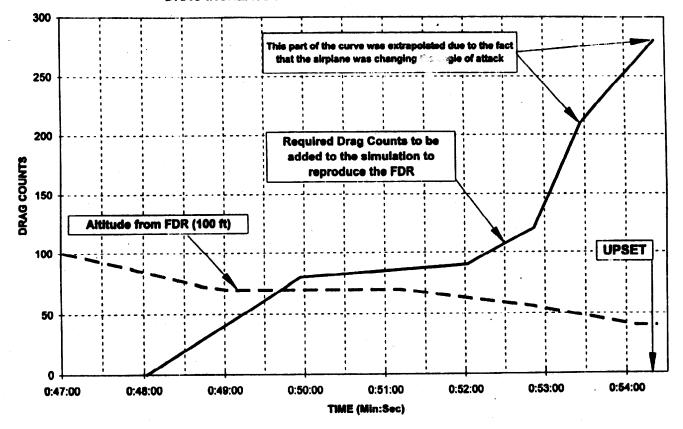
### FIGURE 5 - COMAIR FLIGHT 3272 DRAG INCREASE FROM COMPARISON - FDR AND SIMULATION •

The analysis shows that the aerodynamic degradation started near DFDR time 48:00 and lasted for about 6 minutes. The increase in drag is not linear with time or altitude and a small variation is noticed during the period of time from 50:00 to 52:00. After that, the rate of increase in drag is pronounced, particularly between 52:50 and 53:30.
