Controlled Flight Into Terrain, Korean Air Flight 801, Boeing 747-300, HL7468, Nimitz Hill, Guam, August 6, 1997

Investigative Body: National Transportation Safety Board (NTSB), USA

AIRCRAFT ACCIDENT REPORT

CONTROLLED FLIGHT INTO TERRAIN
KOREAN AIR FLIGHT 801
BOEING 747-300, HL7468
NIMITZ HILL, GUAM
AUGUST 6, 1997

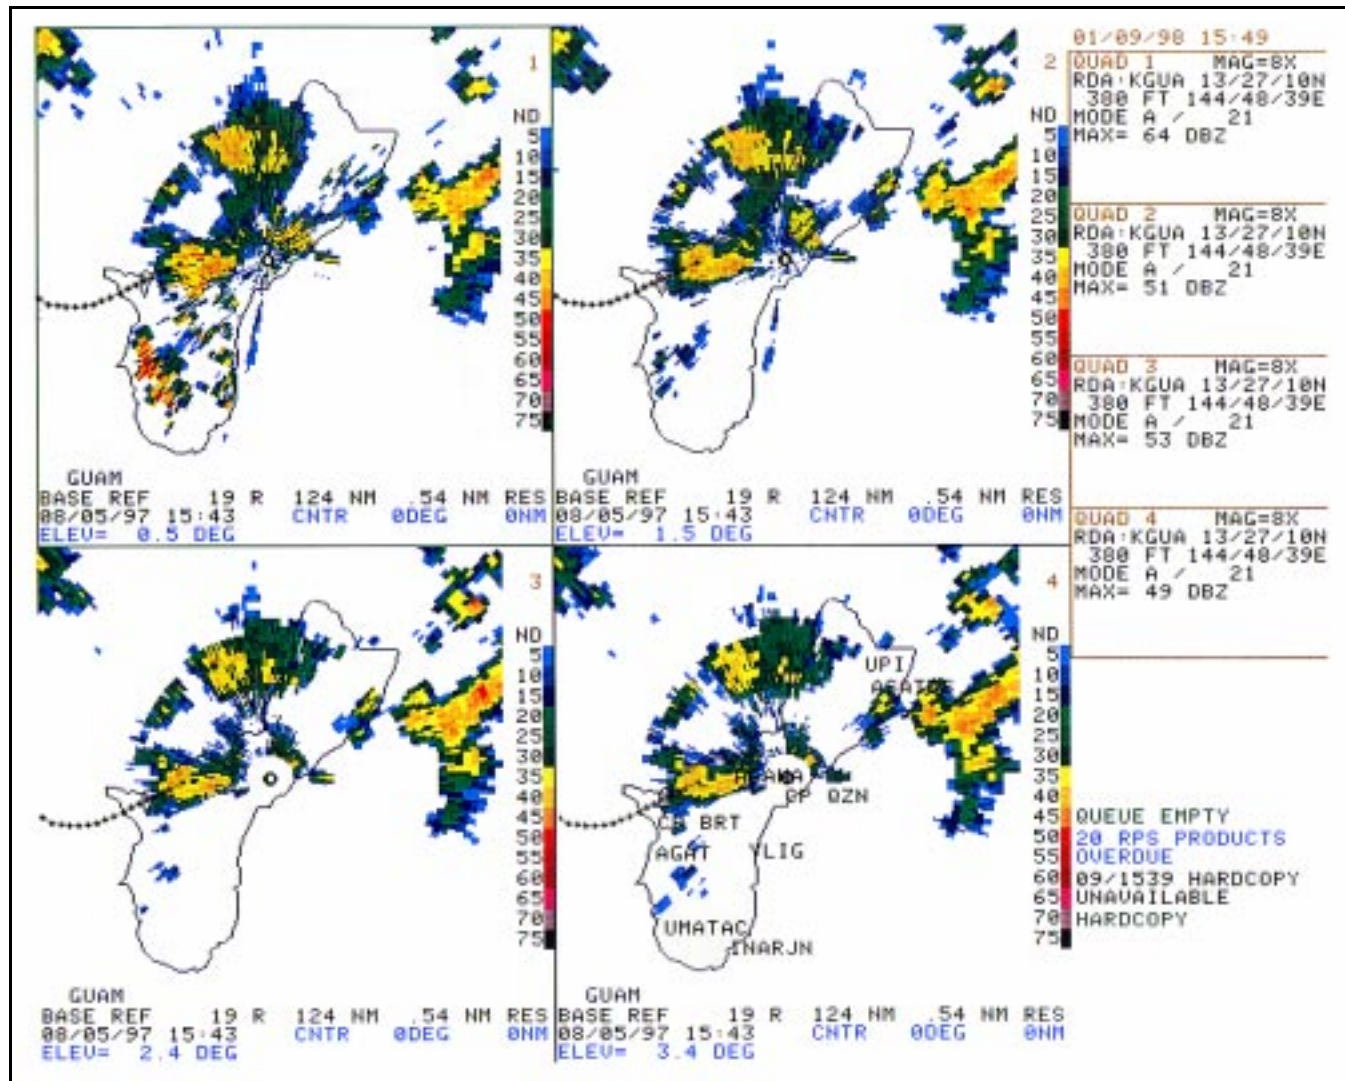
Figure 6. WSR-88D four-panel base reflectivity product for Guam.

The CERAP controller stated that he did not advise the flight crew or the Agana tower controller that he had observed the precipitation on radar while flight 801 was on the approach course to the airport. The controller said that he had assumed that the flight crew was using cockpit radar because they had asked him twice for deviations around weather. The controller stated that the airplane's cockpit radar was more accurate and more precise than the radar he was using at the CERAP. The controller further stated that he did not observe (on radar) the airplane entering the precipitation.

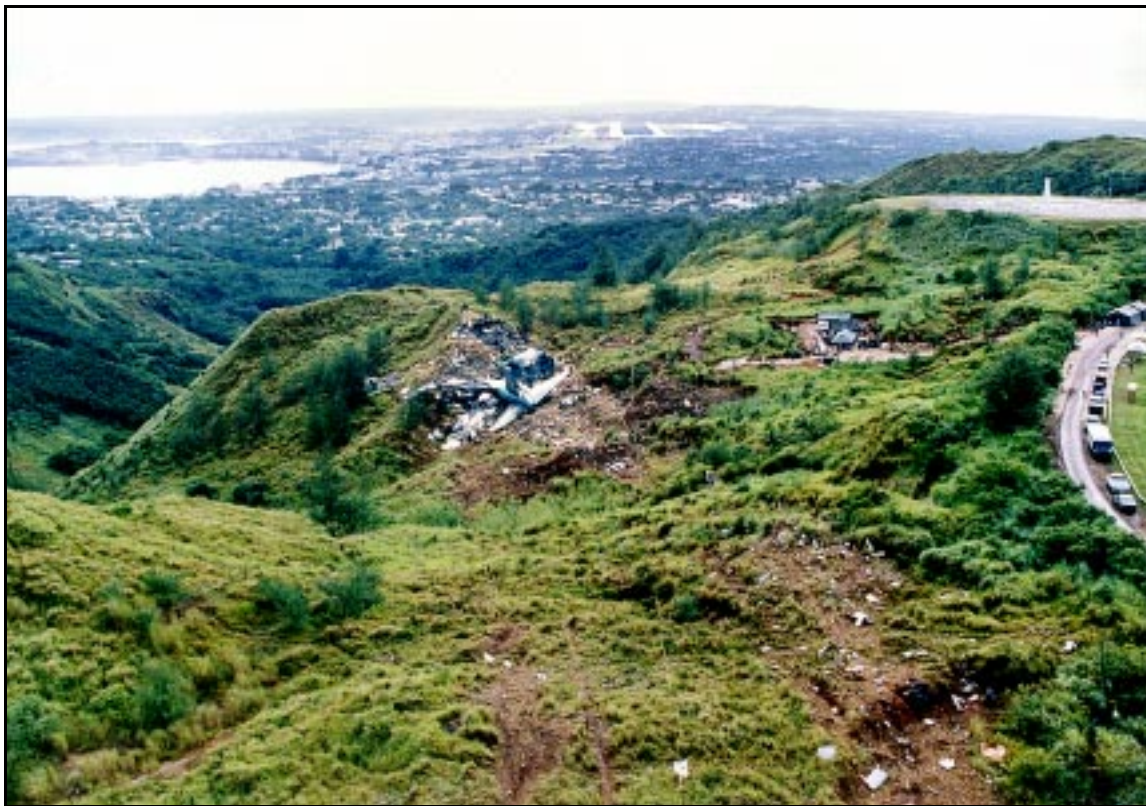
The initial point of impact was evidenced by several cut treetops that extended along the wreckage path. Several ground impact marks, consistent with the main landing gear, were found in the vicinity of the broken oil pipeline, located about 400 feet from the point of initial impact. A ground scar, about 89 feet long, 6 feet wide, and 2 feet deep, was found about 415 feet from the point of initial impact, and several pieces of the No. 1 engine cowl were found embedded in this area, along with parts of the left wing leading and trailing edge flap structure.

Numerous parts of the left main landing gear, including two wheels and tires, were found embedded in a small berm about 1,430 feet from the initial impact point. Most of the fuselage structure was located in the main wreckage area and was found separated into five major sections: the empennage, the aft fuselage, the center fuselage, the forward fuselage, and the cockpit.

Figure 8a. Wreckage from Korean Air flight 801 in relation to Guam International Airport runway 6L (*upper middle*), the NIMITZ VOR (*upper right*), and Apra Harbor (*upper left*).

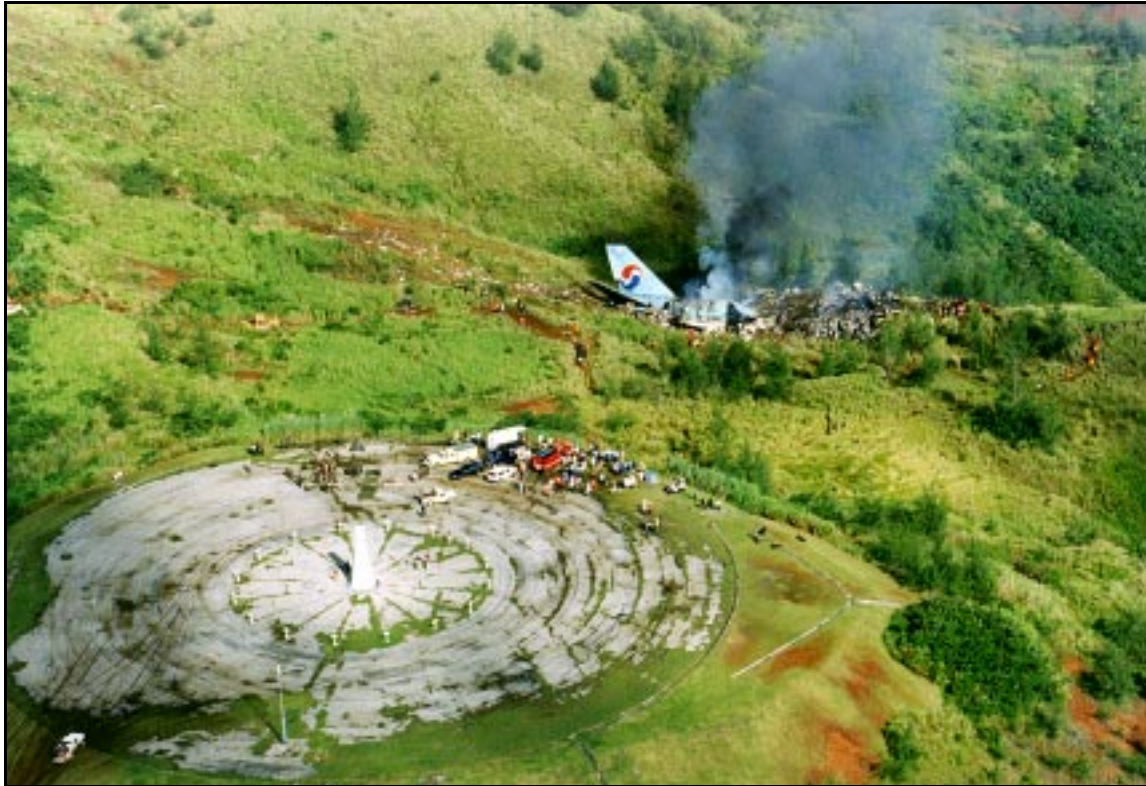
Figure 8b. Closer view of the wreckage from Korean Air flight 801 and the NIMITZ VOR.

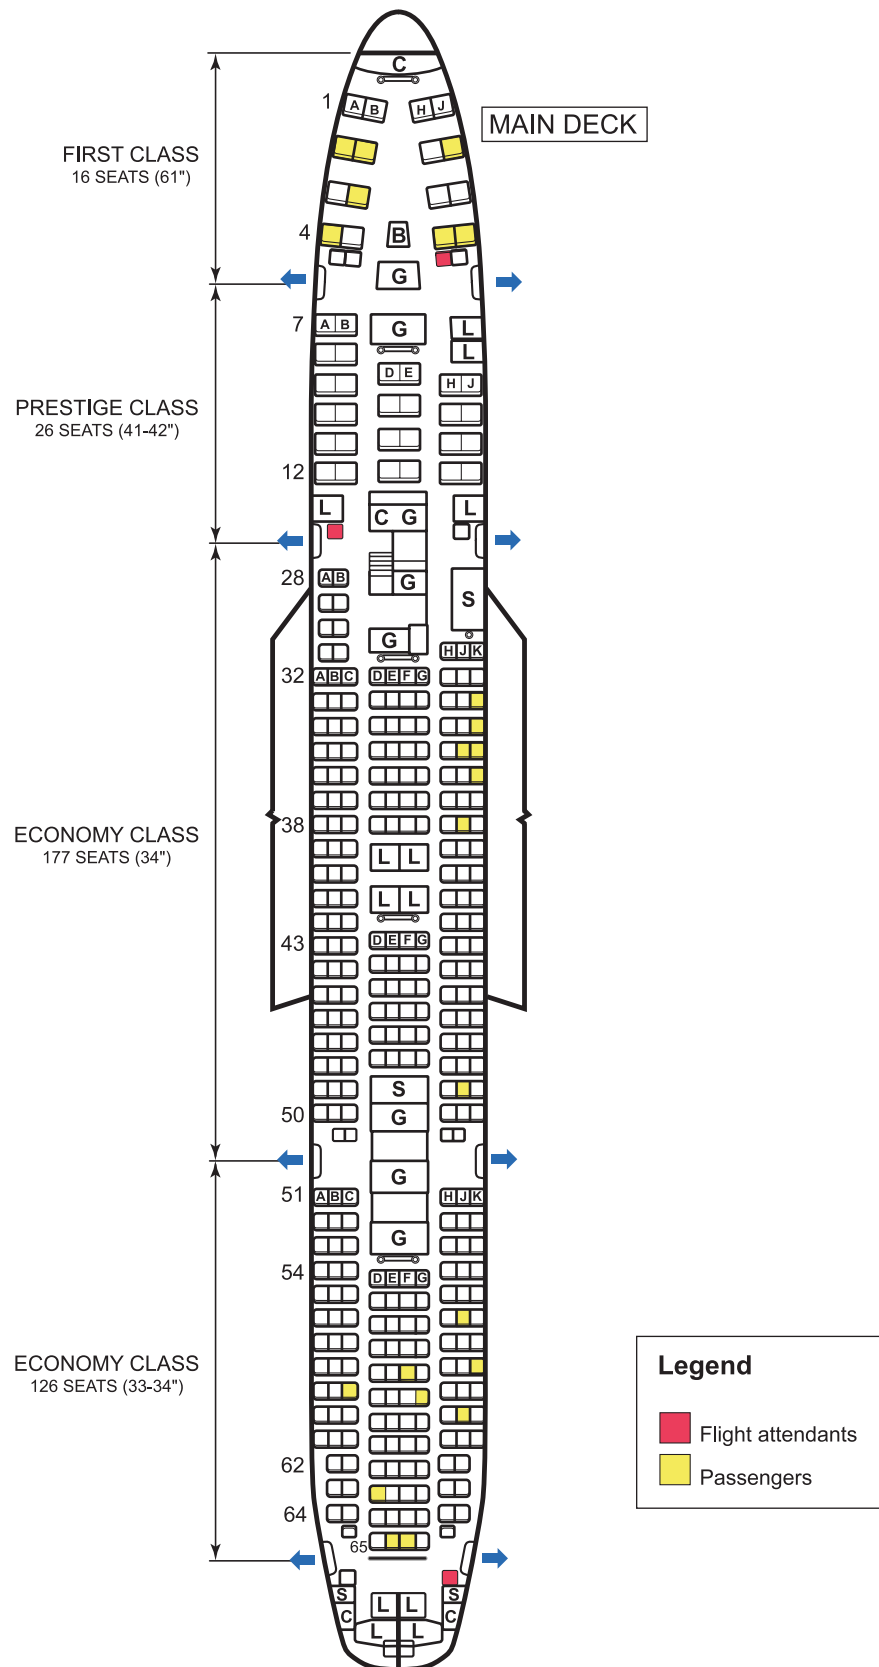
Of the 26 survivors of the accident, 7 passengers and 1 flight attendant were seated in the first class section, 1 flight attendant was seated in the prestige class section, 7 passengers were seated in the forward economy class section, and 9 passengers and 1 flight attendant were seated in the aft economy class section. Two of the surviving flight attendants and 13 of the surviving passengers were seated on the right side of the airplane; 6 of these 13 passengers were seated over the right wing. Figure 9 shows the 747-300 cabin configuration and the survivor seat locations.

Figure 9. Korean Air flight 801 cabin configuration and survivor seat locations.
