## Fuel exhaustion, Executive Airlines, British Aerospace J-3101, N16EJ, Bear Creek Township, Pennsylvania, May 21, 2000

## Aircraft Accident Brief

Accident No.:	DCA00MA052
Operator or Flight Number:	Executive Airlines
Aircraft and Registration:	British Aerospace J-3101, N16EJ
Location:	Bear Creek Township, Pennsylvania
Date:	May 21, 2000

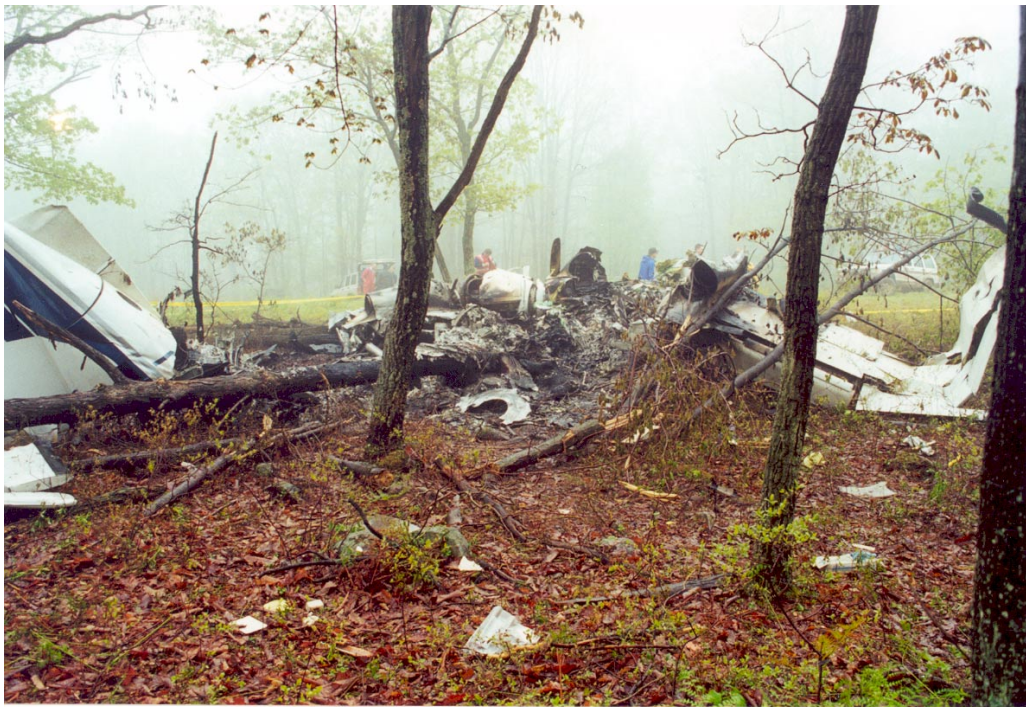
The airplane wreckage was found on the top of a mountain on the east side of a pipeline clearway on state-owned property. Ground and tree impact marks indicated that the airplane impacted terrain at a steep angle and in an extreme bank angle. Witness marks on the attitude indicator, ground witness marks, airplane crushing, and other damage indicated that the airplane impacted the ground at a 60° nose low attitude and in a 135° left bank. Ground scars indicated that the airplane impacted the ground on a 40° heading. All of the airplane's primary structure was located at the accident site. All recovered primary and secondary flight control surfaces were found at the accident site. As shown in figure 2, fire damage was confined to the immediate impact area, with little fire damage to surrounding trees and foliage.

**Figure 2.** Photo of the accident site illustrating the lack of fire damage to the surrounding area.
