Uncontrolled flight into terrain, Cessna 335, N8345N, Hillsboro, Missouri, October 16, 2000

Aircraft Accident Brief

Accident Number:	CHI01MA011
Operator/Flight Number:	N/A
Aircraft and Registration:	Cessna 335, N8354N
Location:	Hillsboro, Missouri
Date:	October 16, 2000

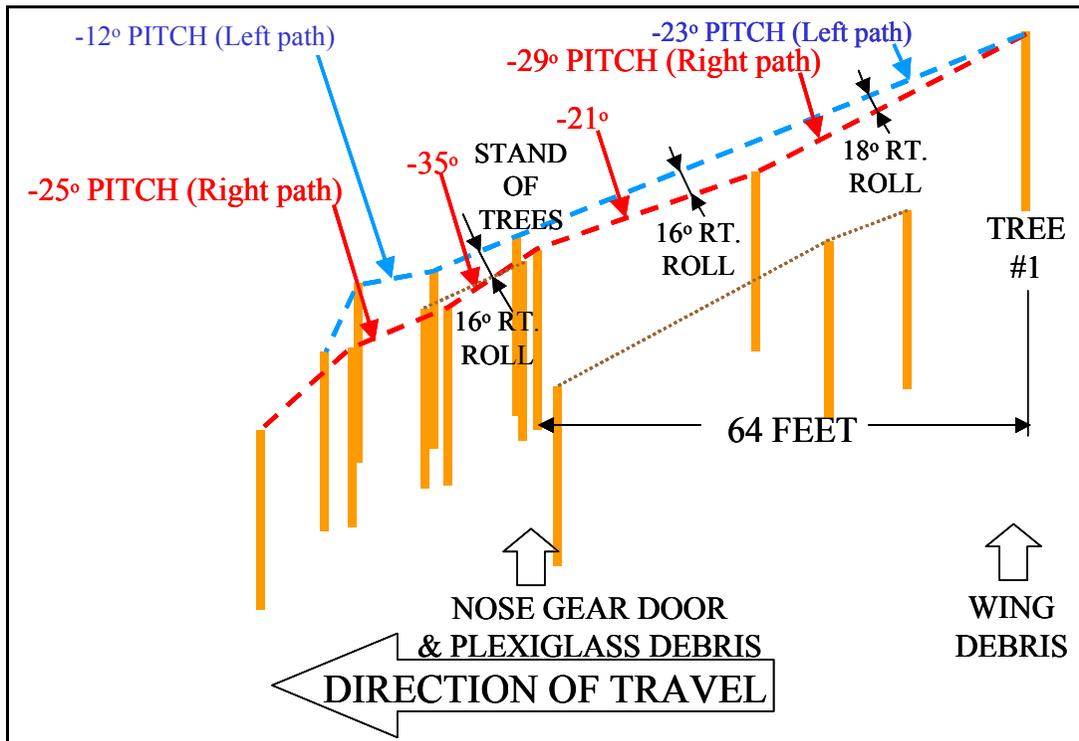
A laser-based measuring device was used to document the accident site. Data from the laser survey were used to create a three-dimensional model of the airplane's flightpath through the trees. The model and the inspection of the accident site revealed that the airplane was in a 16° to 18° right-wing-down attitude during its entry into the trees. (See figure 1.)

No evidence of an in-flight fire or in-flight structural failure was noted. All of the examined fracture surfaces exhibited evidence of overload failure.

Figure 1. Diagram showing the side-view of the broken tree tops, construction lines that connect the trees along the direction of travel, and attitude lines with respect to a horizontal plane. Each vertical line represents the base and top of a remaining tree.

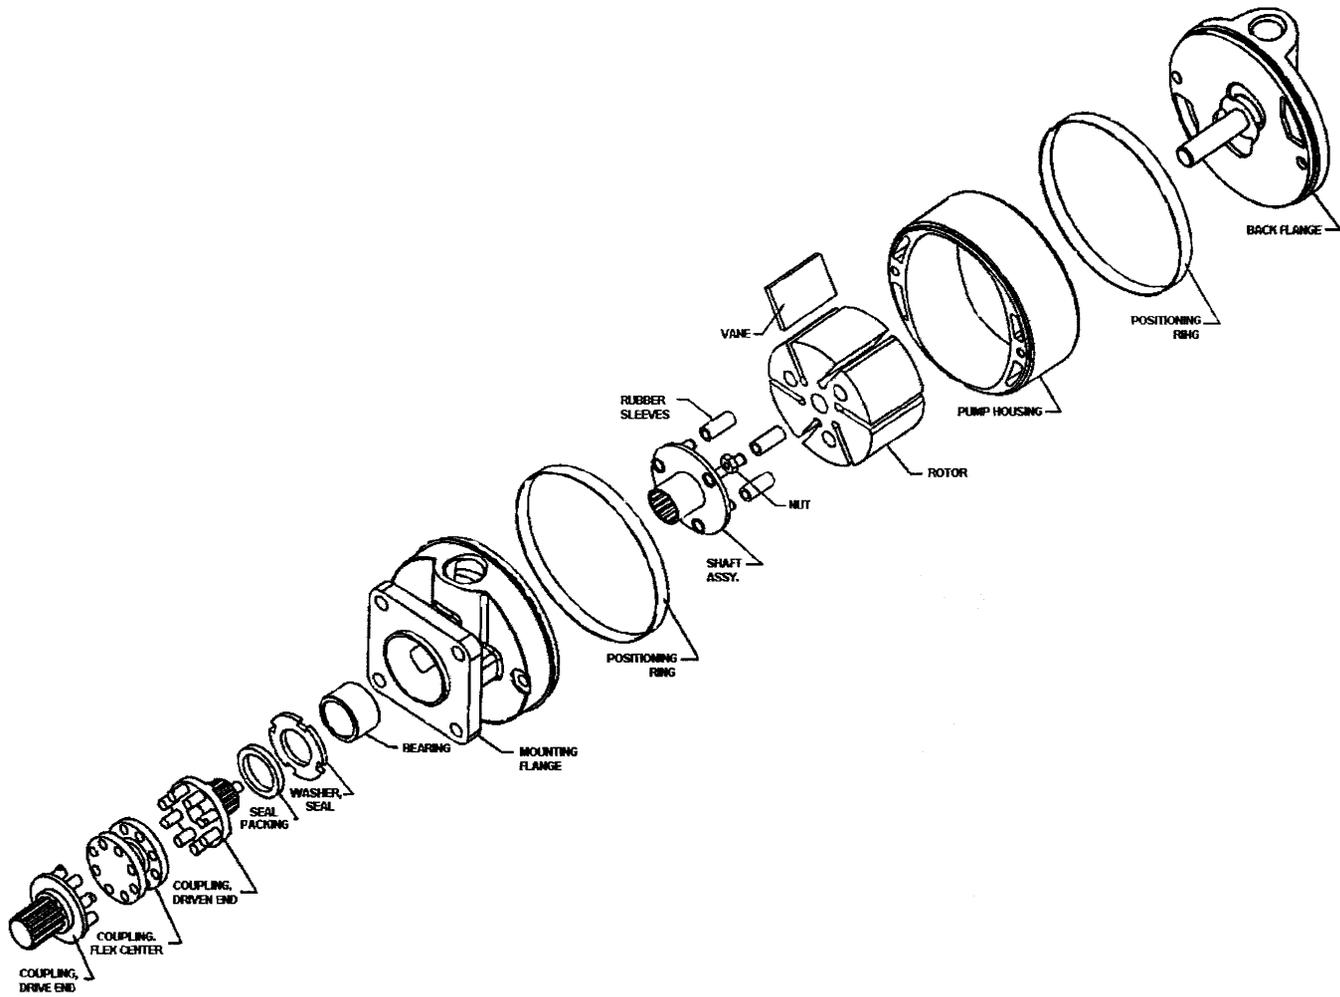
Three pieces of the left engine vacuum pump were found: the mounting flange/pump base, which remained attached to the engine accessory case; the pump housing; and the pump housing back flange. (See figure 2 for a diagram of a Cessna 335 vacuum pump.) Fragments of rotor pieces, between 1 and 2 inches long, were recovered.

Figure 2. Diagram of a Cessna 335 vacuum pump.

The pieces contained short scratches and gouges in the direction of rotor rotation and other scuff marks and scratches in random directions.

The pump mounting was removed from a fragment of the engine case. The drive shaft end coupling did not rotate when light manual force was applied. After it was disassembled, it was determined that the coupling did not rotate because of a fractured braze⁴³ joint between the shaft assembly and the shaft disc. Examination of the braze joint revealed no evidence of rotational scoring. The drive shaft/coupling assembly was further disassembled. The drive coupling, flex coupling (shear coupling), and driven coupling were intact. Four of the six pin shaft drive pins were bent toward one side (not in the direction of rotation) at varying angles. The pump housing was slightly flattened, and no internal rotational score marks were visible around the circumference. The base of the pump housing contained three marks, which encompassed one half of the circumference. All three marks showed metal dislocation toward the same side of the housing. Once the coupling was removed, the carbon bearing under the base of the pump was found broken on the same side. The outside of the pump housing contained numerous impact marks. Wood and dirt were found embedded within the cooling fins.

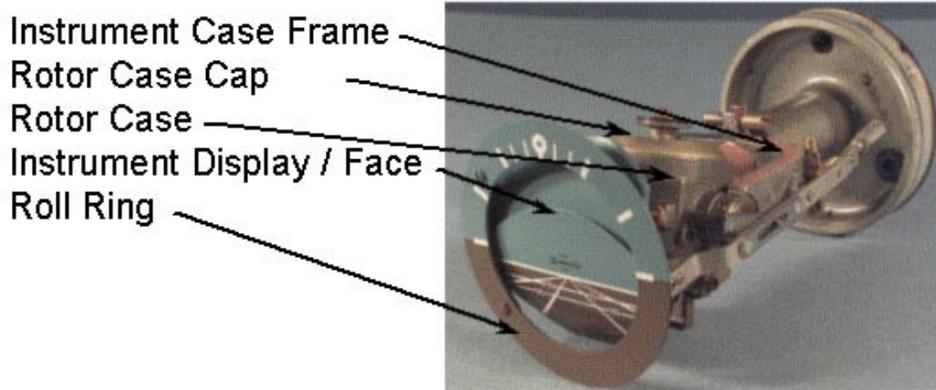
The following components from the left-side attitude indicator/flight director were identified in the wreckage: the gyroscopic rotor, the rotor case cap, two pieces of the rotor case, the instrument face display (including the roll ring), and pieces of the instrument case frame. (See figure 3 for a photograph of an exemplar attitude indicator and its components.) The model of the attitude indicator installed on the accident airplane contained an arm that provides mechanical linkage from the rotor housing to the pilot's display. This arm was located on a fragment of the instrument case frame.

Figure 3. Photograph of an exemplar attitude indicator and its components.

Examination of the interior diameter of the rotor case revealed faint, unevenly spaced diagonal scratches. The measured angle between the scratches and the direction of rotation was between 4.0° and 5.2° . The scratches were consistent with the direction of rotation of the rotor and with the direction the rotor was moving when it exited the case. No other circumferential score marks were found on the inner surface of the case that paralleled the direction of rotation.

Diagonal marks were found on the end of the rotor. Nearly all of the other scratches on the cap were oriented across the direction of rotation at various angles. The center fastener hole on the cap was ripped, with more than half of the periphery remaining. The width of the tears matched the width of the gouges in the rotor. The exterior of the cap contained scratches that resembled the width and approximate locations of the motion-limiting stop wires mounted on an exemplar instrument.

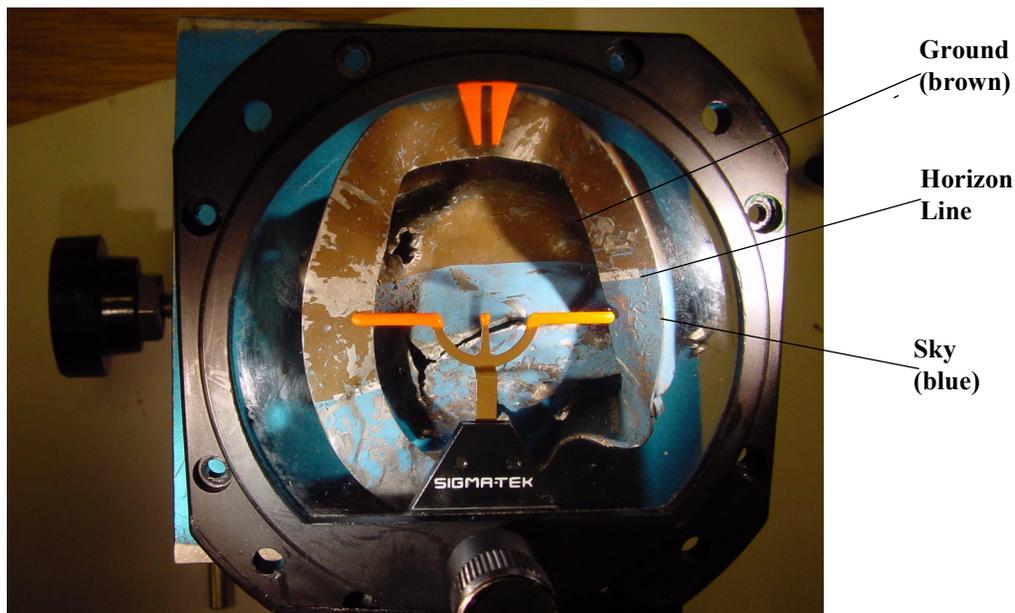
Damage on the facial roll ring resembled the shape of the triangular airplane support housing and the roll index that had been fixed to the instrument case. The relative positions of the damage resembling the triangular support and roll index were on the top and bottom of the ring, respectively, when it was placed at an inverted display of attitude. The face of the instrument was placed behind that of an exemplar instrument and, using the damage on the roll ring for alignment, the marks were within 2° of a wings-level inverted attitude. (See figure 4.)

Figure 4. Photograph showing the face of the accident airplane's primary attitude indicator behind that of an exemplar instrument.

On the basis of the examination of the left-side (primary) attitude indicator, it was determined that the rotor was most likely spinning, but not at a high enough rpm to keep the display erect (the wreckage fragments of the left-side attitude indicator clearly aligned in an inverted attitude), indicating that this attitude indicator was not displaying properly at the time of impact. Although the pilot reported that his primary attitude indicator had failed and examination of the attitude indicator supported that such a failure had occurred, the investigation could not determine the cause of the failure in that instrument.

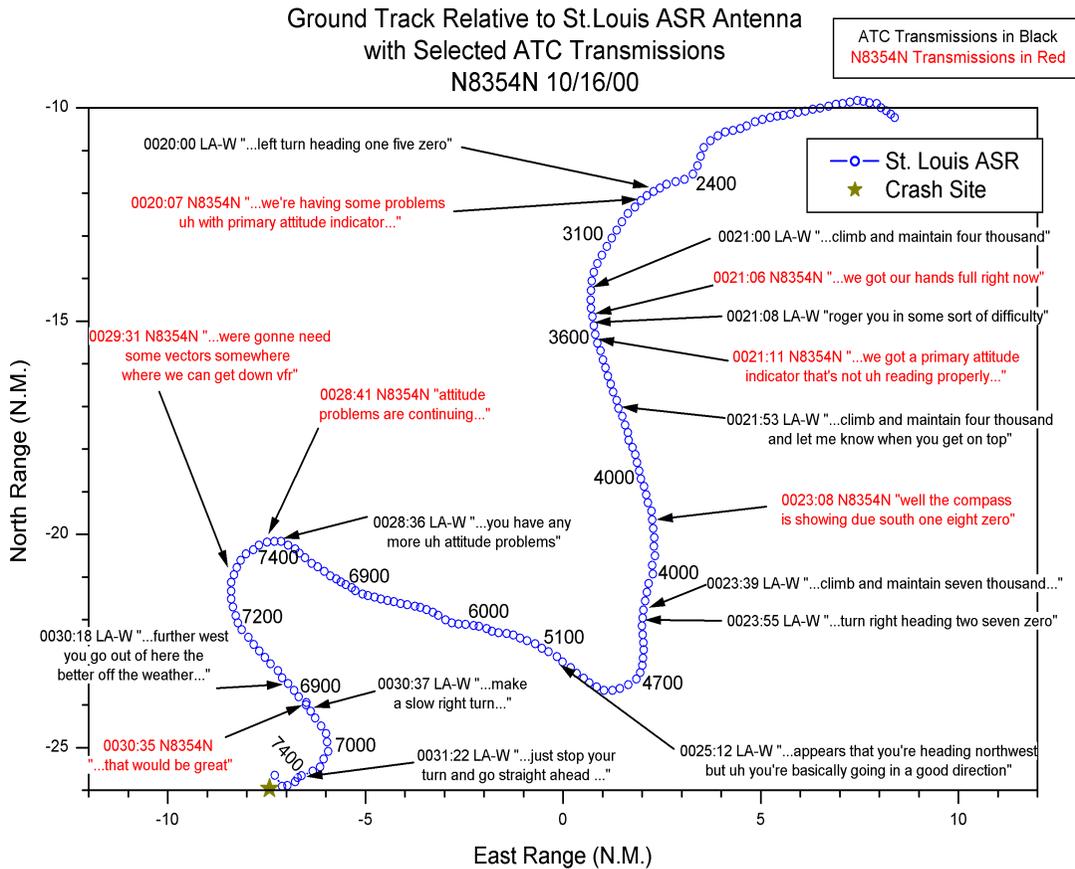
At 1923:55, the St. Louis LW controller instructed the pilot to turn right to a heading of 270°, and, at 1924:04, the controller instructed the pilot to climb to and maintain 7,000 feet. The airplane began the climb and turned right maintaining about a 3.5°-per-second heading change. Calculations show that this turn required an airplane bank angle of 30° and that the airspeed increased to greater than 150 knots. The turn was completed at an altitude of about 5,000 feet, and the airplane continued the climb at 120 knots. By 1928:00, the airplane reached 7,000 feet at a heading of about 300° as the airspeed accelerated to 150 knots. At 1928:30, the airplane began a left turn to the southeast to a heading of about 140° at an altitude that varied between 7,100 and 7,400 feet. The calculated bank angle in the turn was about 25°.

Figure 5. Ground track of the accident airplane's last 12 minutes of flight.

Following the LW controller's instruction to make a slow right turn at 1930:37, the airplane began turning to the right. Calculations reveal that, during the turn, the airplane descended to about 6,800 feet while maintaining an airspeed of about 150 knots. The airplane then descended to about 6,500 feet and then climbed at over 3,000 feet per minute (fpm) for the next several seconds. The airspeed was calculated to be about 120 knots during the climb, with a bank angle of approximately 25°. At 1931:31, the airplane reached its maximum altitude of 7,700 feet.
