## Runway excursion during landing, Southwest Airlines Flight 2066, Boeing 737-300, N343SW, Amarillo, Texas, May 24, 2003

## Aircraft Accident Brief

Accident Number:	FTW03MA160
Operator and Flight Number:	Southwest Airlines Flight 2066
Aircraft and Registration:	Boeing 737-300, N343SW
Location:	Amarillo, Texas
Date:	May 24, 2003

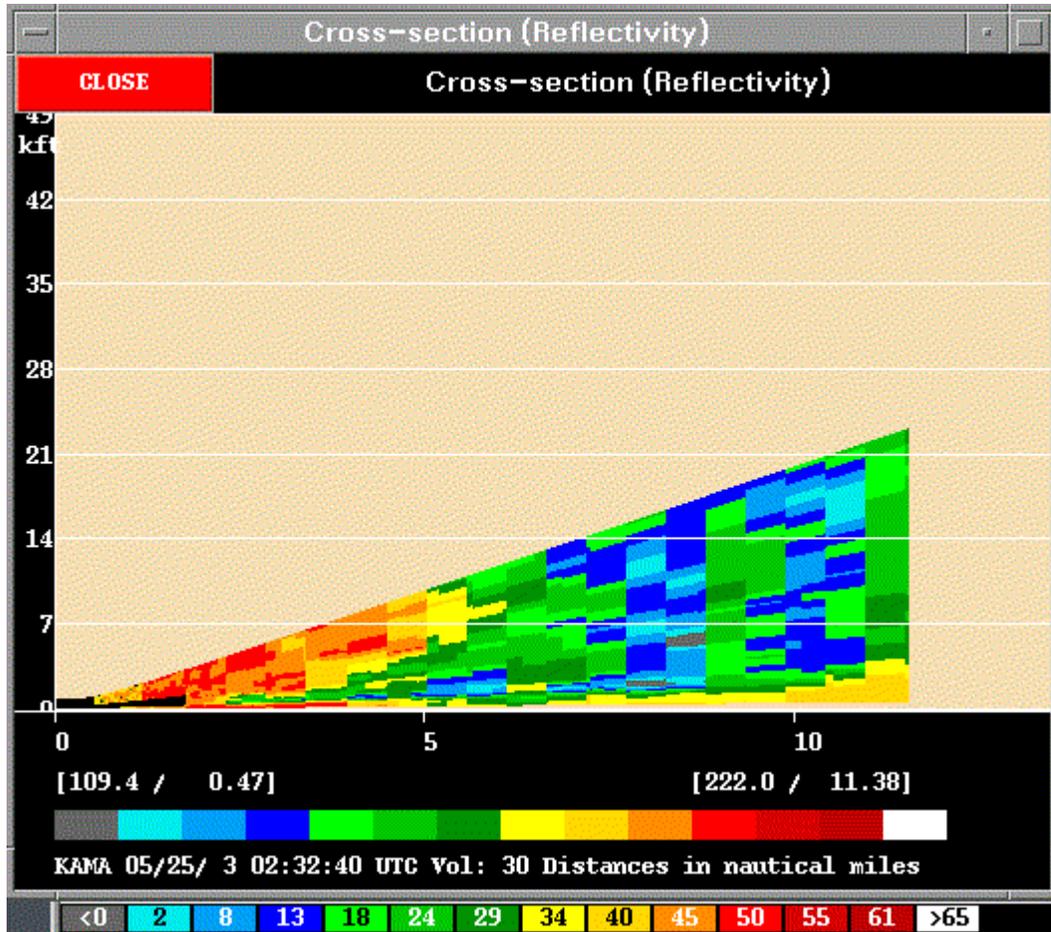
**Figure 1.** Weather Echo Intensity Cross-Section for 0232:40Z.

For the 0232:40Z scan, the cross-section reflectivity image indicates that the weather echo intensities along the approach to runway 4 reached 54 decibels (dBz), or level 5 (intense) activity (see figure 1).<sup>13</sup>

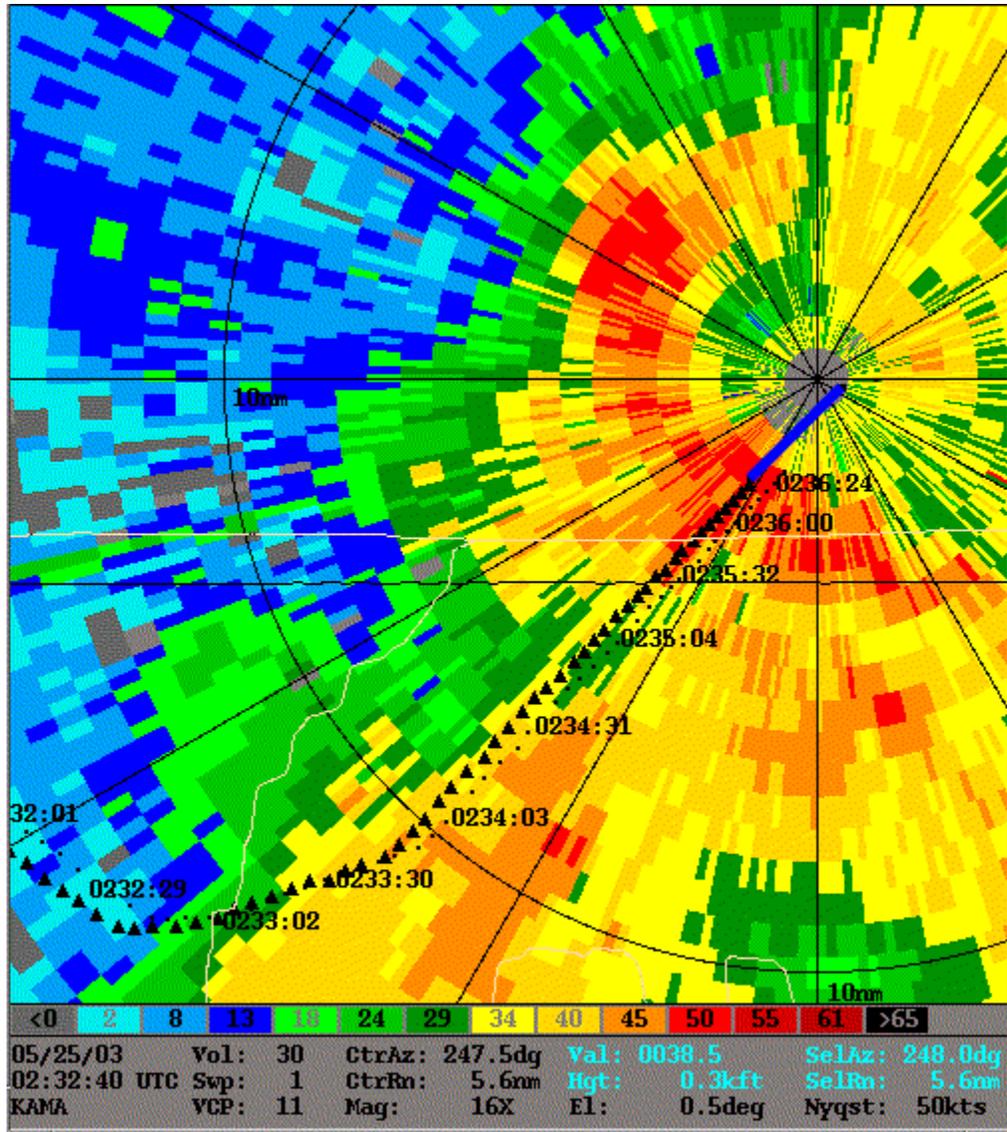
**Figure 2.** Base Reflectivity Image for 0232:40Z (0.5° elevation angle).

For the 0232:40Z scan, the base reflectivity image indicates that very strong to intense weather radar echoes were detected along the approach to runway 4 (see figure 2).

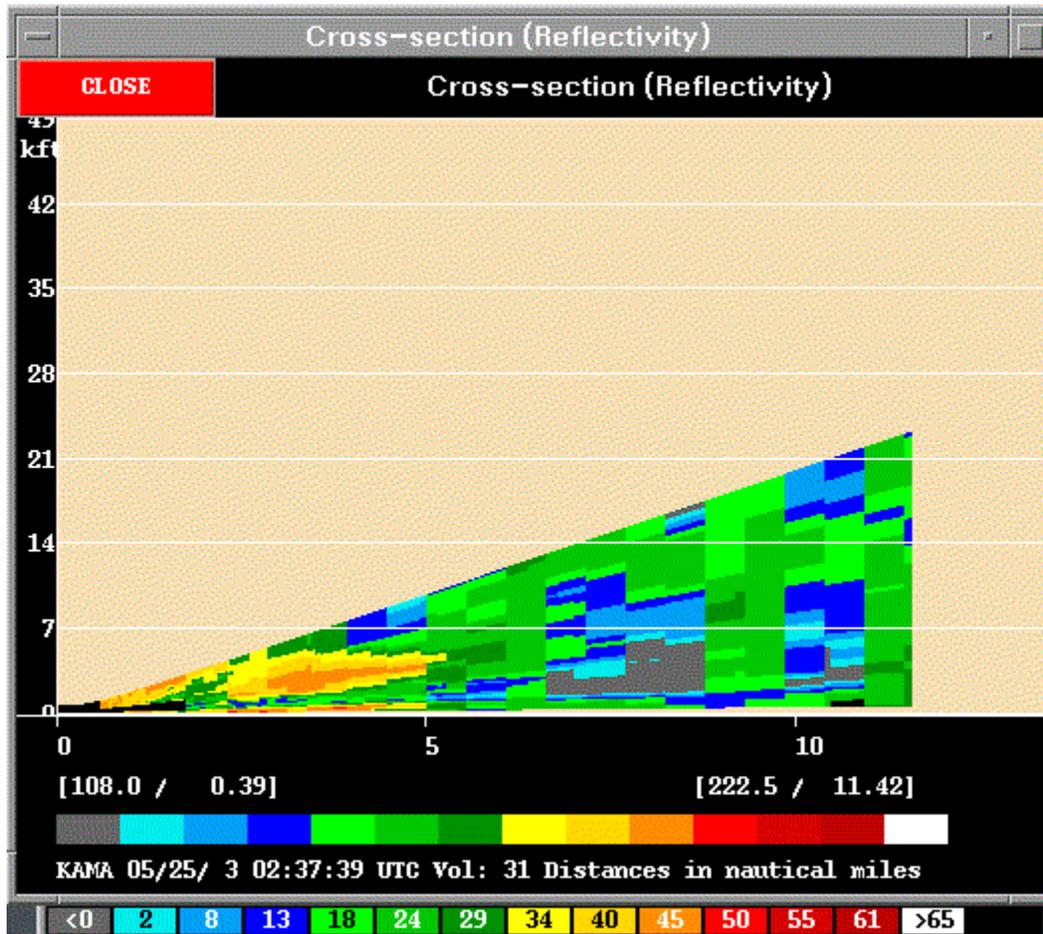
**Figure 3.** Weather Echo Intensity Cross-Section for 0237:39Z.

For the 0237:39Z scan, the cross-section reflectivity image indicates that very strong weather echoes were detected in the approach area of runway 4 (see figure 3).

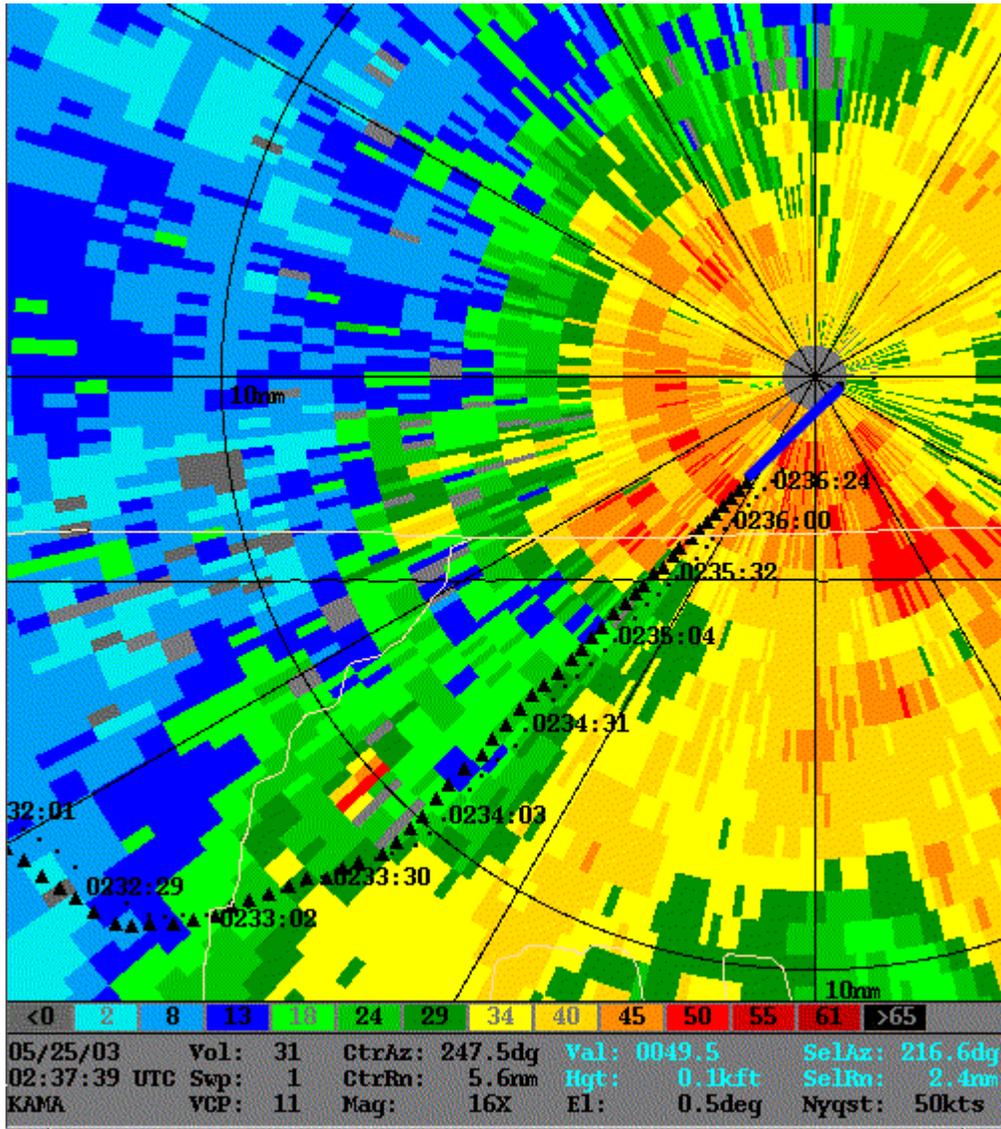
**Figure 4.** Base Reflectivity Image for 0237:39Z (0.5° elevation angle).

For the 0237:39Z scan, the base reflectivity image indicates that very strong weather radar echoes were detected in the approach area to runway 4. Strong or greater weather echoes were detected from about 3 nm southwest of the runway 4 threshold to the runway threshold (see figure 4).

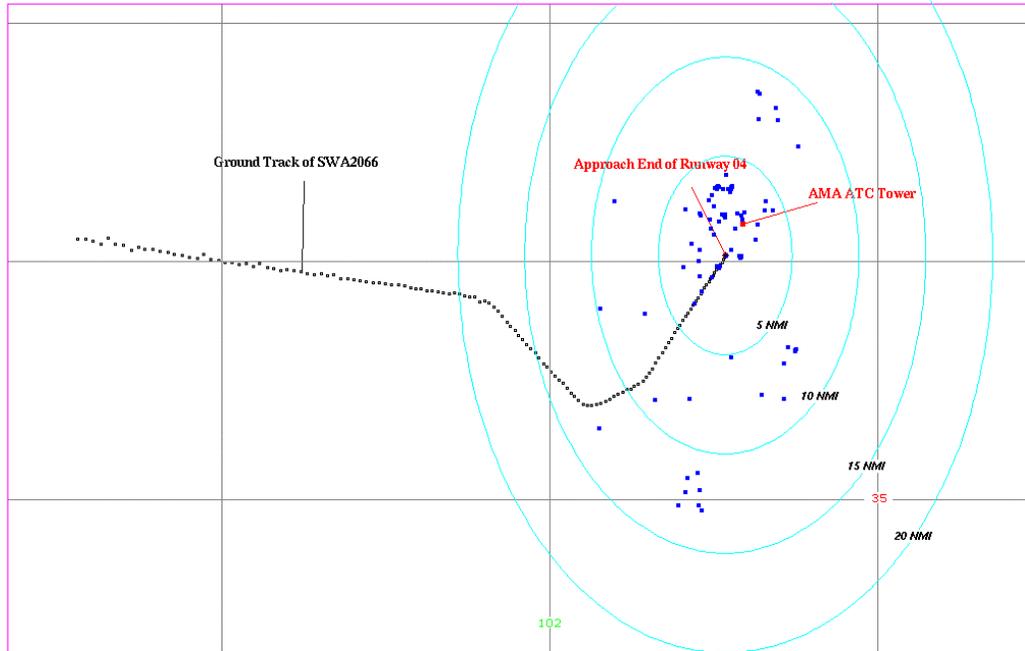
**Figure 5.** Cloud-to-Ground Lightning Strikes From 0233Z to 0237Z.

According to the National Lightning Detection Network (NLDN),<sup>14</sup> 505 cloud-to-ground strikes were recorded within a 15-mile radius of the runway 4 threshold between 0225Z and 0240Z. A cloud-to-ground lightning strike was recorded near the runway 4 threshold at 0233:23Z. About seven cloud-to-ground lightning strikes were recorded near or along the airplane's flightpath from 0233Z to 0237Z (see figure 5).

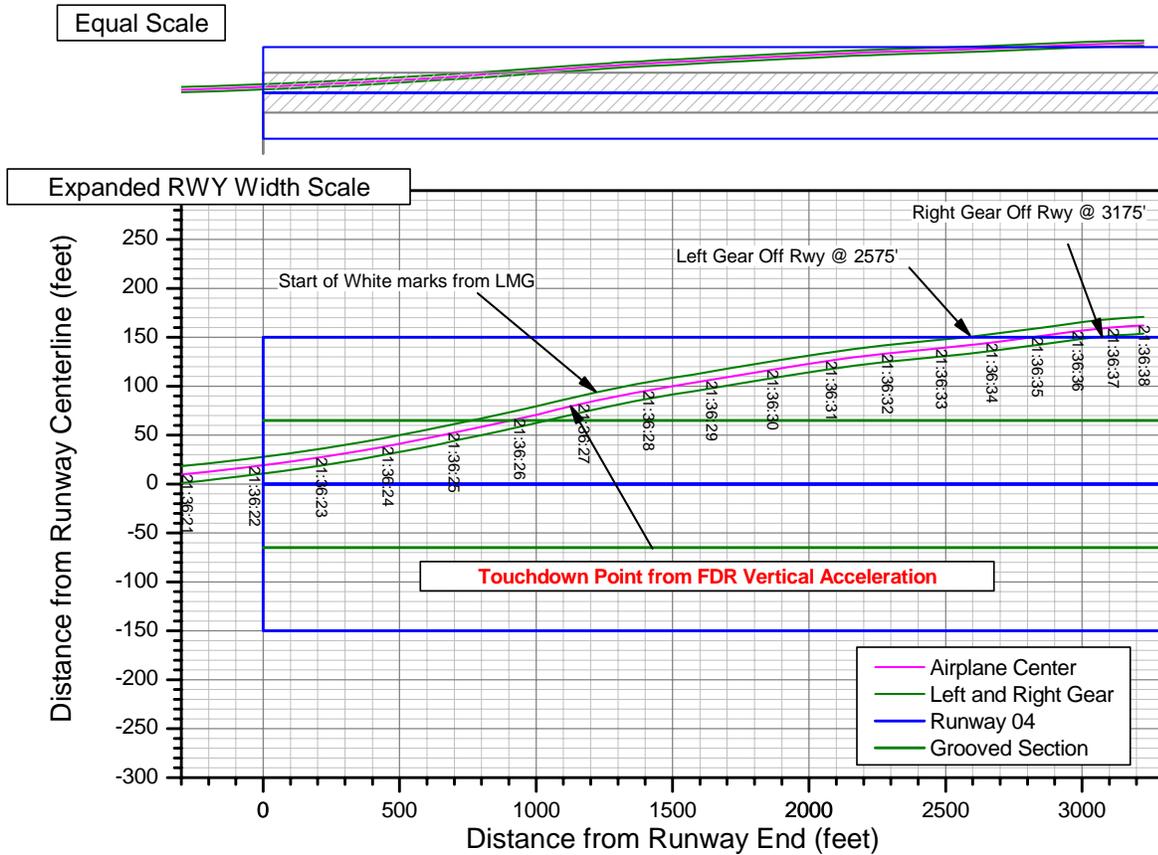
**Figure 6.** Integrated Ground Track During Approach and Landing.

consistent with tire marks<sup>21</sup> were found about 1,250 feet from the threshold and 60 feet from the runway's left edge. Ground scarring indicated that the left main landing gear's outboard tire went off the left edge of the runway 2,575 feet from the threshold, followed by the left gear inboard tire at 2,700 feet. The nosewheel went off the runway at 3,000 feet, and nosewheel ground tracks ended at 3,475 feet, which was consistent with the collapse of the nose landing gear. Ground scarring also indicated that the right main landing gear was off the runway 3,175 feet from the threshold. Ground and runway markings indicated that the right main landing gear was back on the runway 3,750 feet from the threshold, followed by the left main landing gear at 3,837 feet.

FDR data, CVR data, and ground scar information were examined to determine the airplane’s flightpath and ground track before touchdown and the airplane’s ground roll after touchdown. The Safety Board conducted an FDR data flightpath integration study to calculate the airplane’s flightpath and ground track. In addition, the Aircraft Performance Group completed a kinematics study of the airplane’s motion during the approach and landing. The study used FDR data and kinematic extraction techniques to derive wind speeds, wind directions, and the ground track for the accident airplane. The ground tracks calculated by both methods were consistent with the markings on the runway (see figure 6 for integration results).
