Collision with Trees and Crash Short of the Runway, Corporate Airlines Flight 5966, BAE Systems BAE-J3201, N875JX, Kirksville, Missouri, October 19, 2004

Aircraft Accident Report

NTSB/AAR-06/01

**COLLISION WITH TREES AND CRASH SHORT OF THE RUNWAY
CORPORATE AIRLINES, FLIGHT 5966
BAE SYSTEMS BAE-J3201, N875JX
KIRKSVILLE, MISSOURI
OCTOBER 19, 2004**

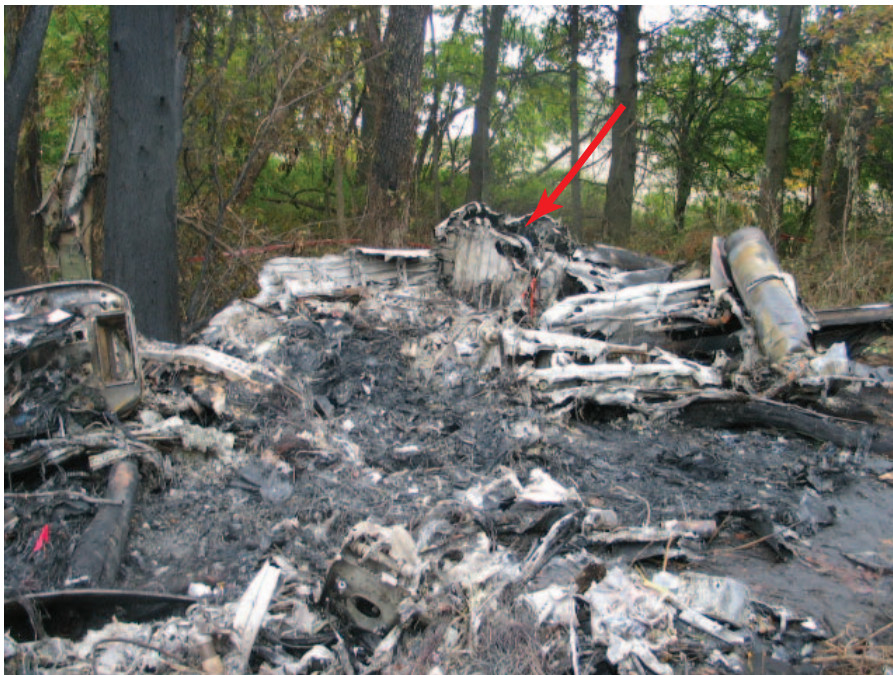
The main wreckage (which included the remains of the fuselage and the empennage, the right wing, the inboard portion of the left wing, and the remains of the right engine and propeller and the left propeller) was located in an almost circular area about 30 feet in diameter and exhibited extensive fire damage. Most of the main wreckage and the surrounding vegetation were consumed by fire. Figure 5 is a photograph of the main wreckage area.

Figure 5. Photograph of the main wreckage area.

The forward section of the airplane is in the foreground, and the tail section is in the background (the aft pressure bulkhead is indicated by the red arrow).

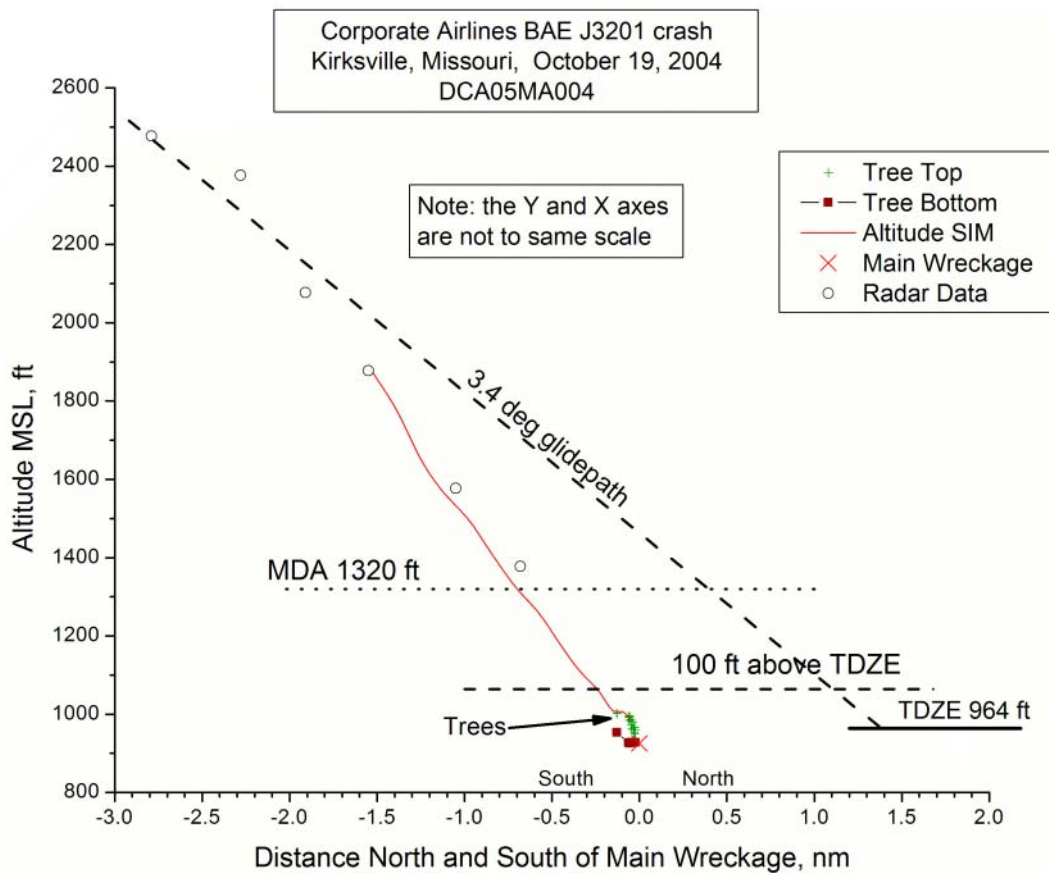
Figure 6. The accident airplane’s descent profile during the accident approach with the airport/runway location shown.

The following altitudes are also shown: MDA, 100 feet above the TDZE, and the TDZE. Additionally, a 3.4° visual glidepath to the airport is shown for reference purposes only.

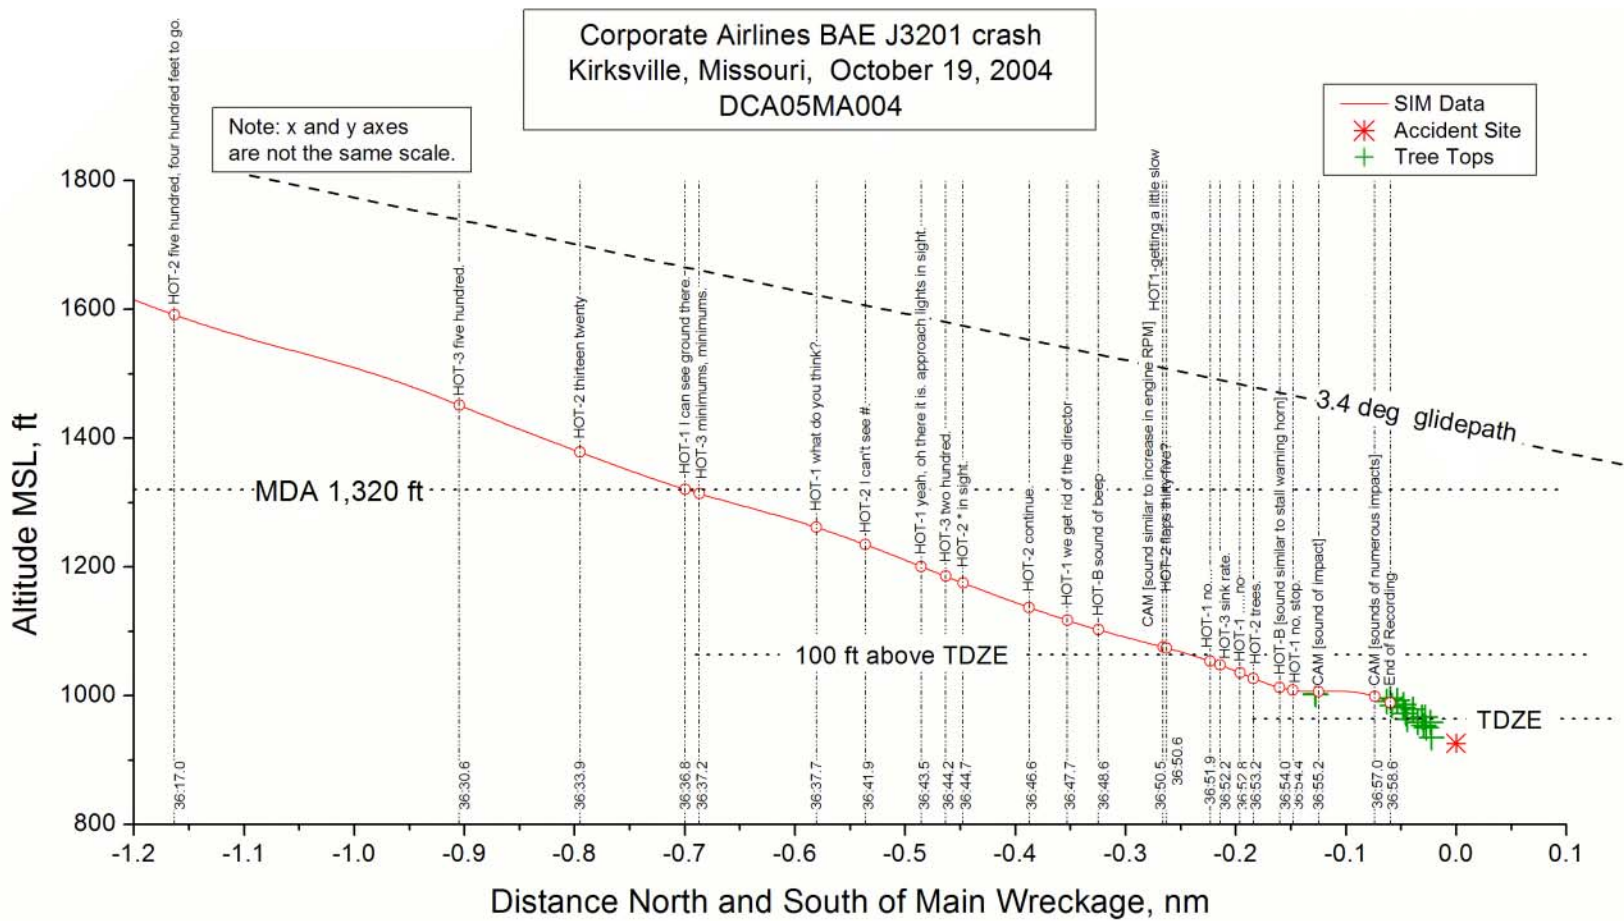
Figure 7. The accident airplane's descent profile during the accident approach with CVR comments overlaid. The following altitudes are shown: MDA, 100 feet above the TDZE, and the TDZE. Additionally, a 3.4° visual glidepath to the airport is shown for reference purposes only.
