Runway Overrun, Inter-Canadien Fokker F28 Mk 1000 C-GTIZ, St. John's, Newfoundland, 01 August 1999

AVIATION INVESTIGATION REPORT

A99A0100

Report Number A99A0100

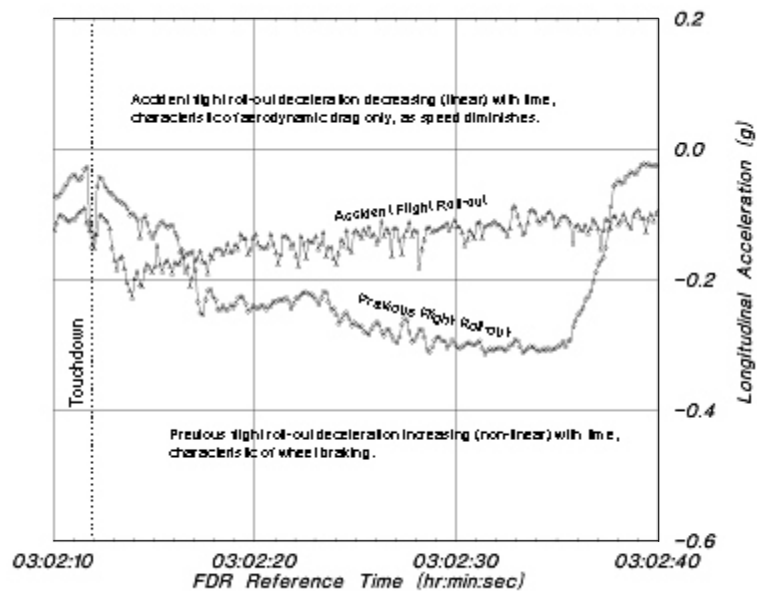
Figure 1 - Deceleration profiles

The FDR data of these two flights were compared, as shown in Figure 1. Based on FDR data and aerodynamic coefficients for the aircraft, it was estimated for the accident flight that, within approximately four seconds of touchdown, sufficient weight was transferred to the aircraft's main wheels to activate ground/flight relay switches and allow activation of the antiskid system.

immediately after touchdown (characteristic of wheel spin-up), followed by five seconds of relatively constant deceleration of about -4 feet/sec/sec. Flight 4 revealed two subsequent distinct deceleration segments attributed to effective wheel braking. During the accident ground roll, the deceleration was linear and decreased with time, characteristic of aerodynamic braking. The wheel braking on the accident flight was determined to be negligible, with most of the deceleration due to aerodynamic braking.

The deceleration data provided by the FDR showed that the aircraft did not decelerate in a similar manner to a flight landing on the same runway in St. John's earlier that day in similar conditions. Further, representative flights flown in a flight simulator consistently showed that the aircraft was capable of stopping within the confines of the shortened runway. Therefore, extensive testing of the brake system was carried out, and a comprehensive evaluation of the runway condition was undertaken to assess why the landing roll carried the aircraft beyond the end of the runway.

FDR analysis and performance calculations suggest that there was sufficient weight on wheels for the ground/flight relays to switch to the 'ground' position within four seconds of touchdown. FDR data also suggest that main wheel spin-up occurred shortly after touchdown. With these two parameters met, the normal braking system should have been available to the crew shortly after the aircraft touched down. The application of the alternate braking system caused the wheels to lock and resulted in the flat spots found on each tire. The locked wheels indicate that the alternate braking system was functioning. The lack of any discernable increase in deceleration indicates that poor braking conditions prevailed.

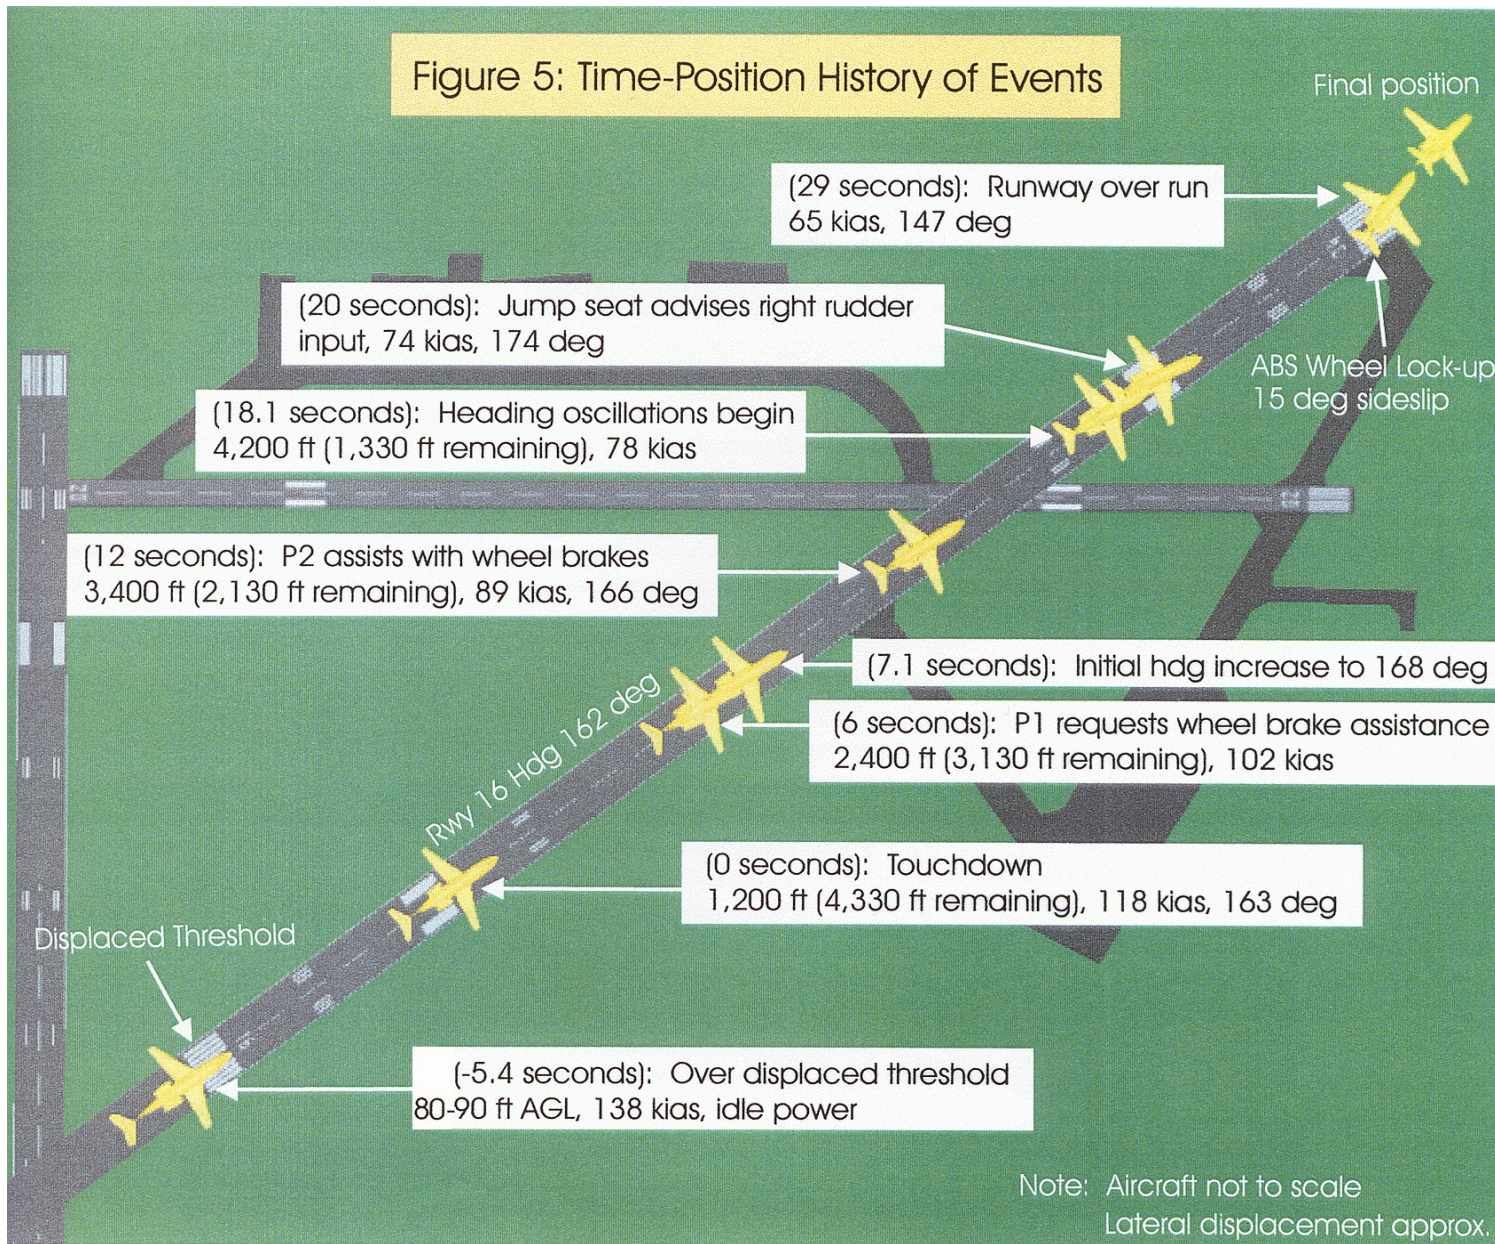
As the main gear touched, the aircraft's heading gradually began to increase from 163°M, reaching 168°M seven seconds after touchdown. The nose gear touched two seconds after the main gear, and the captain applied the brakes. Six seconds after touchdown, the captain perceived that there was no braking action and urgently requested wheel-braking assistance from the co-pilot. The aircraft was now approximately 2400 feet beyond the displaced threshold and decelerating through 102 KIAS, on a heading of 168°M. The aircraft continued down the runway, near the centreline, with the nose 4° to 7° to the right of the runway heading. Maximum toe braking was applied continuously throughout the roll, and the crew reported applying the alternate braking system approximately 2900 feet from the runway end; however, there was no discernable braking effect from either brake system. The co-pilot confirmed toe braking application about 12 seconds after main-gear touchdown, 3400 feet from the displaced threshold (2130 feet from the runway end) at 89 KIAS. Approximately 1330 feet from the runway end, the first of two heading oscillations began. The aircraft's heading increased from 170°M to 178°M, then decreased to 147°M. The aircraft departed the end of the runway, slightly left of the centreline, on a heading of 147°M at 65 KIAS. (See Appendix A for a schematic of the landing.)
