**Runway excursion, Royal Air Maroc Boeing 747-200 CN-RME,  
Dorval/Montreal International Airport, Quebec, 23 July 2000**

## **AVIATION INVESTIGATION REPORT**

**A00Q0094**

### **RUNWAY EXCURSION**

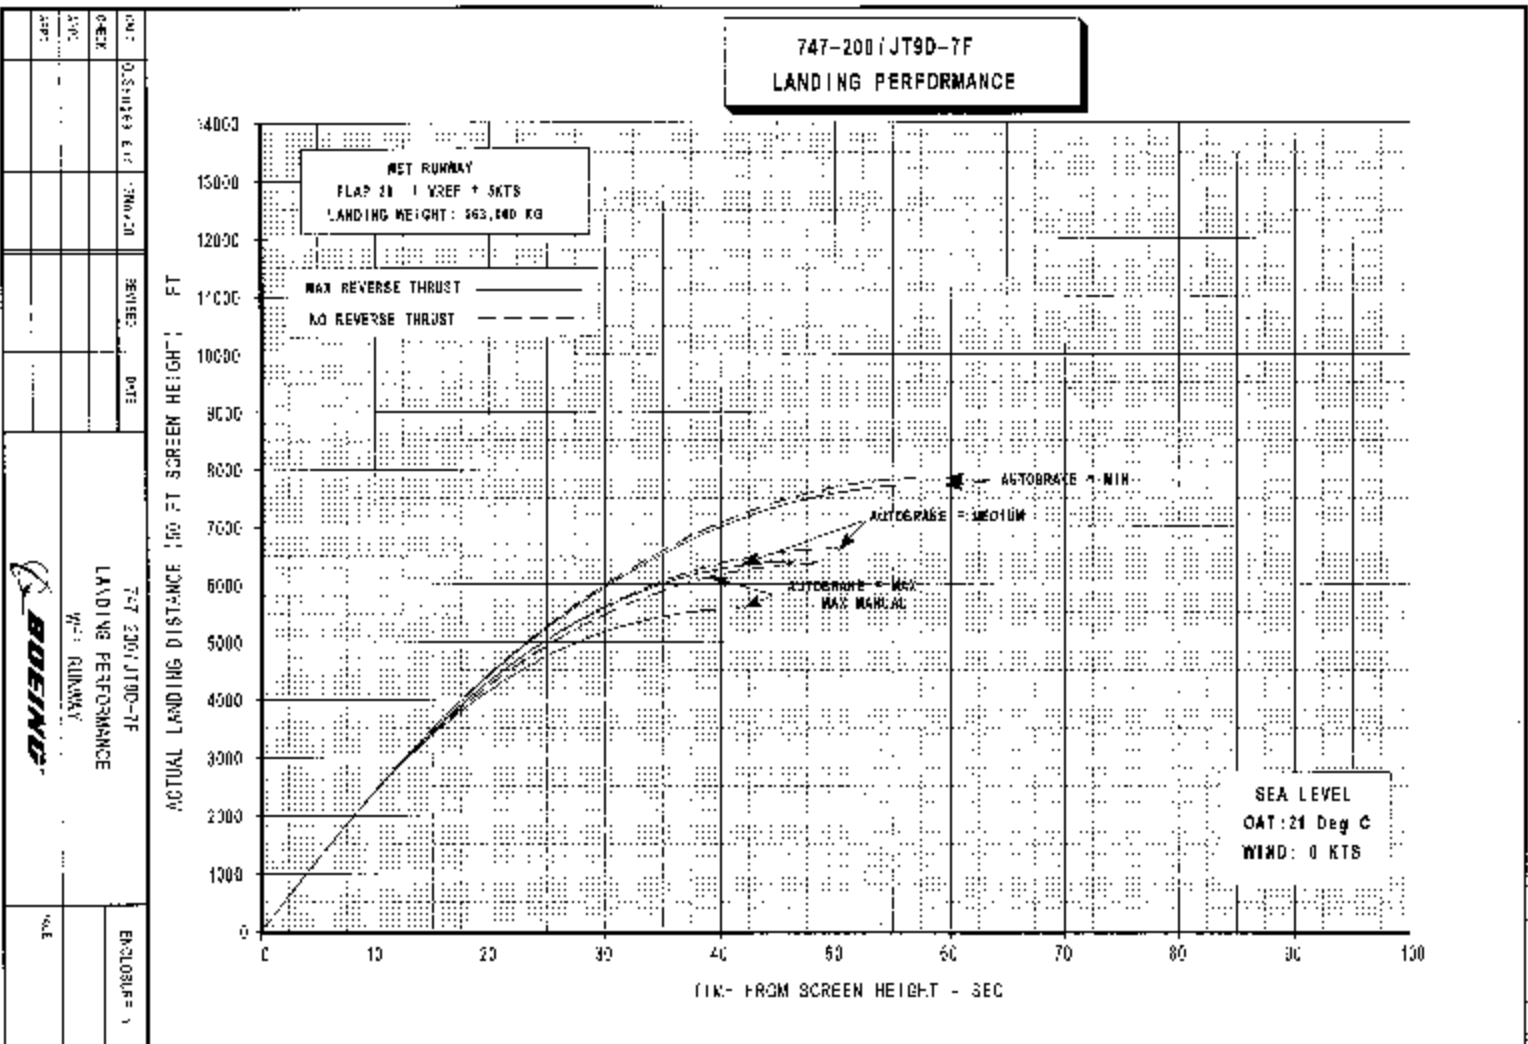
Appendix B—Landing Distances on Wet Runway: Calm Wind

During the approach, the PNF occasionally glances at the data from the inertial navigation system (INS), such as wind direction and speed. This allows the PNF to recognize the possibility of wind shear and take corrective action as required. It was reported that no signs of wind shear were observed from the INS data during the approach. However, the surface wind changed just before touchdown, causing a variable tailwind component of about 15 knots on landing. A 15-knot tailwind component when the runway is wet increases the landing roll distance by 1000 to 1400 feet, depending on the braking method used. (See Appendices B and C.)
