**AVIATION INVESTIGATION REPORT
A04H0004**

**REDUCED POWER AT TAKE-OFF AND COLLISION WITH
TERRAIN**

**MK AIRLINES LIMITED
BOEING 747-244SF 9G-MKJ
HALIFAX INTERNATIONAL AIRPORT, NOVA SCOTIA
14 OCTOBER 2004**

Report Number A04H0004

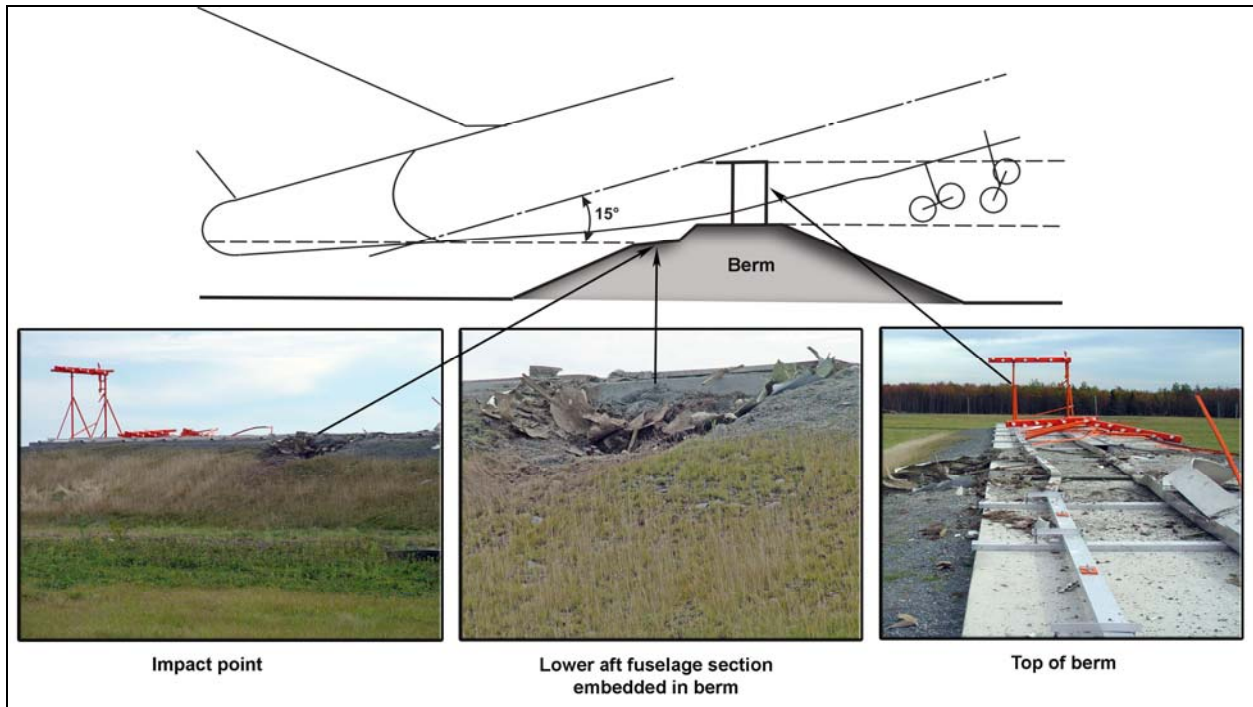
Photo 4. Minimum aircraft pitch attitude at point of impact with berm

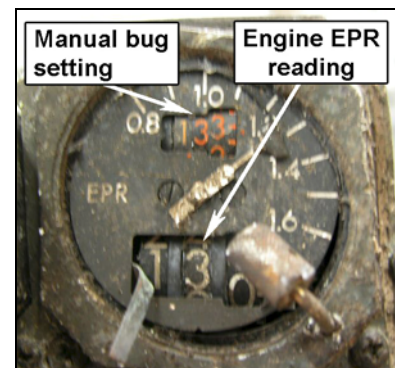
The number 2, number 3 and number 4 EPR gauges were recovered and examined. The number 2 EPR gauge had a manual bug setting of 1.32 and an engine indication reading of 1.01; the number 3 EPR gauge had a manual bug setting of 1.3X (the last digit had broken off at impact) and an engine indication reading of 1.02; and the number 4 EPR gauge (see Photo 6) had a manual bug setting of 1.33 and an engine indication reading of 1.305. The EPR settings on the three recovered instruments were set to 1.32–1.33. These readings were considered to be reliable, with the slight differences attributed to movement during the impact sequence.

Photo 6. Engine number 4 EPR gauge

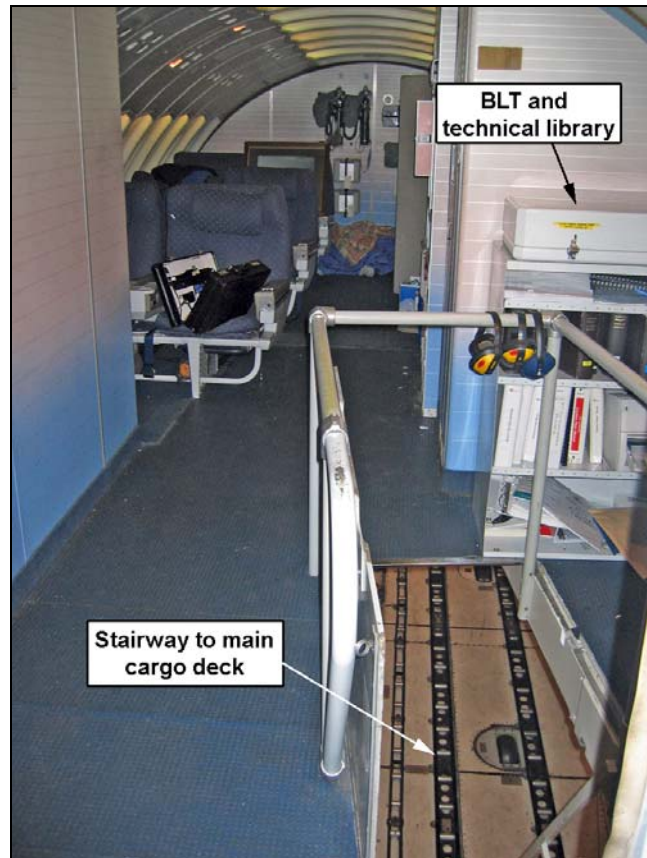
The first officer should have then gone to the company laptop computer in the upper deck rest area and opened the BLT program (see Photo 7). Since the BLT defaulted to the previous information used, and the take-off at Bradley International Airport had been a RTG II reduced thrust take-off, that option (RTG II) should have been selected in the window. The first officer should have then used the drop-down menus to insert on the performance page the airport, runway, runway conditions, aircraft bleeds (always defaulted to OFF), anti-ice, and optimum flap. Since there were no aircraft defects and no applicable NOTAMs (notices to airmen) for Halifax, the first officer should have proceeded to the next step. Without a planned weight in the planned weight block, a maximum take-off weight of 321 580 kg should have been generated after “calculate” was selected. Since the maximum take-off weight calculated by the BLT in RTG II would have been less than the planned take-off weight, the first officer would have had to return to the BLT icon and select the maximum thrust (7Q rating).

Photo 7. Upper deck configuration

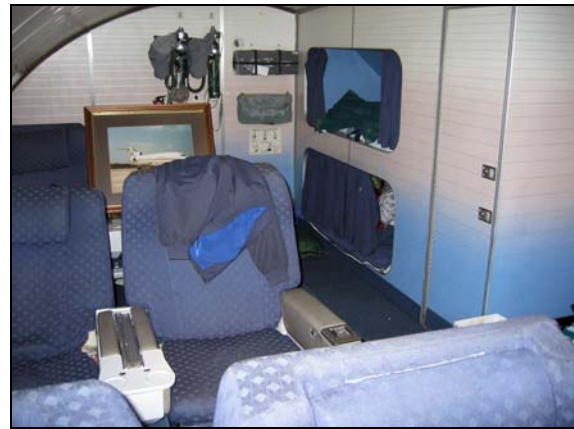
The on-board rest facilities on the accident aircraft included a captain's cabin, two bunks, and first-class seats (see Photo 8). The operating captain and the first officer would have had the opportunity to sleep on board the aircraft while transiting from Luxembourg to Bradley. However, other MK Airlines Limited crews indicated that they rarely were able to sleep on the first leg of the MKA1601/MKA1602 route because of the time of day. They also stated that they began to feel the effects of fatigue during the stopover in Halifax and might obtain a nap in Halifax, if the turnaround time permitted. Feeling fatigued at this stage of the flight would be consistent with the expected lowest point of a crew member's circadian rhythm. In the case of the accident flight, which was delayed leaving Luxembourg, the circadian low point would have fallen somewhere between Bradley and Halifax. Other crews also indicated that they normally were able to get several hours of sleep while transiting between Halifax and Zaragoza.

Photo 8. Upper deck crew rest area
