Autopilot malfunction, Serious incident occurring on December 3, 2002 near Munich, involving an Airbus A300-600.

Investigation Report

5x011-0/02
August 2004

Type of Occurrence: Serious Incident
Date: 3 December 2002
Location: near Munich
Aircraft: Transport Aircraft
Manufacturer / Model: Airbus Industry / A300-600
Injuries to Persons: 1 crew member slightly injured
Damage: Aircraft not damaged
Other Damage: None
Source of Information: Investigation by BFU

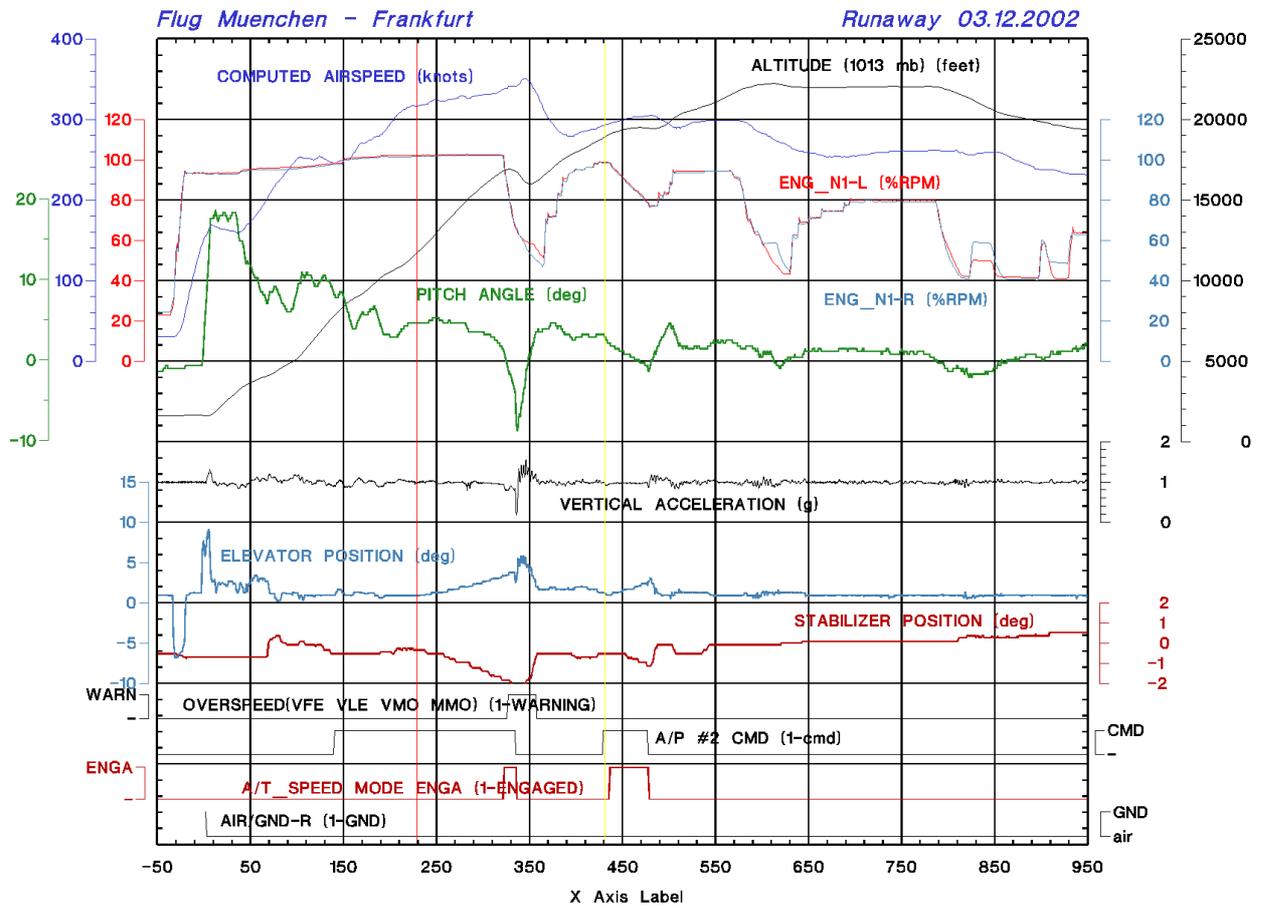
FDR Readout

The aircraft was equipped with a magnetic tape flight data recorder LORAL F 2100, P/N 2100-4043-02, S/N 182396. It recorded 300 parameters during a 25 hour period. The relevant parameters from take off until 950 seconds after take off were selected and are shown in Appendix 1.

The recording dated 3 December 2002 showed that with engaged AP 1 the flight from Frankfurt to Munich occurred without incident. On the flight back with AP 2 engaged and during climb a position change of the THS occurred at an altitude of about 17 000 ft. The THS continuously turned with a rate of 0,01 °/s in the direction of "nose down". At the same time the horizontal stabilizer deflected into the contrary position.

60 seconds after the beginning of the position change the nose dropped, climb rate decreased and airspeed increased. After 20 more seconds the power of both engines decreased and the nose dropped further. After another 20 seconds the AP 2 was disengaged and the nose dropped once more. The deflection of the elevator decreased for a short time whereas the reached position of the THS of 2.5° remained.

10 seconds after the disengagement of the AP the THS had almost reached its neutral position again. By the time the airplane was back into climb it had undergone an altitude loss of 1 000 ft, the airspeed had reached a maximum of 351 KIAS and vertical acceleration had been between 0.2 g and 1.5 g.
