Birdstrike on takeoff, Accident of aircraft BOEING B-737, registration PH-BTC, at Barcelona Airport (Spain), on 28 November 2004

Micro-summary: Following a birdstrike on takeoff, the Boeing 737 continued to the destination, where the damage manifested as a loss in lateral control and runway excursion.

A-070/2004

Accident of aircraft
BOEING B-737,
registration PH-BTC,
at Barcelona Airport
(Spain), on 28
November 2004

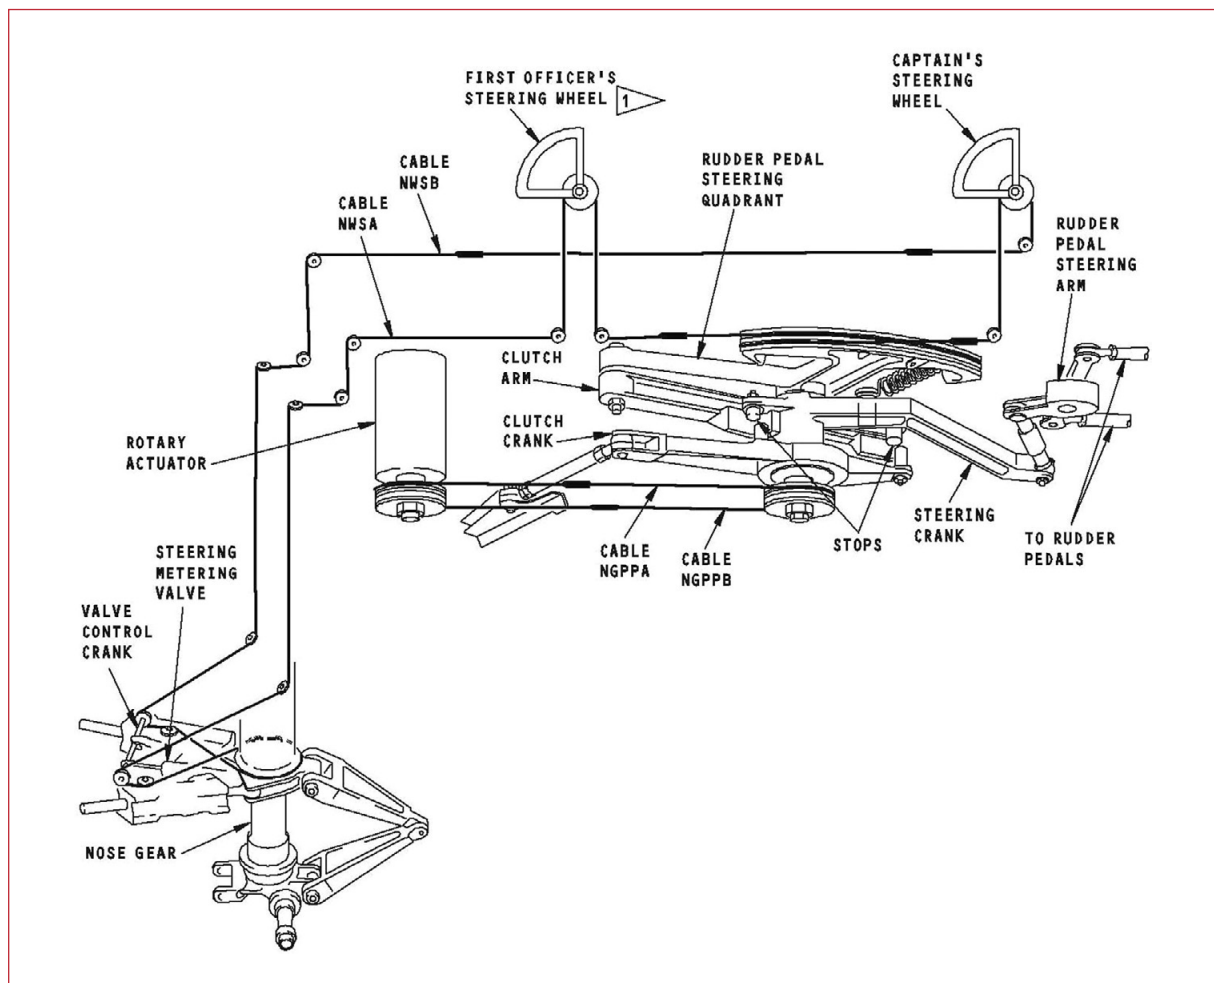
Figure 1.6.1. NWS mechanism from the AMM. Cable NWSB (on the right side of the NLG when looking in the direction of the flight) was found broken after the accident

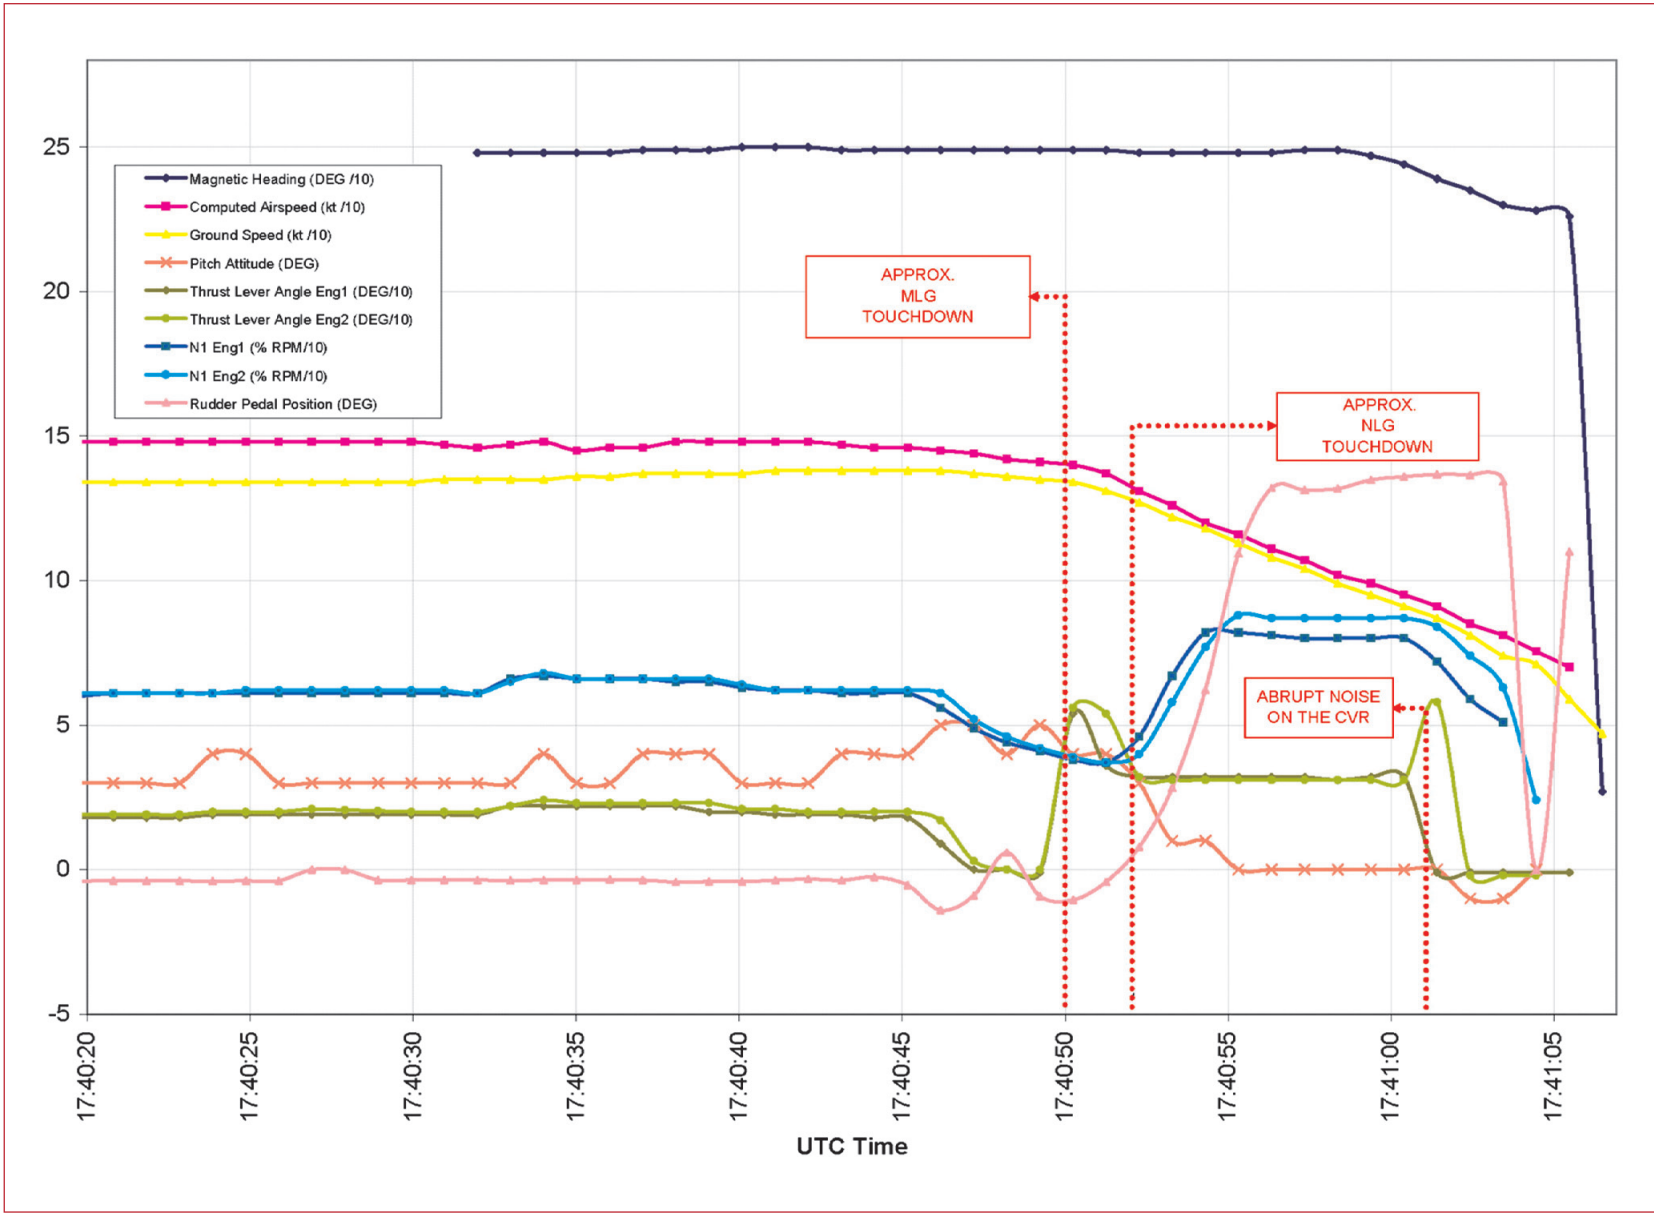
The deflection of the pedal continued until it reached the maximum with airspeed of 111 kt at 17:40:56 h.

Figure 1.11.2.1. Several parameters during landing

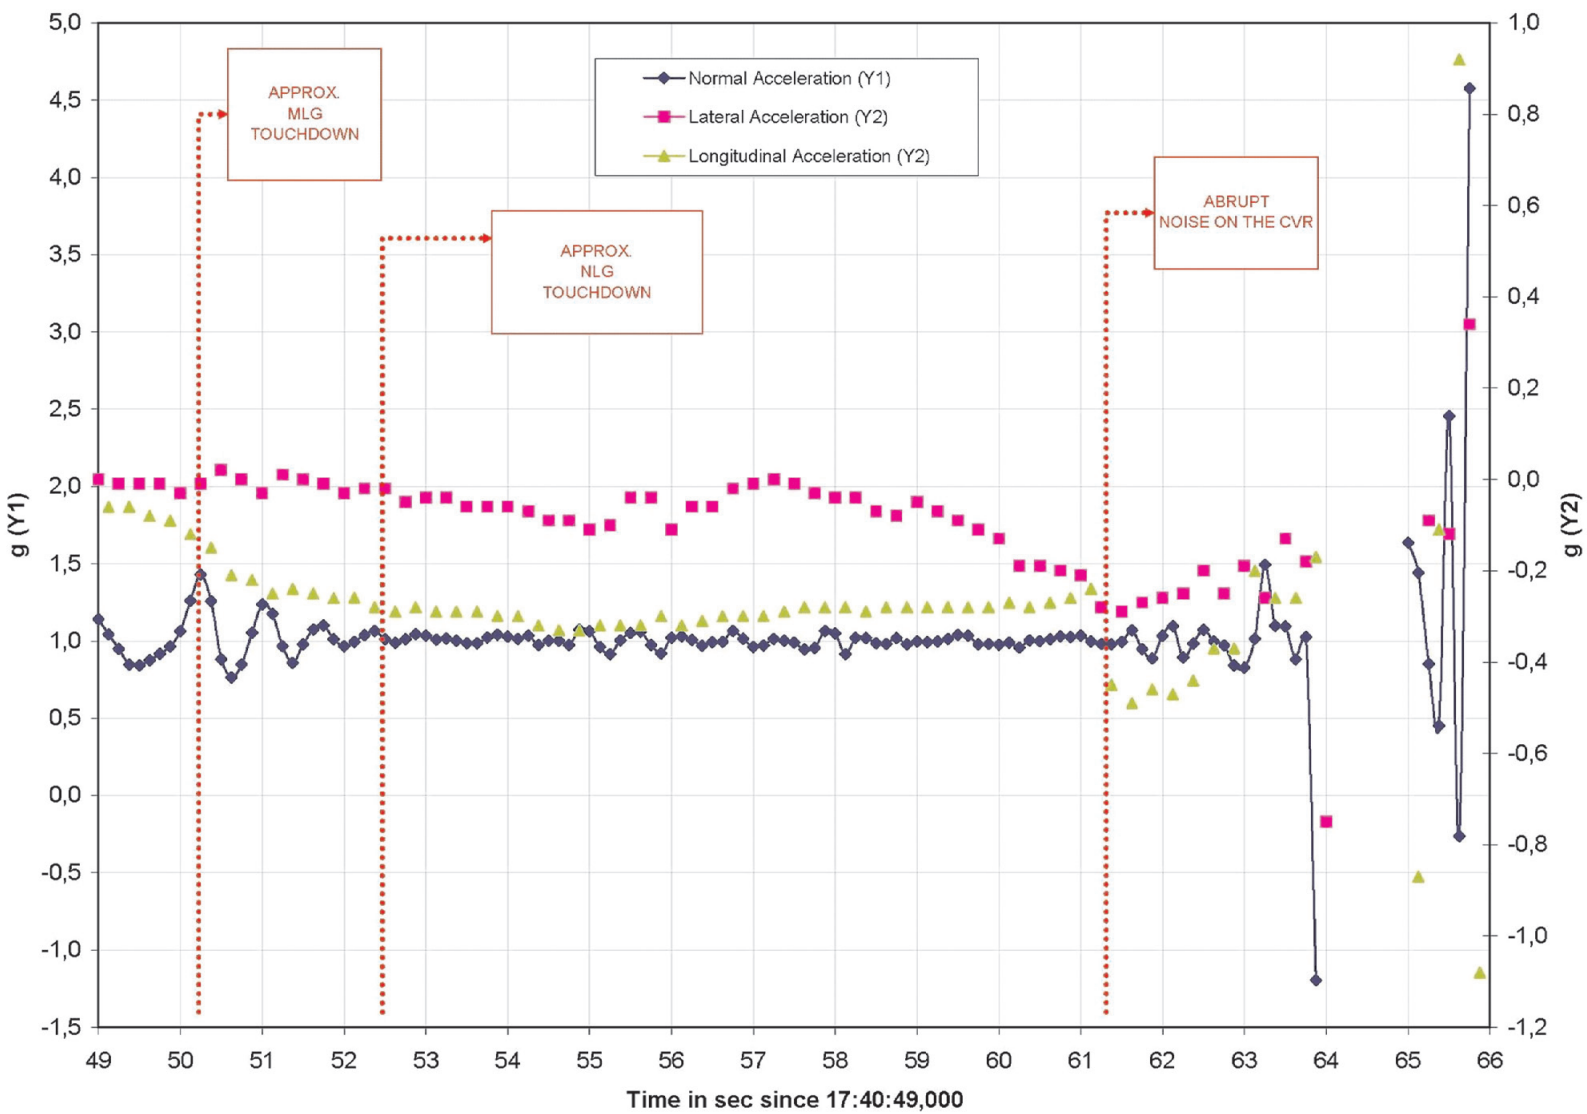
Figure 1.11.2.2. Accelerations during touchdown and landing roll

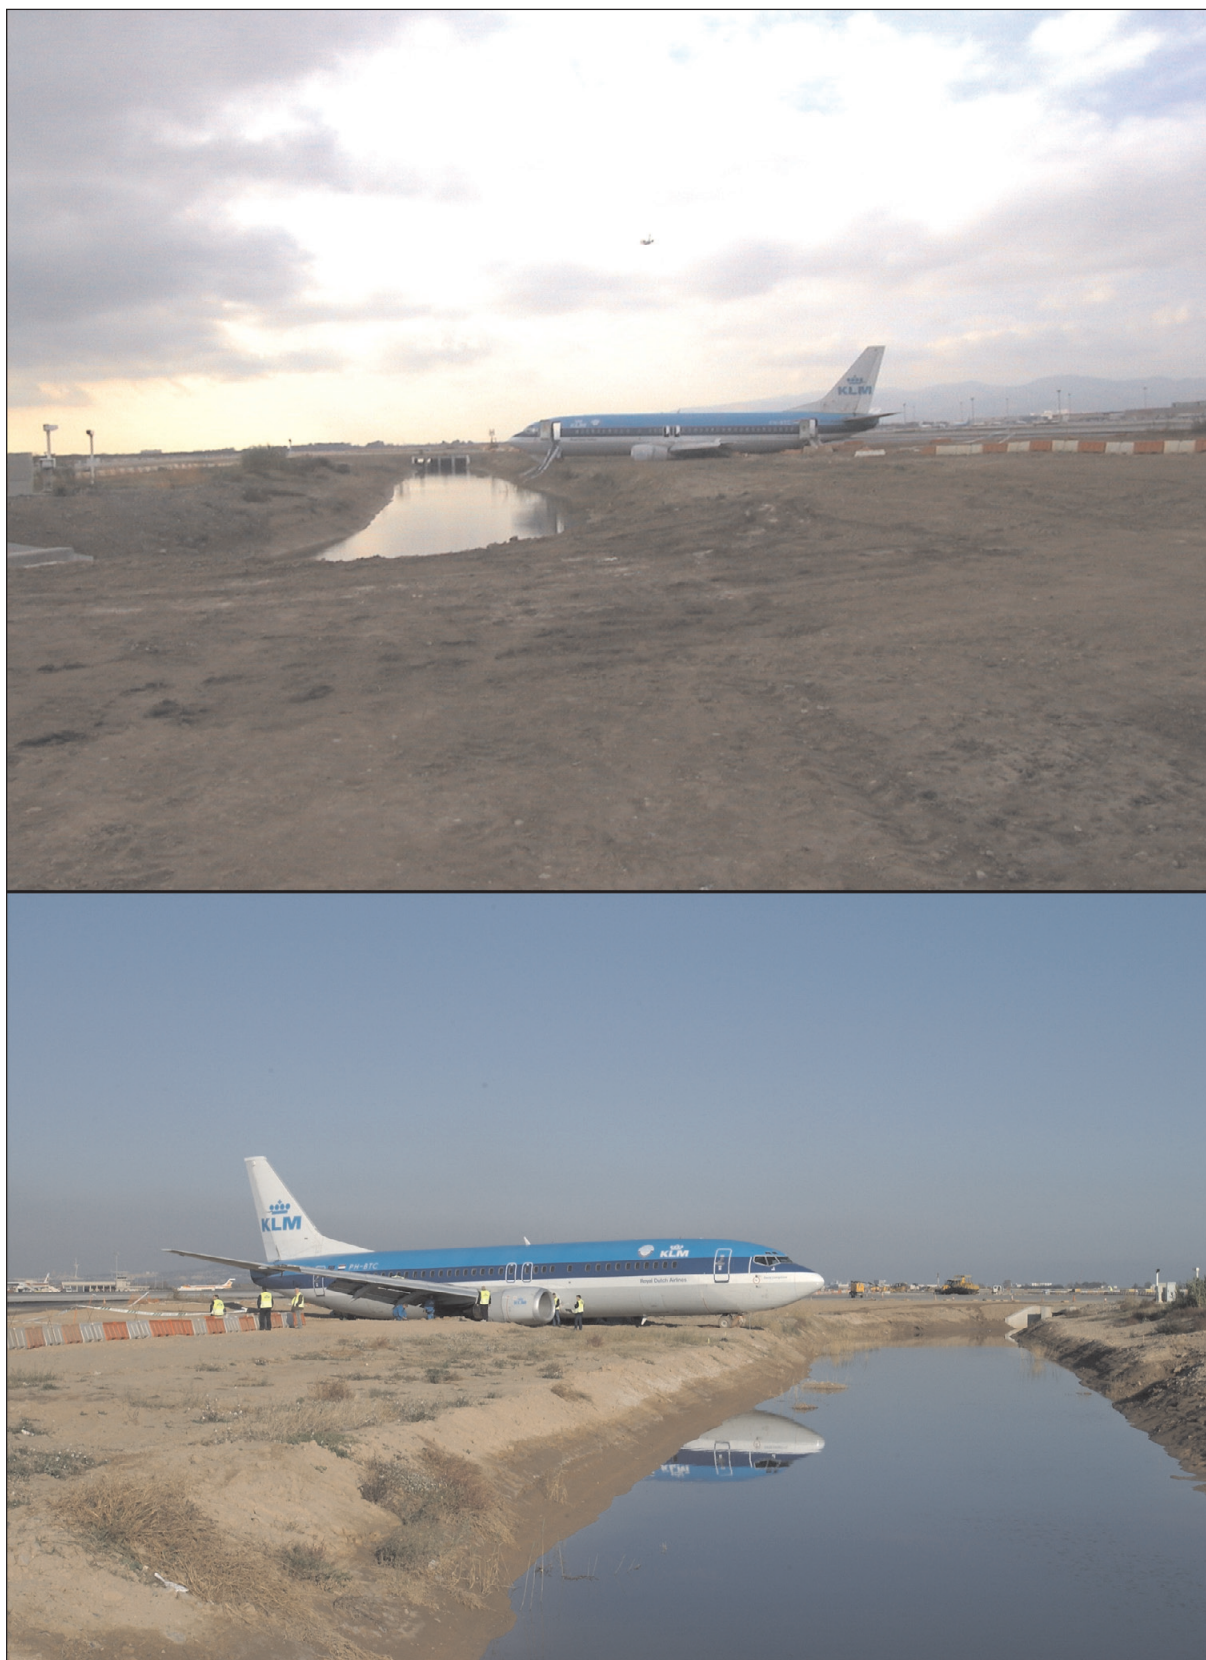
The aircraft came to a stop close to the edge of a rain drainage canal that ran approximately parallel to runway 25R. The canal was approximately 15 m wide, and 2.5 m high from the surface of the water. The water depth was approximately 1.5 m.

Photo 1.12.1.2. Final position of the aircraft close to the edge of the canal

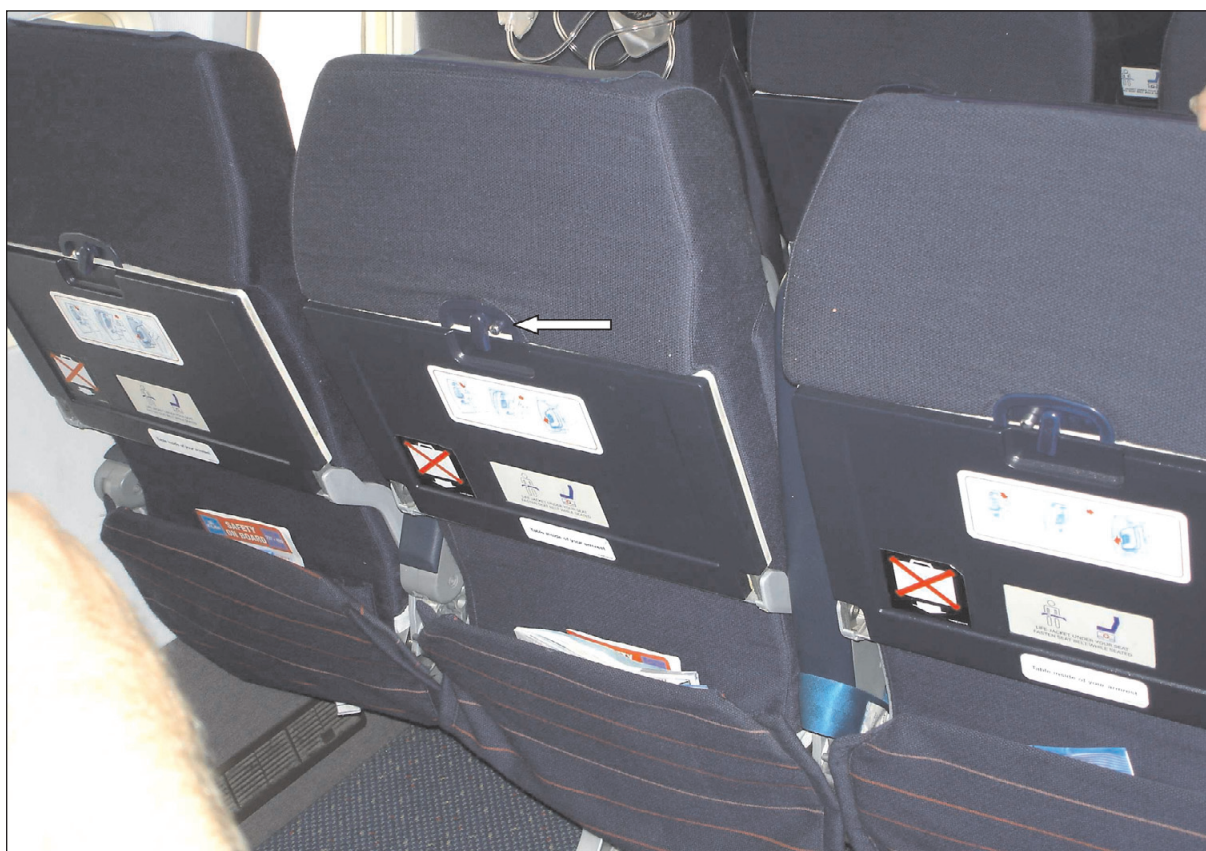
The meal tray table of the back of seat 10B (in front of seat 11B), which was located in the forward left hand emergency exit passageway, was found to have the restrain pin on its right hand side (i.e. towards the aisle). Therefore, the normal escape path of the passengers towards the type III emergency exit could easily release the tray (see Photo 1.15.1.1, white arrow in central seat back).

Figure 1.15.1.1. The latch of the meal table of the centre seat may rotate towards the sense of the Type III emergency exit escape path (to the left of the photo) and therefore it could be released during the emergency evacuation
