## TCAS manoeuvre south of Jyväskylä on October 29, 2002

## Aircraft Incident Report

B 4/2002 L

### TCAS manoeuvre south of Jyväskylä on October 29, 2002

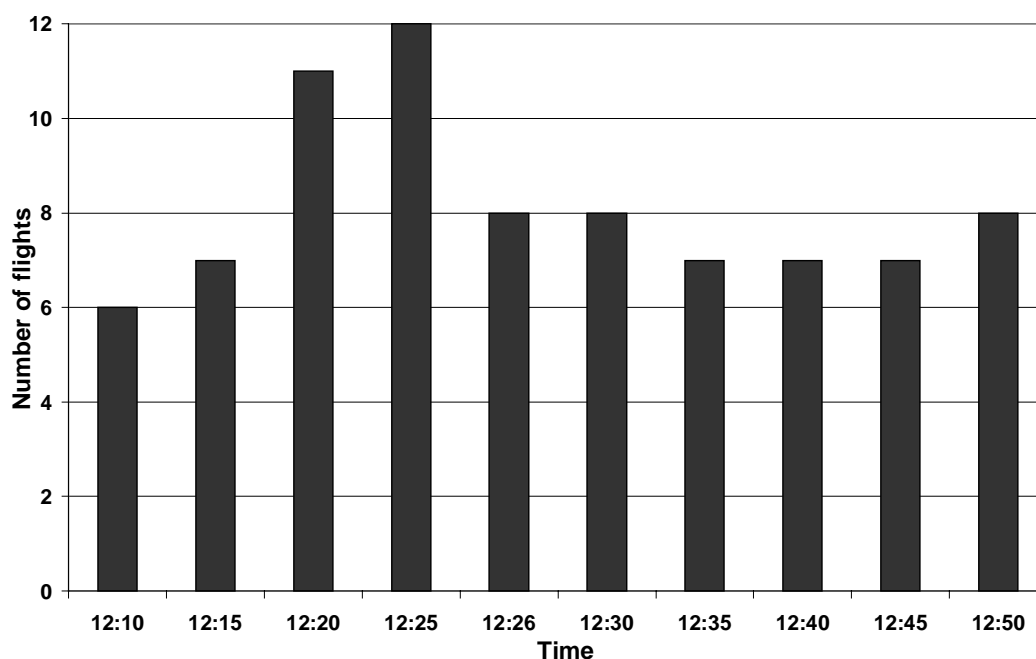
Figure 3. The traffic volume in sector suite 4 (sectoring at 12.25 hours)

On the day of the incident at 12.00 - 13.00 hours the forecast traffic volume in the combined sectors 3, 4 and 5 was 29 flights and the capacity 20 flights per hour. The actual traffic was 36 flights. The forecast traffic in the combined sectors 4 and 5 was 19 flights and the capacity 20 flights per hour. The actual traffic was 25 flights. The forecast traffic in sector 3 was 16 flights and the capacity 20 flights per hour. The actual traffic was 20 flights. The total traffic volume was an usual short afternoon peak in these sectors.

The ACC supervisor decided to separate sector 3 from sectors 4 and 5 because the forecast indicated that the capacity of the combined sectors 3, 4 and 5 would be exceeded. Sector suite 3 with sector 3 as responsibility area was opened at 12.25 hours. After this the actual traffic volume at 12.25 - 13.00 hours in sector 3 was 15 flights. In the combined sectors 4 and 5 the actual traffic volume was 20 flights.

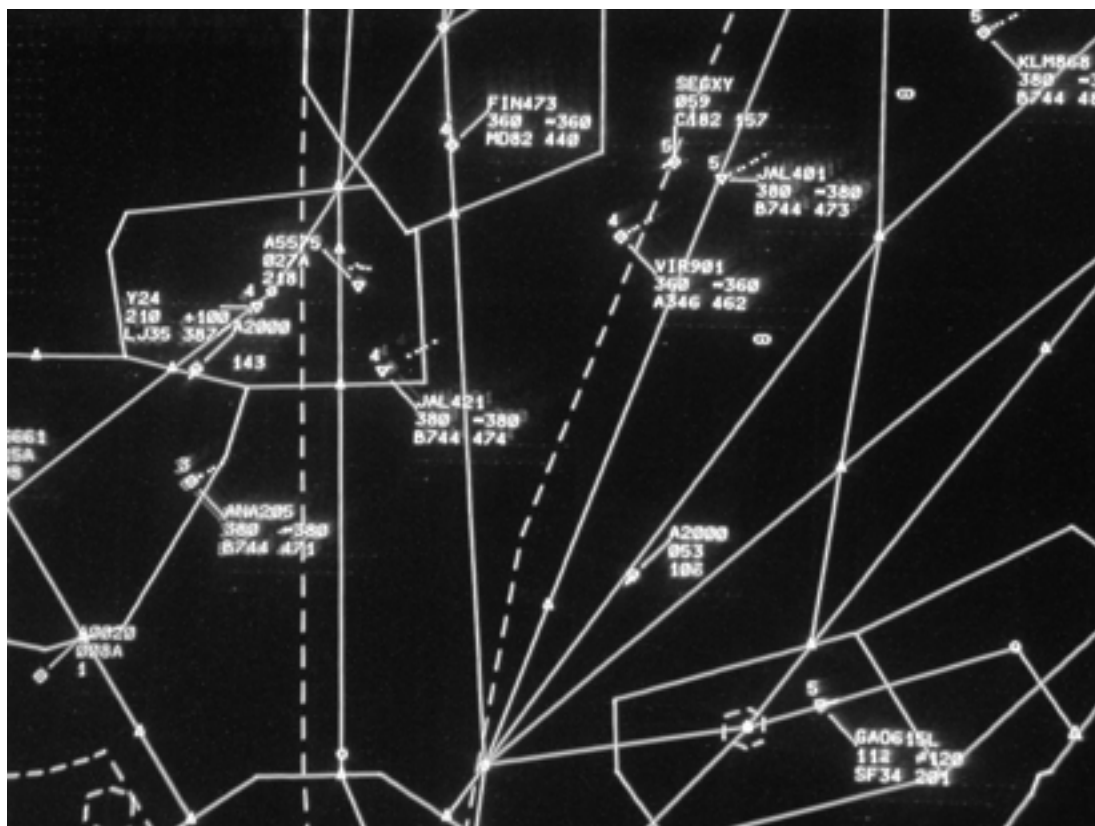
Figure 4. Part of R1 radar display at 12.30.30 hours

At 12.30.30 hours R1 cleared Finnair 473 to FL 130. The clearance was, however, conditional: "When ready, descend to FL 130" i.e. the pilots could initiate the descent at their discretion. Finnair 473 was then about 15 NM south of VOR/DME radio beacon LUONET. Virgin 901 was then at a distance of about 25 NM from Finnair 473. Neither R1 nor R2 noticed that radar separation with Virgin 901 would soon be lost. There was no other significant traffic with regard to the clearance of Finnair 473 to descend to FL 130. R1 had no telephone calls during 12.26.40 - 12.31.40 and R2 during 12.24.00 - 12.34.00. Both controllers and the sector assistant were in the sector suite during this time.

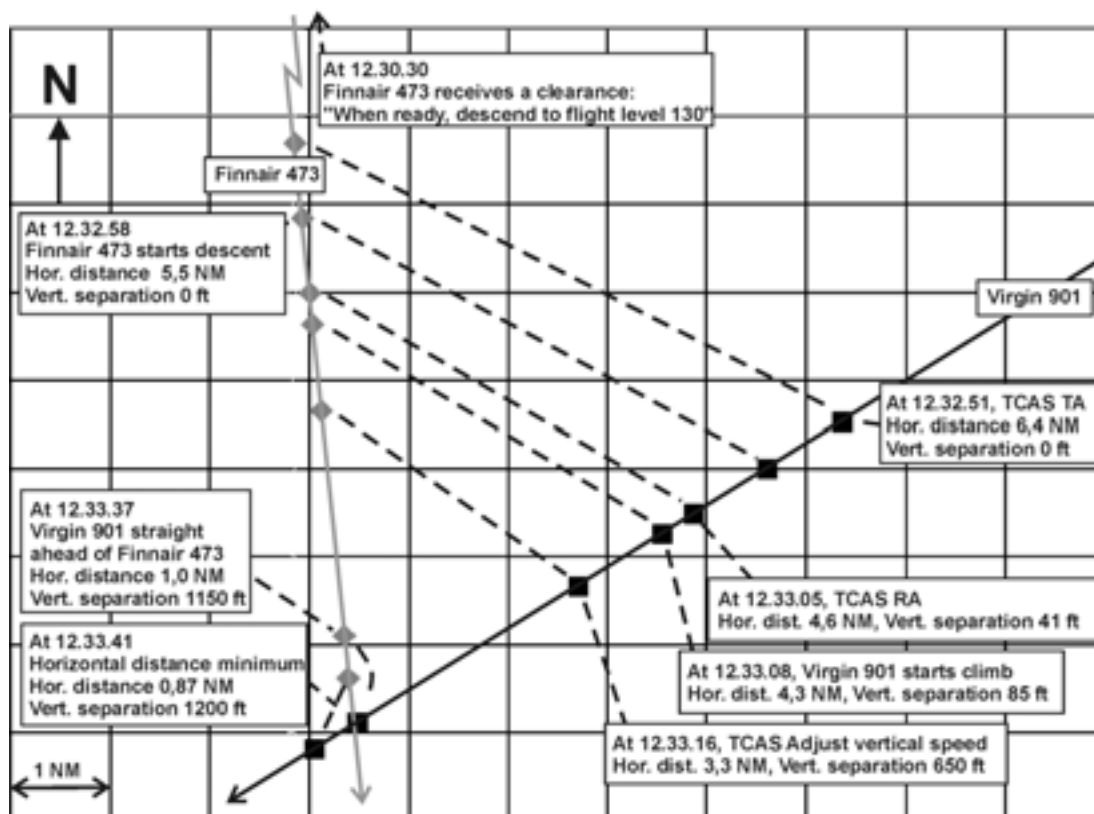
Figure 5. The flight tracks of the aircraft

R1 noticed that the aircraft would not collide and assumed that they would perform TCAS manoeuvres. He did not issue any clearances in order to avoid conflicts between the clearances and the TCAS advisories. He told that his decision not to say anything was affected by the fact that he was familiar with the mid-air collision which took place at the border of Germany and Switzerland in July 2002. His actions after Finnair 473 TCAS report complied with the valid instructions.
