## **In-flight explosion, Report on the accident to Boeing 747-121, N739PA at Lockerbie, Dumfriesshire, Scotland on 21 December 1988**

**Micro-summary: A bomb destroyed this Boeing 747-121 in cruise.**

Aircraft Accident Report No 2/90 (EW/C1094)

**Report on the accident to Boeing 747-121, N739PA at Lockerbie, Dumfriesshire, Scotland on 21 December 1988**

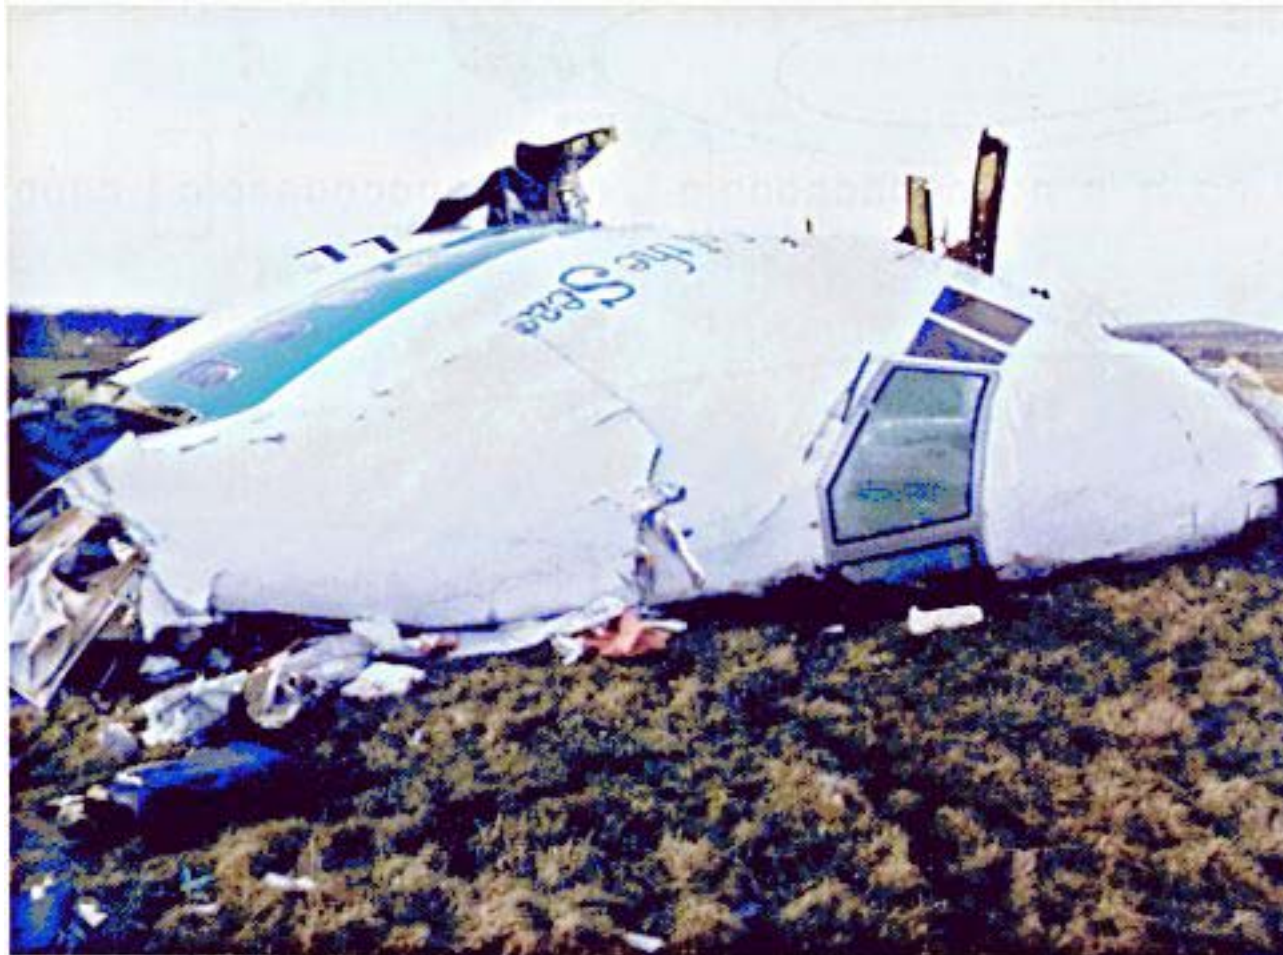
**Figure B-9**

The complete fuselage forward of approximately station 480 (left side) to station 380 (right side) and incorporating the flightdeck and nose landing gear was found as a single piece [Appendix B, Figure B-9] in a field approximately 4 km miles east of Lockerbie at OS Grid Reference 174808. It was evident from the nature of the impact damage and the ground marks that it had fallen almost flat on its left side but with a slight nose-down attitude and with no discernible horizontal velocity. The impact had caused almost complete crushing of the structure on the left side. The radome and right nose landing gear door had detached in the air and were recovered in the southern trail.

**Photograph of nose and flight deck**

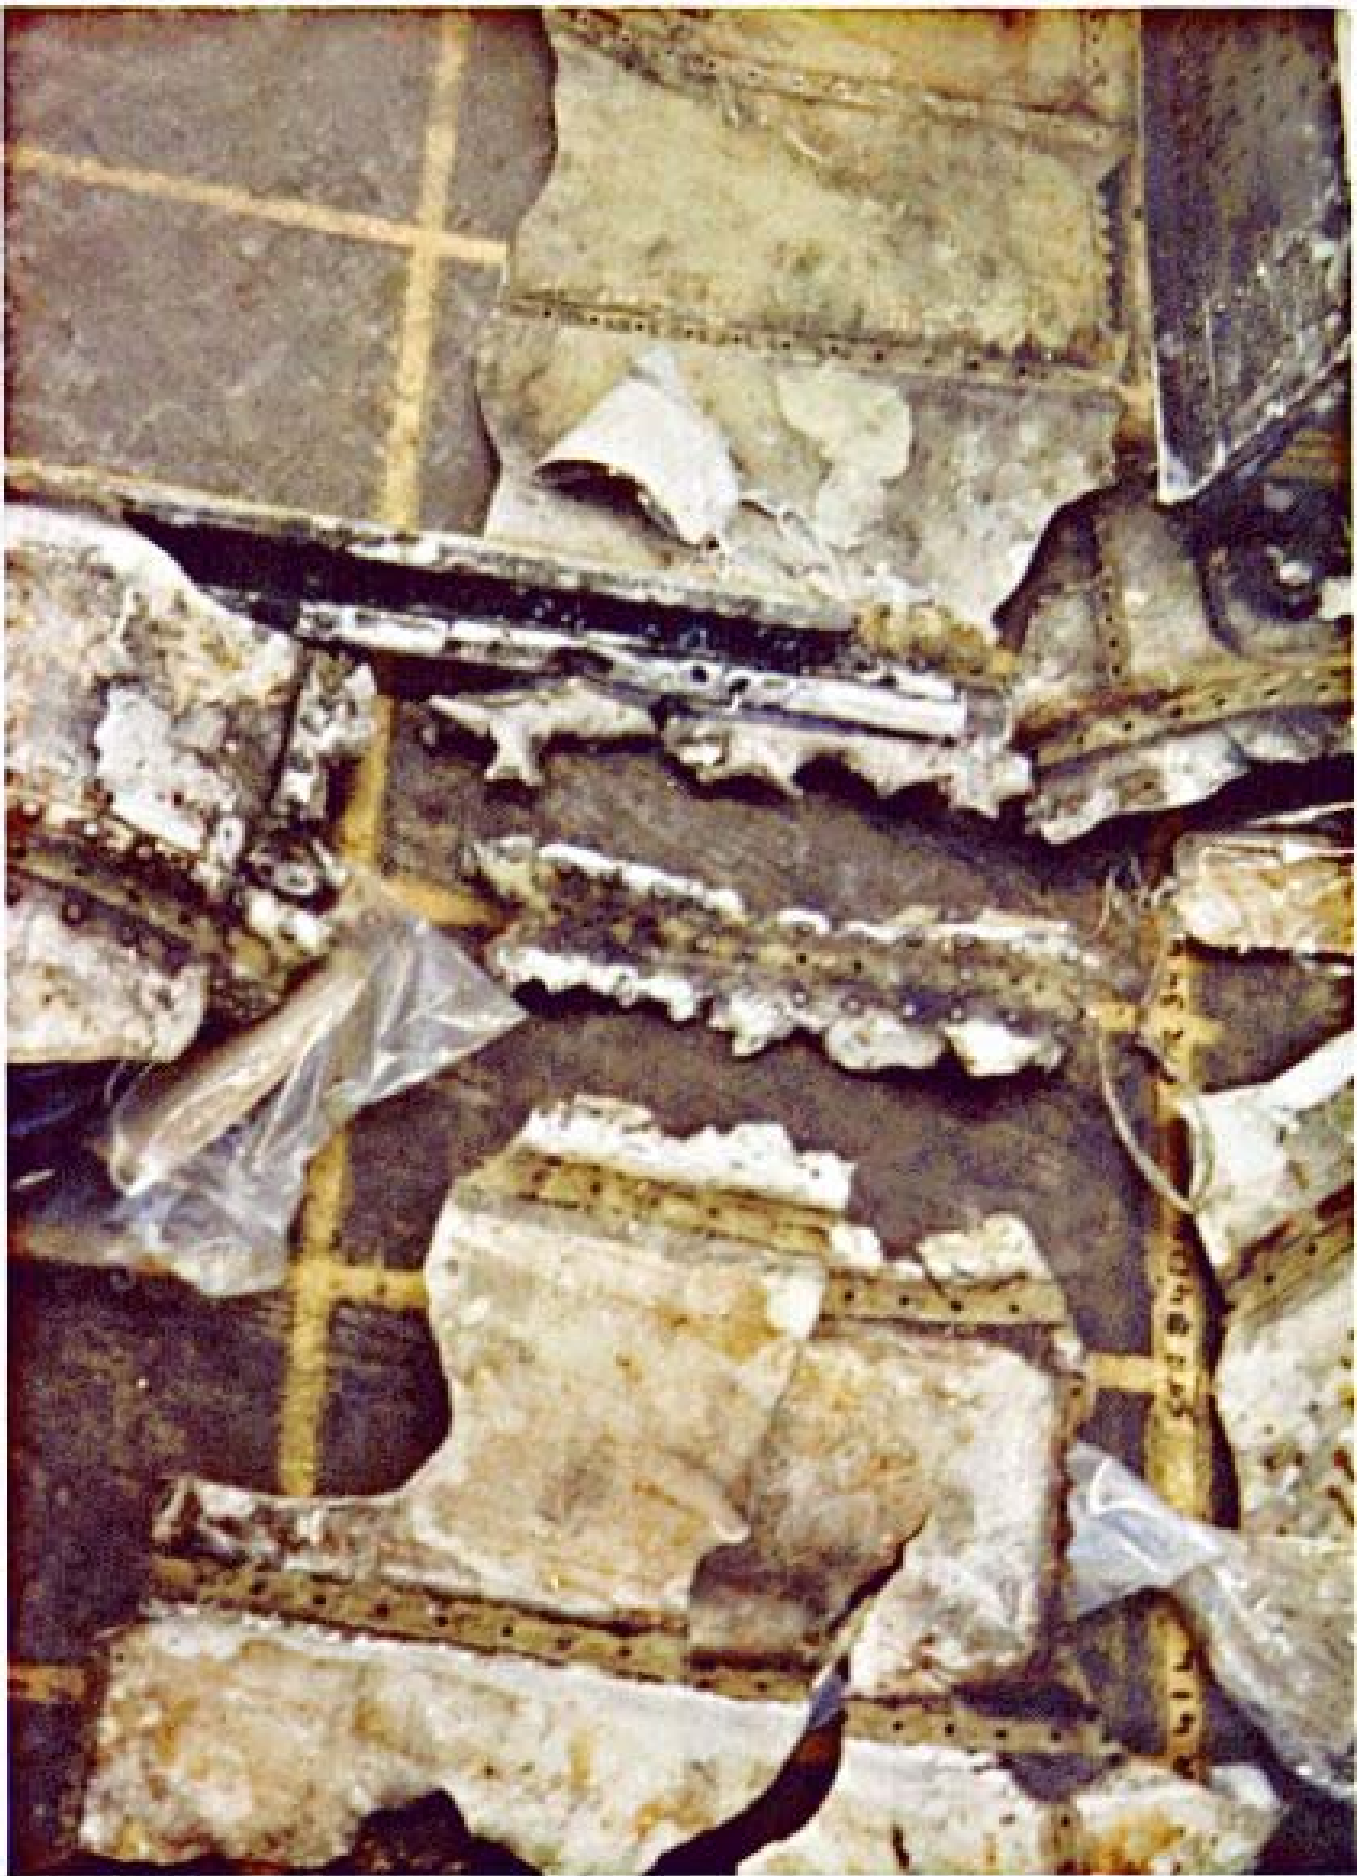
**Figure B-15**

The reconstruction revealed the presence of damage consistent with an explosion on the lower fuselage left side in the forward cargo bay area. A small region of structure bounded approximately by frames 700 & 720 and stringers 38L & 40L, had clearly been shattered and blasted through by material exhausting directly from an explosion centred immediately inboard of this location. The material from this area, hereafter referred to as the 'shatter zone', was mostly reduced to very small fragments, only a few of which were recovered, including a strip of two skins [Appendix B, Figure B-15] forming part of the lap joint at the stringer 39L position.

Surrounding the shatter zone were a series of much larger panels of torn fuselage skin which formed a 'star-burst' fracture pattern around the shatter zone. Where these panels formed the boundary of the shatter zone, the metal in the immediate locality was ragged, heavily distorted, and the inner surfaces were pitted and sooted- rather as if a very large shotgun had been fired at the inner surface

**Detail of shatter zone of fuselage**

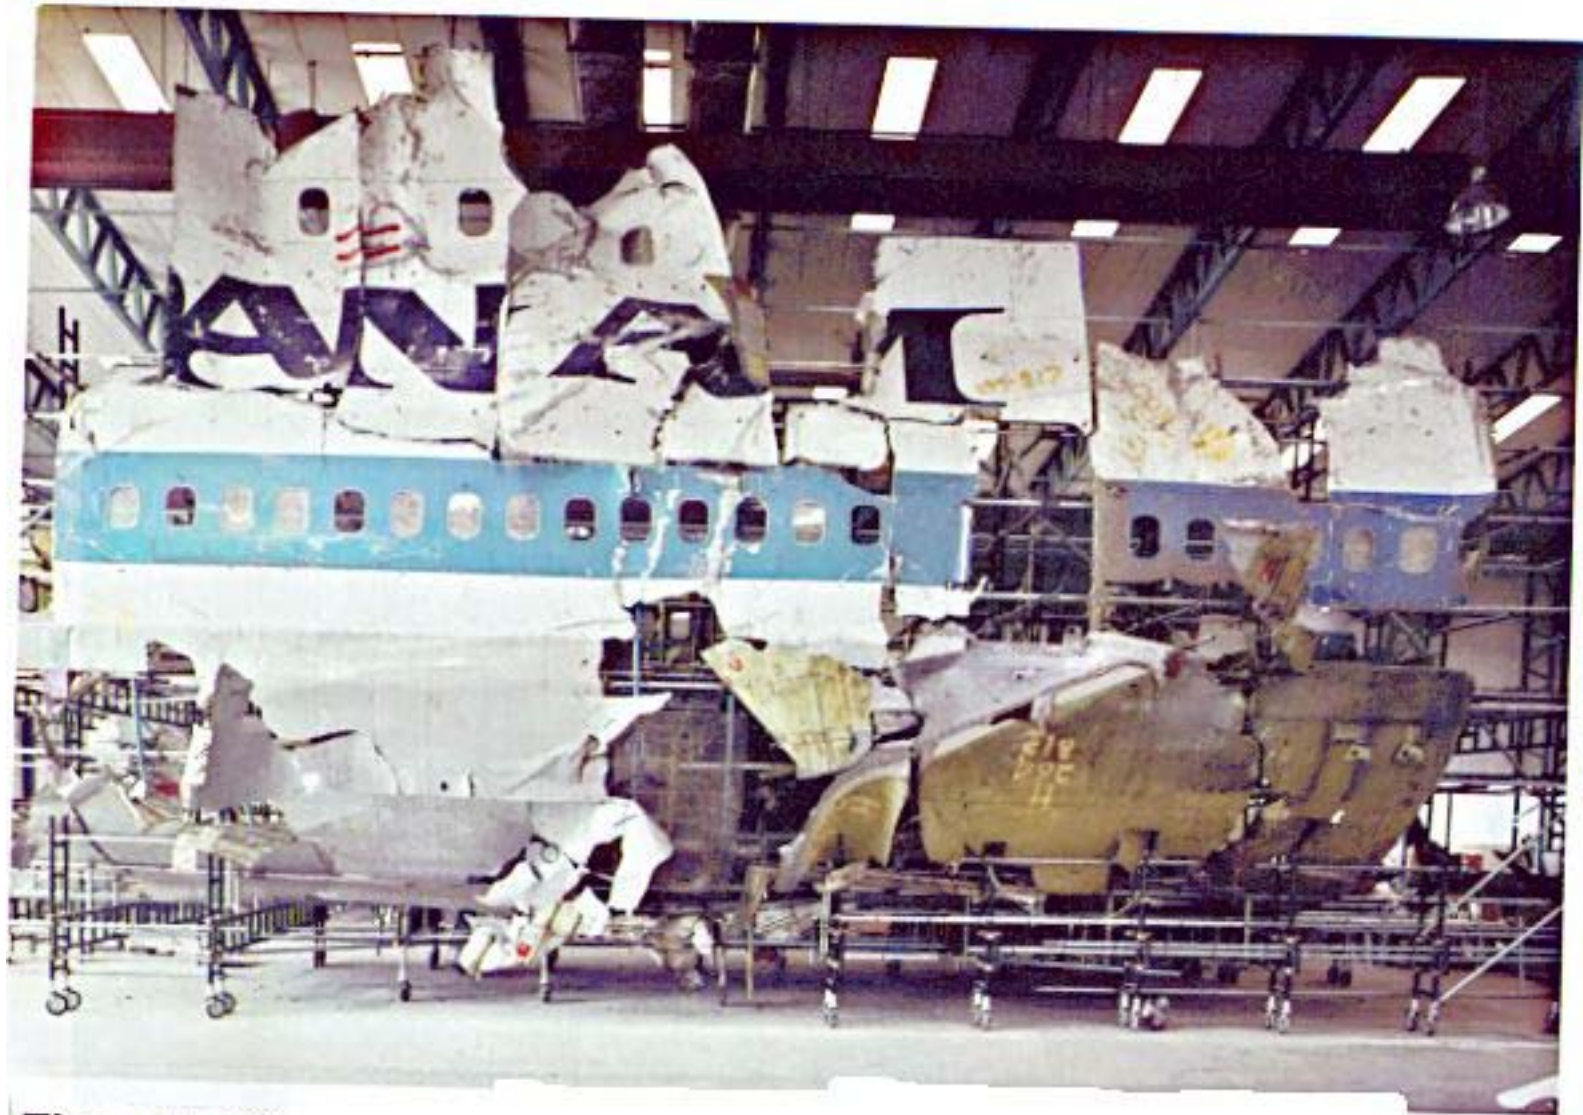
**Figure B-16**

**Fuselage three-dimensional reconstruction**

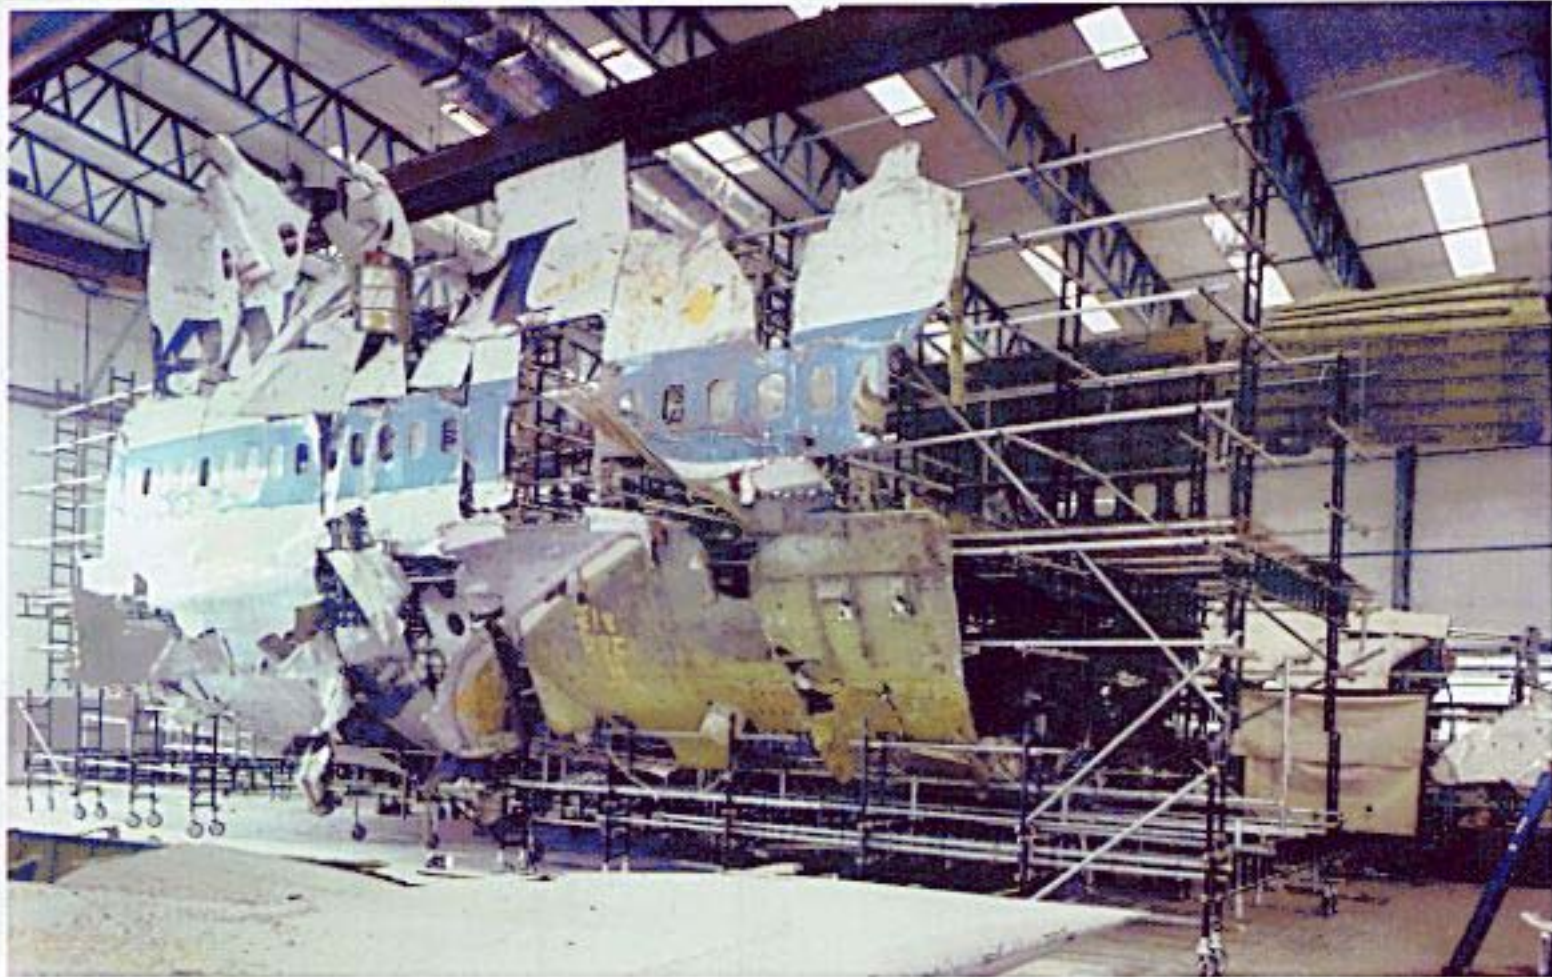
Figure B-17

Fuselage three-dimensional reconstruction

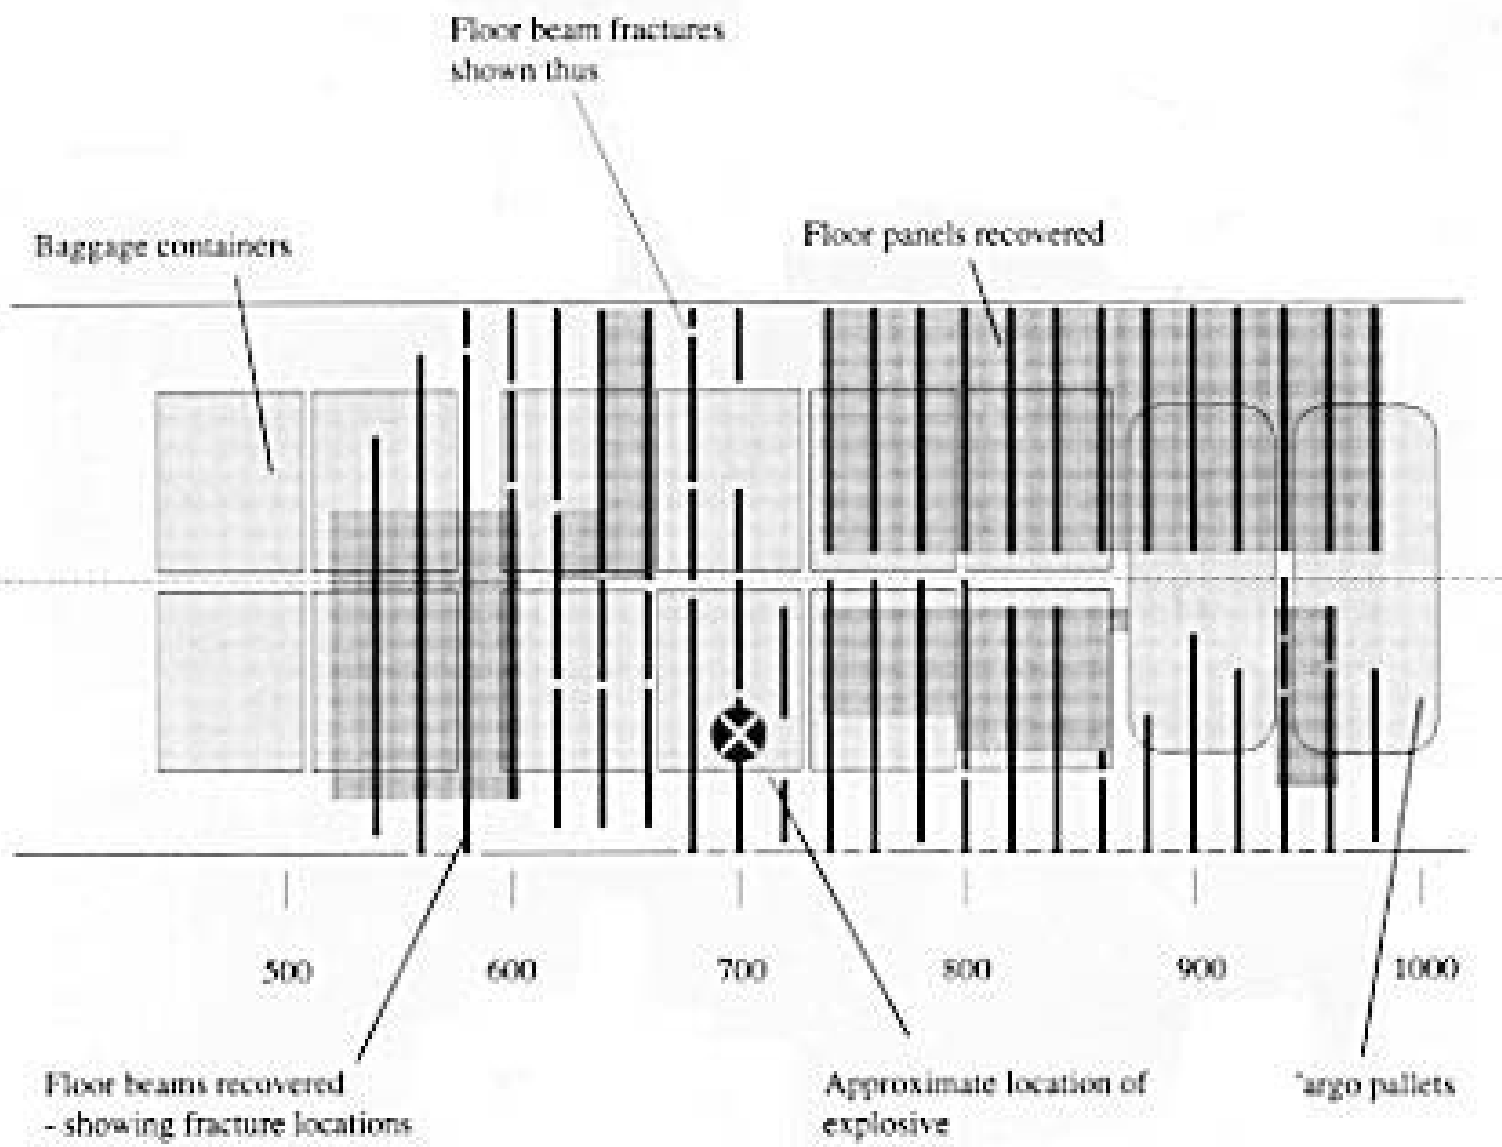
**Figure B-18**

### Plot of floor damage in area of explosion

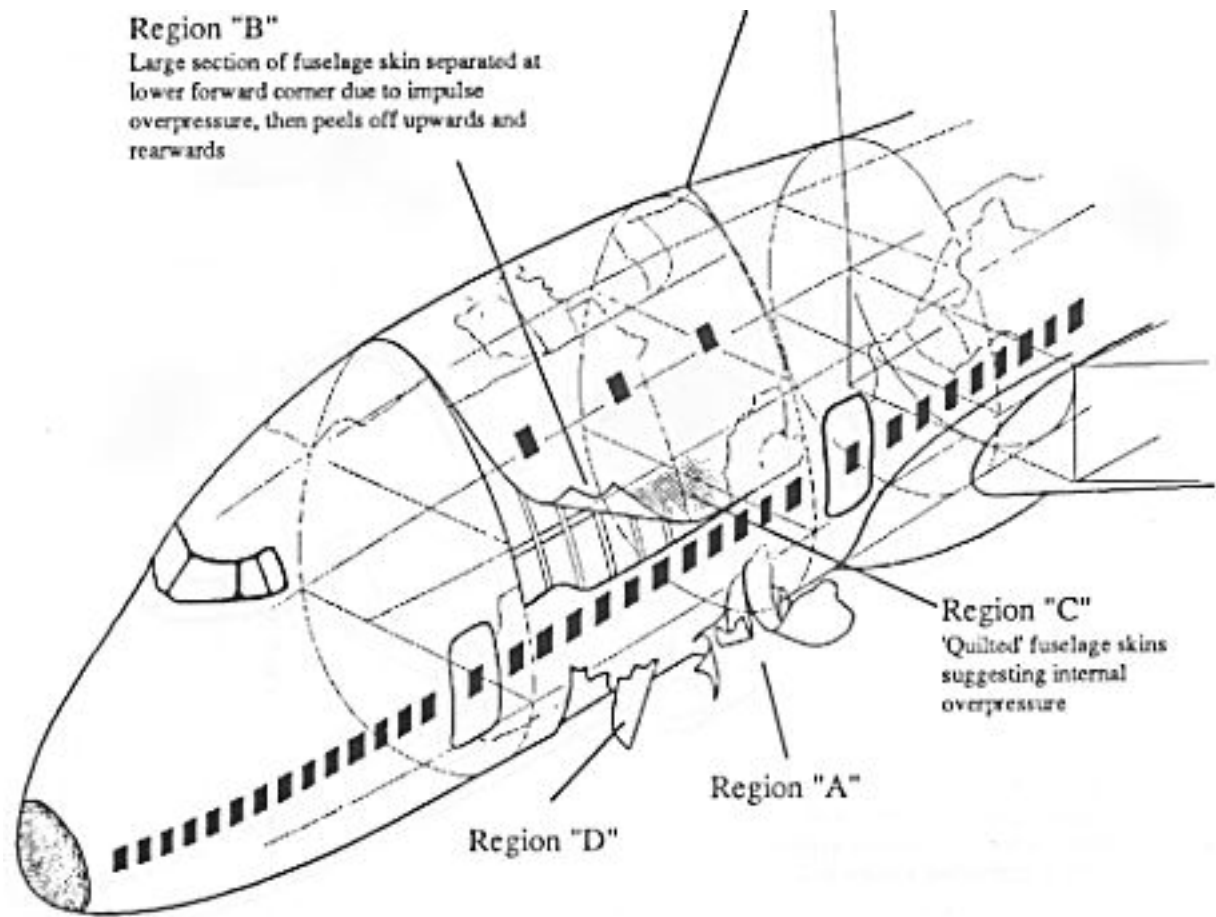
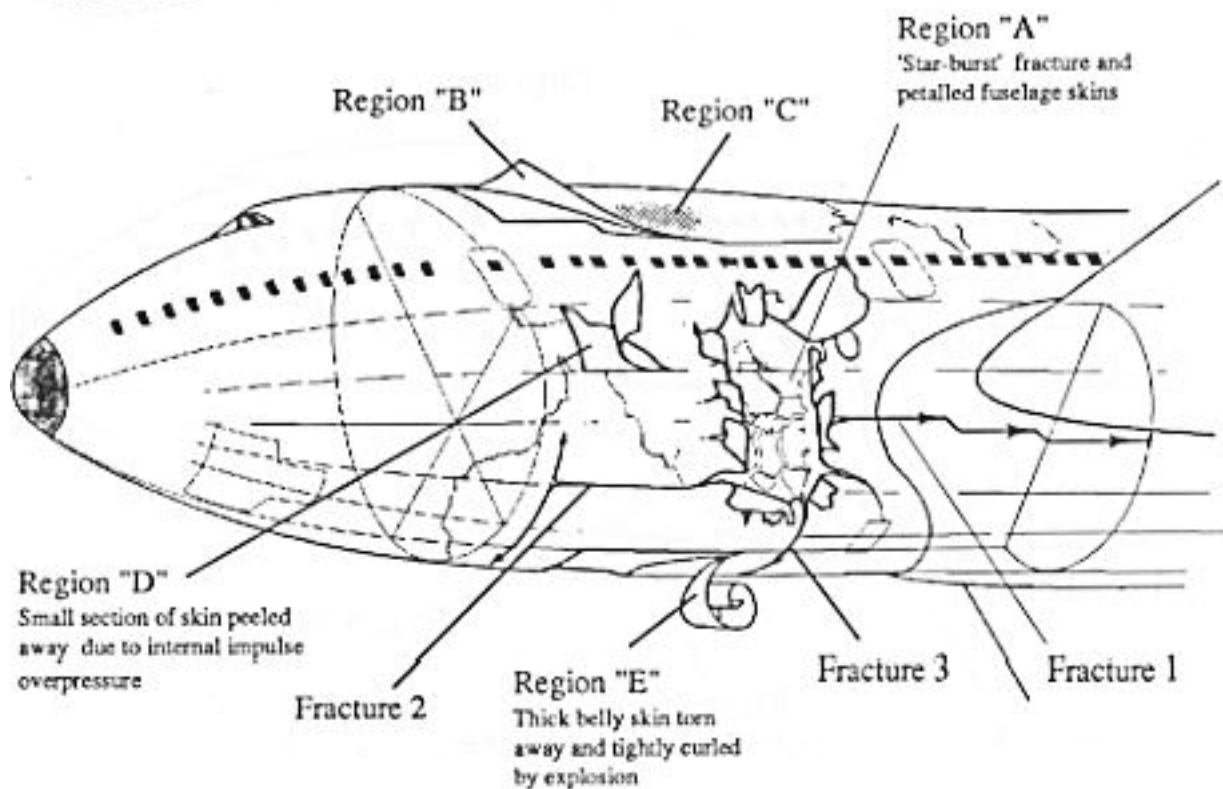
**Figure B-19**

**Explosive Damage - left side**  
 (schematic representation)

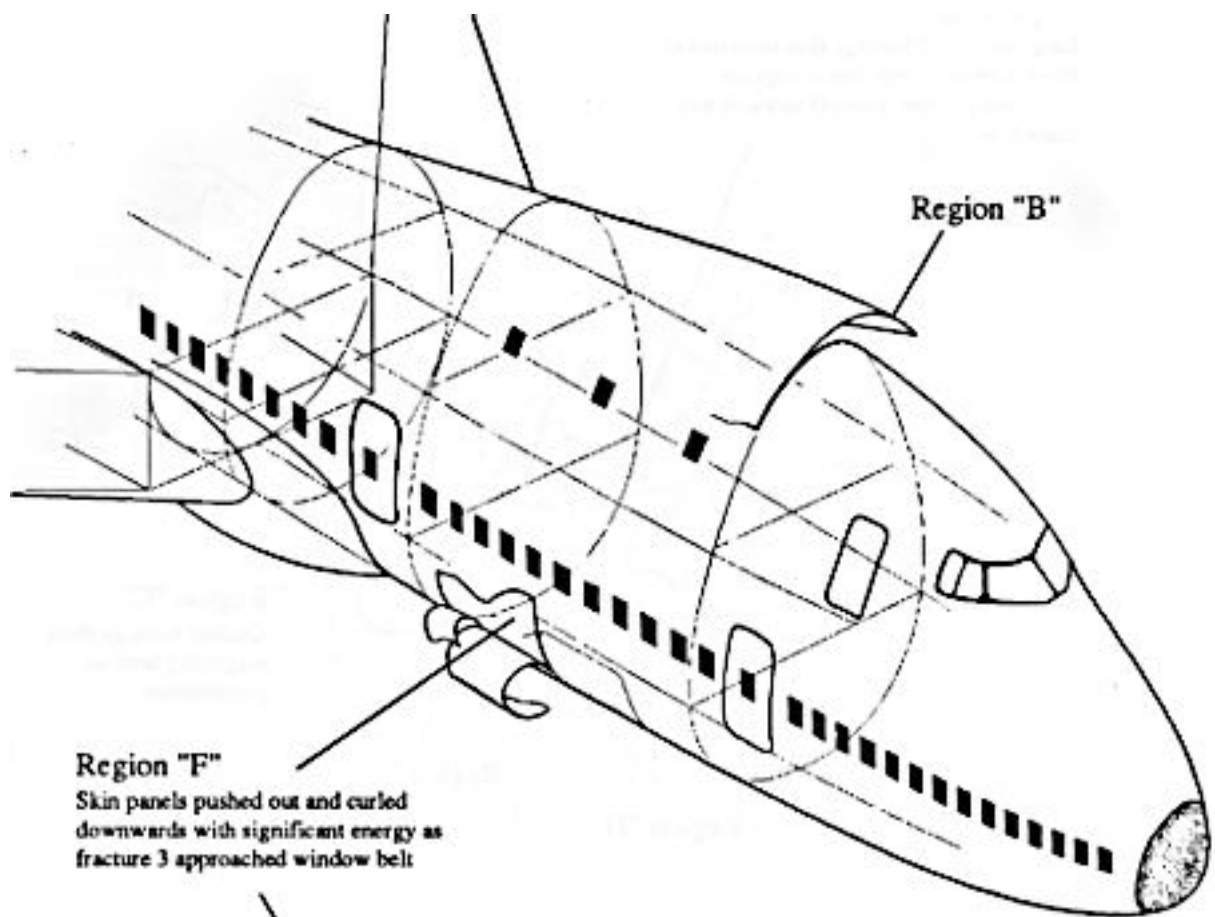
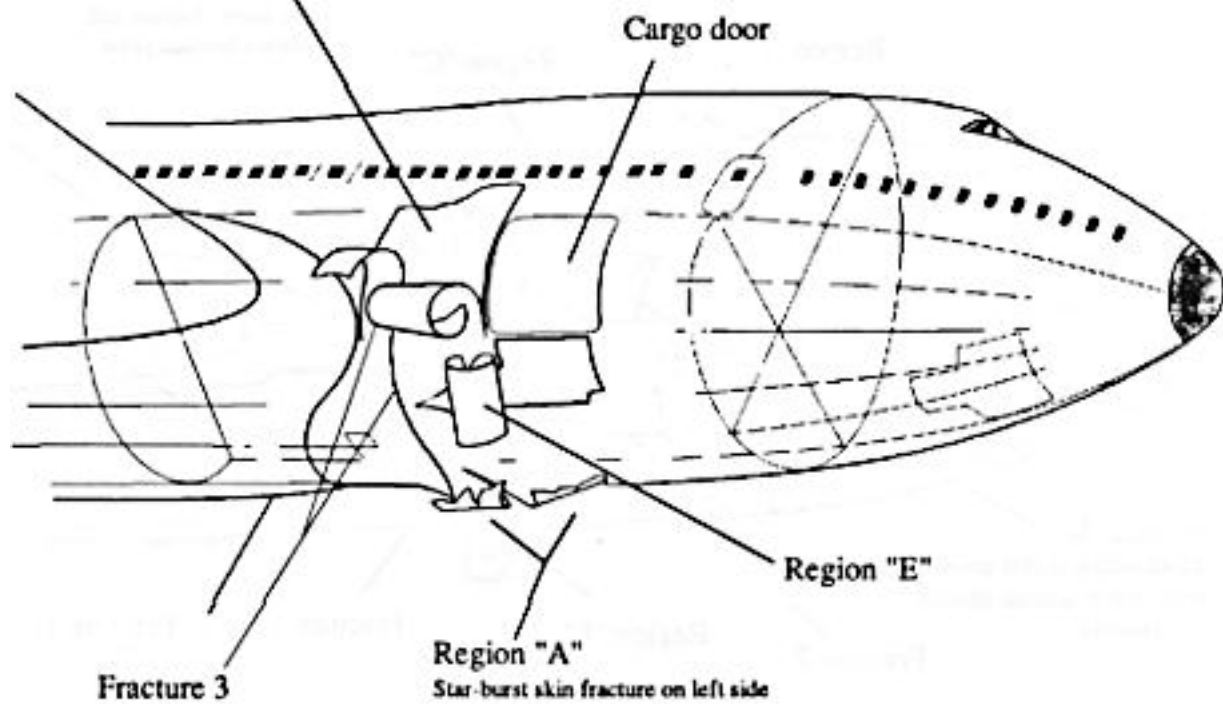
**Figure B-20**

**Explosive Damage - right side**  
(schematic representation)

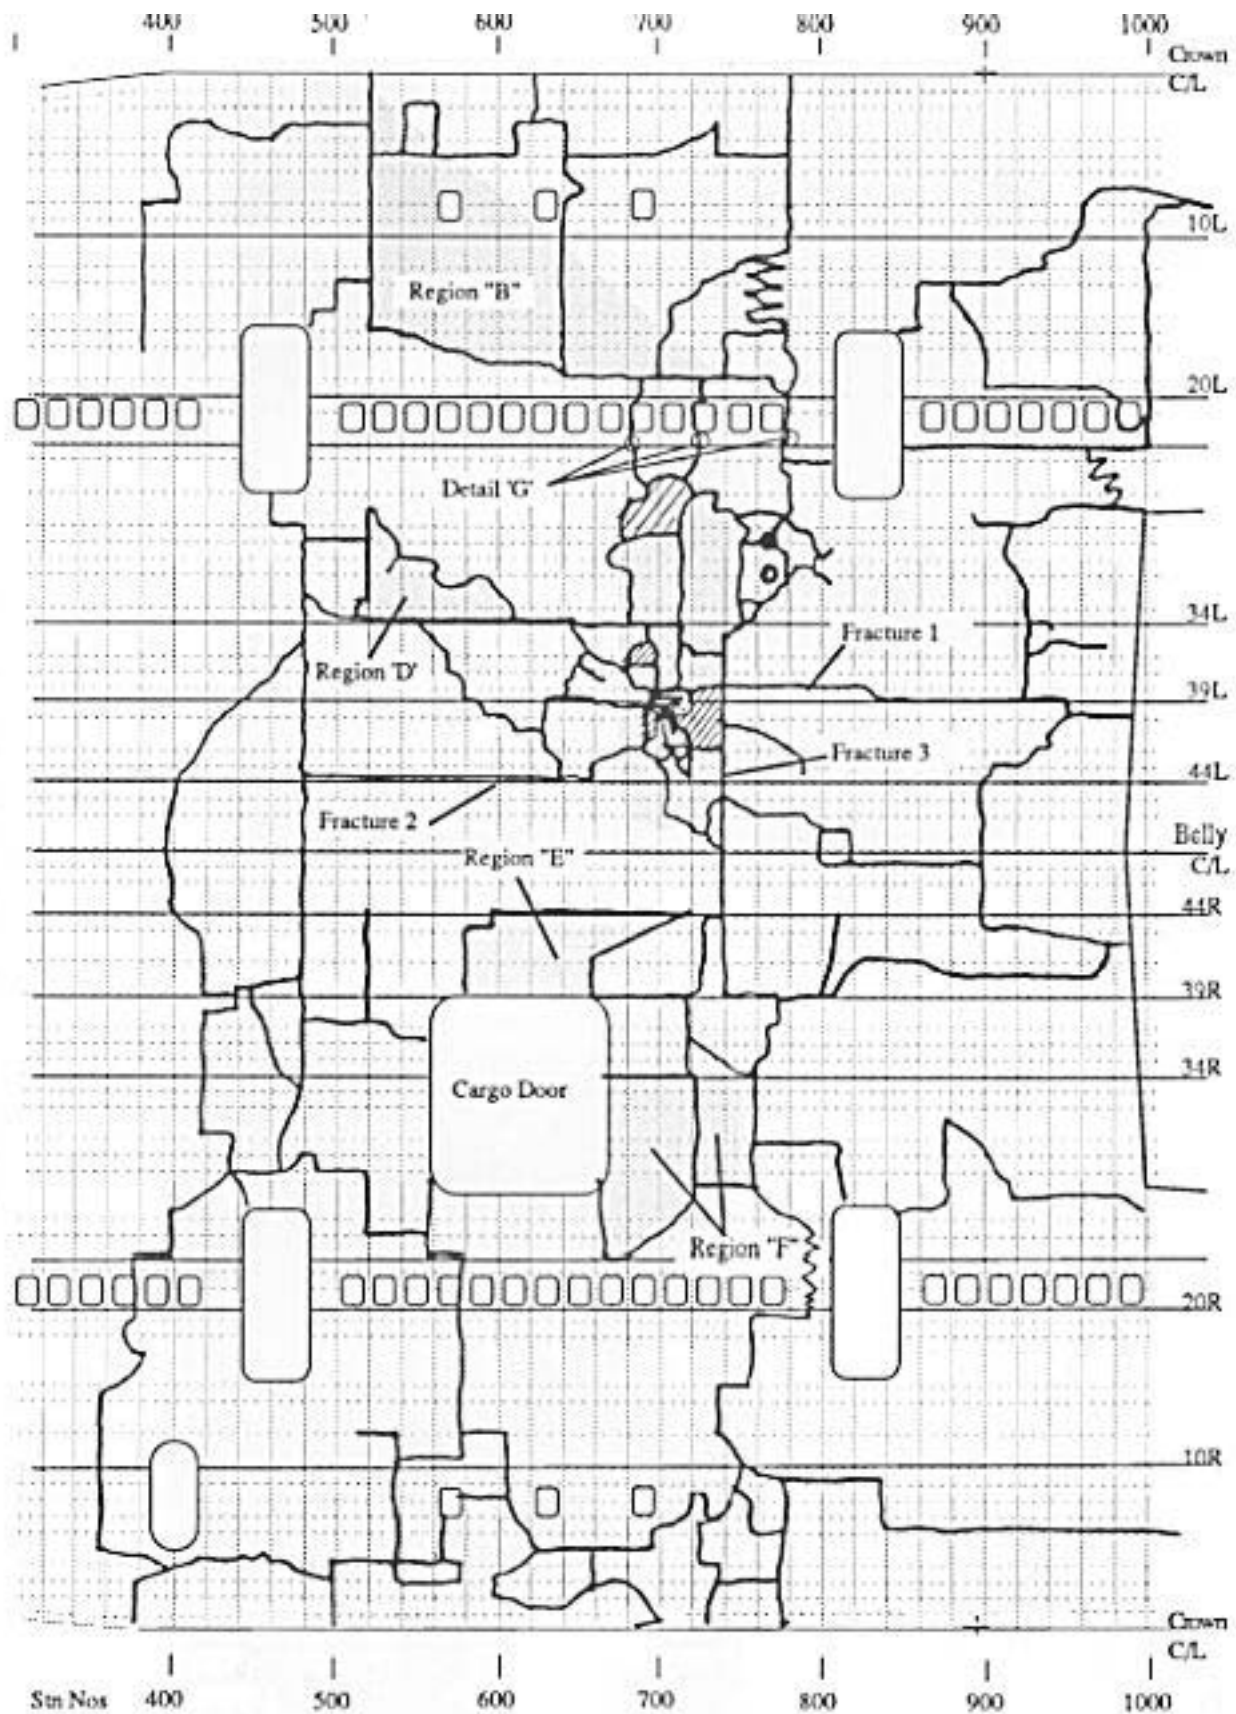
**Figure B-21**

**Skin Fracture Plot**

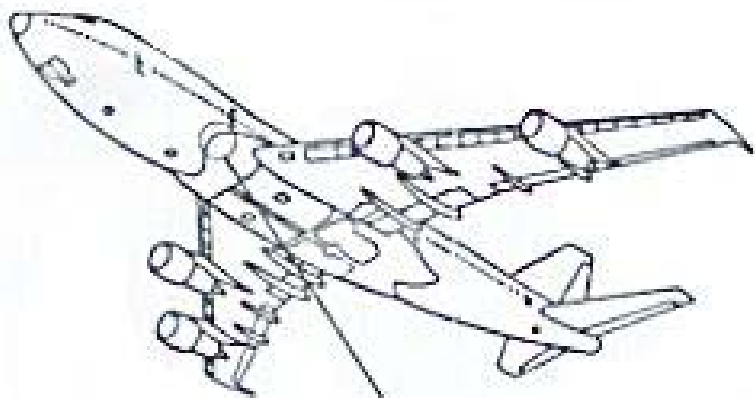
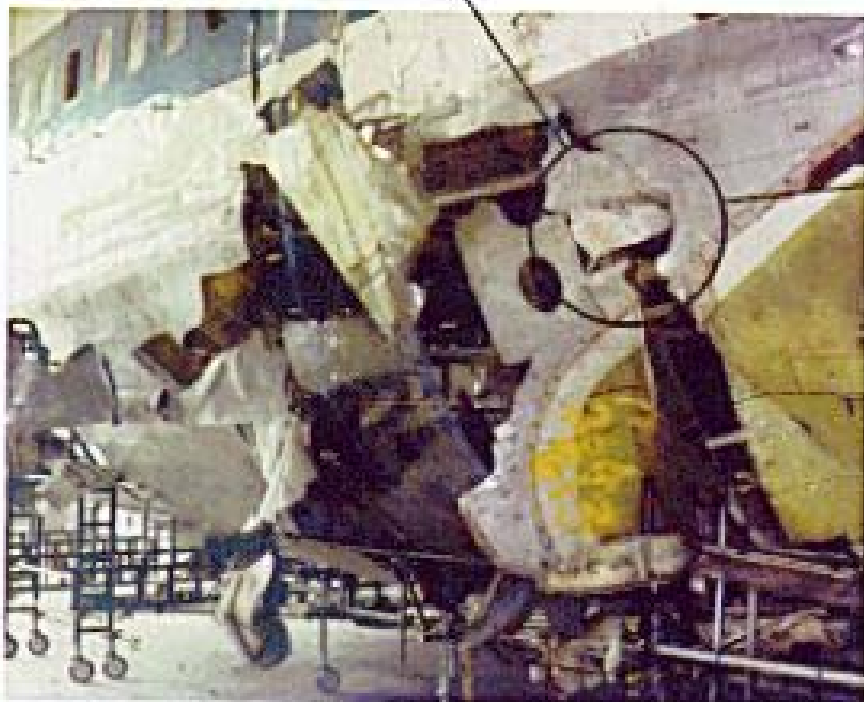
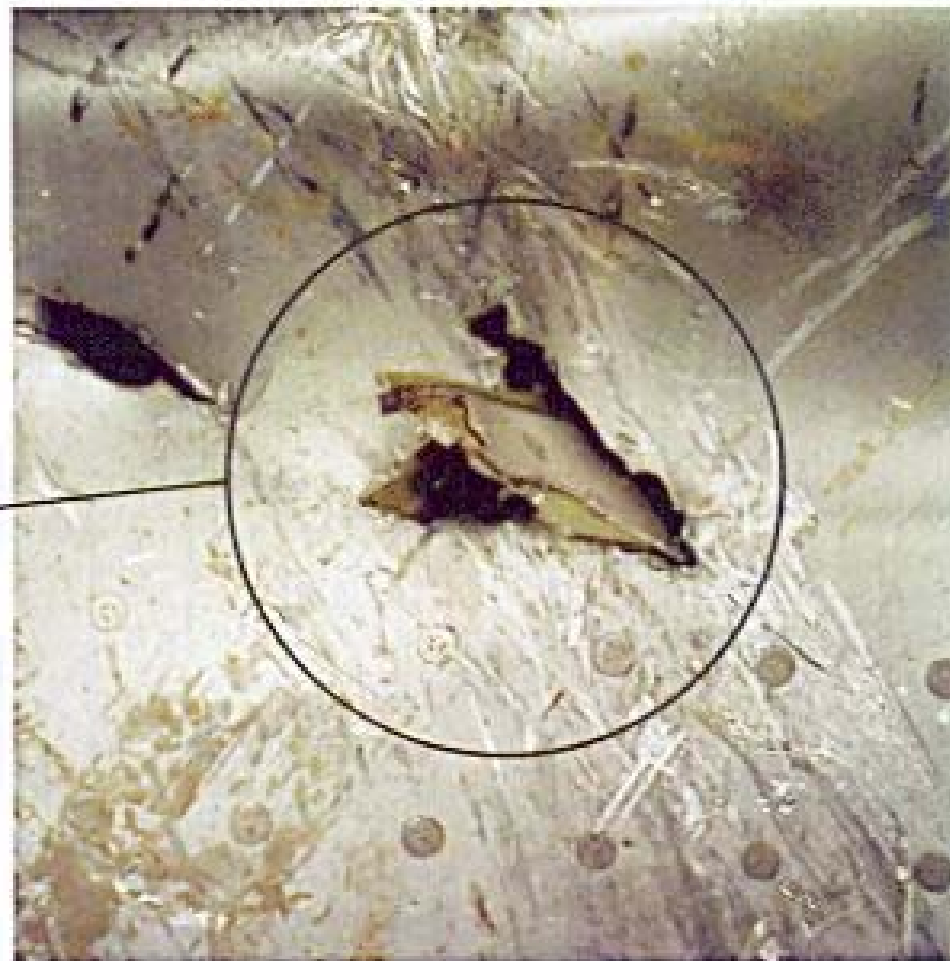
**Figure B-22**

**Spar cap embedded in fuselage**

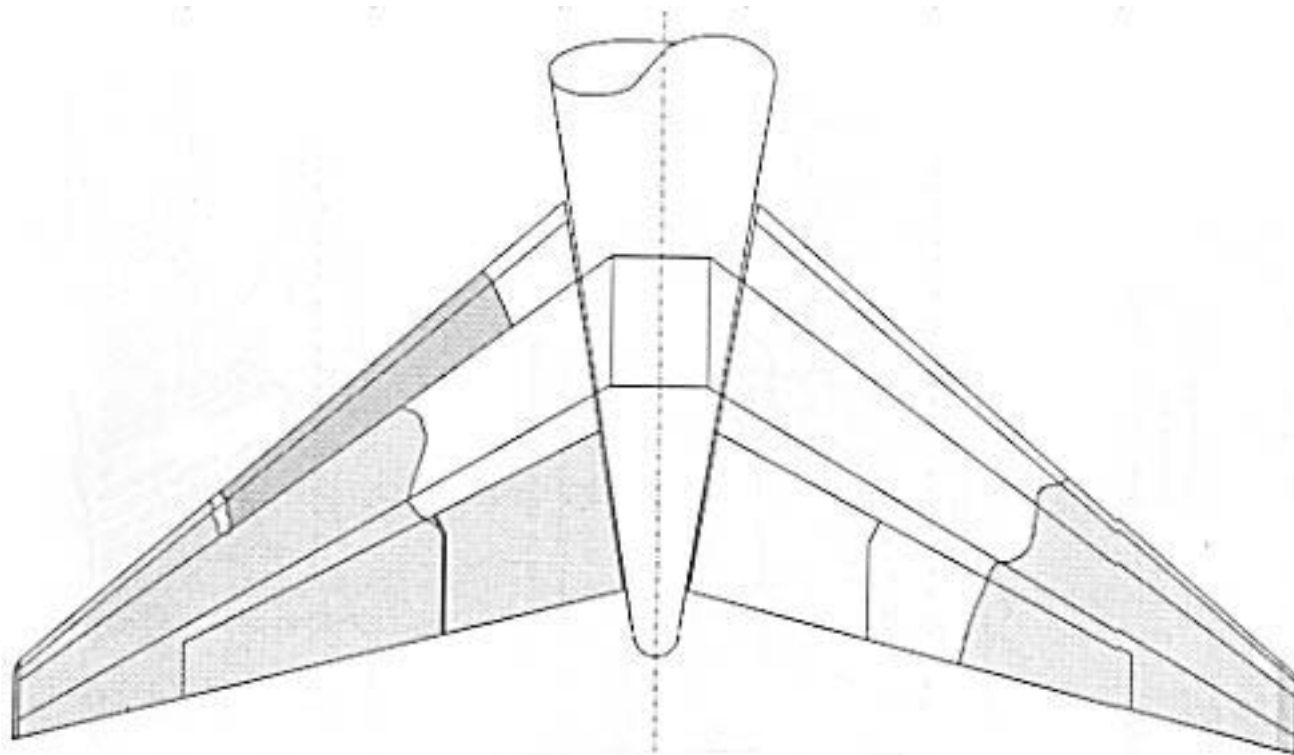
**Figure B-23**

**Initial Damage to Tailplanes**

(shaded areas denote wreckage recovered from southern wreckage trail)

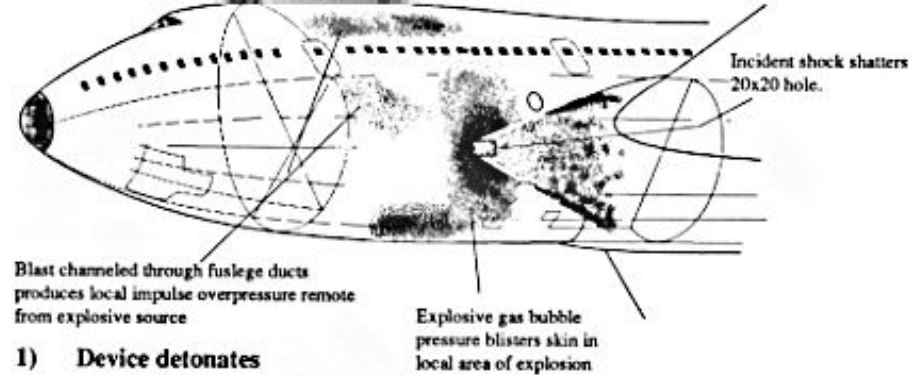
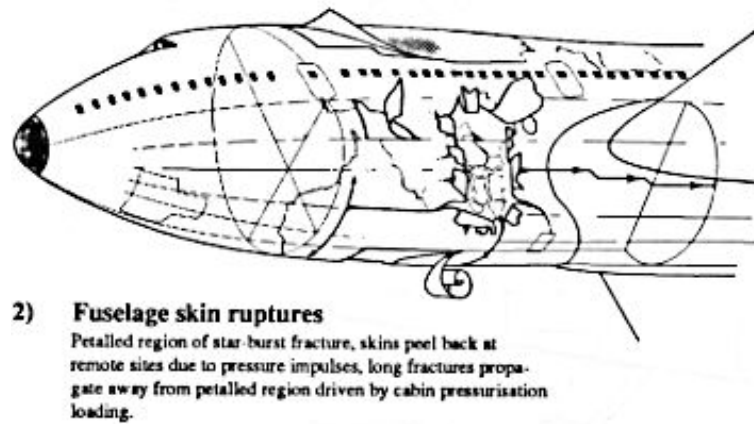
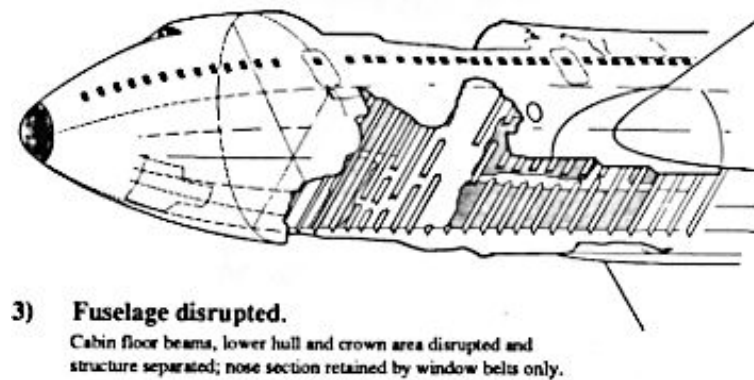
**Figure B-24**

**Fuselage Initial Damage Sequence**  
(schematic representation)

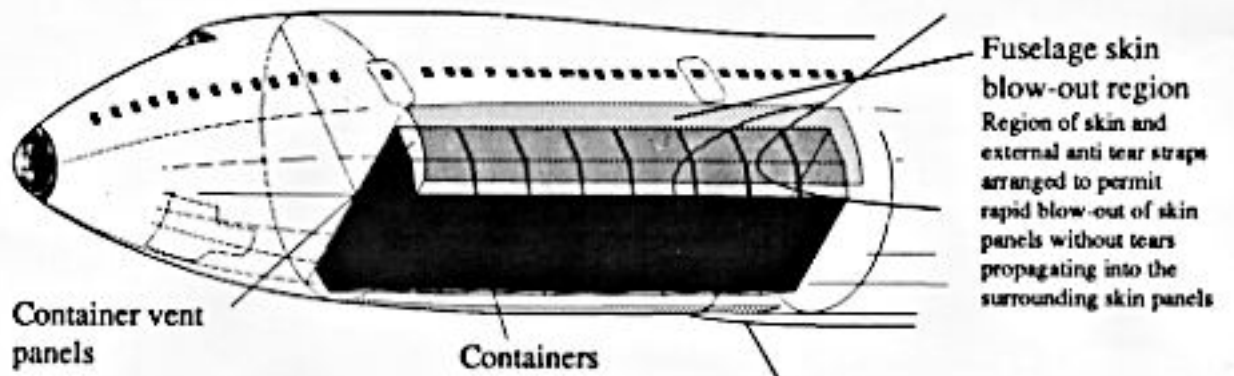
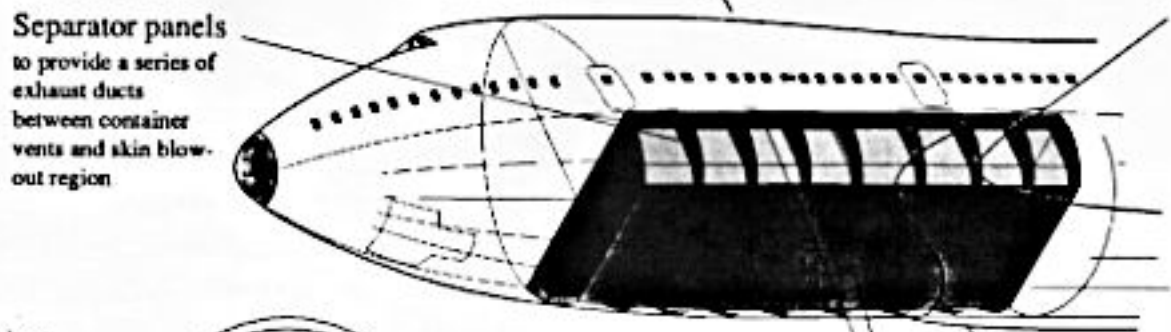
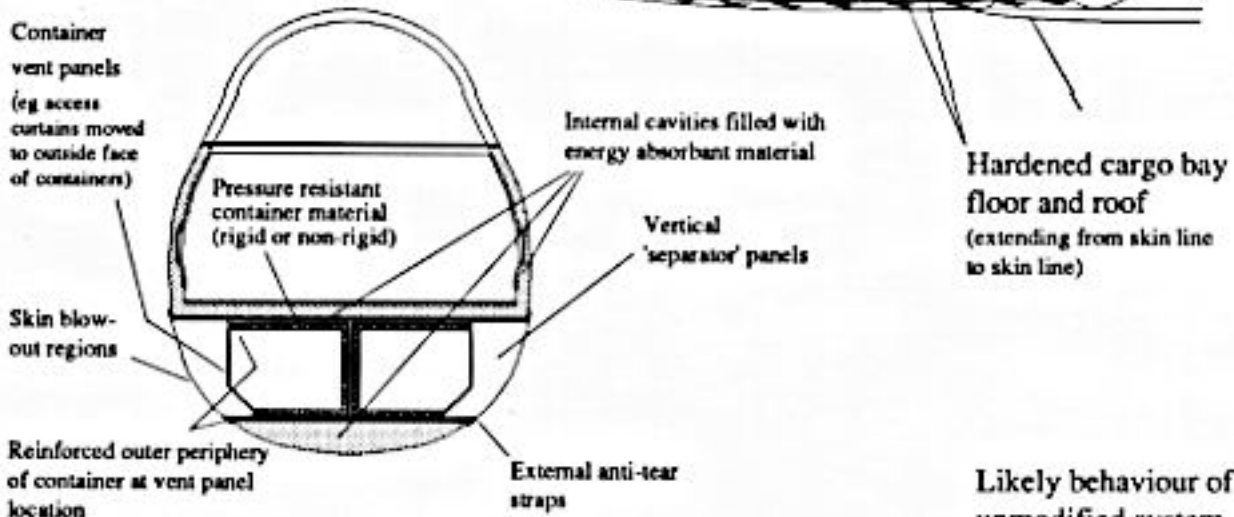
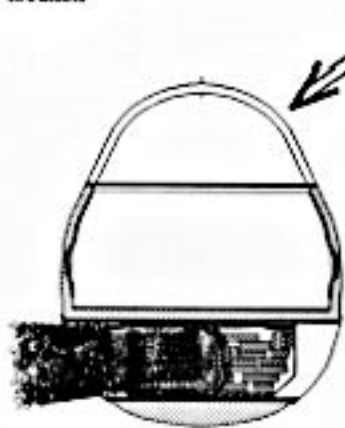
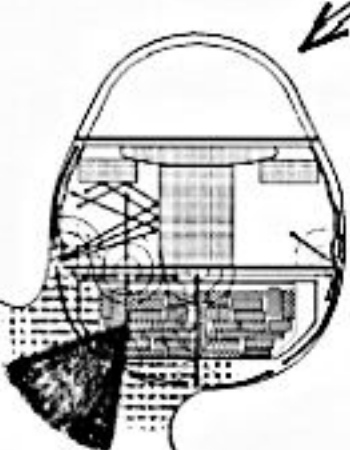
- 1) large, uncontrolled star-burst rupture of fuselage with extended cracking
- 2) ducting of shock and gas overpressure through fuselage cavities
- 3) local enhancements as ducted shocks/gas overpressures re-combine
- 4) re-radiation into cabin as pseudo explosive sources
- 5) reflection off hard surfaces producing local pressure enhancements

provision of lightweight energy absorbing material within the cavities to limit reflection and propagation of pressure waves within the cavities, and radiation of shock waves into the cabin from the conditioning air vents. Materials such as vermiculite, which are of low density yet have excellent explosive energy absorption properties, may have application in this area, perhaps in lieu of the existing insulation material.

**Aim of modified system**

- 1) venting through blow-out panel(s) to dissipate peak overpressure quickly
- 2) controlled size of fuselage aperture with 'clean' boundary and no extended cracks
- 3) minimal ducting through cavities
- 4) energy absorbed by baggage in adjoining containers (non-rigid container)

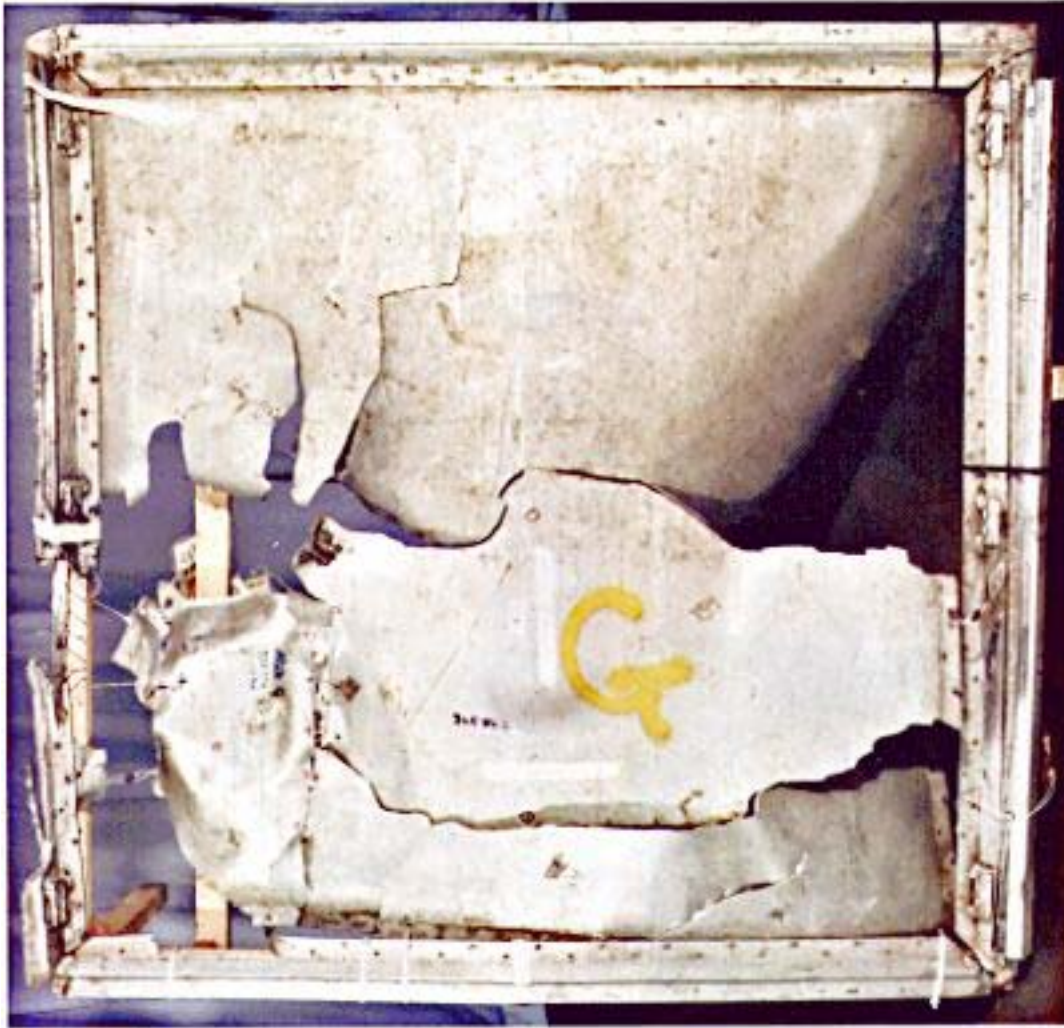
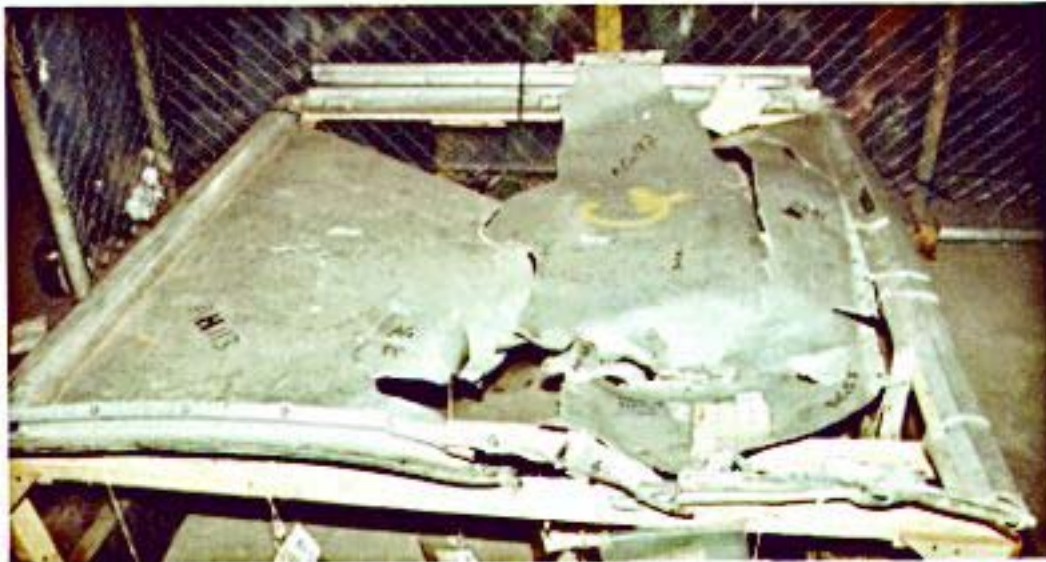
**Figure F-3**

**Detail of Damage to Container Floor**
