## **In-flight explosion, Report on the accident to Boeing 747-121, N739PA at Lockerbie, Dumfriesshire, Scotland on 21 December 1988**

**Micro-summary: A bomb destroyed this Boeing 747-121 in cruise.**

Aircraft Accident Report No 2/90 (EW/C1094)

**Report on the accident to Boeing 747-121, N739PA at Lockerbie, Dumfriesshire, Scotland on 21 December 1988**

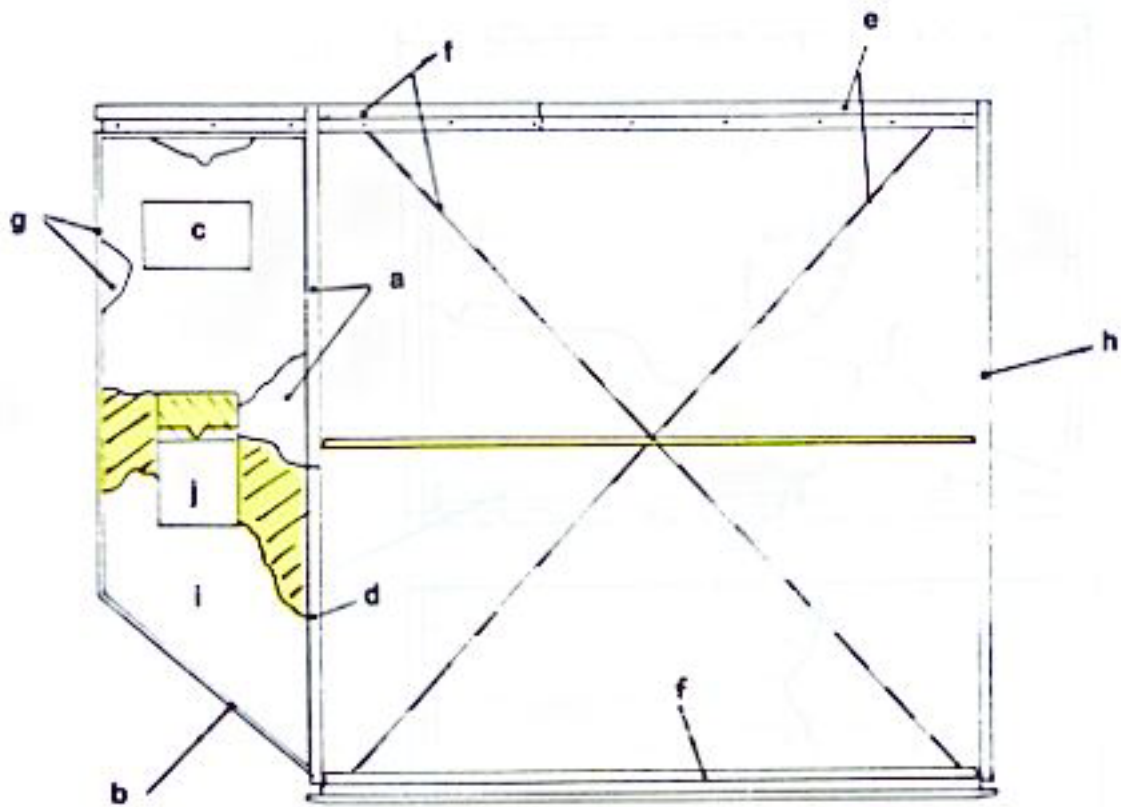
**Figure F-5**

- a Curtain aperture left side vertical edge member, upper half
- b Sloping face edge member
- c Container manufacturer's data plate containing burnt piece of material which itself contained a fragment of circuit board
- d Curtain aperture left side vertical edge member, lower half
- e Upper edge member, right half, attached to roof edge member and one curtain bar
- f Upper edge member, left half, attached to roof edge member, cutrain wire and lower curtain bar
- g Left edge vertical member
- h Curtain aperture right side vertical member
- i Left side lower skin section adjoining sloping face
- j Soot stained plastic sheet

**Aft face of container AVE 4041 PA, view looking forward**

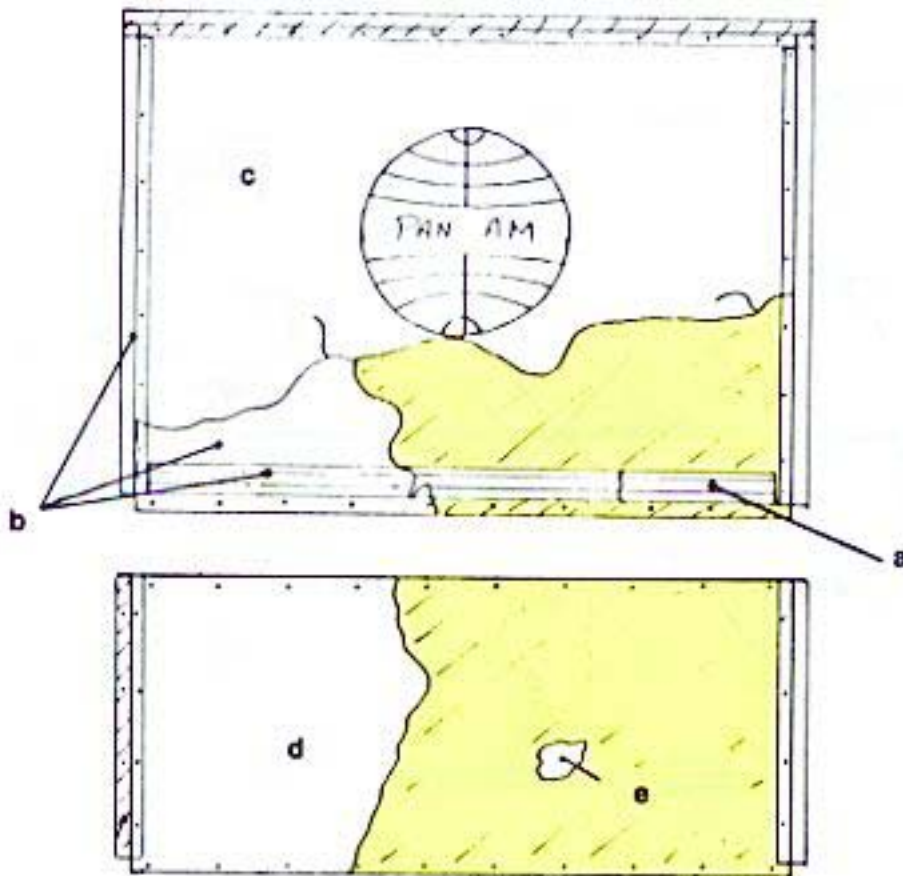
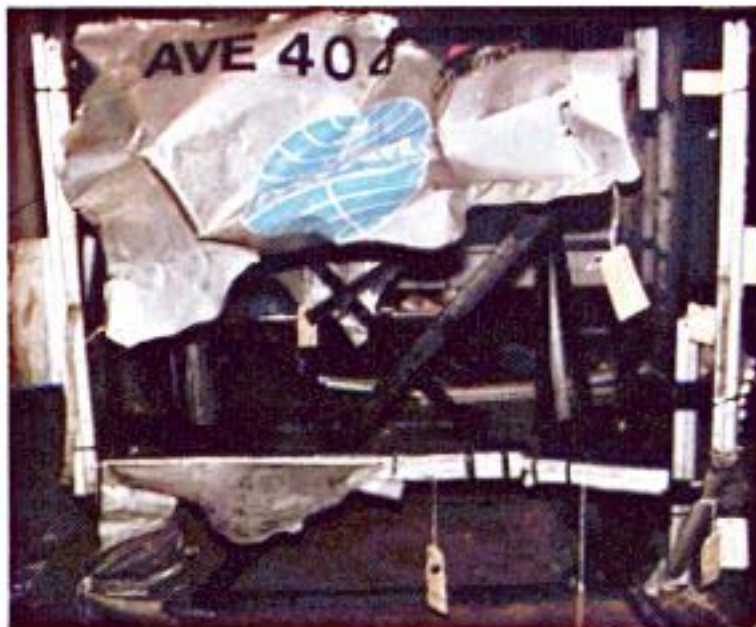
**Figure F-6**

- a** Stiffener section from base of vertical face
- b** Vertical face forward edge member, lower stiffener section and skin fragment
- c** Distorted upper section of vertical face skin
- d** Forward section of sloping face skin, severely distorted
- e** Fragment of container skin, provisionally thought to be part of sloping face skin.

**Outboard faces of AVE 4041**

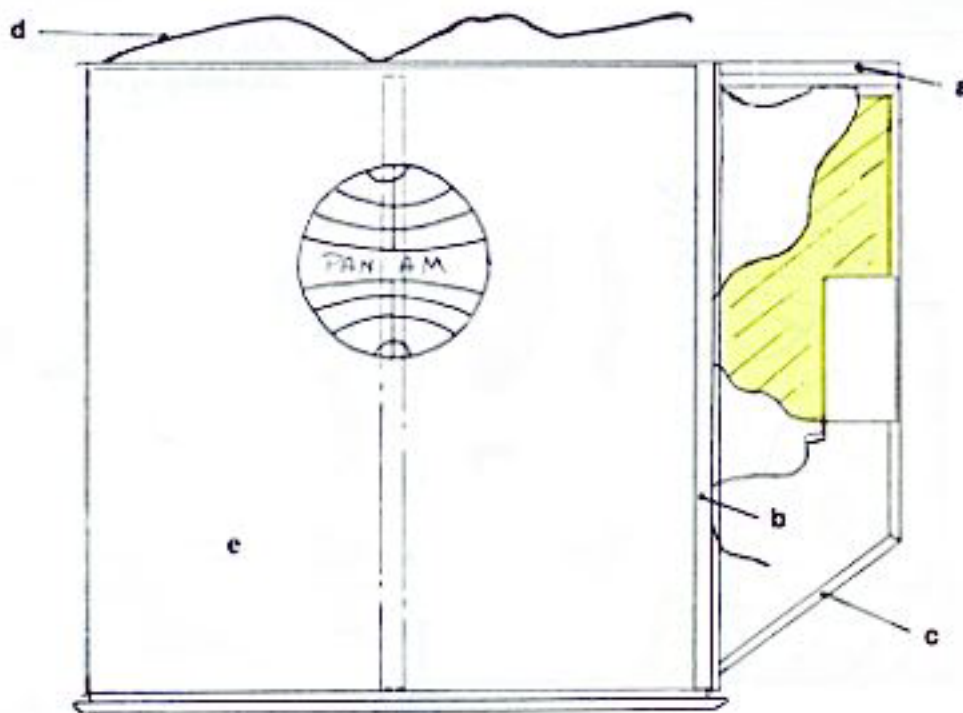
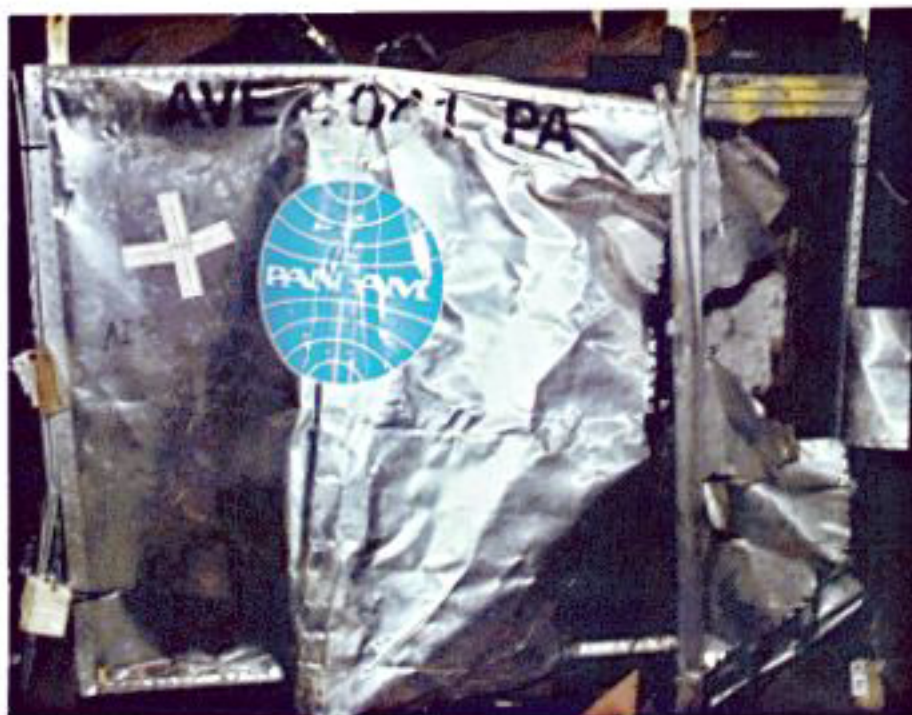
- b Forward face outboard skin, attached to vertical edge member
- c Forward edge member of sloping face
- d Roof skin panel, complete except for aft outboard corner
- e Forward face panel, complete with top, left and lower edge members

Forward face of AVE 4041 PA  
Figure F-7

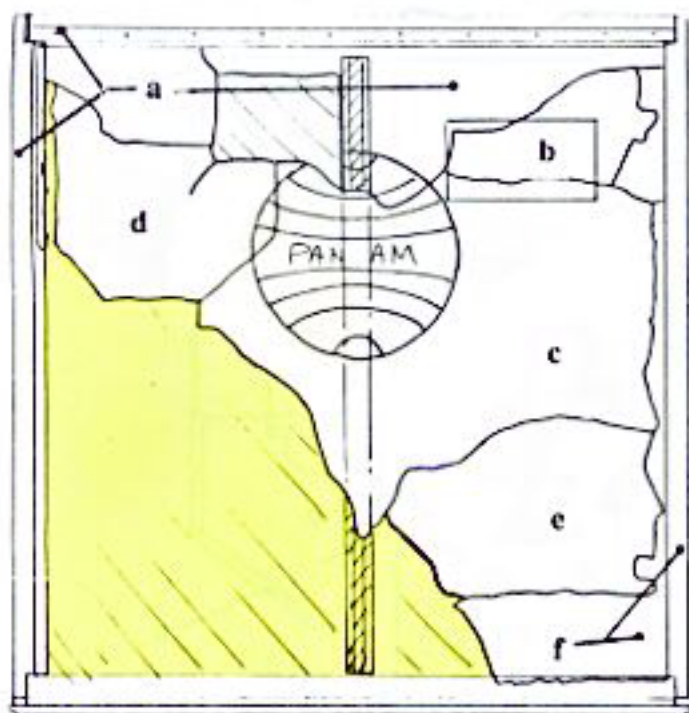
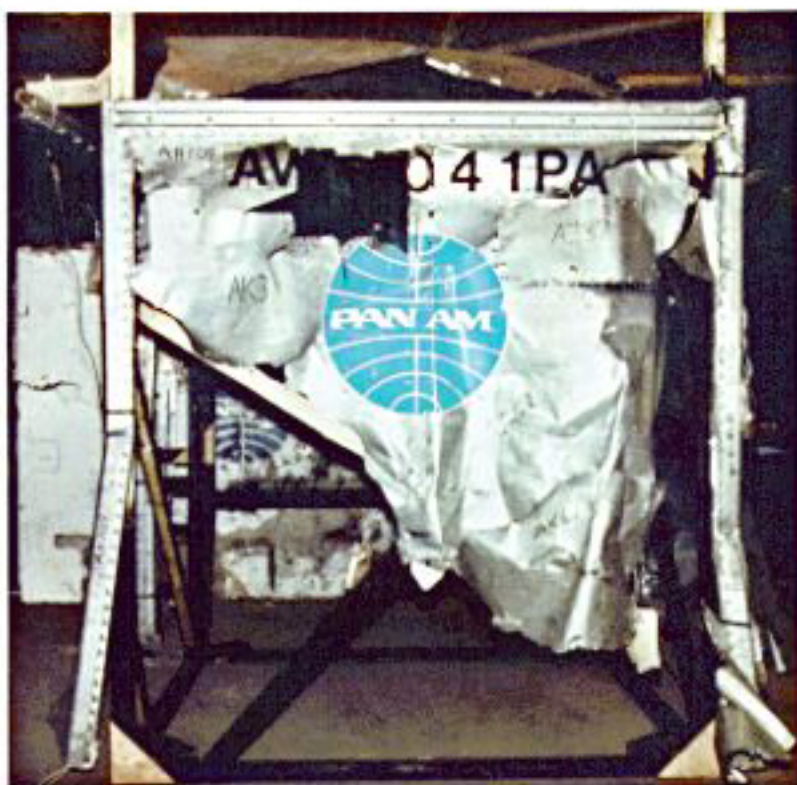
**Figure F-8**

- a Aft, top and roof edge members including upper section of skin
- b Repair patch from upper right side
- c Mid section of skin including stiffener section
- d Upper skin section
- e Lower skin section
- f Right side vertical edge member attached to lower piece of skin

**Inboard face of container AVE 4041 PA**

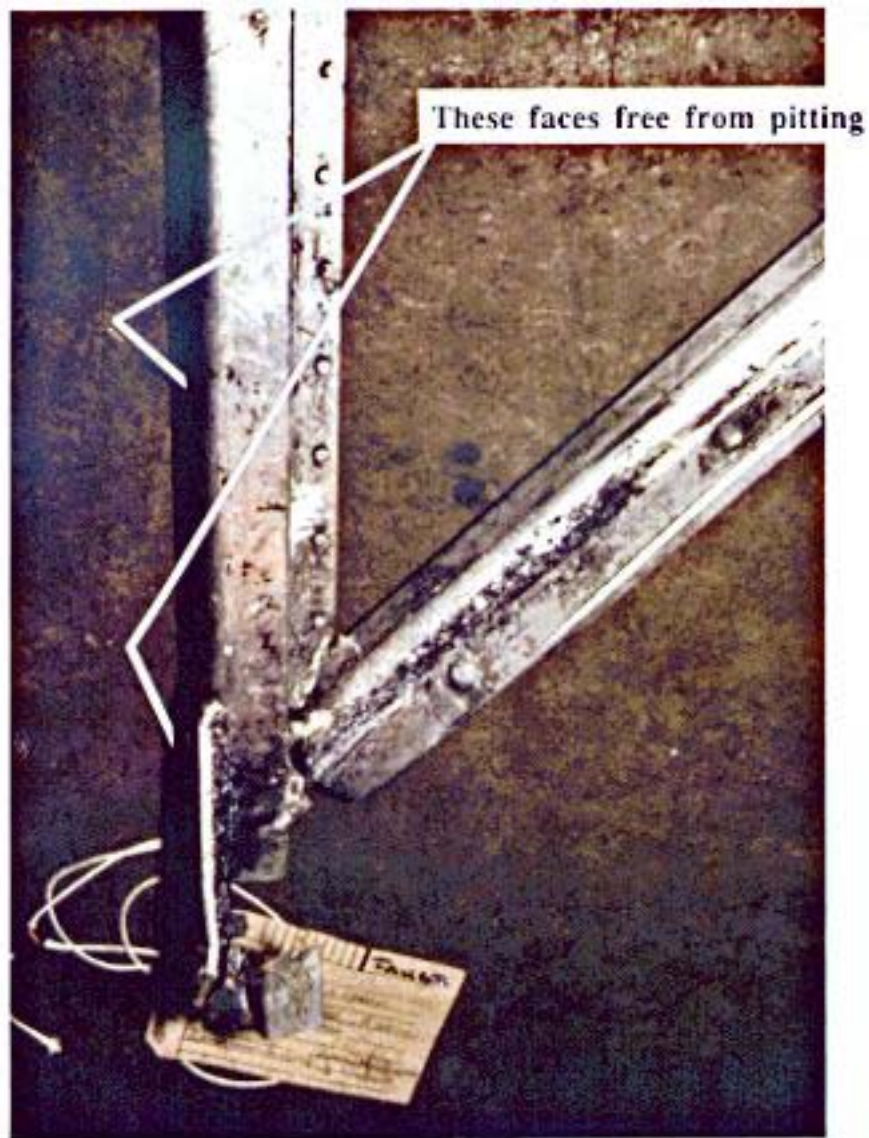
**Figure F-9**

**Detail of items from aft face of container  
AVE 4041 PA showing evidence of blast  
damage**

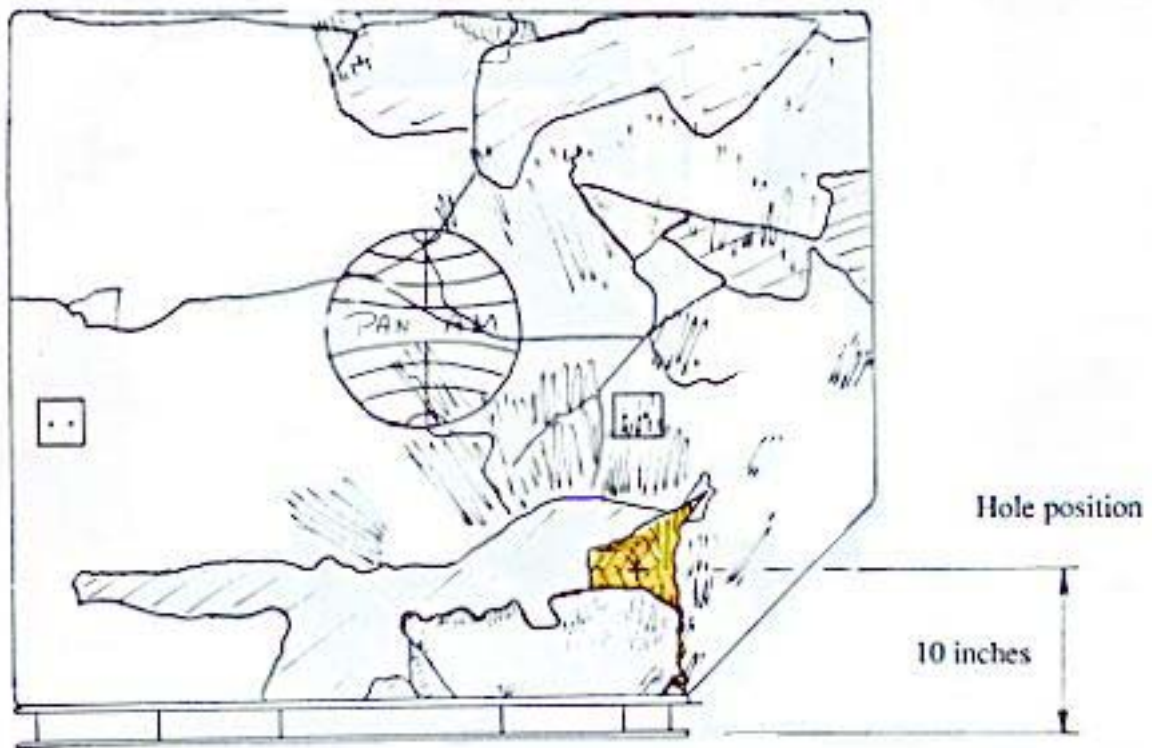
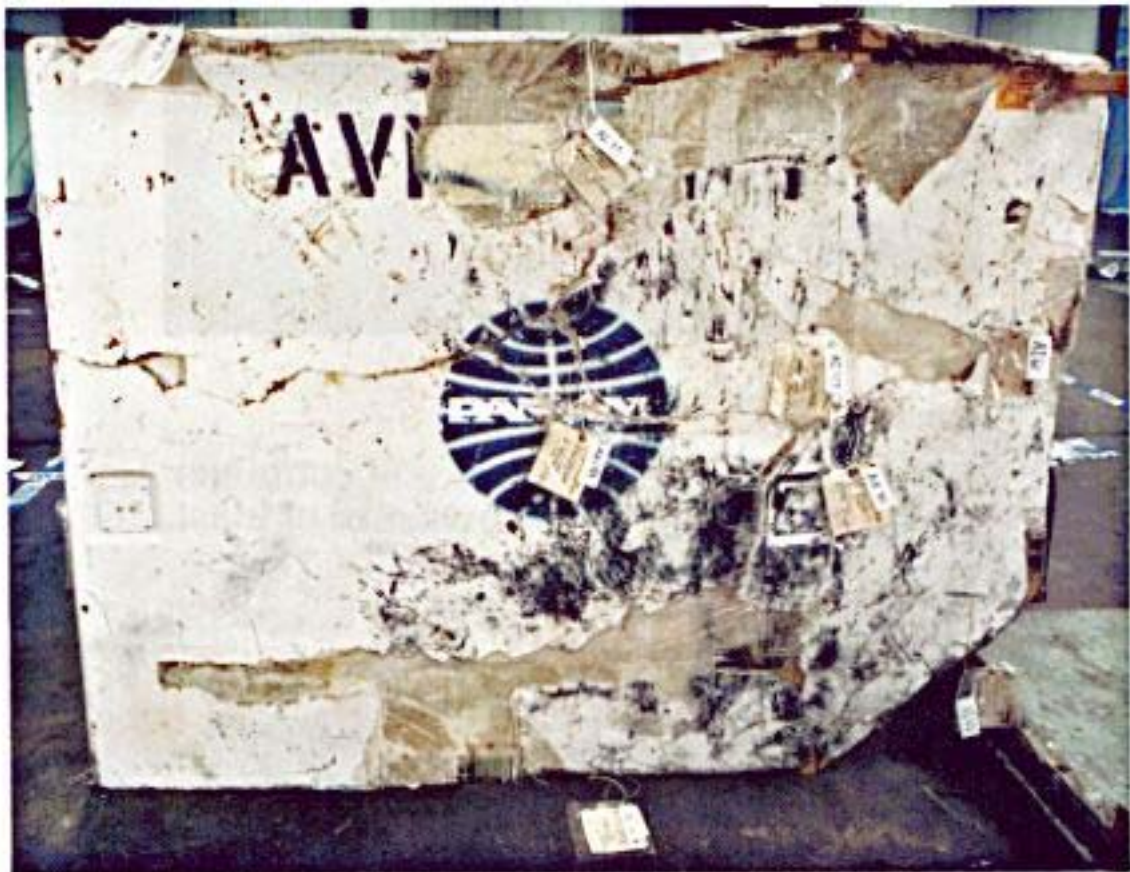
**Figure F-10**

Blast damage to the forward face of container 7511 was as a direct result of hot gases/fragments escaping from the aft face of container 4041. No evidence was seen to suggest that more than one IED had detonated on Flight PA103.

**Forward face of container AVN 7511 PA,  
view looking aft**

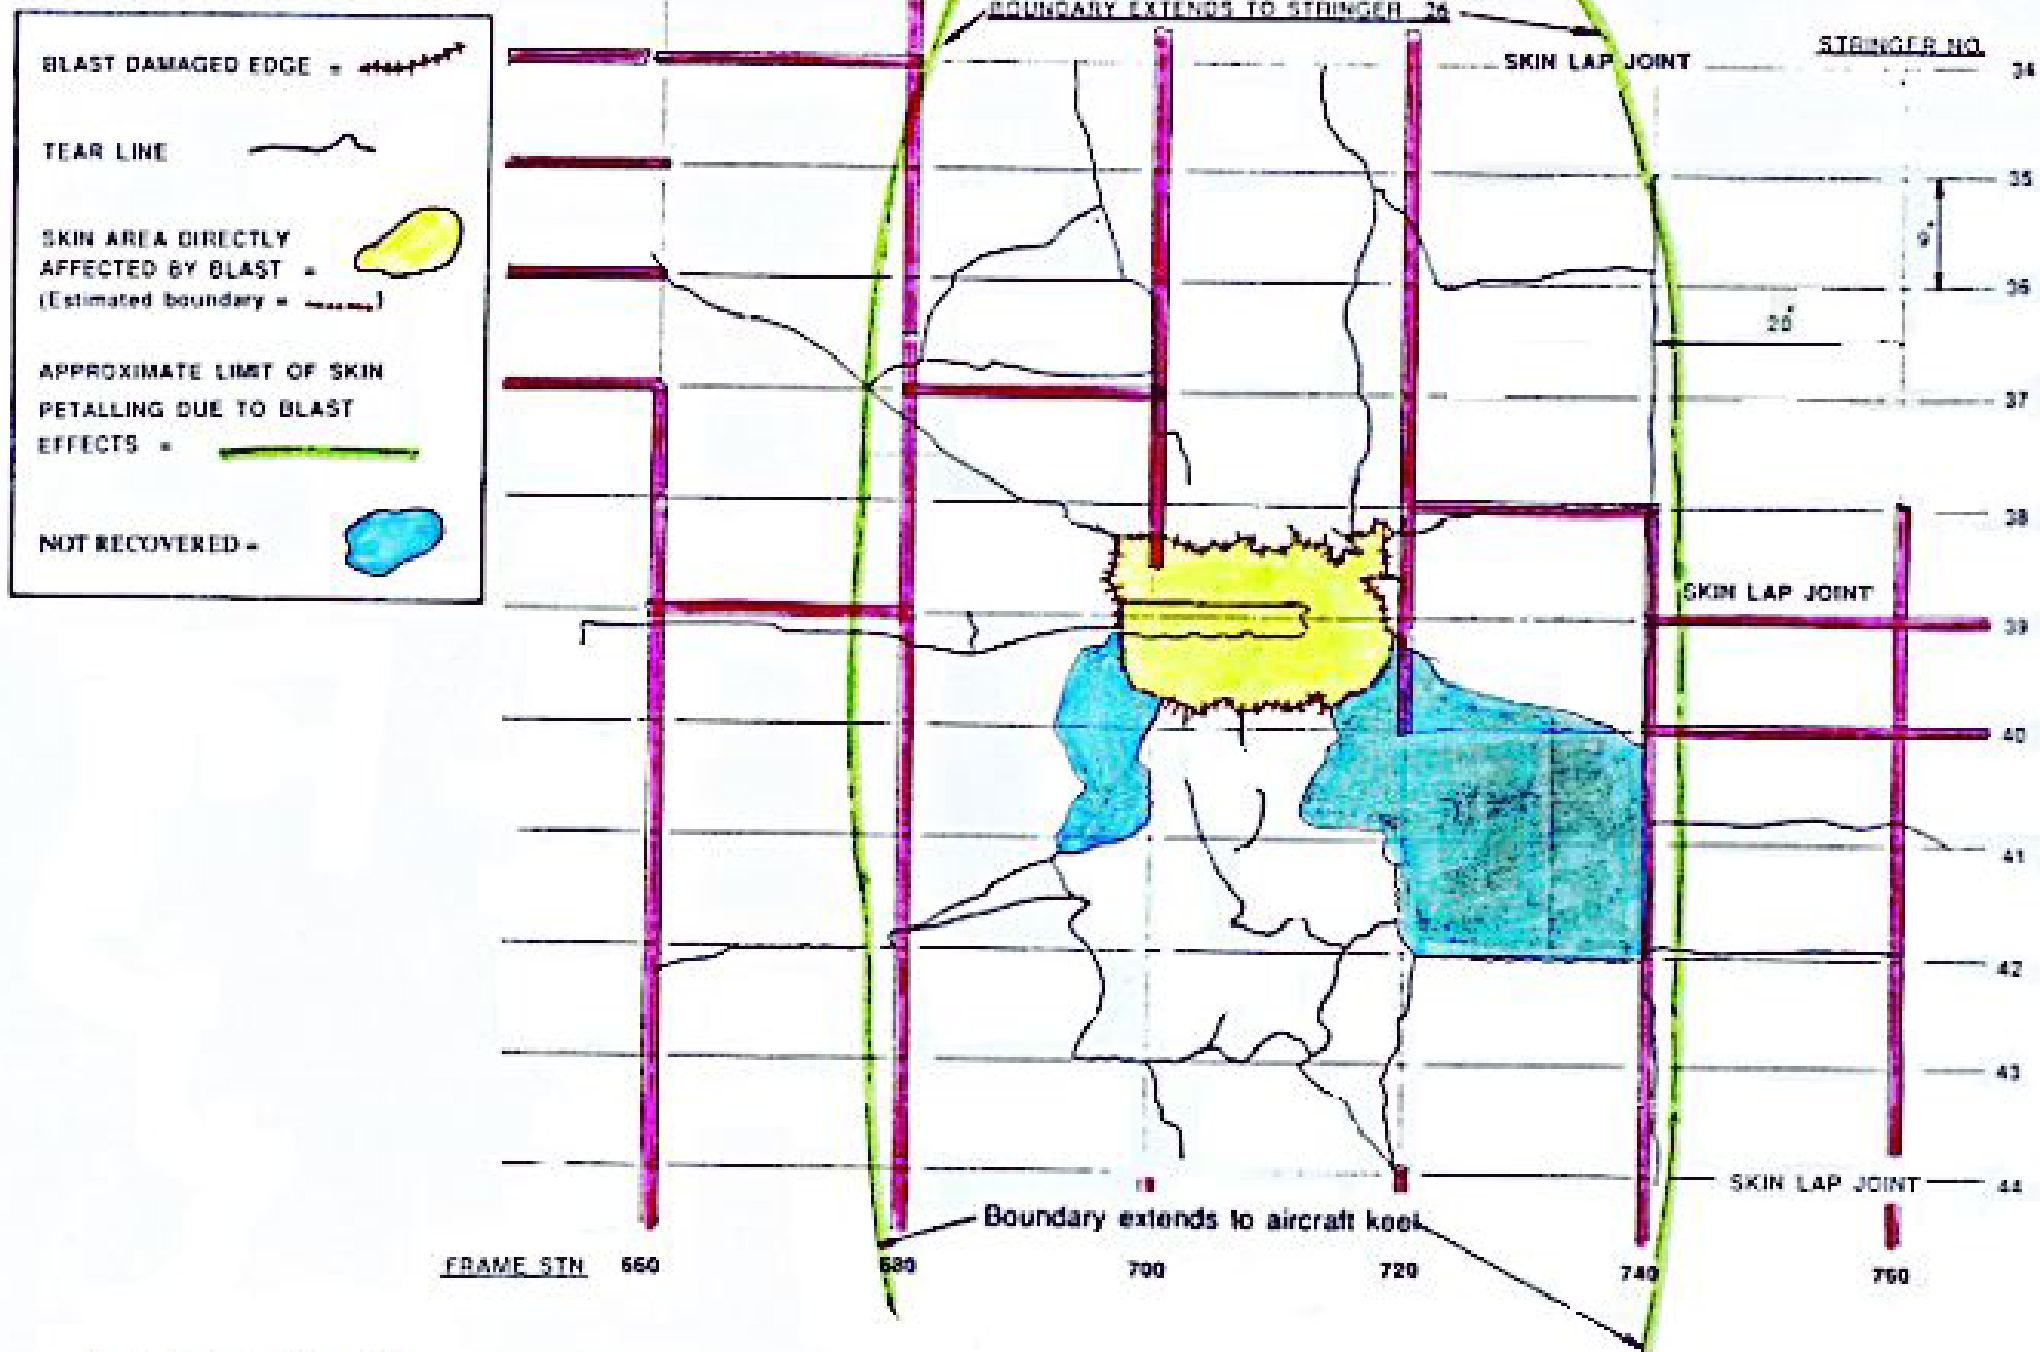
**Figure F-12**

**N739PA Skin Structure Damage Diagram**
