Explosive decompression on climb, Report on the accident to BAC One-Eleven, G-BJRT over Didcot, Oxfordshire on 10 June 1990

Aircraft Accident Report No. 1/92 - (EW/C1165)

**Report on the accident to BAC One-Eleven, G-BJRT over Didcot, Oxfordshire
on 10 June 1990**

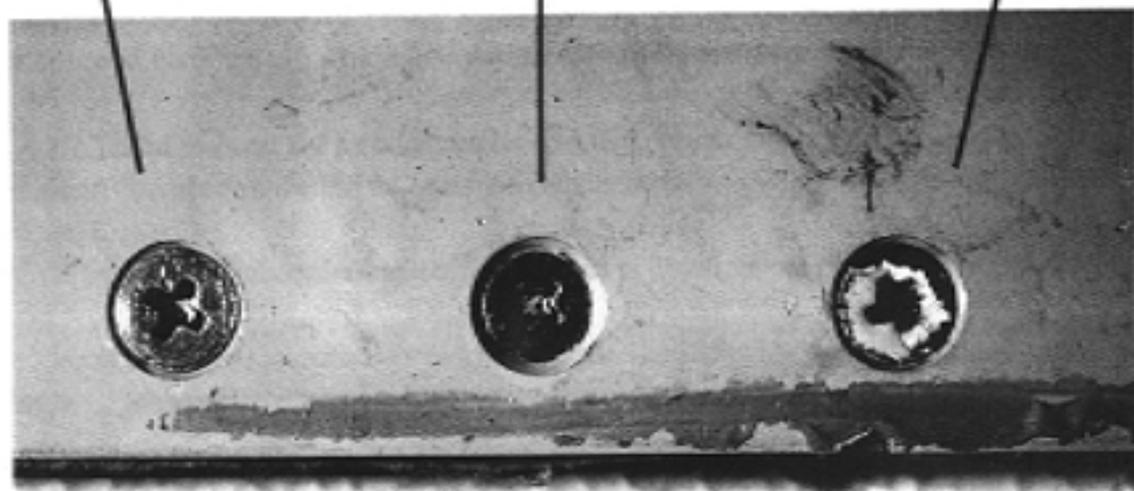
The window was finished in primer and had countersunk holes for the bolts; an A211-8C bolt head sits significantly further below the surface of the window, down in the countersink, than does an A211-8D bolt head, leaving an annulus of unfilled countersink which is easily discernible when viewed under good conditions. This excessive annulus of unfilled countersink was not seen.

New 8 UNC

Old 10 UNF

Comparison of bolt heads in countersinks
(shown approximately 1.9 life-size)
