**Air Accidents Investigation Branch**

**Report on the incident to  
Airbus A320-212, G-KMAM  
London Gatwick Airport  
on 26 August 1993**

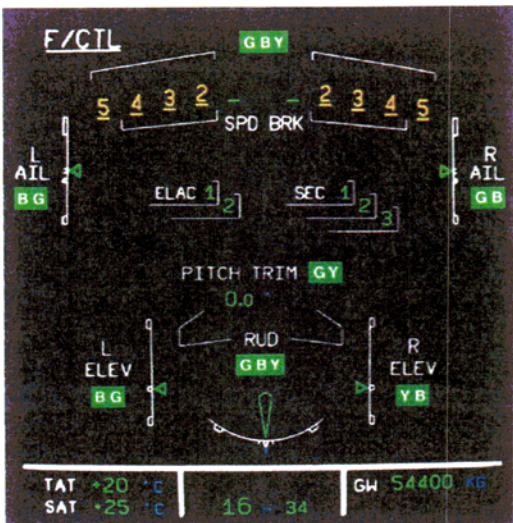
SPOILER DEMAND  
NO SPOILER DEPLOYMENT

If an error condition persists for three seconds the spoiler indications change to amber. The corresponding spoilers on the other wing are closed and isolated, and are also shown in amber.
