Report on the accident to Aerospatiale AS332L Super Puma, G-TIGK, in North Sea 6 nm South West of Brae Alpha Oil Production Platform on 19 January 1995

Event Date: 1995-01-19 at 1240

Investigative Body: Aircraft Accident Investigation Board (AAIB), Great Britain

Aircraft Accident Report No: 2/97 (EW/C95/1/1)

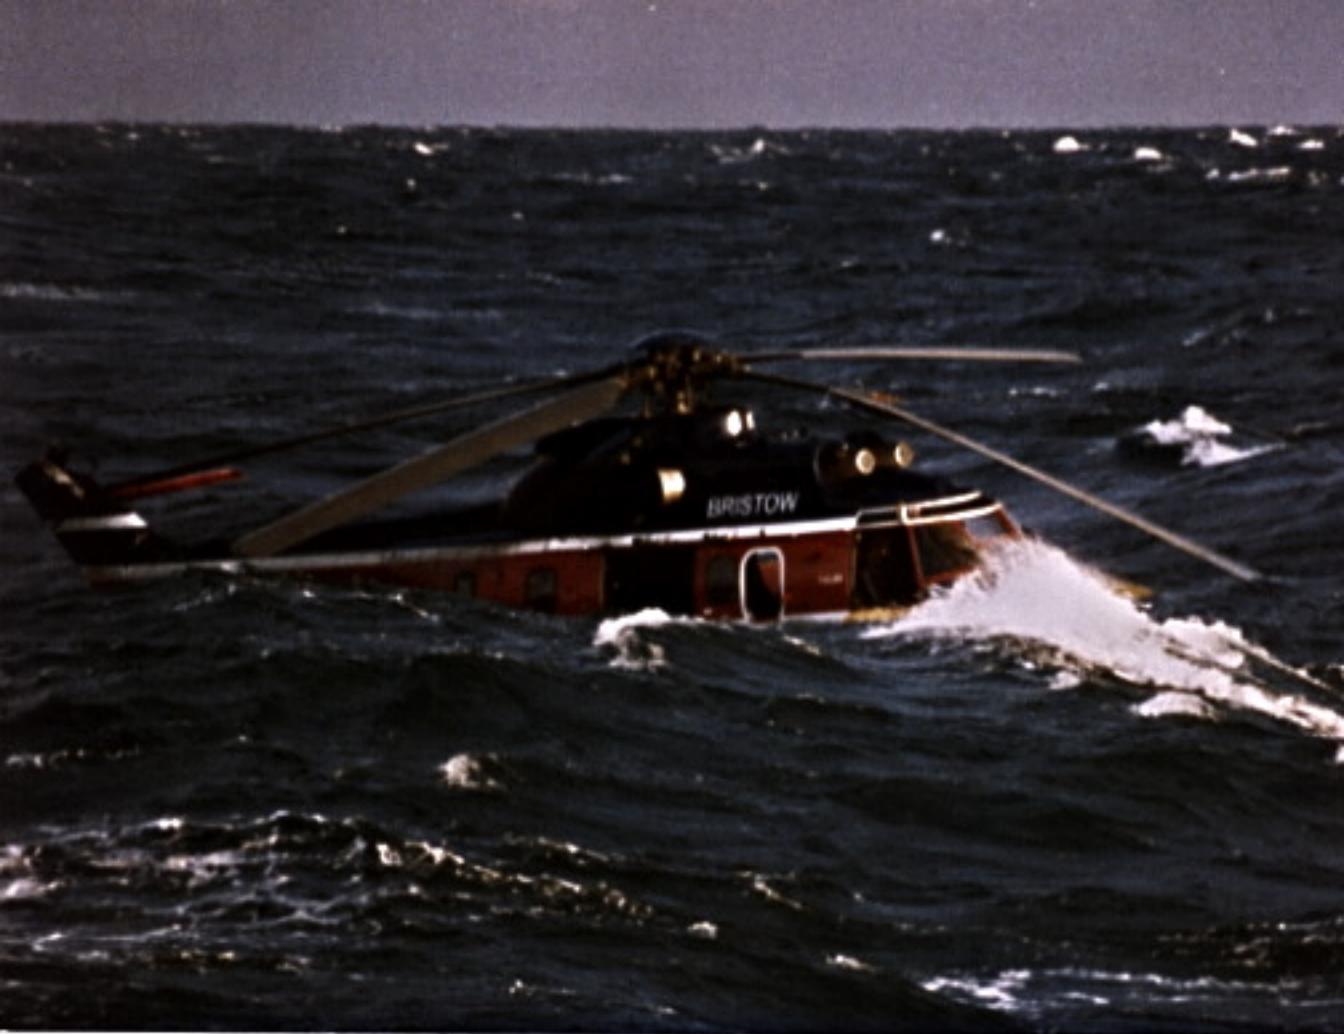
Showing G-TIGK drifting in heavy seas after ditching and evacuation of occupants, with tail rotor/gearbox missing and damaged main rotor blade.

Photographs and videos were examined immediately following the accident and these showed the helicopter floating after the ditching, with the aid of its flotation bags, but without its tail rotor or tail rotor gearbox. All four main rotor blades were visible, although one blade appeared to have been damaged by bending loads.

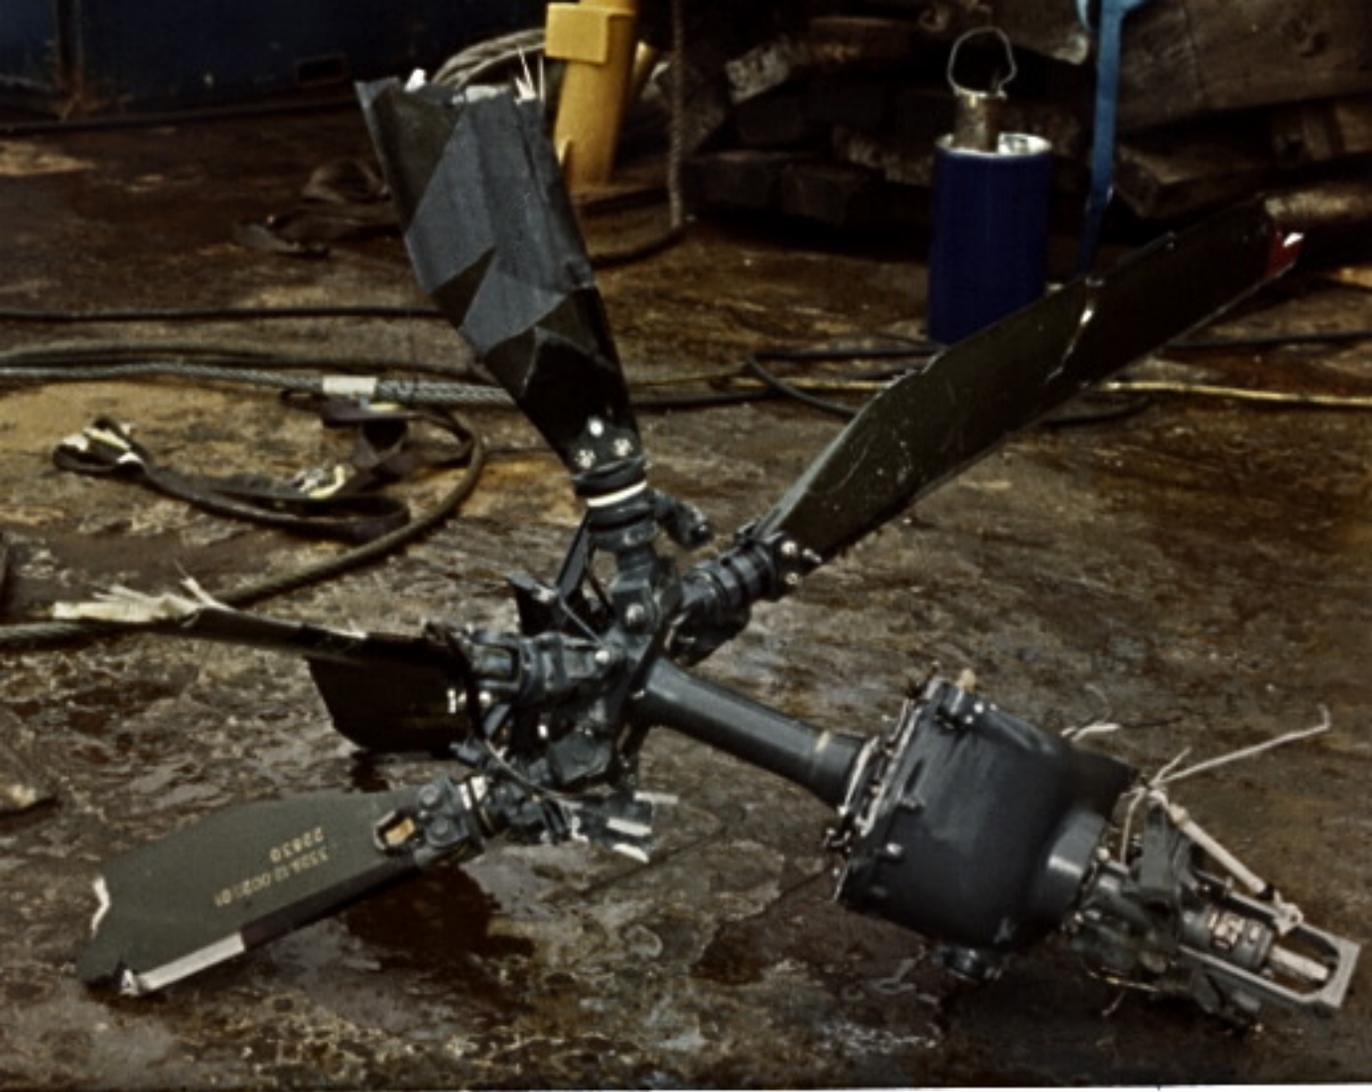
Both the main wreckage and the tail rotor/tail rotor gearbox assembly were successfully recovered, under AAIB supervision, on the 23 and 24 January respectively. Appendix A, Figure 4A shows the damaged tail rotor and gearbox after recovery. The separated 5.94 metre section of the outboard 'Black' main rotor blade (s/n 269) was also recovered from the sea bed. The majority of the outboard lengths of the 'Blue' (s/n 499), 'Yellow' (s/n 517) and 'Red' (s/n 939) main rotor blades were not recovered, but some 2.9 metres, 2.8 metres and 1.9 metres respectively of their roots were salvaged. After initial examination aboard the deck of the salvage vessel, which showed clear evidence of lightning strikes on two main rotor blades and one tail rotor blade (see Appendix A, Figure 4B), the recovered wreckage was transported to the AAIB facility at Farnborough for detailed examination. Subsequently, one of the missing outboard sections of a main rotor blade was found on a beach in Norway and was returned to the operator and thence to the AAIB. It was identified as the missing 5.49 metres long section of the 'Red' main rotor blade.

Figure 4A: Showing recovered tail rotor, gearbox and pitch servo assembly, with 'White' blade root section uppermost.

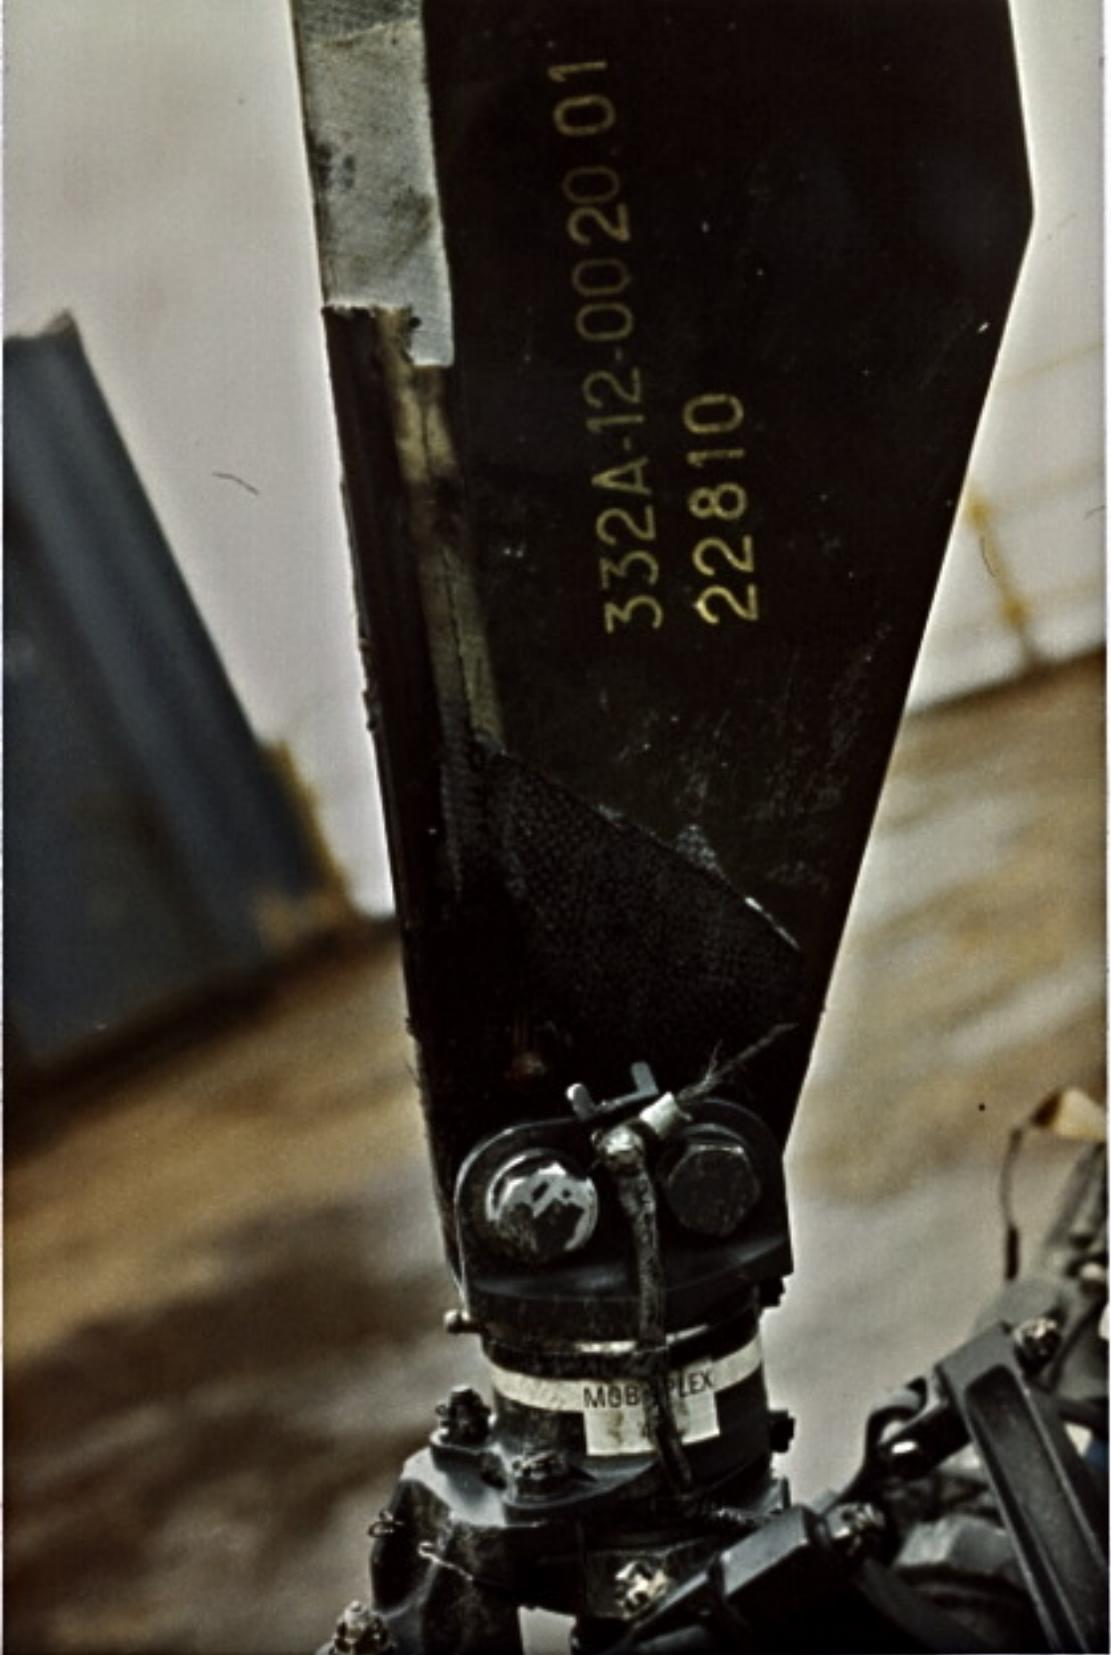
- (3) The White tail rotor blade root section (Appendix A, Figures 4A, B, 10 and 11), which had suffered marked delamination of its composite skins and associated thermal damage of its root areas, together with loss of its anti-erosion shield, brass conducting strip and failure of the braided bonding strap and its attachment lug to the blade bolt (see also section 1.12.4.2).

Figure 4B: Showing outboard side of 'White' tail rotor blade root with leading edge erosion shield and brass strip missing, and failed braided bonding strap.

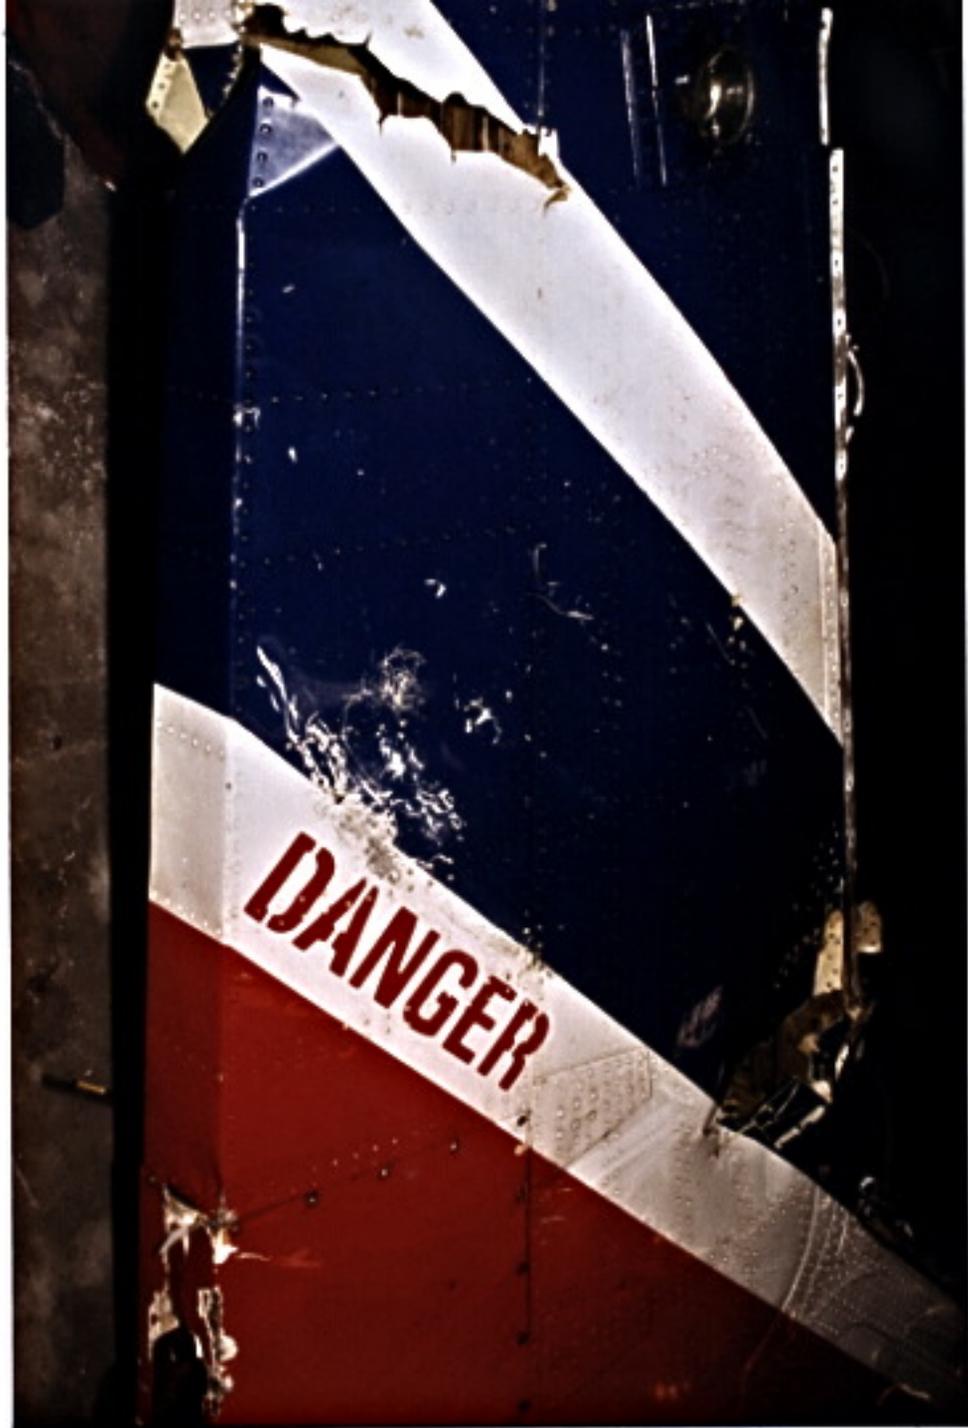
Examination of the aircraft tail boom pylon revealed evidence of a number of tail rotor blade impacts on the rear face and on the right side (Appendix A, Figure 5). The tail rotor gearbox had suffered failure of its two lower attachment lugs (Appendix A, Figure 6) and the bolt at the upper attachment position had also failed. Four of the five tail rotor blades were fractured at approximately 40% span; the outboard sections were not recovered. The fifth tail rotor blade was extensively damaged, but the whole span remained. With the exception of the 'White' tail rotor blade, all tail rotor blade damage appeared to be consistent with the effect of the blades striking the pylon after the gearbox had separated. The gearbox had been retained finally by 2 of the 4 stainless steel hydraulic lines, which served the tail rotor pitch control servo, before they severed after the ditching (Appendix A, Figure 7).

Figure 5: Showing deep gash in trailing edge of tail boom pylon and tail rotor blade impact damage on right side.

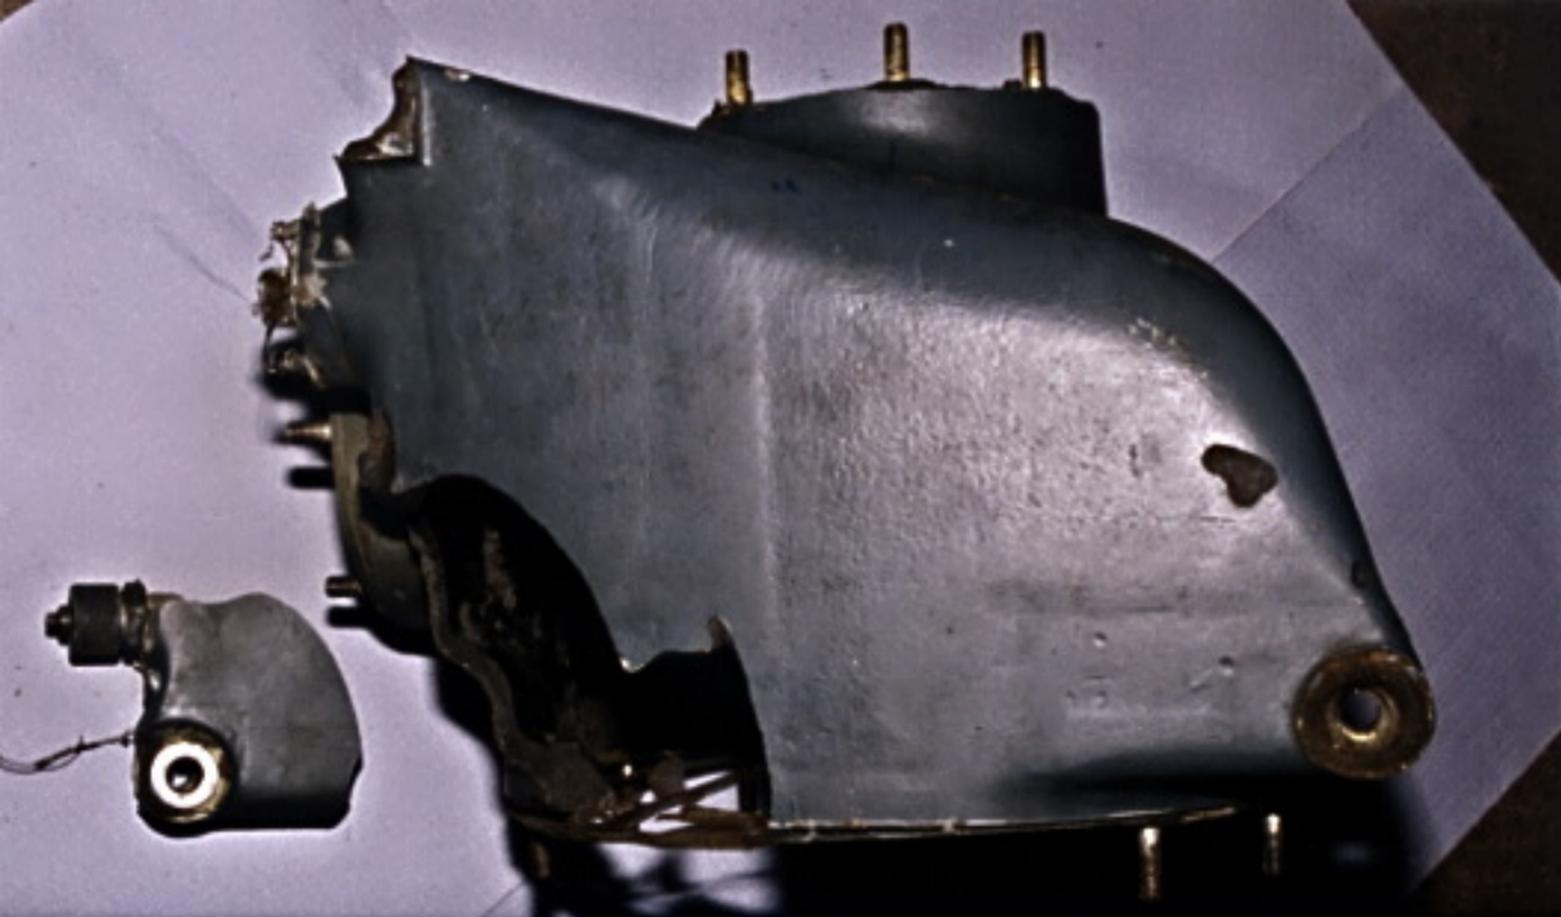
Examination of the tail rotor gearbox/pylon area confirmed that the gearbox had separated as a result of failure of the magnesium alloy gearbox casing at, or close to, the two lower attachment points, in addition to failure of the upper attachment bolt. Metallurgical examination of the separated head end of the upper attachment bolt revealed that it had fractured across the threaded portion in a plane between one and two threads from the point at which the thread runs out into the plain shank (see Appendix A, Figure 12A). Examination of the threaded portion remaining in the pylon structure showed that the failure was in a plane positioned slightly below the face of the barrel nut housing. Once the housing had been cut away from the structure and slit to release the barrel nut and the threaded fractured end of the bolt, it was evident that the bolt had only been

Figure 6: Showing failed lower attachments of gearbox (left attachment is upper one in this photograph, right is lower).

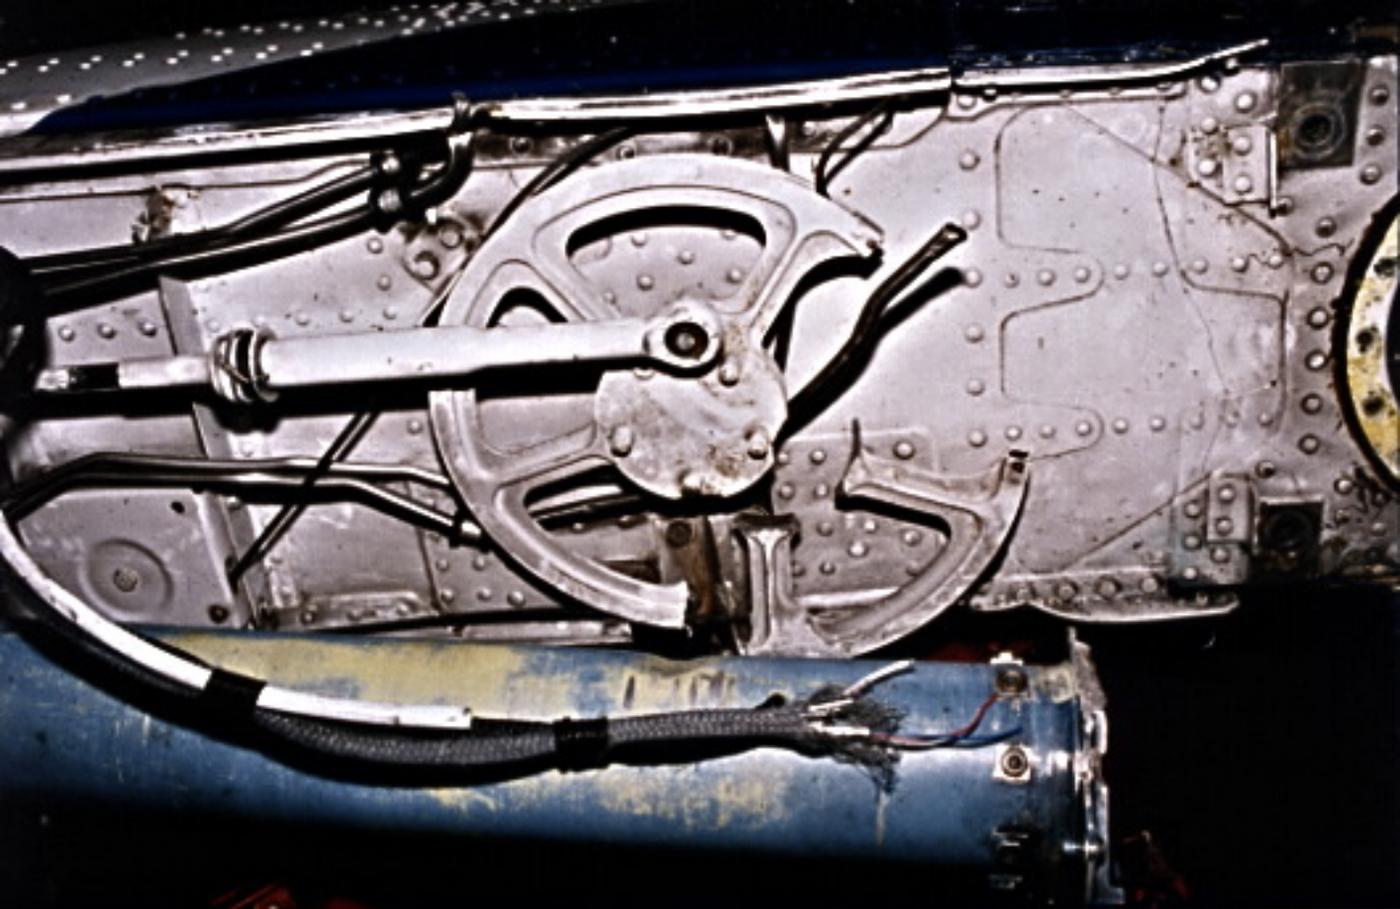
Figure 7: Showing the four severed hydraulic pipes, with two right side pipes sharply bent around damaged right support flange.

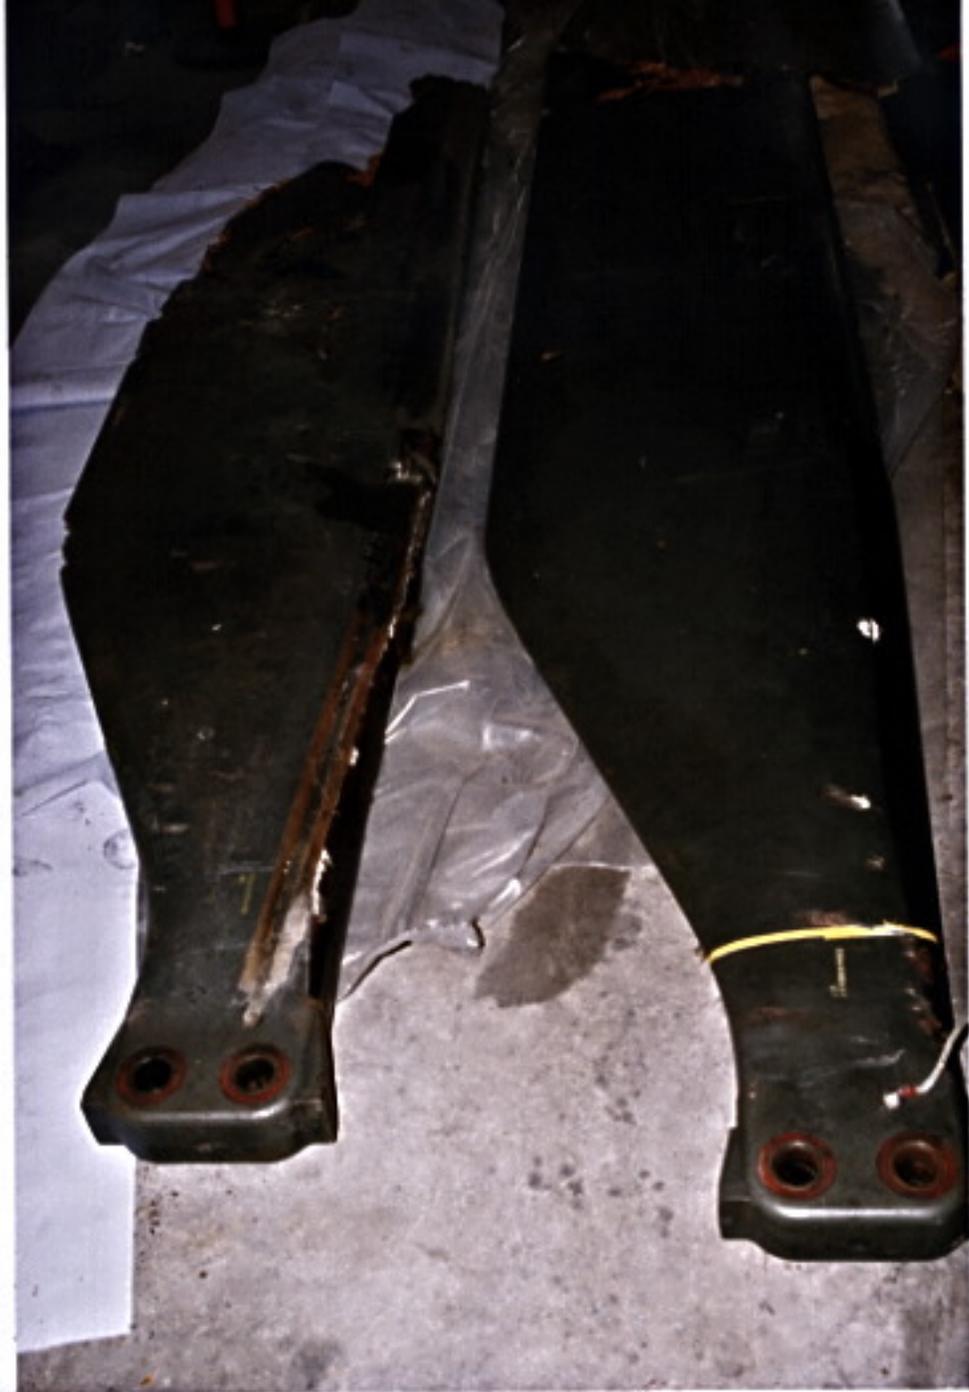
- (1) The Blue main rotor blade (Appendix A, Figure 8), which had suffered complete loss of the brass strip linking the stainless steel leading edge anti-erosion shield to the braided earth cable, with attendant evidence of thermal damage and 'fissuring' to the composite material below the strip and failure of the braided earthing connection which crosses the flapping hinge. The bolt attaching the braiding to the blade hinge assembly inboard of the flapping hinge had been over-stressed.

Figure 8: Showing recovered inboard section of 'Blue' main rotor blade with bonding strip missing, alongside 'Yellow' MRB for comparison.

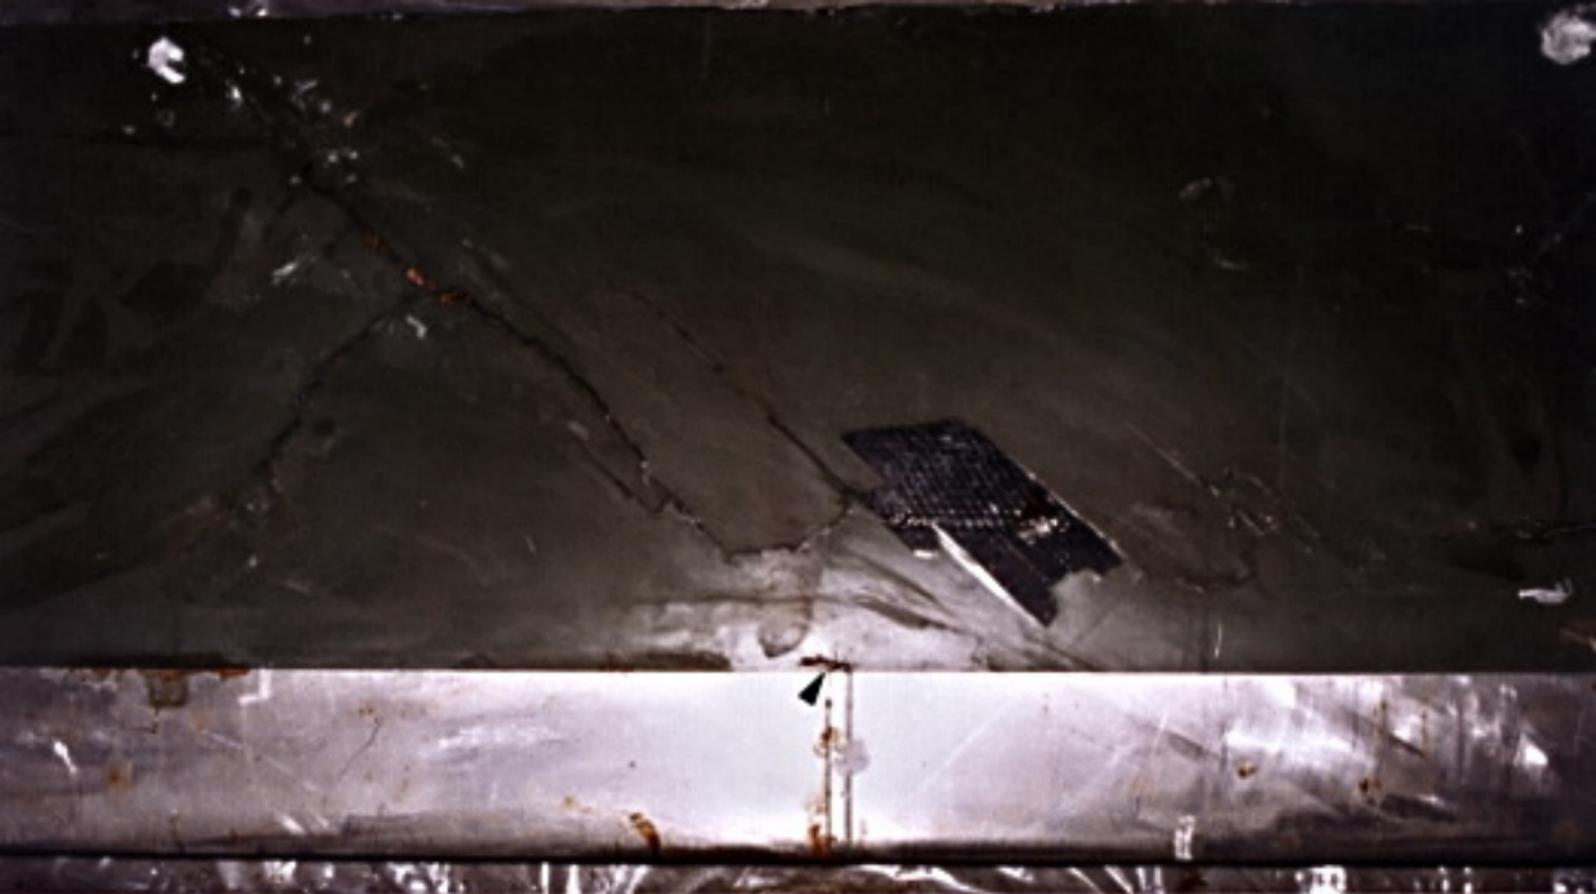
Figure 9A: Showing localised blade skin damage at overlap of leading edge anti-erosion shield sections due to related arcing on 'Black' MRB.

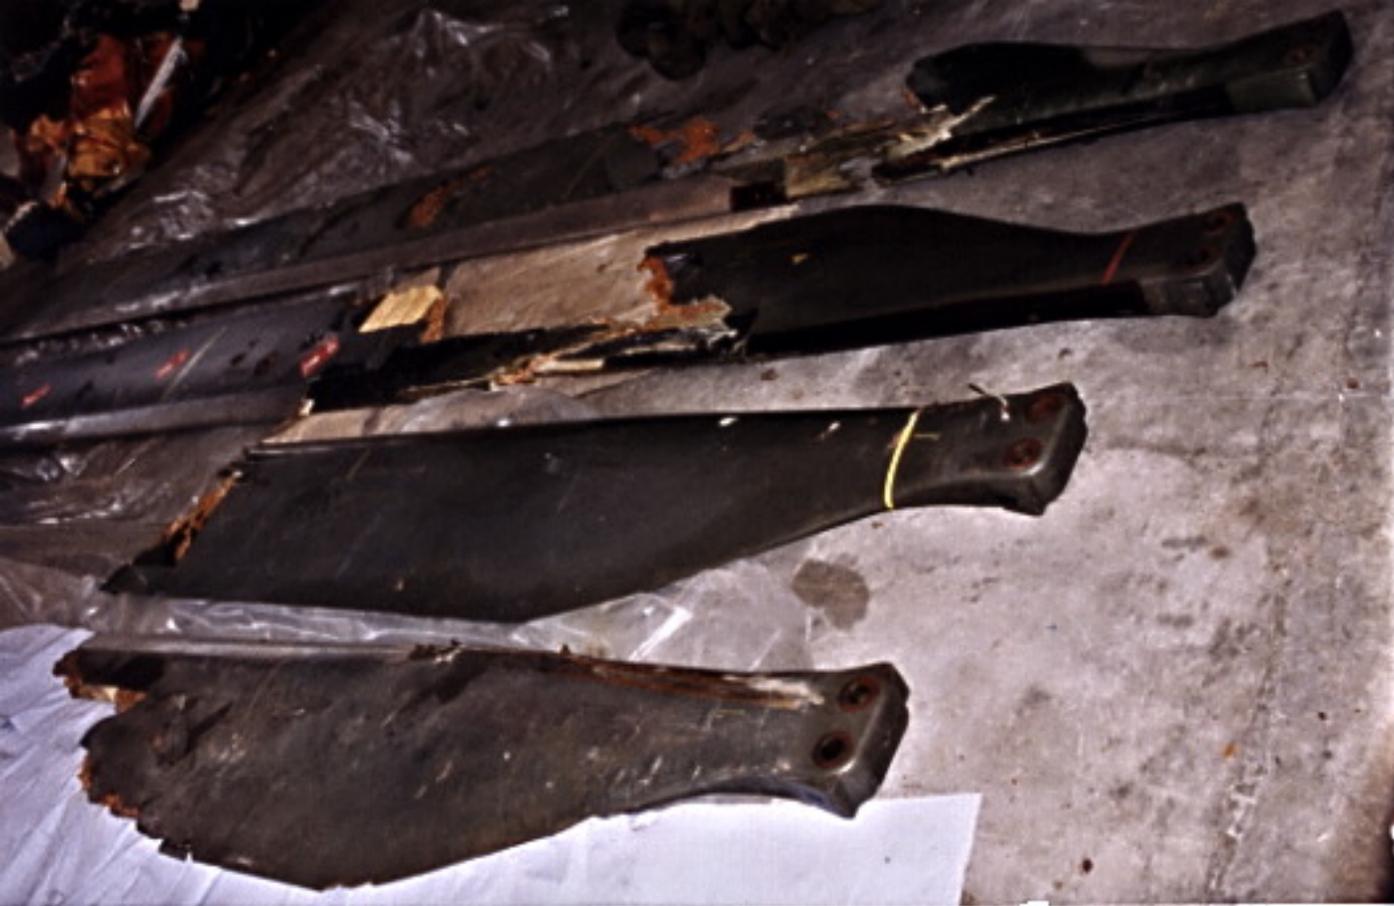
Figure 9B: Showing all recovered main rotor blade sections, with 'Blue' blade in foreground and 'Black' blade sections in background.

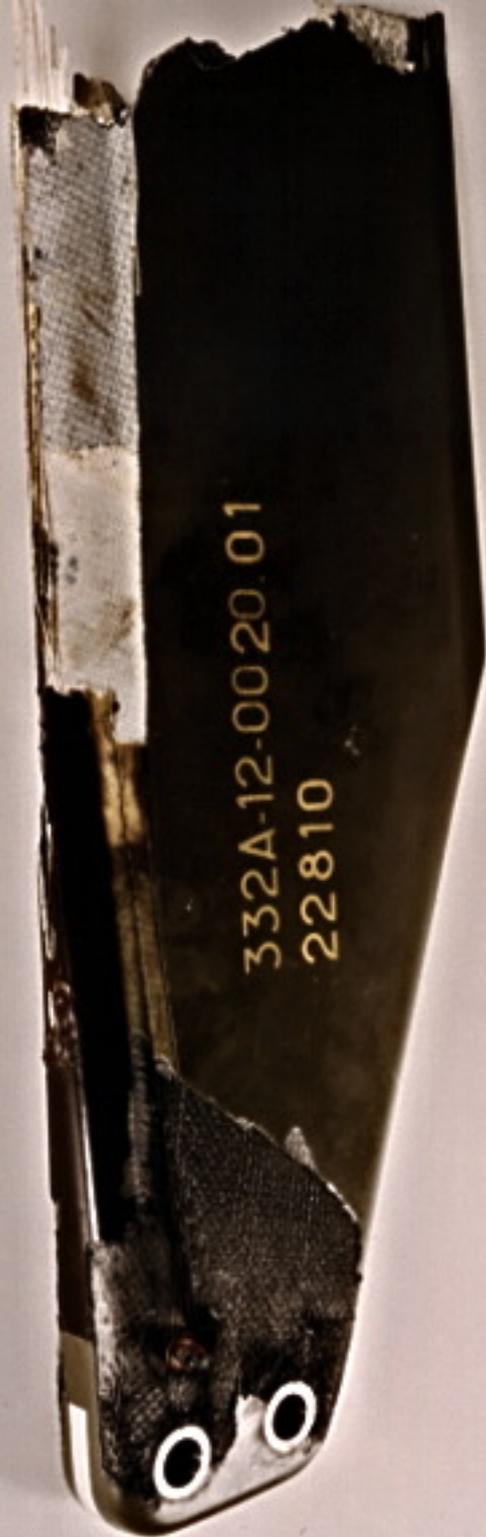
Figure 10: Showing damaged outboard (right) side of 'White' tail rotor blade, with thermal delamination of root area, full length fissure of composite within bonding strip recess and removal of leading edge skin layer under deatched anti-erosion shield.

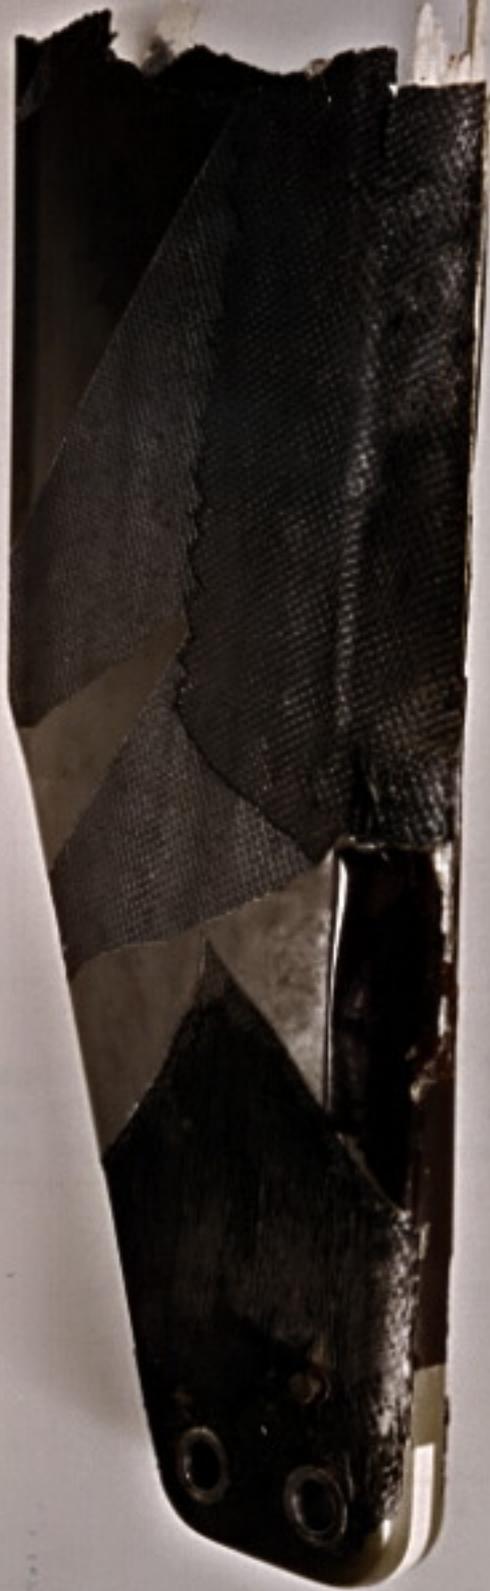
Figure 11: Showing damaged inboard (left) side of 'White' tail rotor blade, with thermal delamination of root area and general delamination outboard, including the leading edge from which the anti-erosion shield detached.

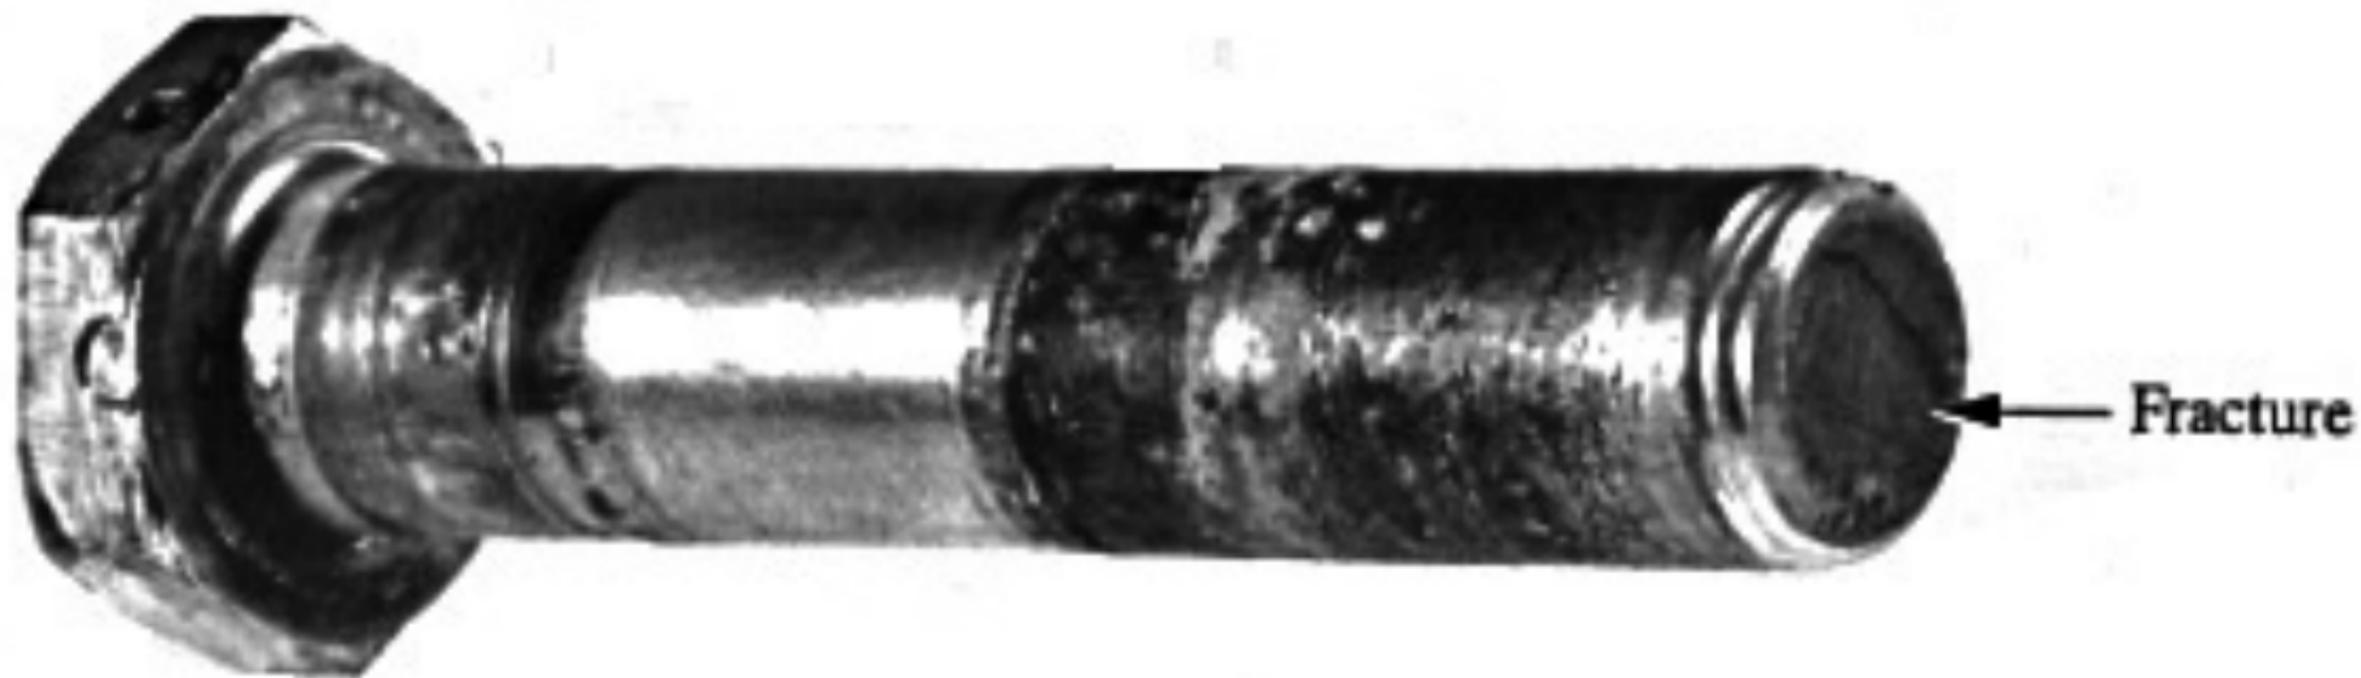
Figure 12A: Showing upper length of tail rotor gearbox upper attachment bolt with fracture face arrowed.

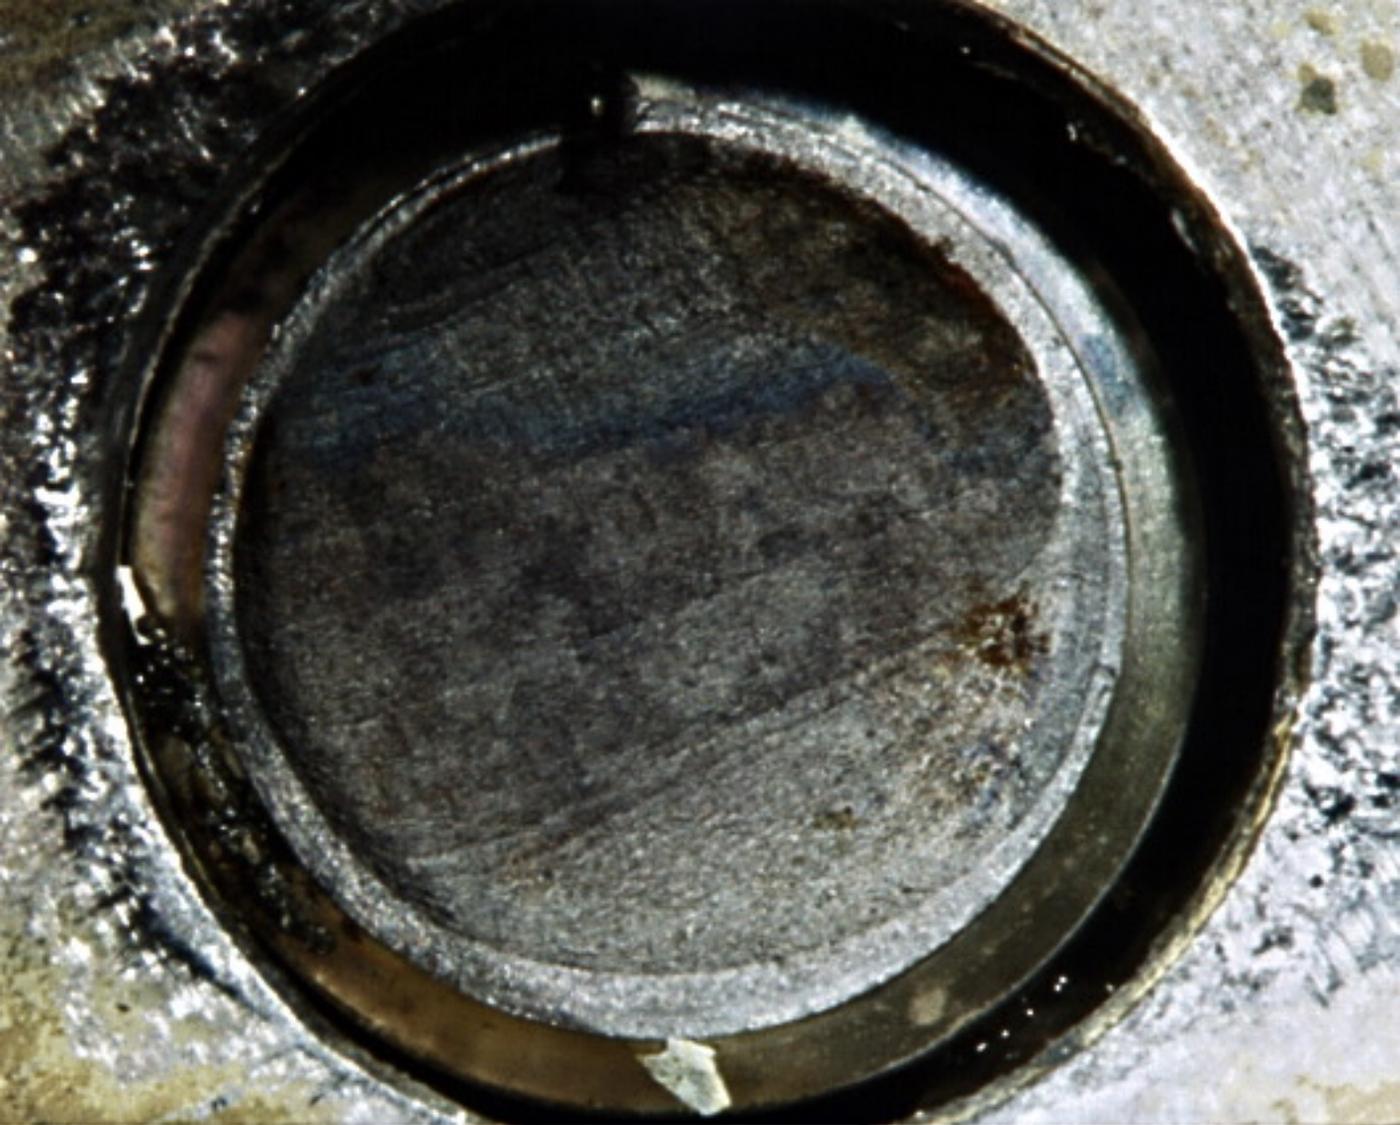
Two major damage mechanisms were visible on both mating fracture faces. The first appeared to be annular fatigue propagation extending around the thread form and which had developed from multiple origins in the thread root. This fatigue had extended, in the form of a helical crack, through approximately two turns of the threaded bolt section in the barrel nut. This pattern of fatigue was consistent with the effect of either a cyclic bending load or cyclic tensile loading with an offset load axis with, in either case, the loading having been applied whilst the bolt was rotating.

The second mechanism was simple bending fatigue, covering most of the area of the remaining section, with only a very small area having finally separated in overload. The lower fractured surface of the bolt is shown in Appendix A, Figure 12B.

The annular damage was of medium-to-high stress/medium-to-low cycle fatigue, whilst the bending failure across the middle of the section was due to high stress/low cycle fatigue. A count of the fatigue striations on the central fracture face of the head/shank end indicated some 150 to 200 cycles, representing rather less than ten seconds of operation if the fatigue cycling had been induced by tail rotor imbalance. Although some 50 striations were visible on the annular fracture face of the head/shank end, the crack extended into the unfractured thread for a further thread turn where fatigue was presumed to be present.

Figure 12B: Showing fracture surface of lower (threaded) end of tail rotor gearbox upper attachment bolt, with shallow (bright) annular band of initial radial fatigue propagation from the thread root, and secondary bending fatigue striations clearly evident emanating from upper arc, before the final overload failure evident within lower segment of fracture.

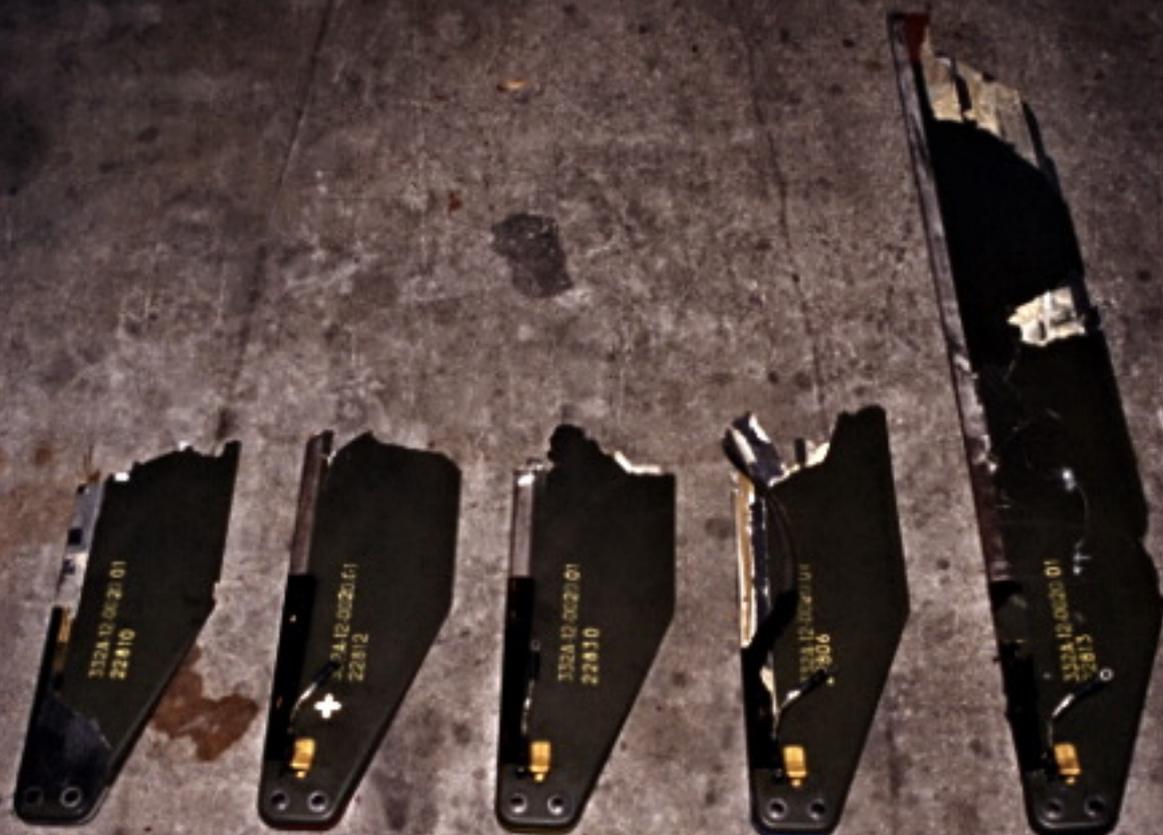
Figure 13: Showing the recovered tail rotor blade sections with, left to right in this photograph, 'White', 'Red', 'Blue' and 'Black' blades, outboard (right) sides uppermost. Note similar lengths of first four severed blades, caused by rotational penetration into aft side of pylon (Figure 5, A-6).

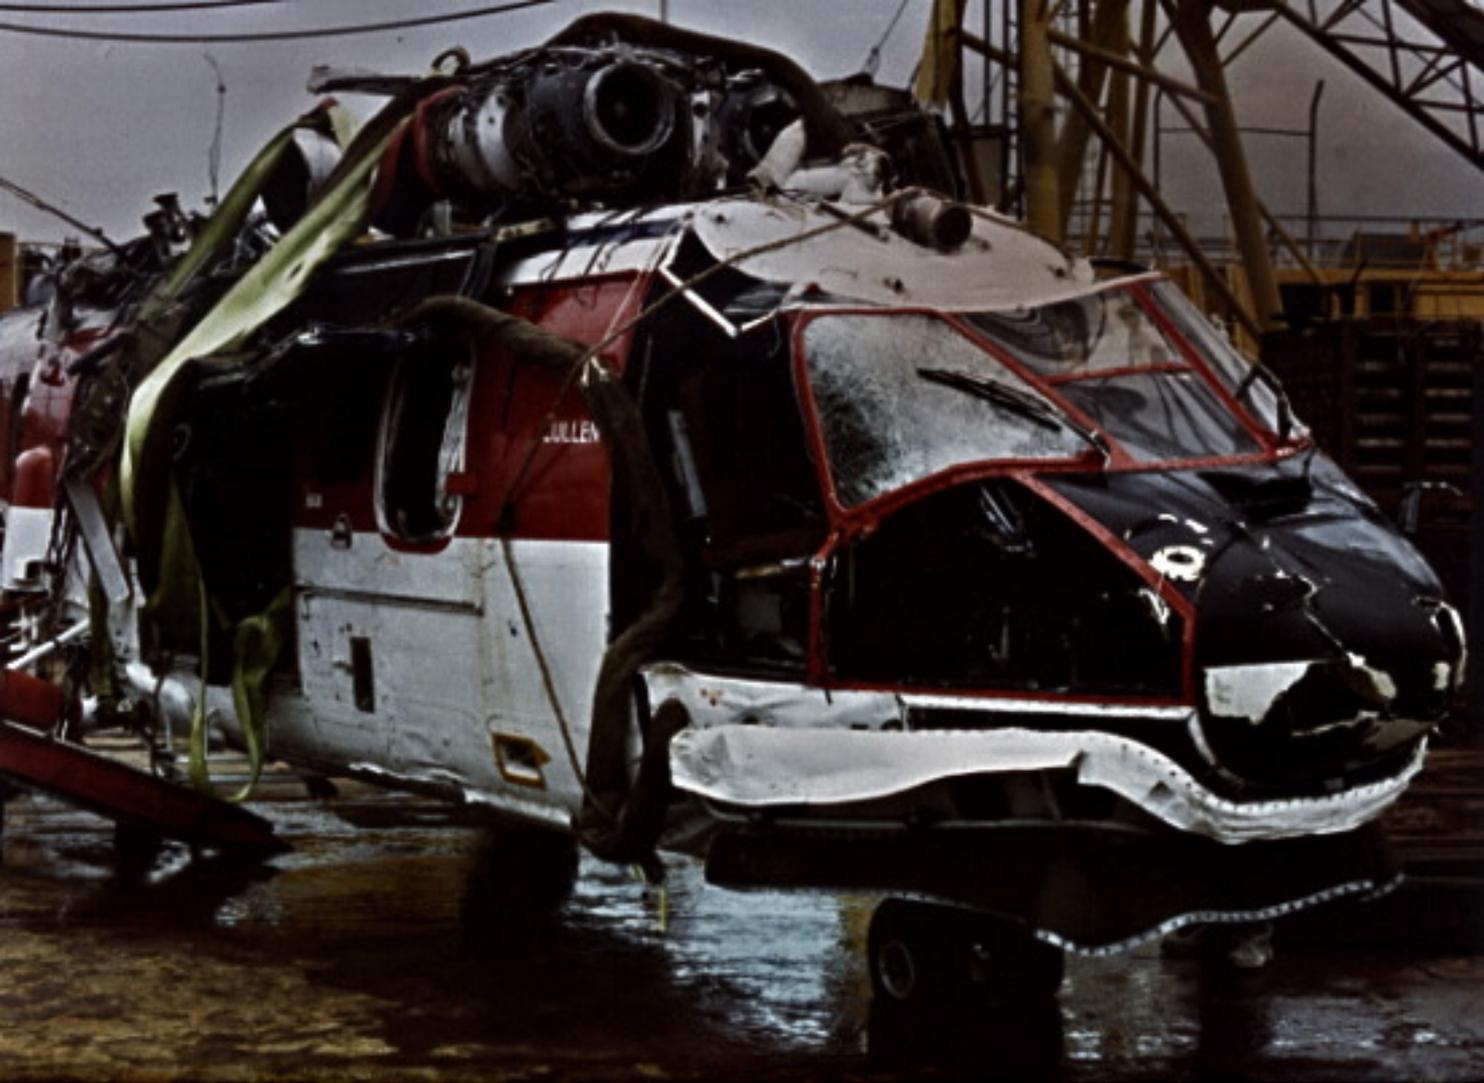
Figure 14: Showing the recovered helicopter onboard MSV Stadive without its main rotor head and main gearbox assembly which detached during the first associated 'lift' from the seabed and was recovered before the main airframe structure shown here.
