Report on the accident to Aerospatiale AS332L Super Puma, G-TIGK, in North Sea 6 nm South West of Brae Alpha Oil Production Platform on 19 January 1995

Event Date: 1995-01-19 at 1240

Investigative Body: Aircraft Accident Investigation Board (AAIB), Great Britain

Aircraft Accident Report No: 2/97 (EW/C95/1/1)

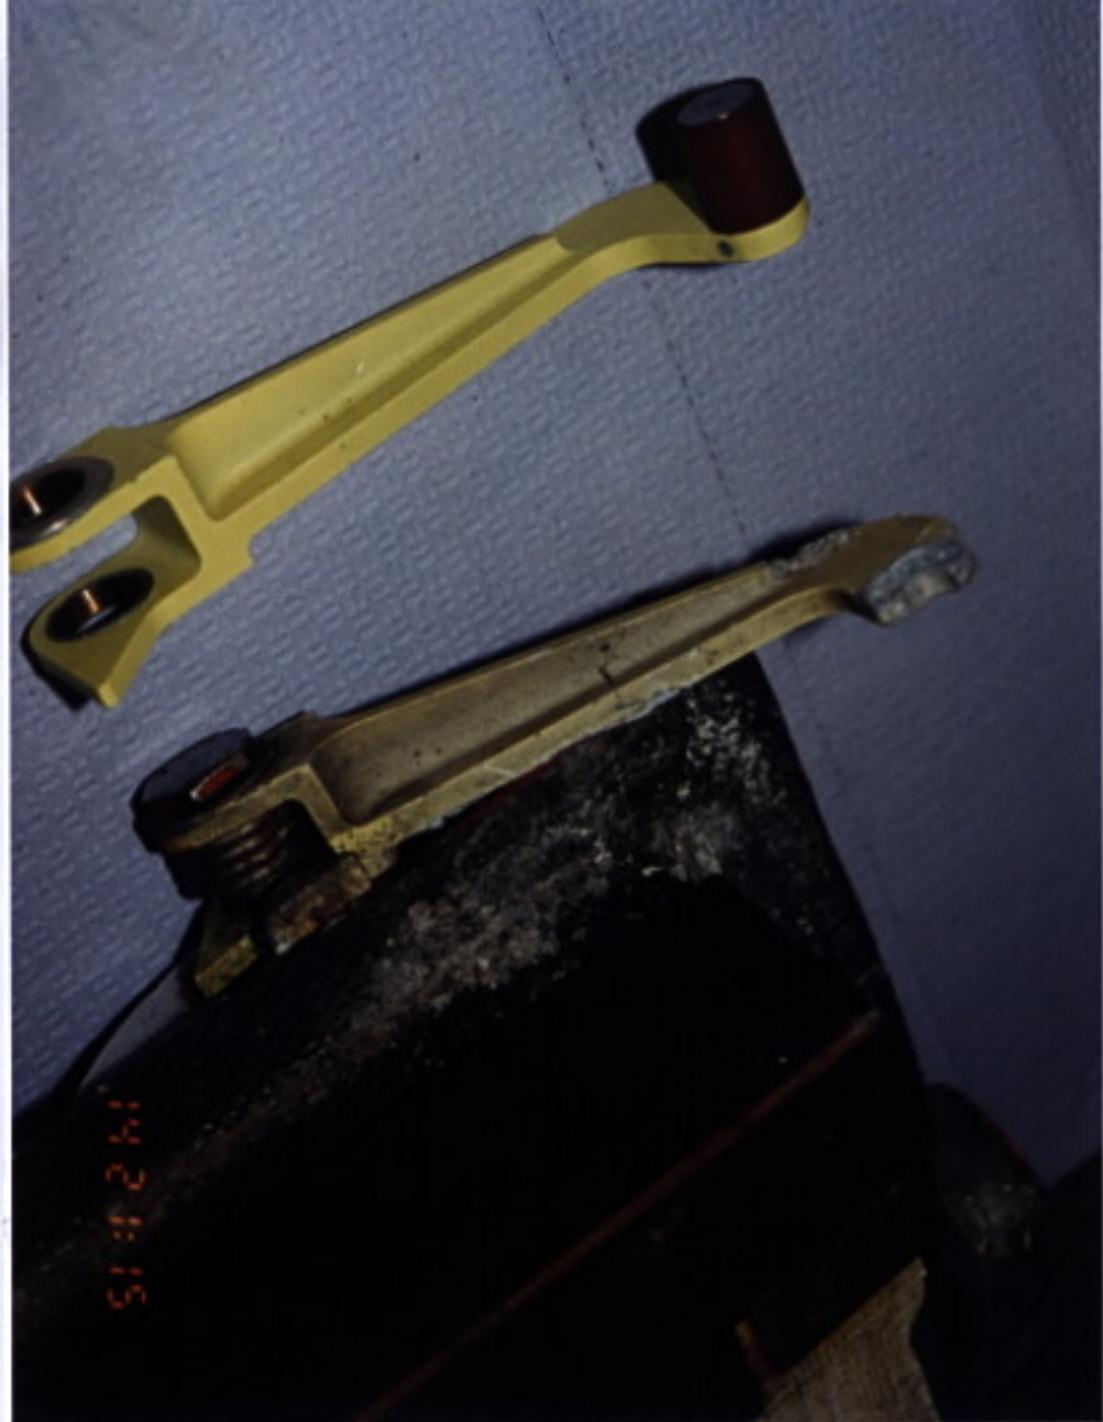
Figure 5: Showing hook-shaped broken end of spring-loaded arm at upper forward corner of left main door, after detachment of roller end, with new arm/roller for comparison; aft arm on this door and forward arm on right door were also broken in this manner.

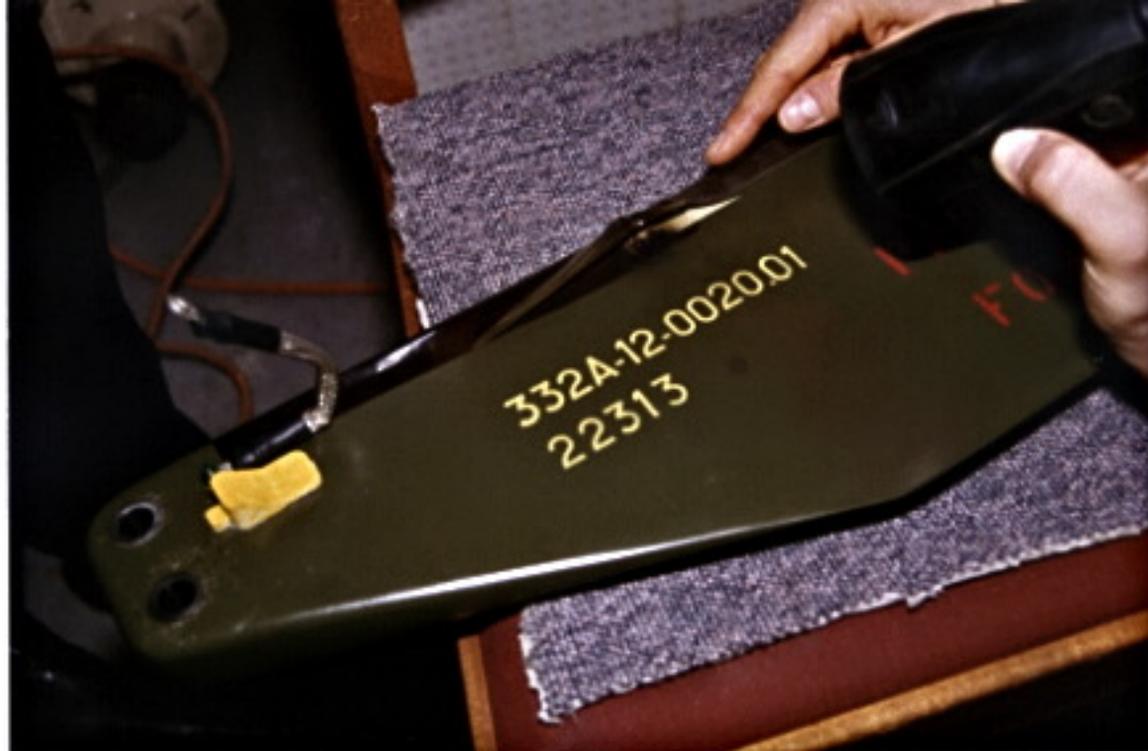
Figure 2: Showing 'peel-back' of inboard end of anti-erosion shield from brass conducting strip after 12.7kA low energy test (shield tip input).

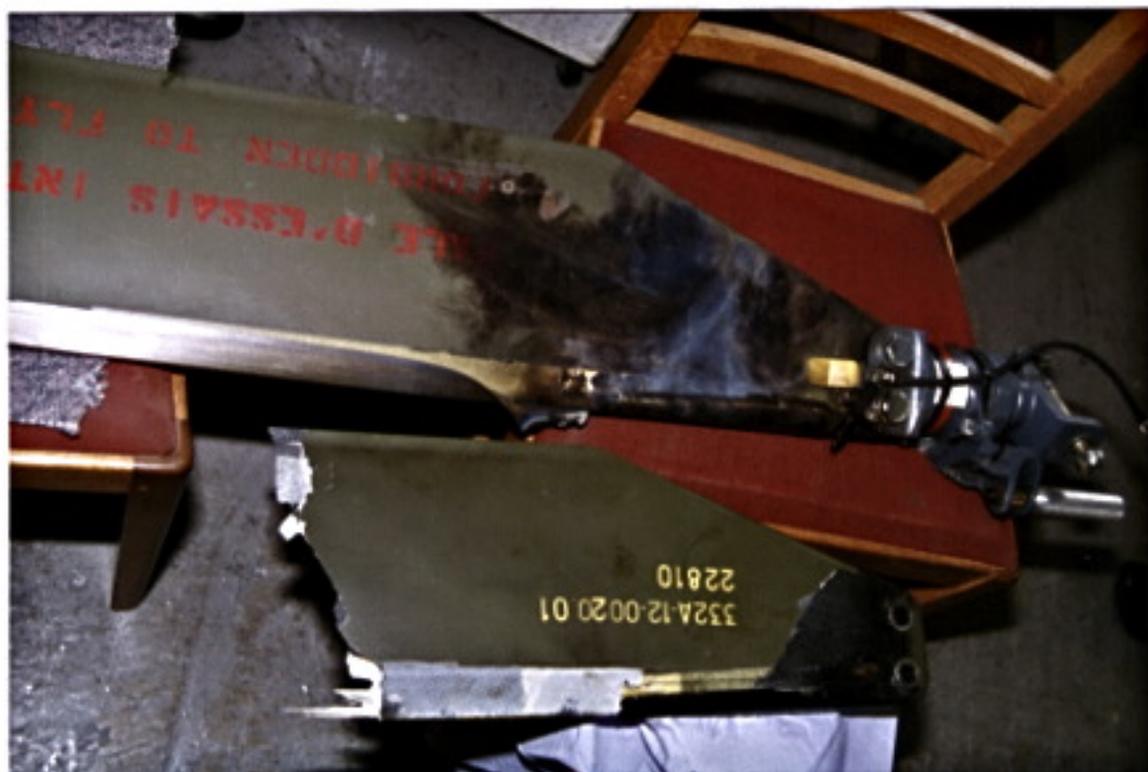
Figure 3: Showing post-test damage to inboard span of TRB s/n 22200 after 190.9kA input to shield tip, with White TRB section for comparison.

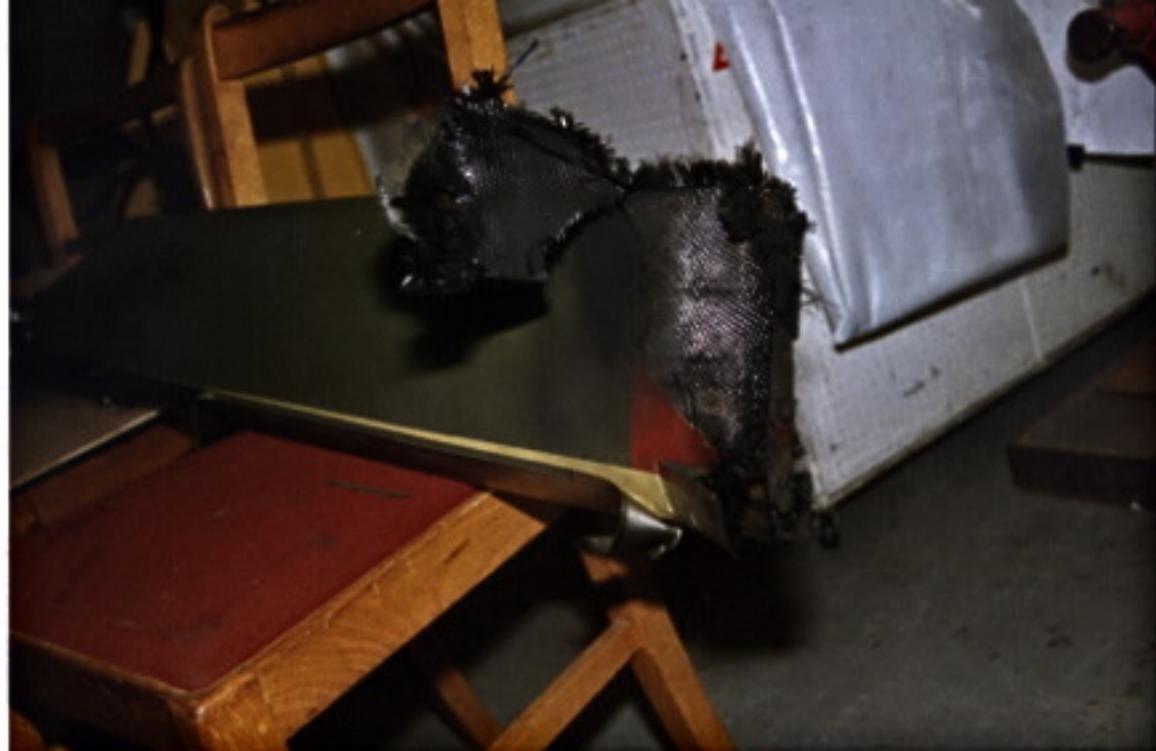
Figure 4: Showing tip damage to TRB s/n 20667 after 180.1kA input to trailing edge tip, with peel-back and general debonding of erosion shield.

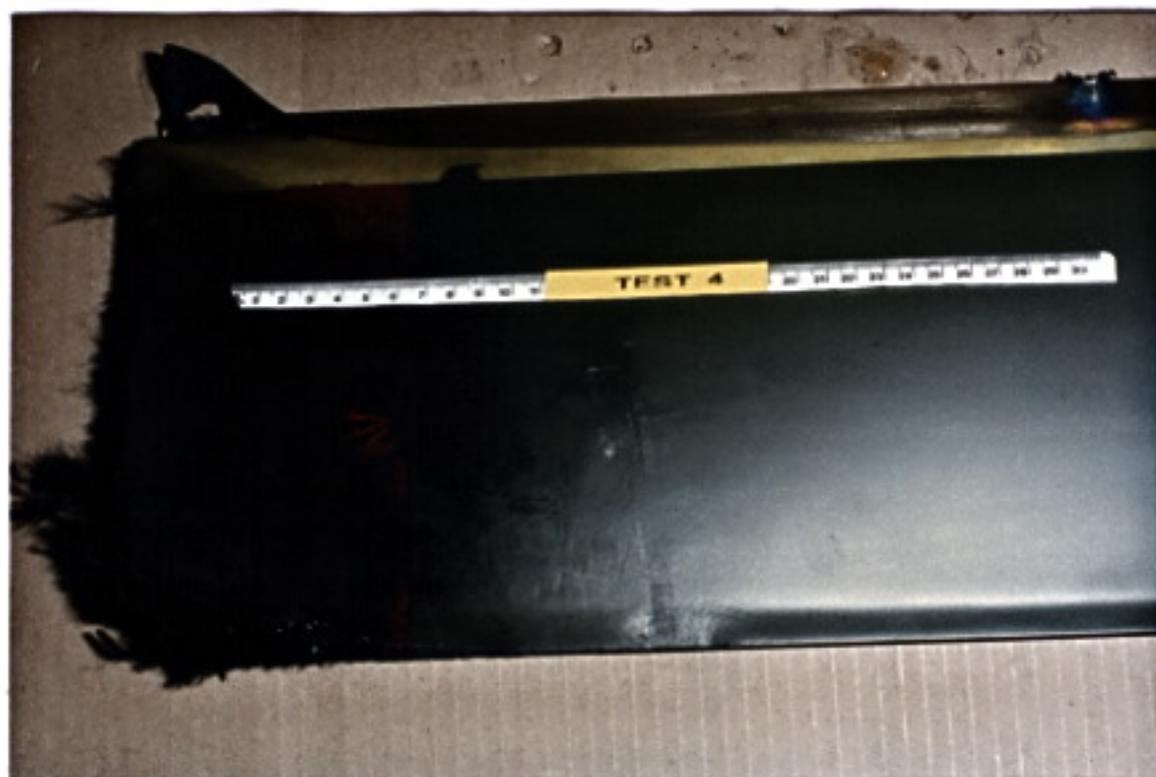
Figure 5: Showing tip damage to TRB s/n 21667 after 253.7kA input to trailing edge tip, with debonding of erosion shield and 'burn-holes'.

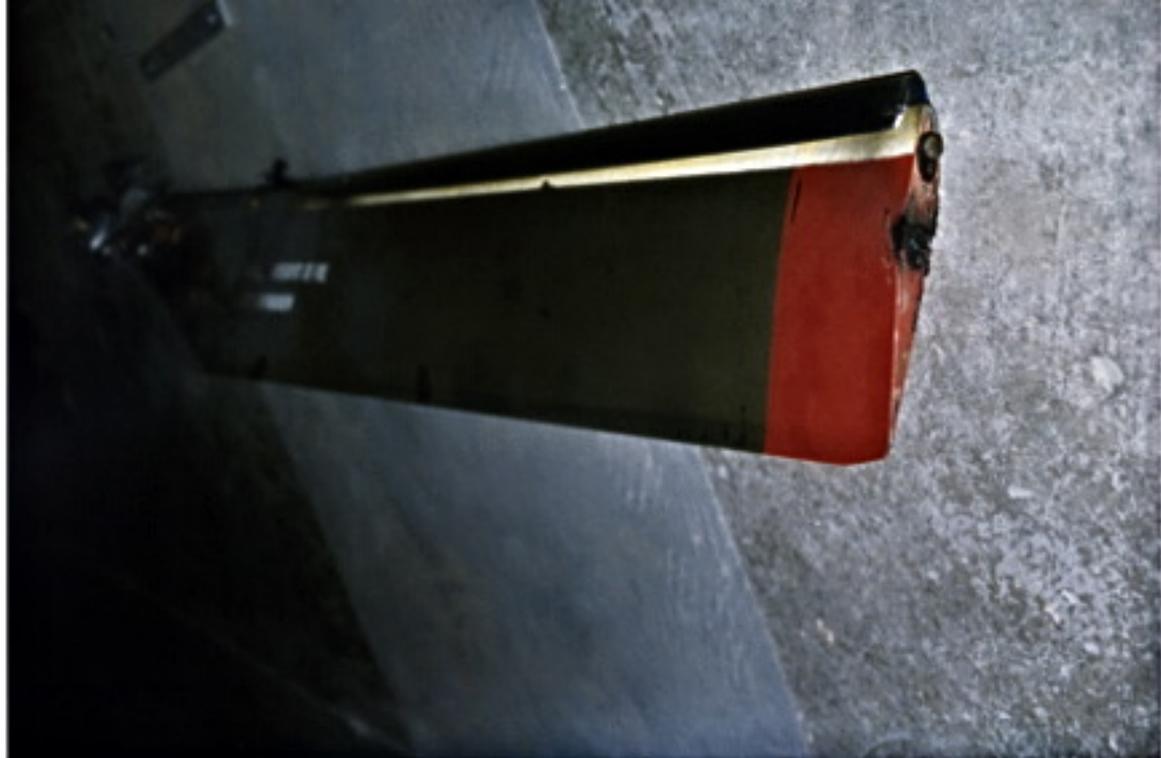
Figure 6A: Showing TRB s/n 20636 after 198.9kA input to aft tip bolt with minor damage around bolt, but almost complete separation of shield.

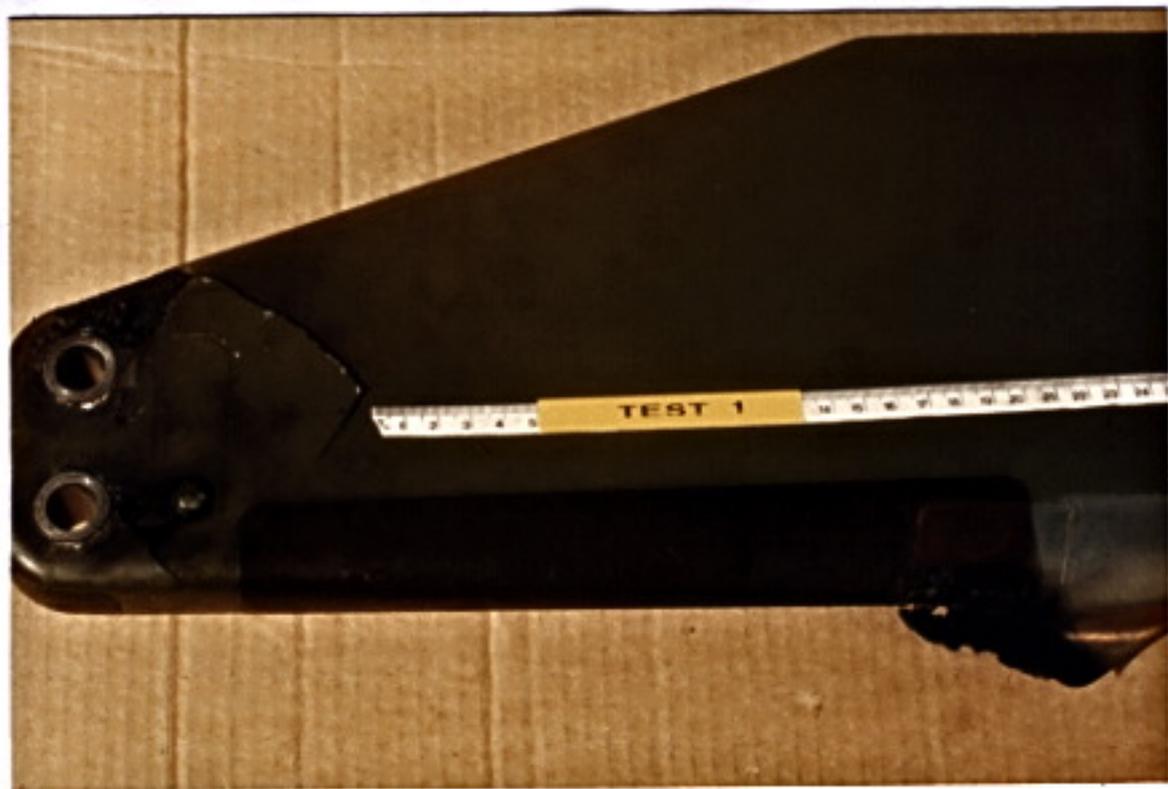
Figure 6B: Showing thermal delamination damage to root area of above TRB.

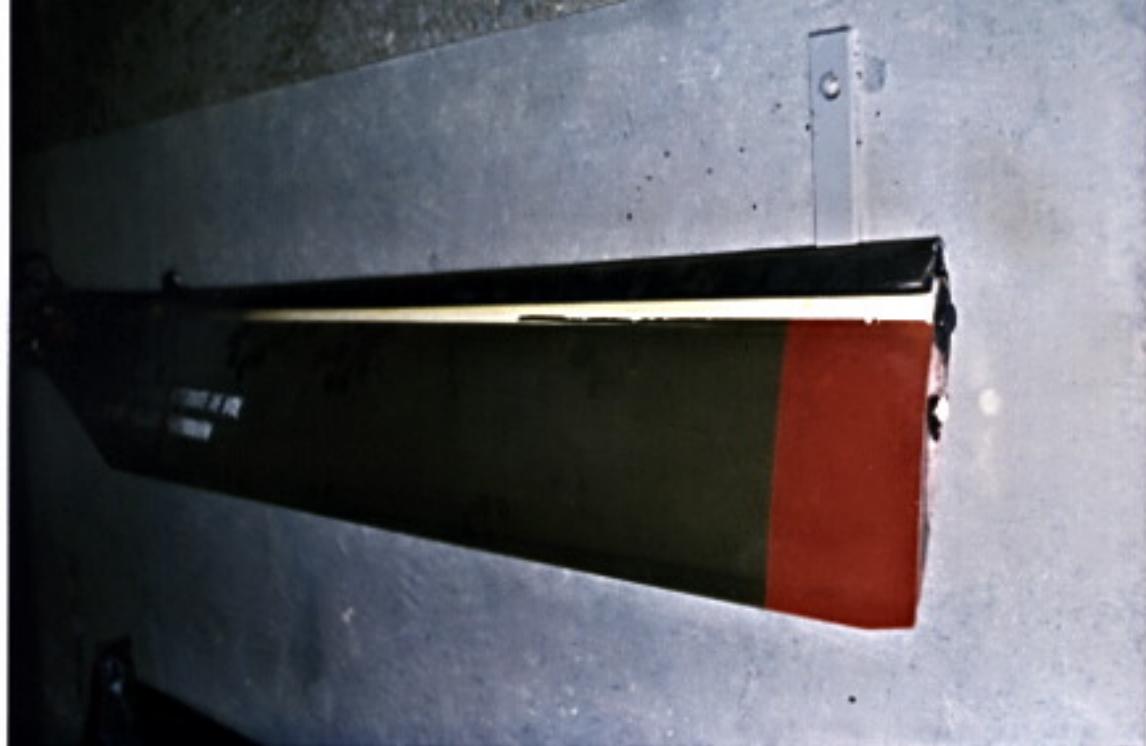
Figure 7A: Showing TRB s/n 20625 after 194.9kA input to forward tip bolt with minor damage around bolt and to erosion shield tip, but almost complete separation of shield.

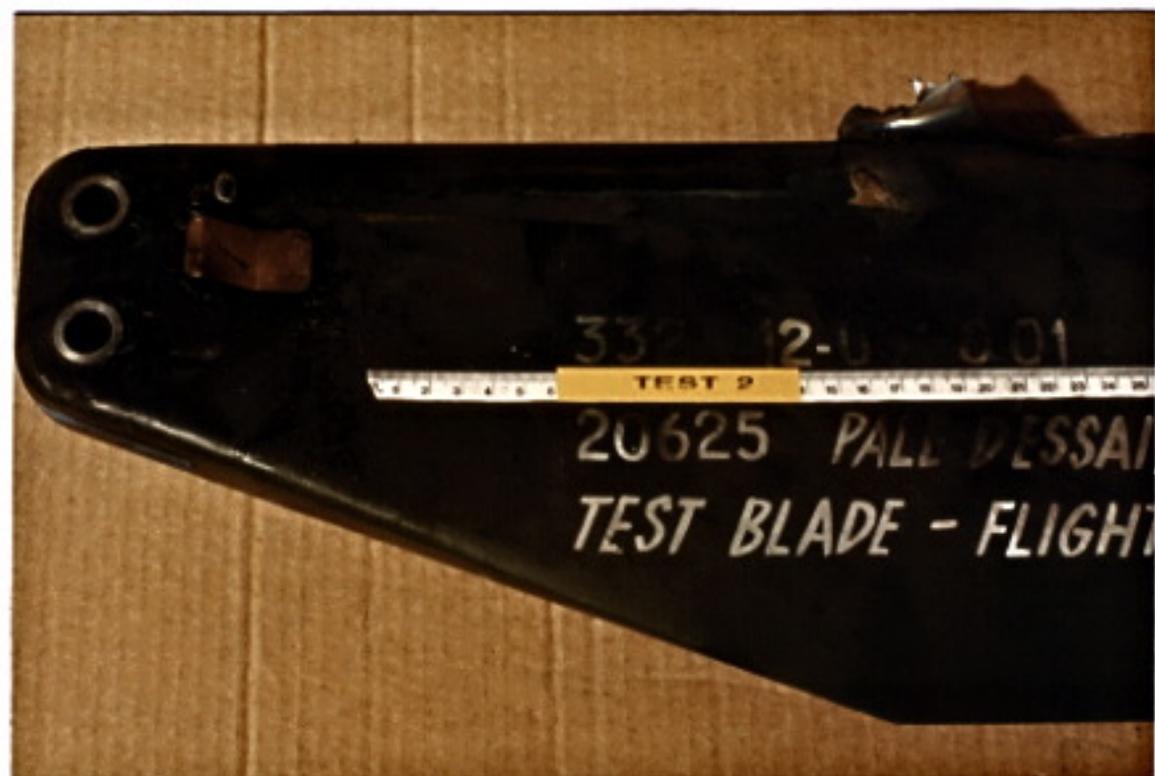
Figure 7B: Showing damage to inboard area of above TRB.

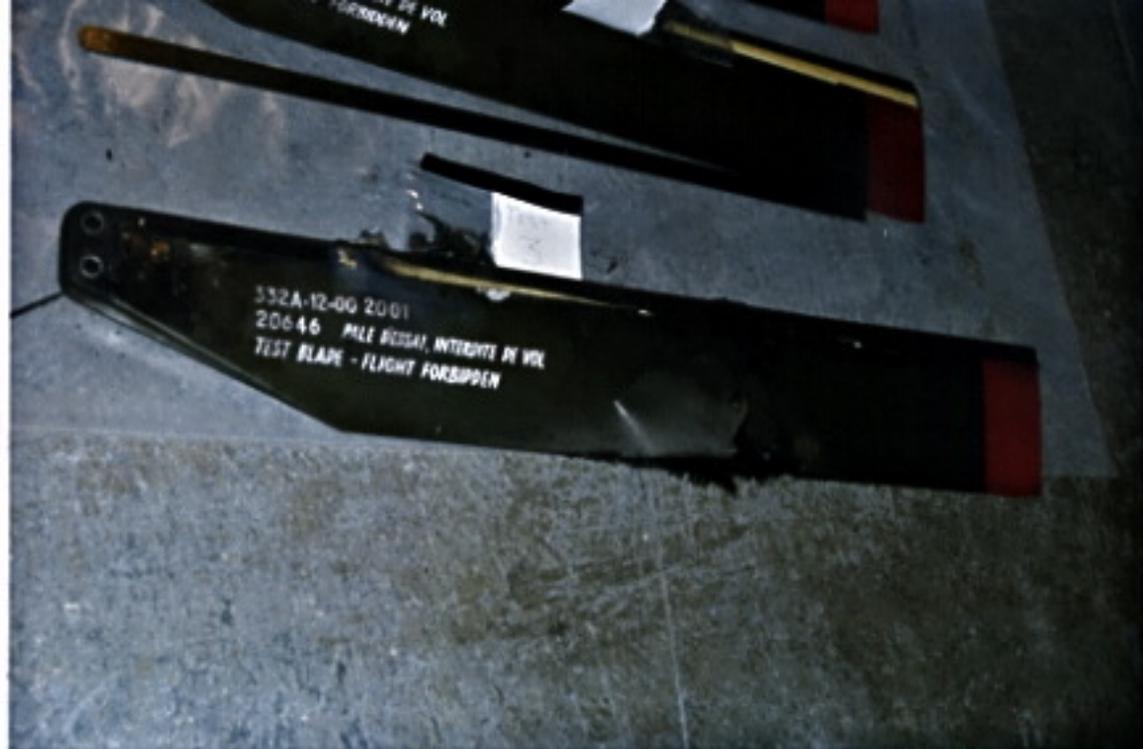
Figure 8A: Showing general marked damage to TRB s/n 20646 after 188.2kA input to trailing edge, 0.5 metre from tip.

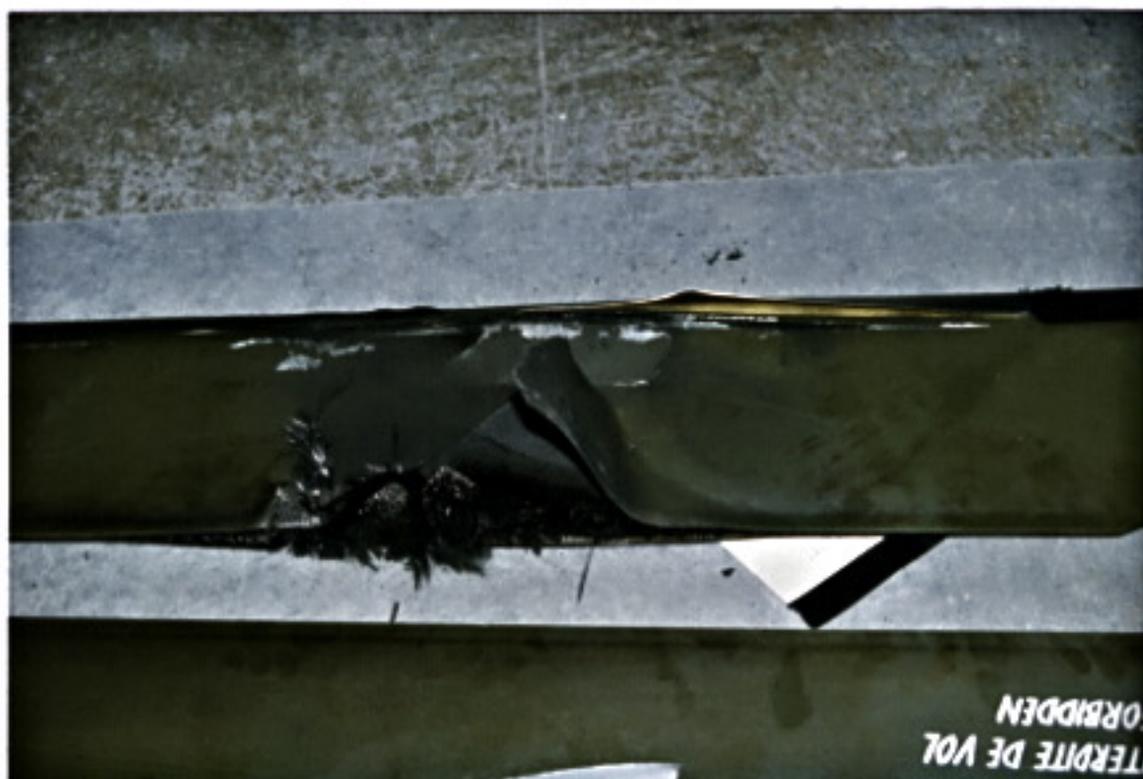
Figure 8B: Showing gross disruption of mid-aerofoil on above TRB and spanwise cracking of skins just aft of erosion shield.

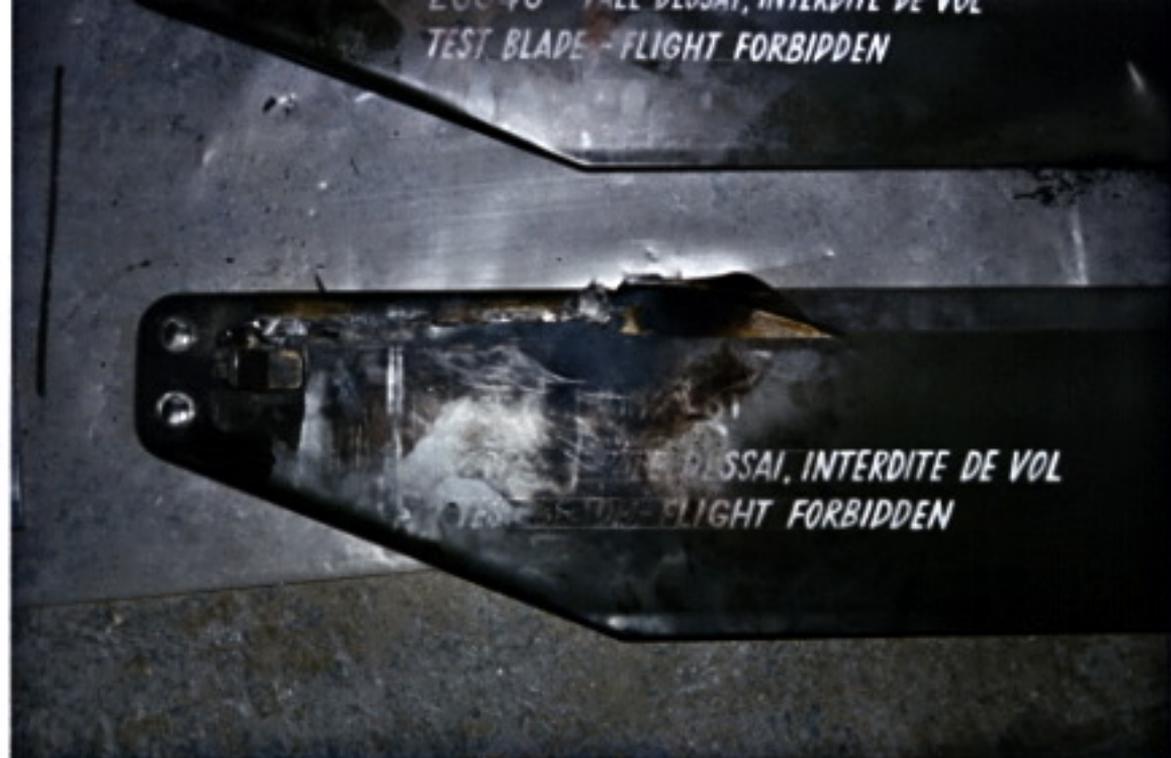
Figure 9A: Showing damage to TRB s/n 20732 after 206.9kA input to inboard end of erosion shield, with local peel-back of shield.

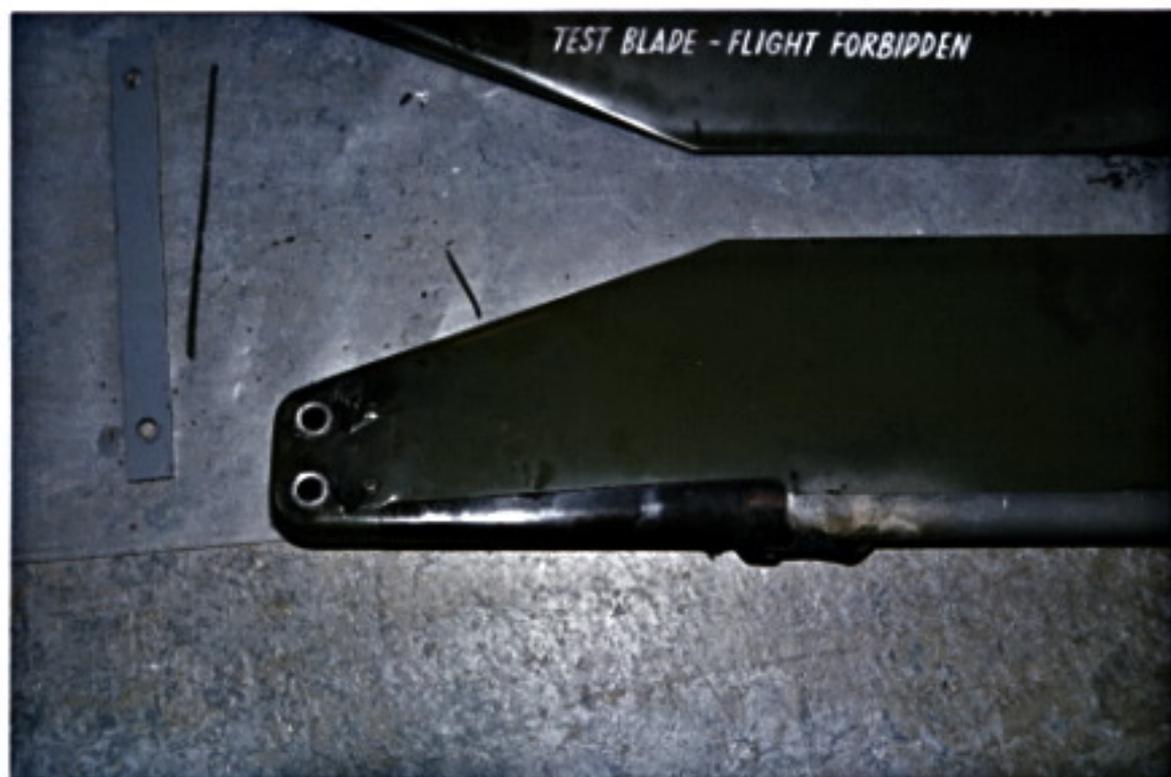
Figure 9B: Showing skin delamination and disbonding outboard of both steel bushes in root area (inboard side) of above TRB.

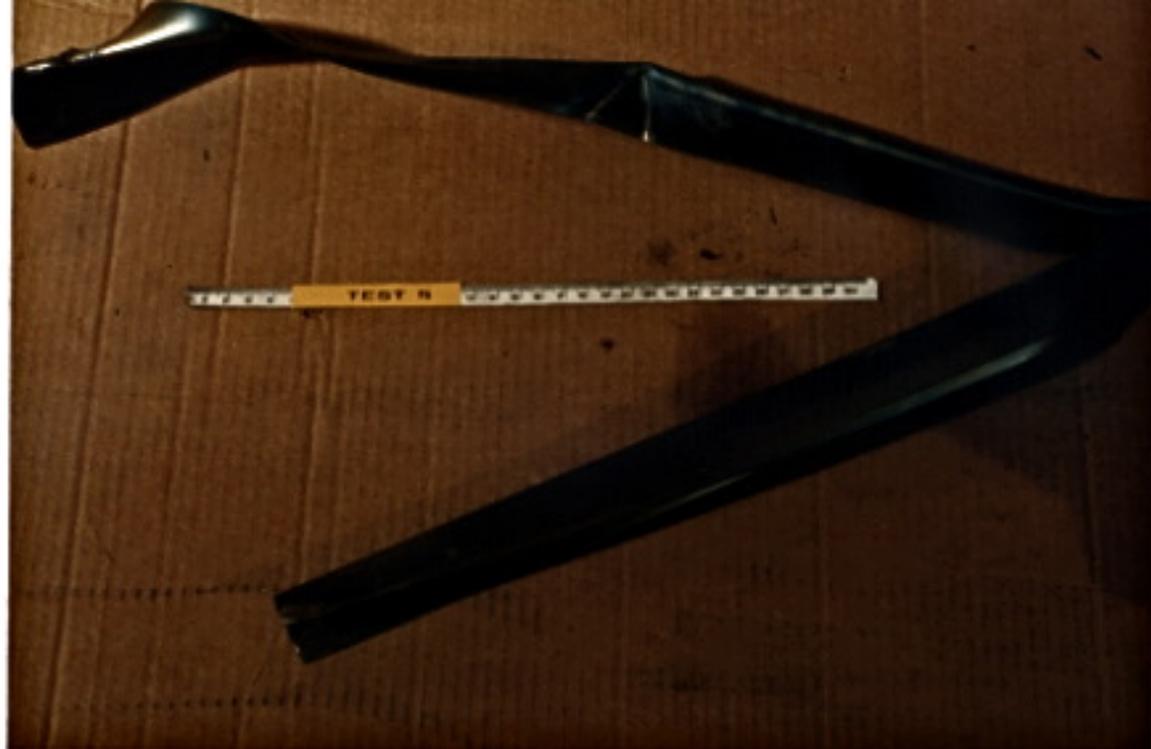
Figure 10A: Showing detached and badly deformed erosion shield after 275.5kA input to aft tip bolt on TRB s/n 20662.

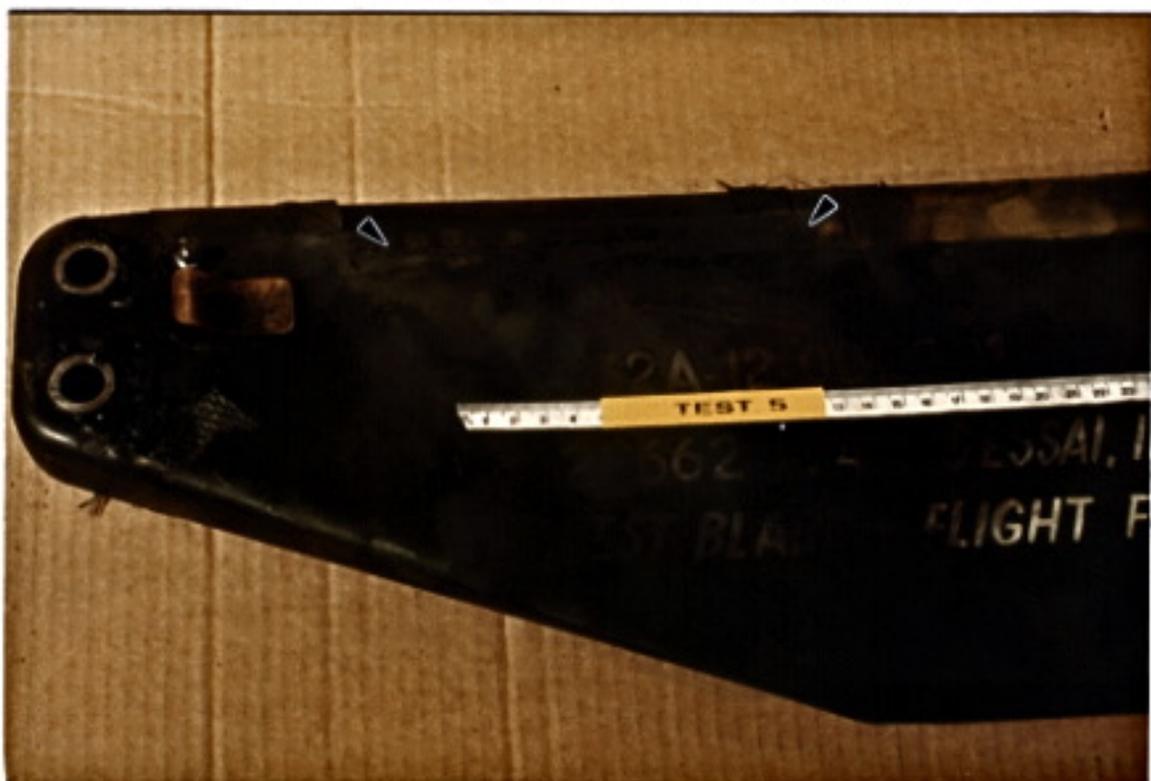
Figure 10B: Showing longitudinal 'fissure'(arrowed) within blade substrate uncovered by loss of brass bonding strip, and root damage on above TRB.

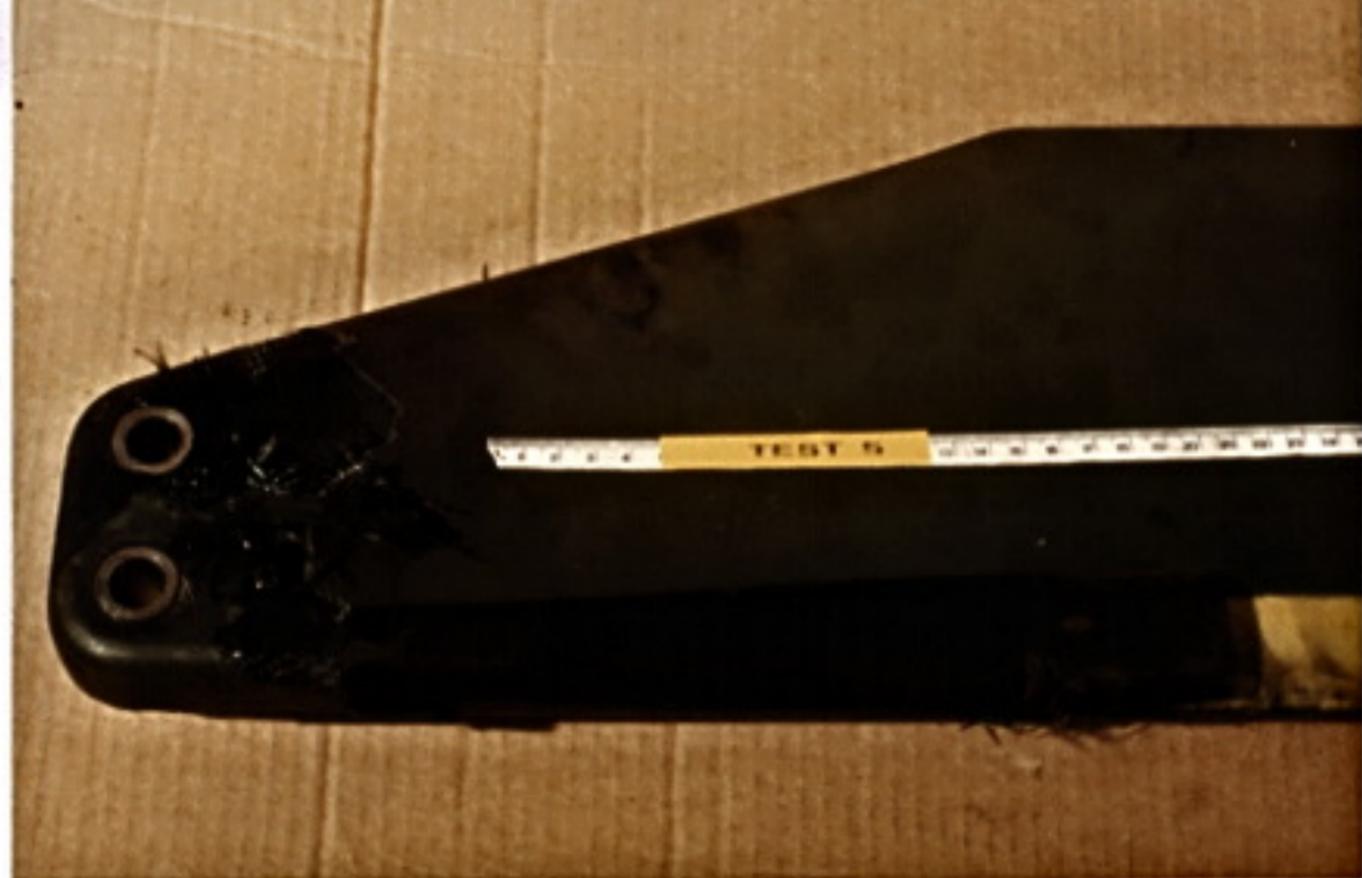
Figure 10C: Showing marked delamination and disbonding of inboard(left) surface of the root of TRB s/n 20662 after 275.5kA input to aft tip bolt.

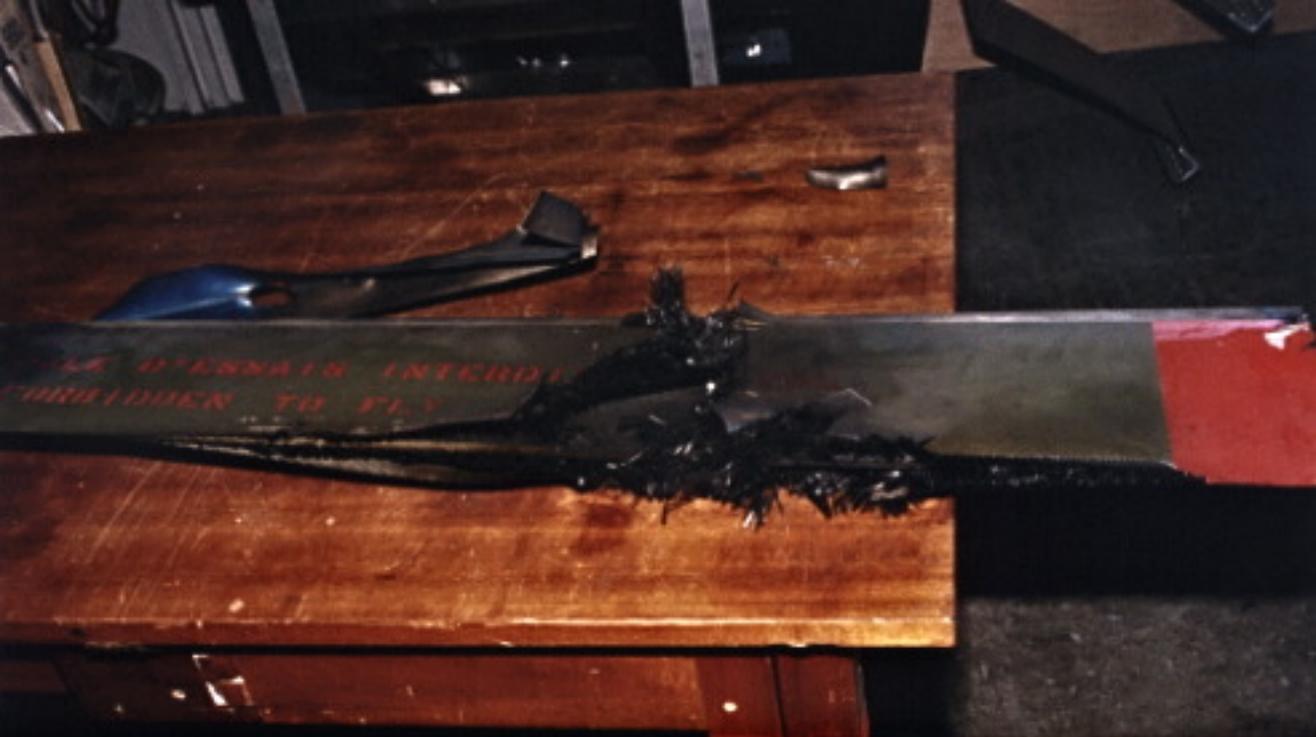
Figure 11A: Showing gross damage to aerofoil of TRB s/n 22313 after 253.3kA input to trailing edge, 34cm from tip.

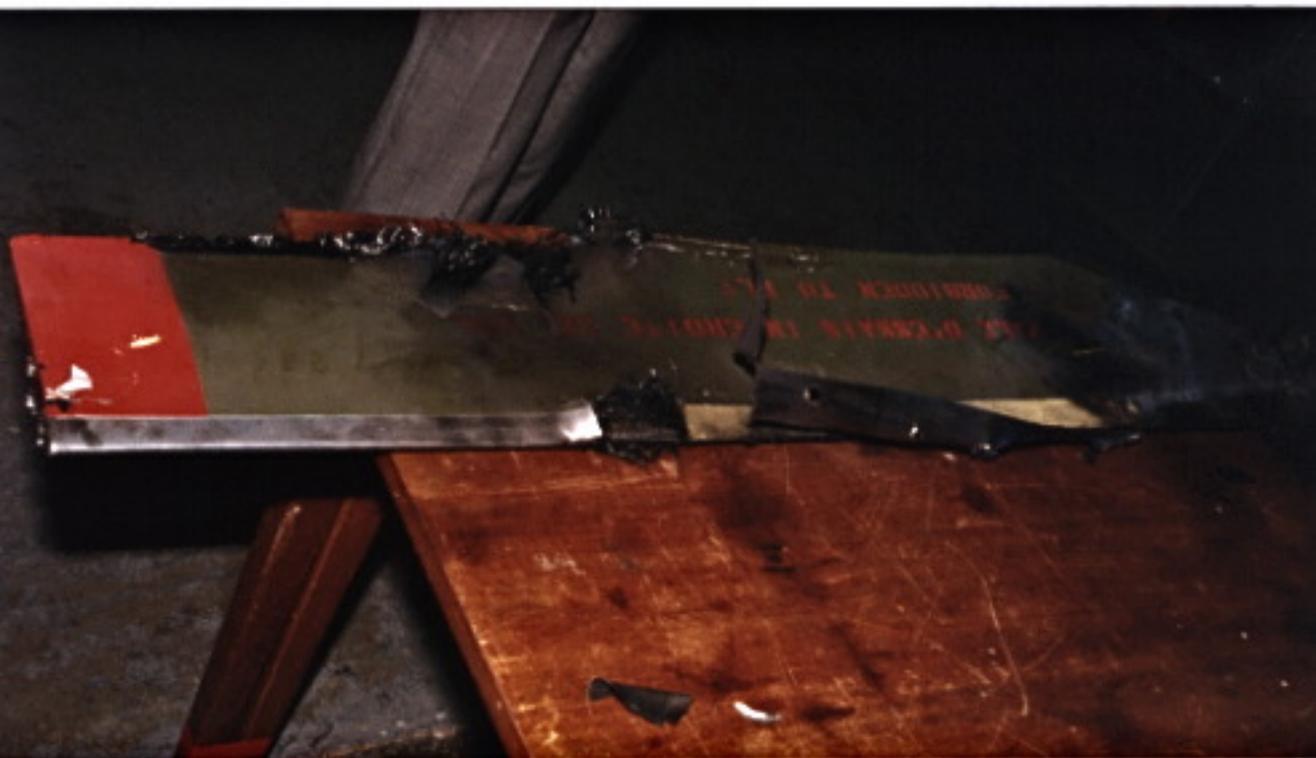
Figure 11B: Showing localised damage to leading edge composite and detached inboard length of shield, with 'burn-holes', on above blade.

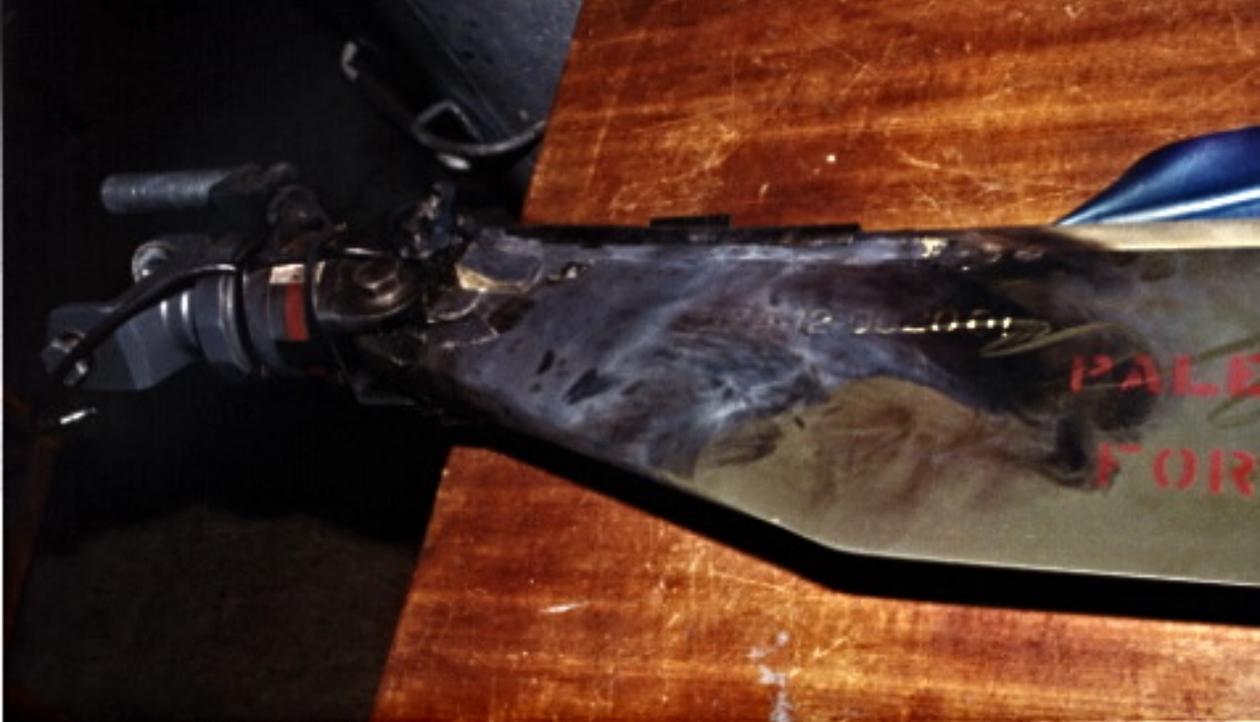
Figure 11C Showing marked thermal affects on outboard side of root on TRB s/n 22313 with carbon fibre damage adjacent attachment bolts.

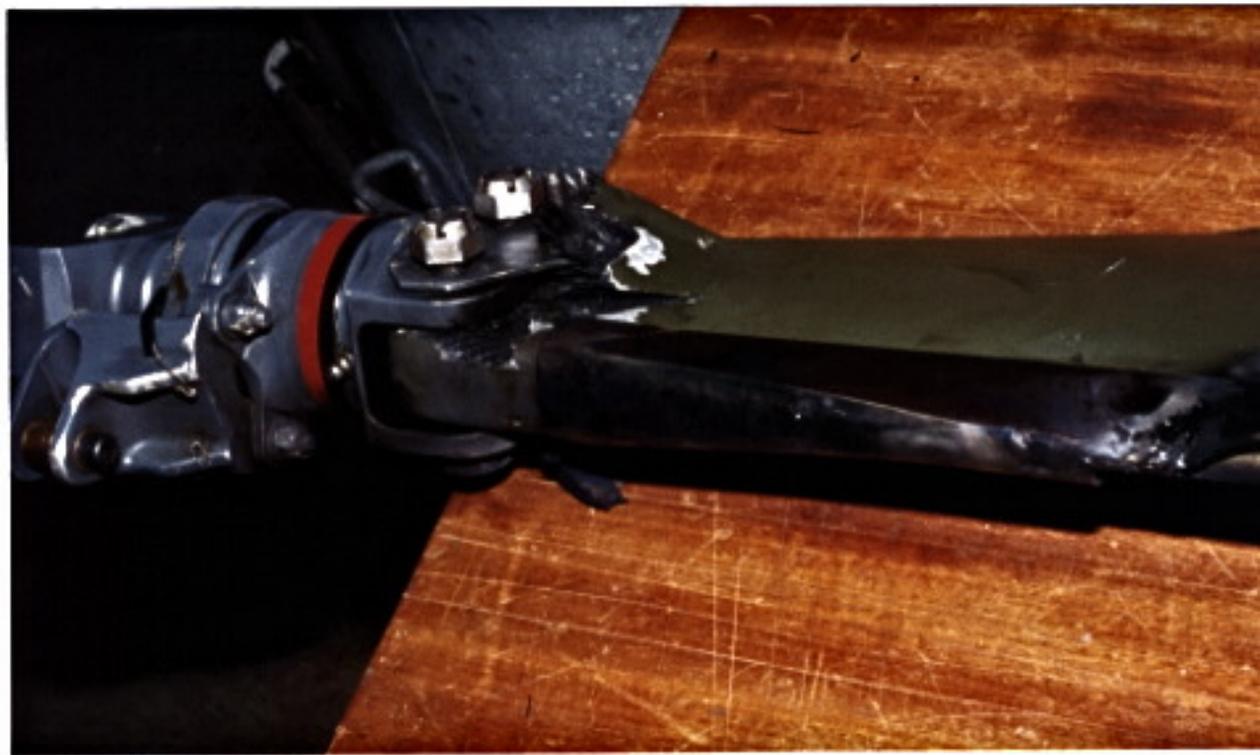
Figure 11D: Showing very marked carbon fibre disbonding and delamination adjacent attachment bolts on inboard side of above blade.

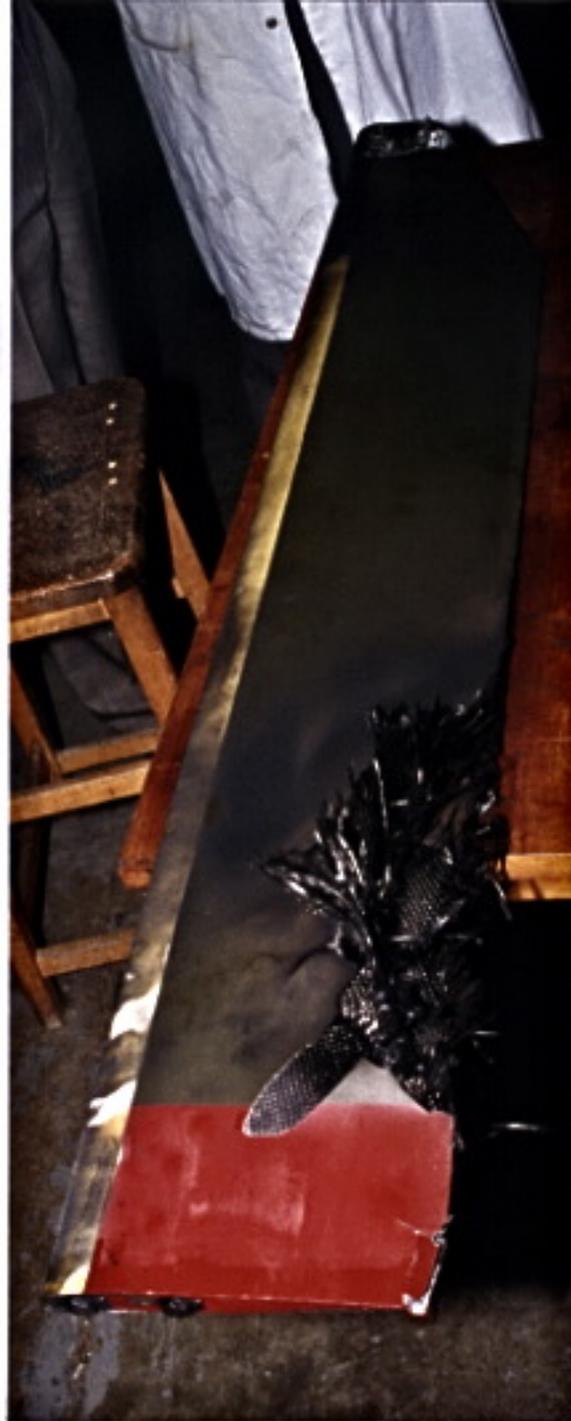
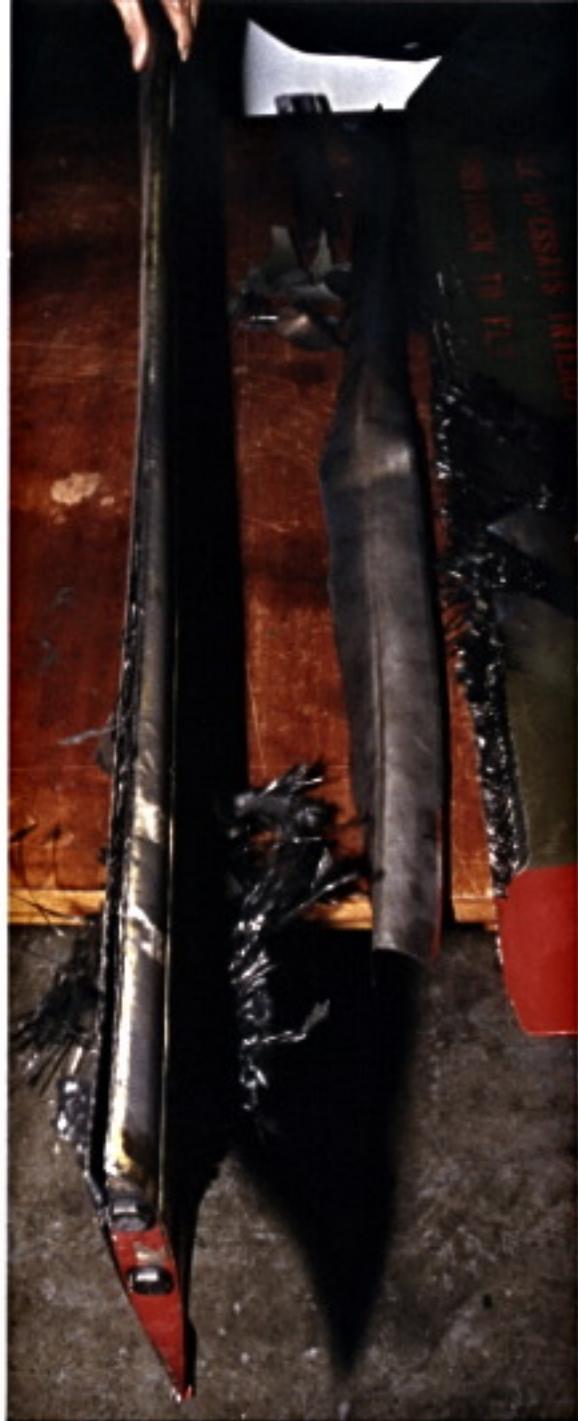
Figure 12A

Showing (Figure 12A) gross damage to aerofoil with (Figure 12B) 'split' in leading edge and detached erosion shield lying alongside TRB s/n 20697 after 253.8kA input to trailing edge, 20cm from tip.

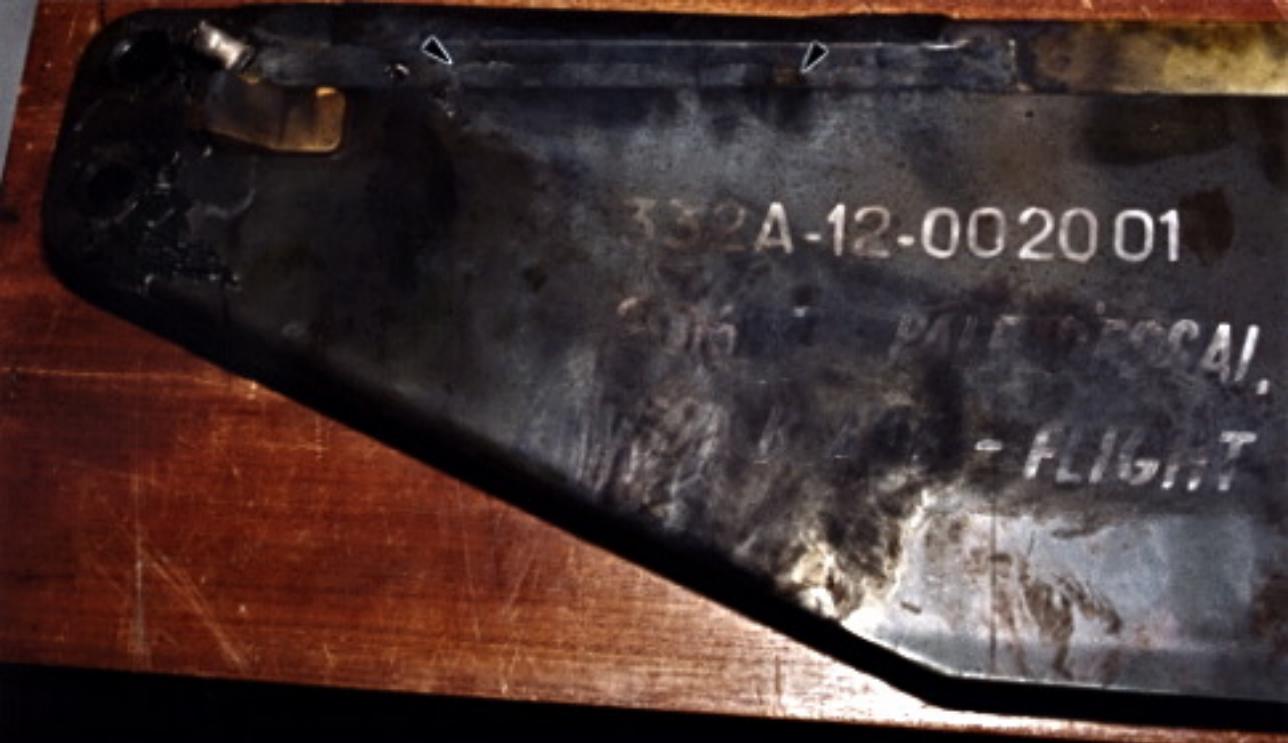
Figure 12C: Showing almost full length 'fissure'(between arrows) within substrate uncovered by loss of brass conducting strip, and root damage adjacent attachment bolt bushes on TRB s/n 20697.
