Report on the accident to Aerospatiale AS332L Super Puma, G-TIGK, in North Sea 6 nm South West of Brae Alpha Oil Production Platform on 19 January 1995

Event Date: 1995-01-19 at 1240

Investigative Body: Aircraft Accident Investigation Board (AAIB), Great Britain

Aircraft Accident Report No: 2/97 (EW/C95/1/1)

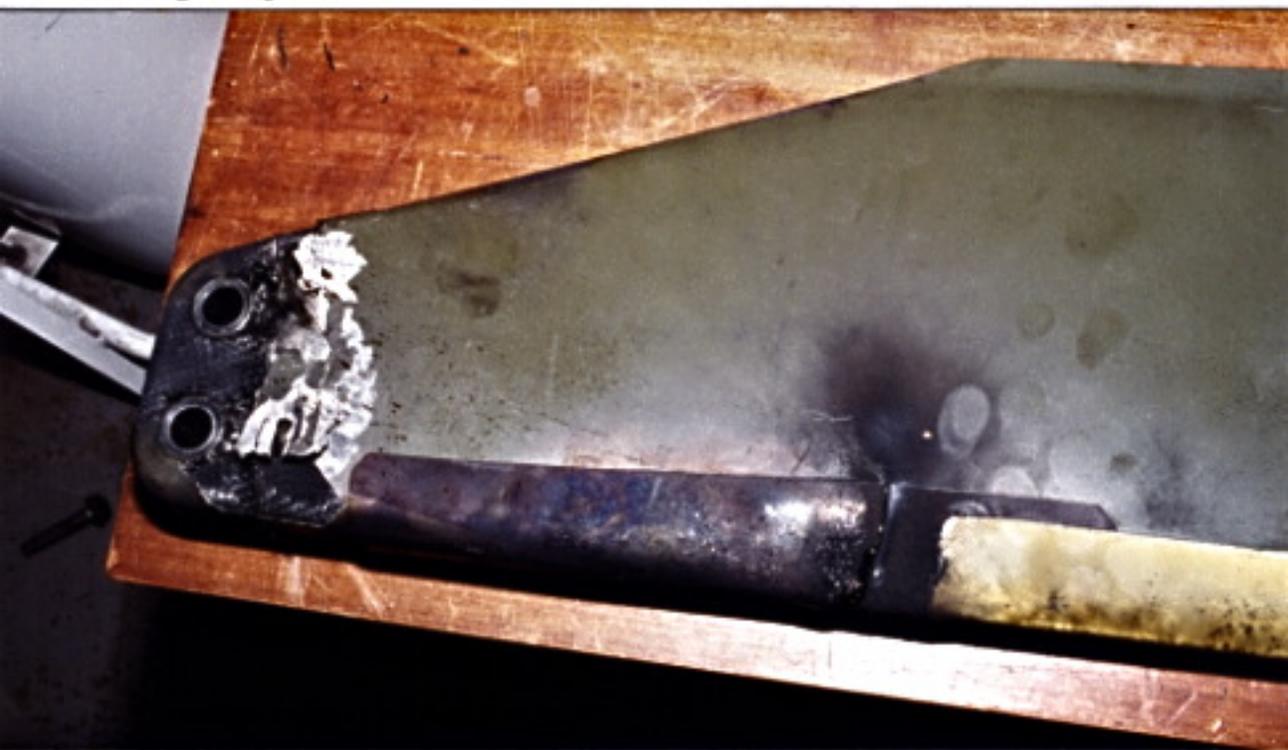
Figure 12D: Showing thermal disbonding and delamination damage to inboard side of root adjacent bushes on TRB s/n 20697.
