Uncommanded roll, Boeing 737-236 Advanced, G-BGJI

Aircraft Incident Report No: 1/98 (EW/C95/10/4)

Report on the incident to Boeing 737-236 Advanced, G-BGJI 15 nm north-west of Bournemouth International Airport on 22 October 1995

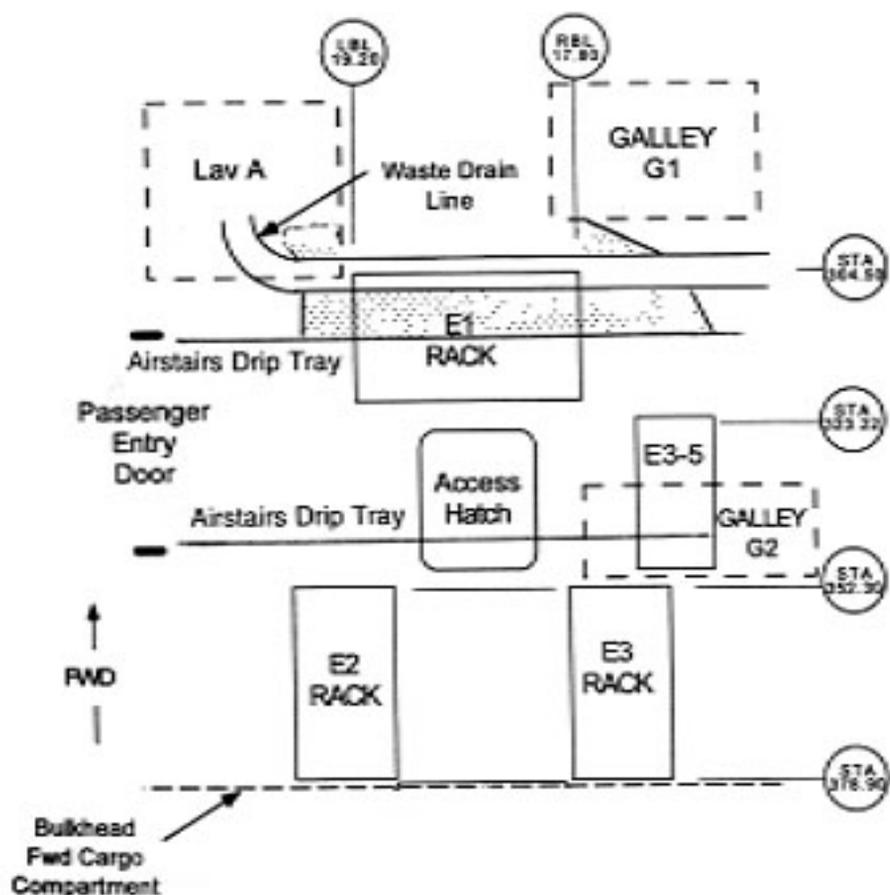
Plan - view of E&E Bay showing location of avionic racks and rubberised fabric shroud protecting E-1 rack (shaded)

Examination commenced with an inspection of the avionics cooling plenum which is situated directly above the E1-1 rack which houses the Yaw Damper Coupler. This had clearly been washed and bore numerous watermarks on its polished aluminium alloy surface. One of these marks, however, was of particular interest since it ran directly above the Yaw Damper Coupler in the rack. The fluid appeared to run forwards from about the mid-point of the plenum on the top surface and then run rearwards to about the same point on the lower surface. A search for a corresponding leak in the rubberised shroud above this apparent path proved negative.

The shroud itself was then removed and examined. Although it had evidently been partially cleaned during the P6 check it was still heavily stained on its upper surface and bore heavy deposits of a waxy substance similar to that used during the floor panel sealing operation. When tested for leakage, the shroud proved water-tight apart from a small area of porosity which had resulted from chafing where it was folded and fastened over the lip of the airstairs drip-tray. This area was fairly remote from the E1-1 rack and it was difficult to conceive any situation whereby fluid entering the bay by this route could contaminate the rack. Doubts were expressed concerning the installation status of the shroud during the incident flight. This arose because, initially, it was not suspected that fluid contamination of the Yaw Damper Coupler was responsible for the incident and investigation was centred on the key components of the directional control system. At an early stage the airstairs drip-tray was removed to greatly facilitate access in the E&E Bay requiring the shroud to be unclipped and rolled back. There is no doubt that it was in the aircraft, attached to the nosewheel bay bulkhead but the inspection team could not recall with absolute certainty that it had been fully fitted. The technician involved with preparing the aircraft for the incident flight had, however, stated that it was completely and correctly installed prior to the flight.

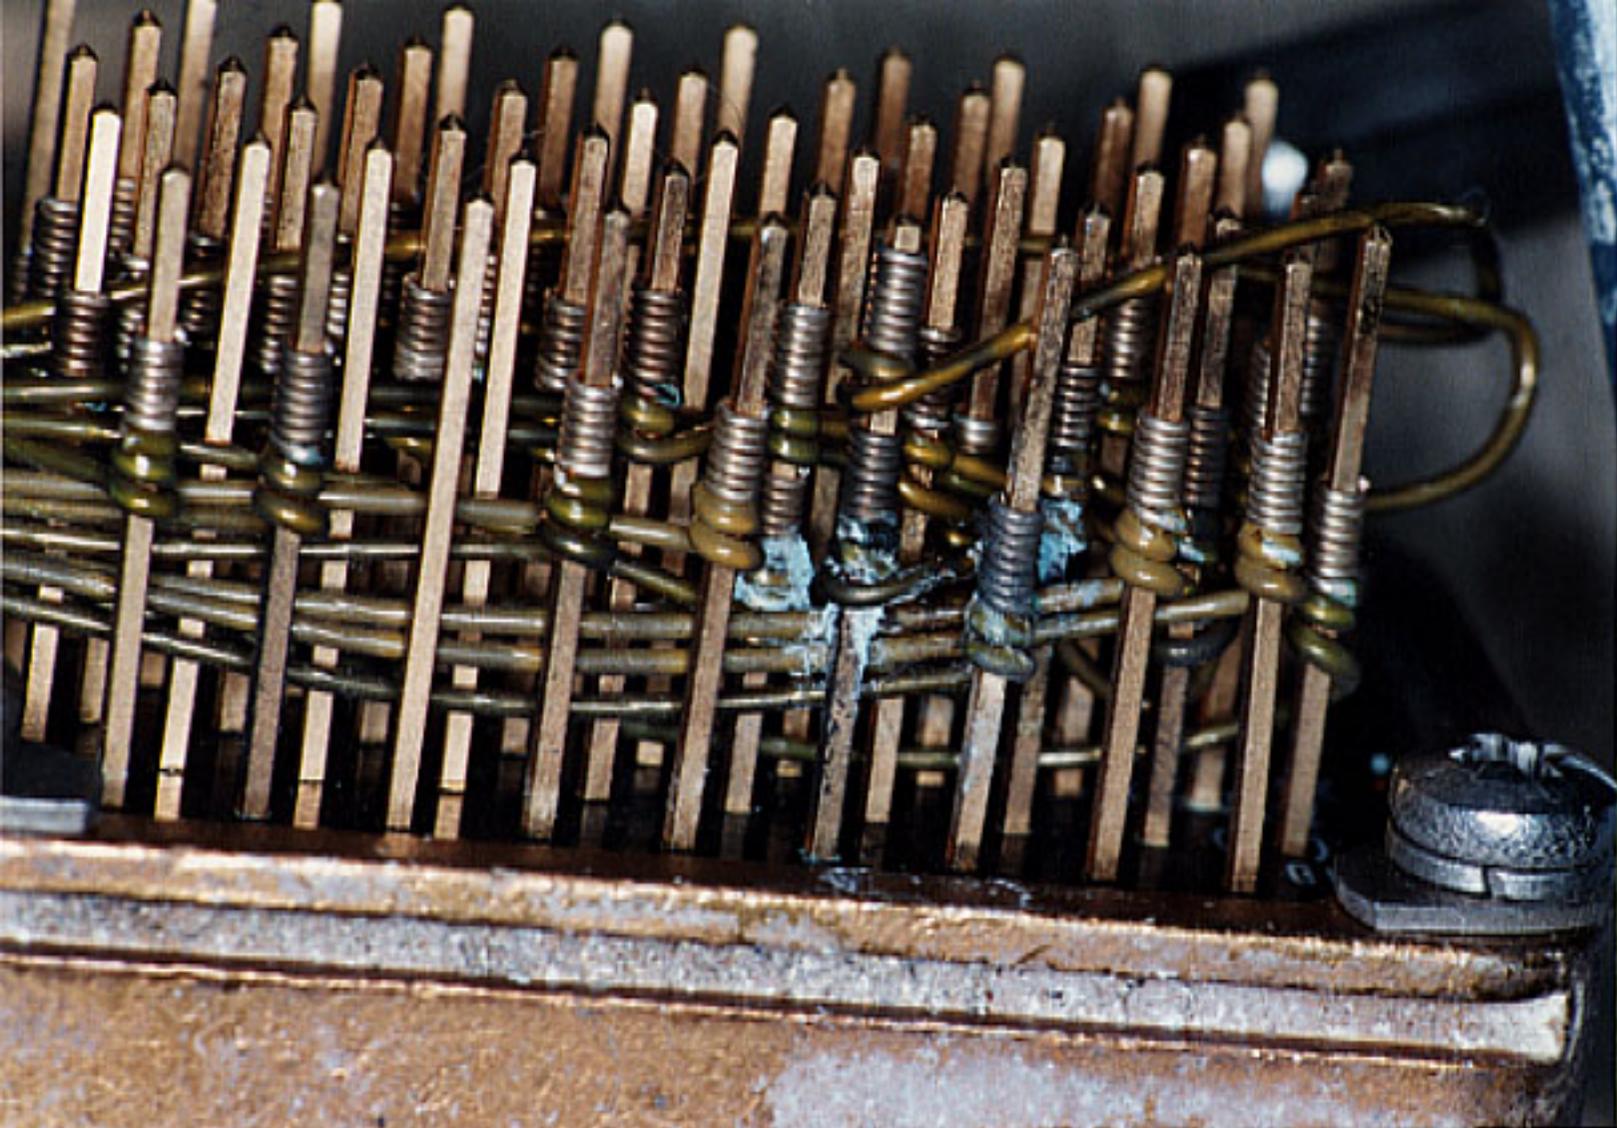
Close-up view of terminal posts at the back of Yaw Damper Coupler connector showing accumulation of electrolytic/corrosion deposits around wire-wrapped joints

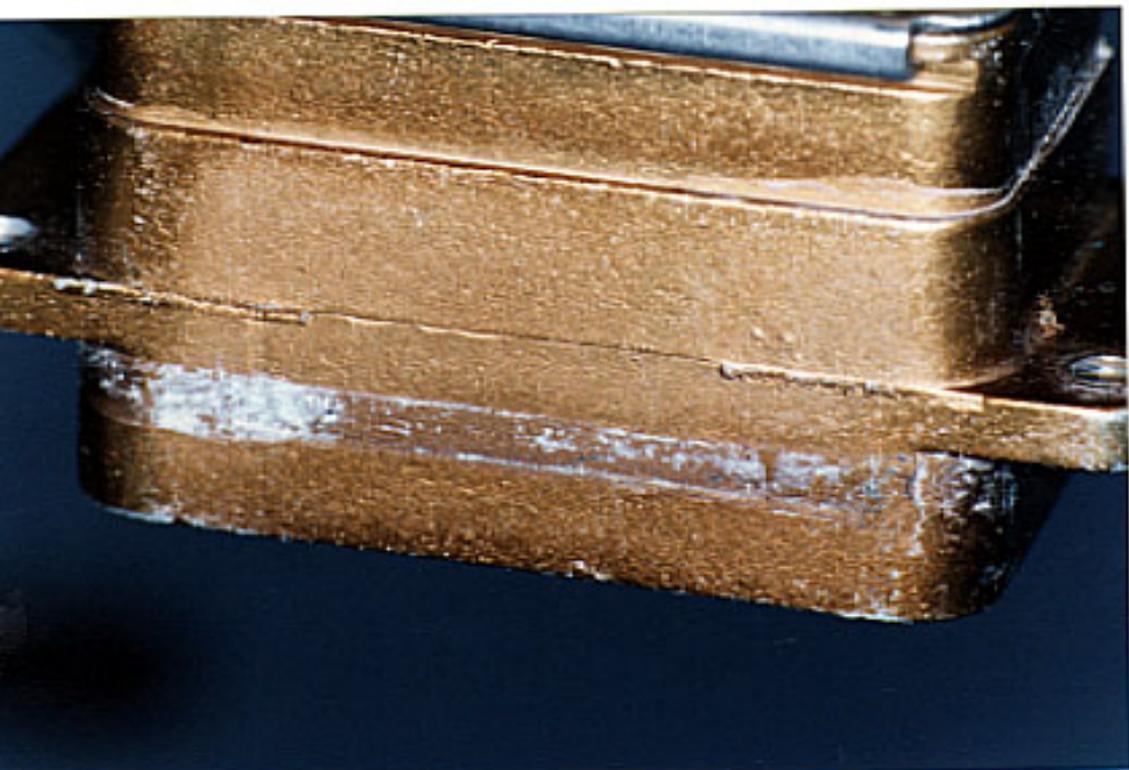
View of YDC connector shell showing evidence of dry corrosion products on exterior surface

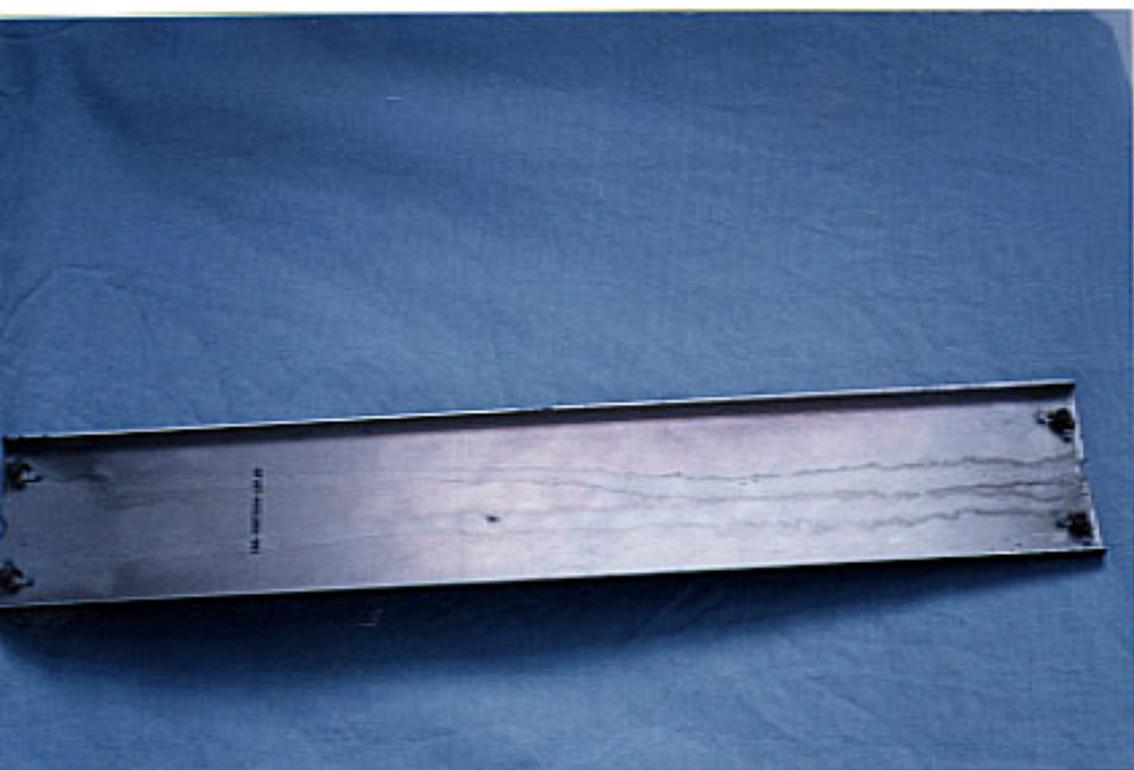
View of YDC lower cover plate showing evidence of dried fluid runs on the inner face
