Proximity conflict, Boeing 737-2D6, 7T-VEY, 21 December 1995

Boeing 737-2D6, 7T-VEY, 21 December 1995

AAIB Bulletin No: 6/96 Ref: EW/C95/12/5 Category: 1.1

INCIDENT

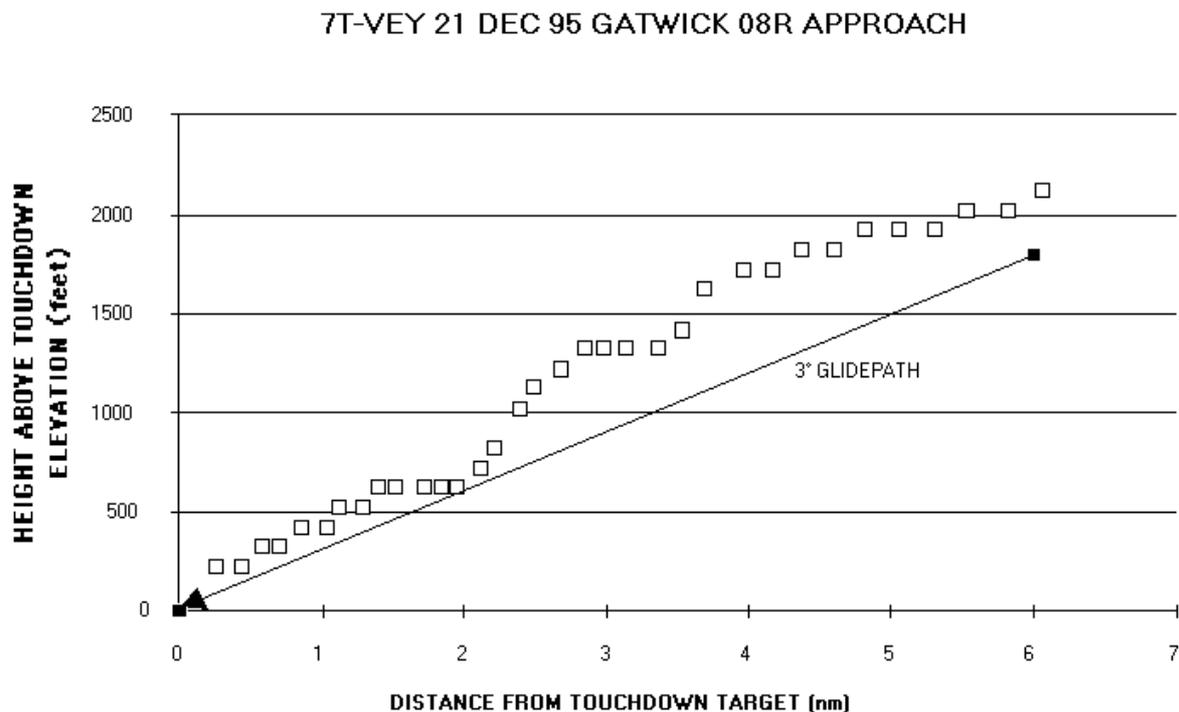
Analysis of the vertical profile of 7T-VEY was carried out using the mode C transponder data. The final approach profile is shown below:

The maximum rate of descent, some 2,100 feet per minute, was achieved just outside 2 nm from the touchdown target. With the Mark 1 GPWS system fitted to this aircraft, the only aural alert available for Mode 1 (Excessive Descent Rate) was "WHOOOP WHOOOP PULL UP". On the later standard of GPWS fitted to the Boeing 737 series, this rate of descent would have triggered only a "SINK RATE" aural warning at this height above the ground.
