## Partial-gear landing, Airbus A340-311, G-VSKY

Aircraft Accident Report No: 4/2000 (EW/C97/11/1)

## Report on the accident to Airbus A340-311, G-VSKY at London Heathrow Airport on 5 November 1997

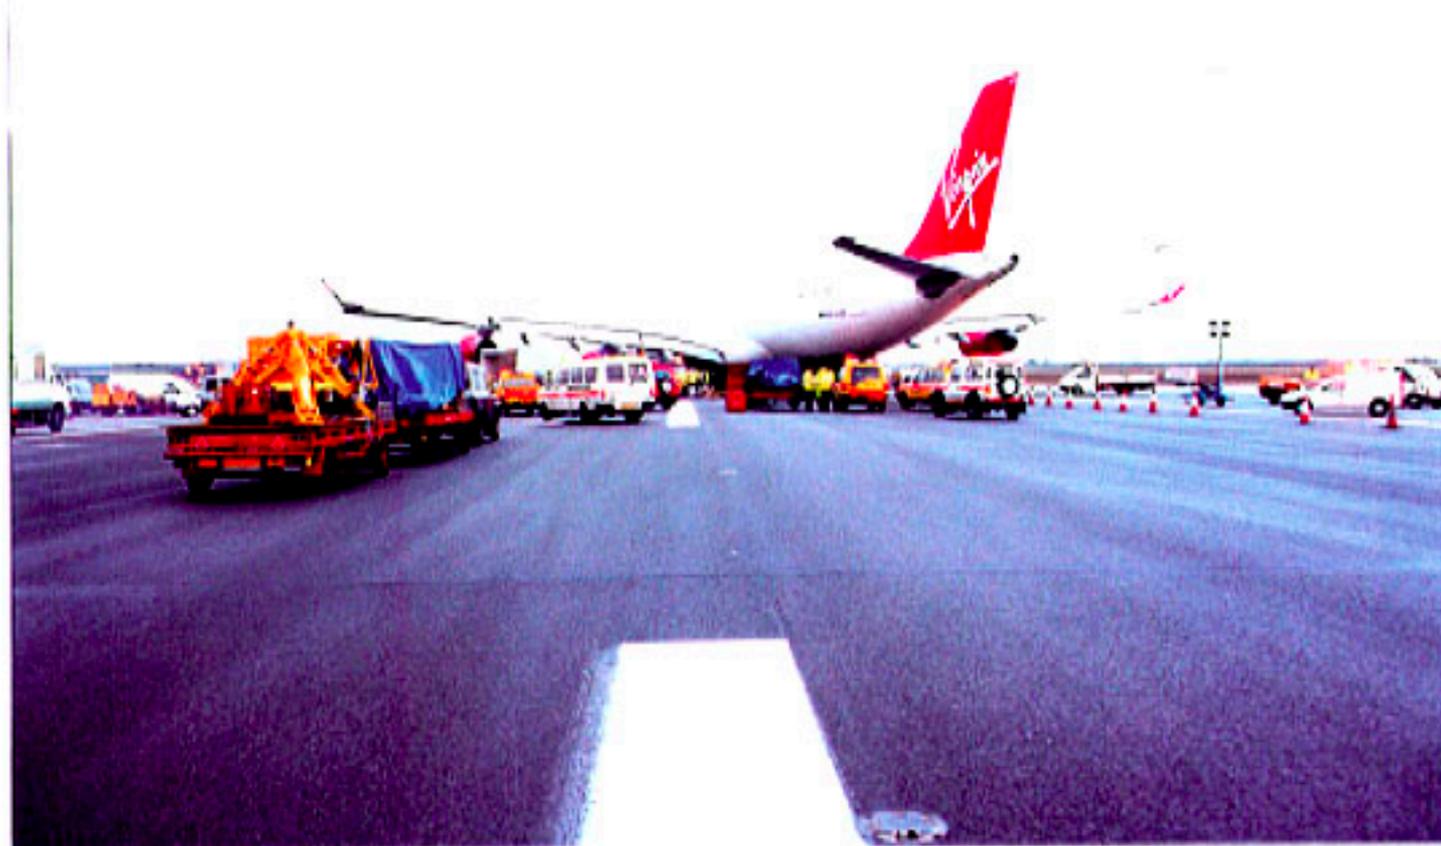
This photograph, taken the following morning, shows the aircraft after jacking and prior to moving. Note the runway centreline markings and aircraft heading. The runway had been repaired by the time this photograph was taken

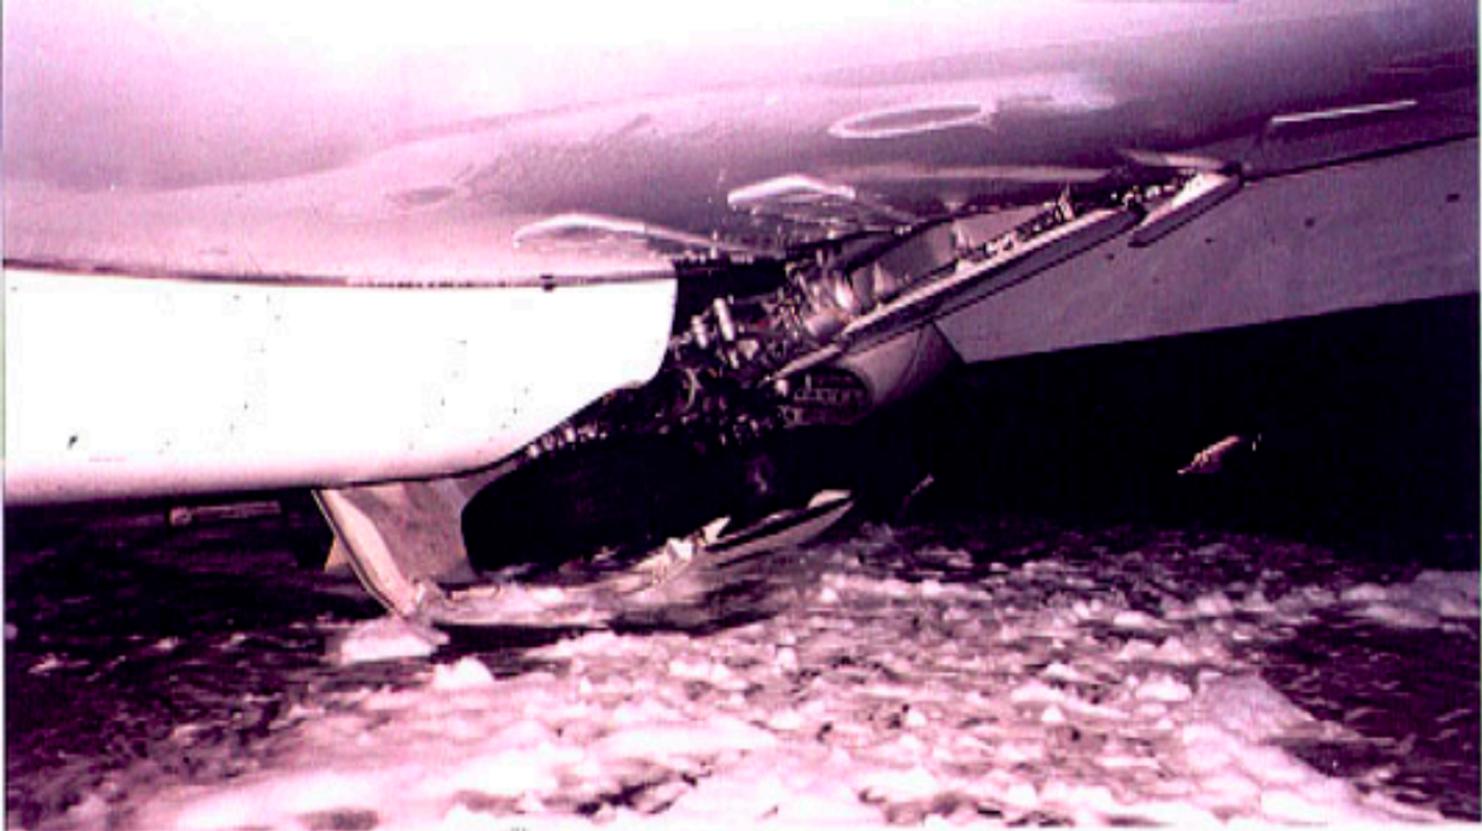
- The left main landing gear was only slightly extended with the outboard wheels and tyres clearly visible. Closer inspection showed that the brake torque rod for the No 6 (left rear inner) brake pack was disconnected at the brake end and had swung out of alignment to become trapped in the open structure of the keel beam within the wheel bay. It was apparent that this landing gear could neither be lowered or retracted once the rod had become so trapped, and there was damage to the ancillary keel beam structure and APU duct which had occurred during the attempts to raise or lower the gear.

LEFT MAIN GEAR JAMMED IN PARTLY EXTENDED POSITION

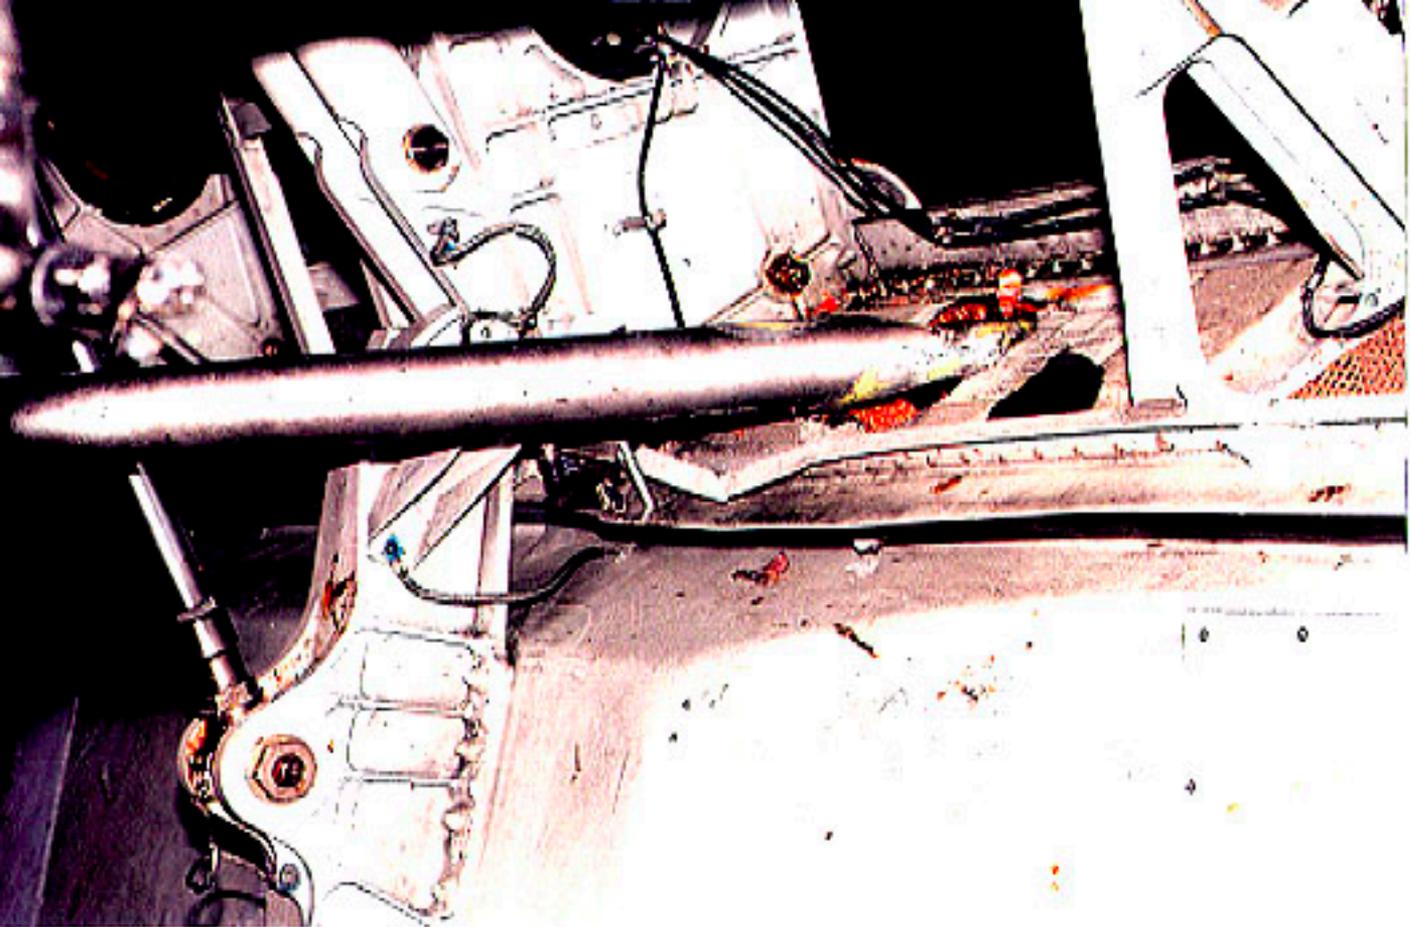
- Subsequent examination of the left main landing gear found that it was jammed by the No 6 brake torque rod which had become trapped in the keel beam structure (Appendix 5) and that the torque pin retaining the rod at the brake end was not present, allowing the unrestrained rod to pivot about the retained end.

No. 6 BRAKE TORQUE ROD JAMMED IN KEEL BEAM STRUCTURE

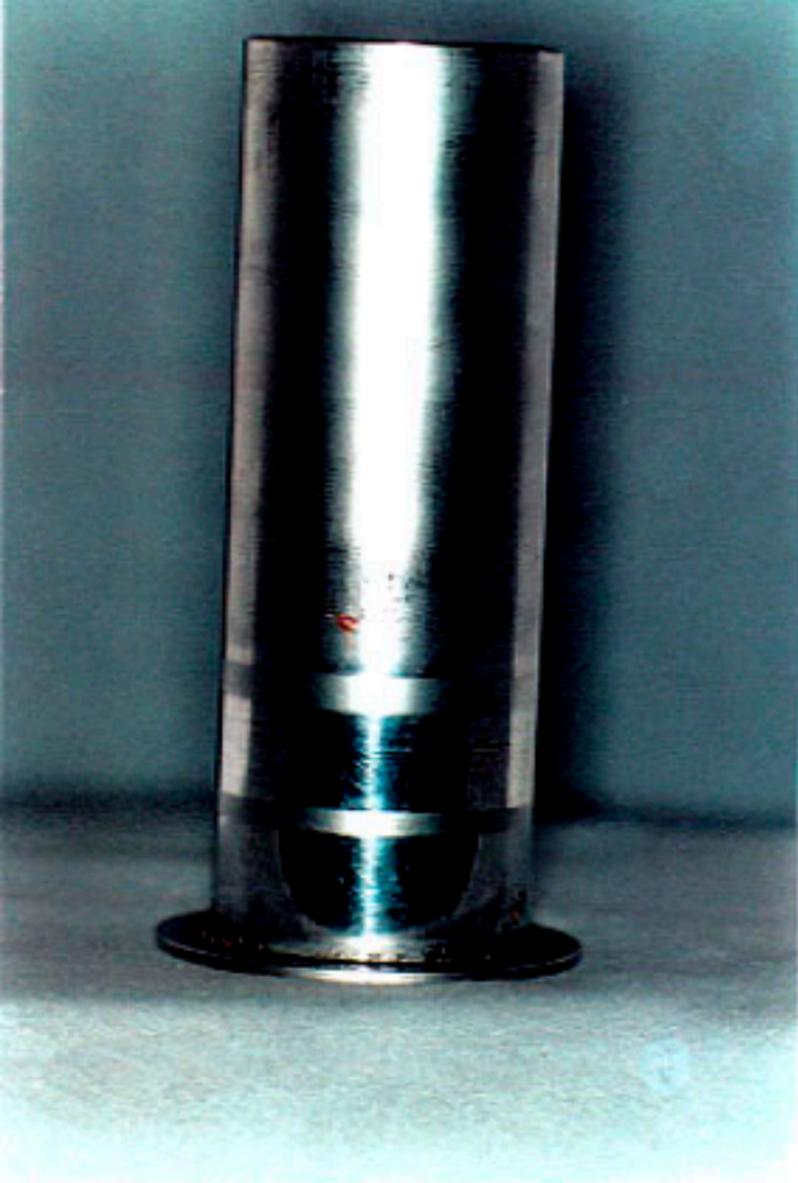
- A later search conducted at Los Angeles International Airport was successful in finding the missing torque pin in the area between the end of the departure Runway 24L and the Pacific shoreline, close to the Airport (Appendices 6 and 7). However, the retaining hardware was not found.

The No. 6 torque pin recovered from the departure  
end of runway 24L at Los Angeles Airport

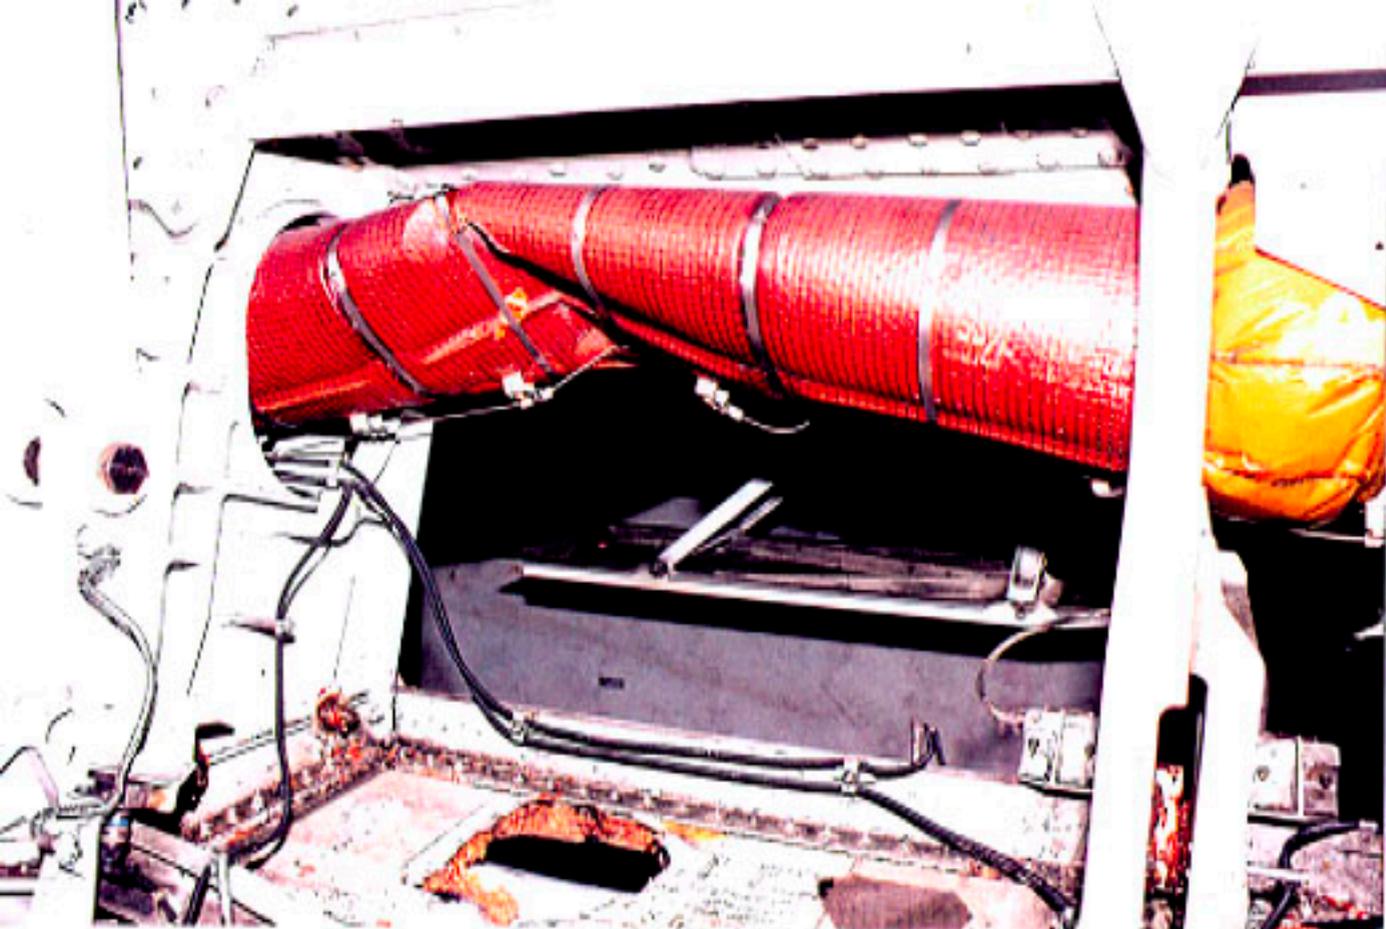
View of the damage to the keel beam area. Note the damage to the honeycomb panel and distortion of the nearer edge member at the bottom of the picture

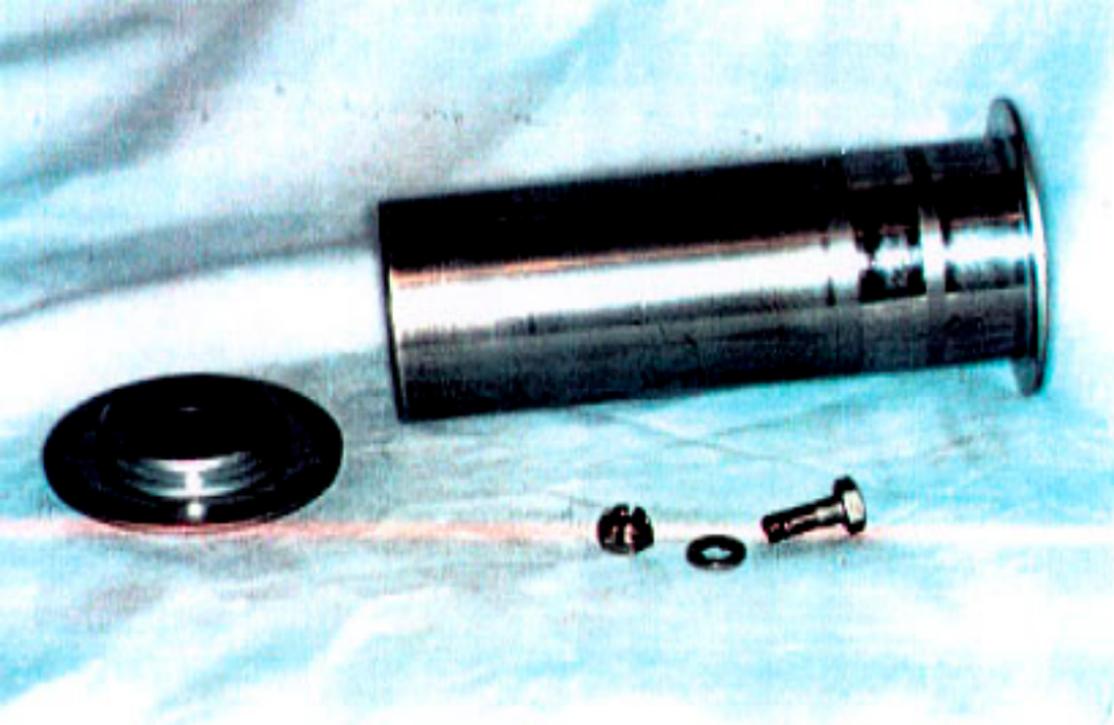
Pin, retainer and fasteners removed from No. 5 position,  
adjacent to missing parts at No 6 brake position.

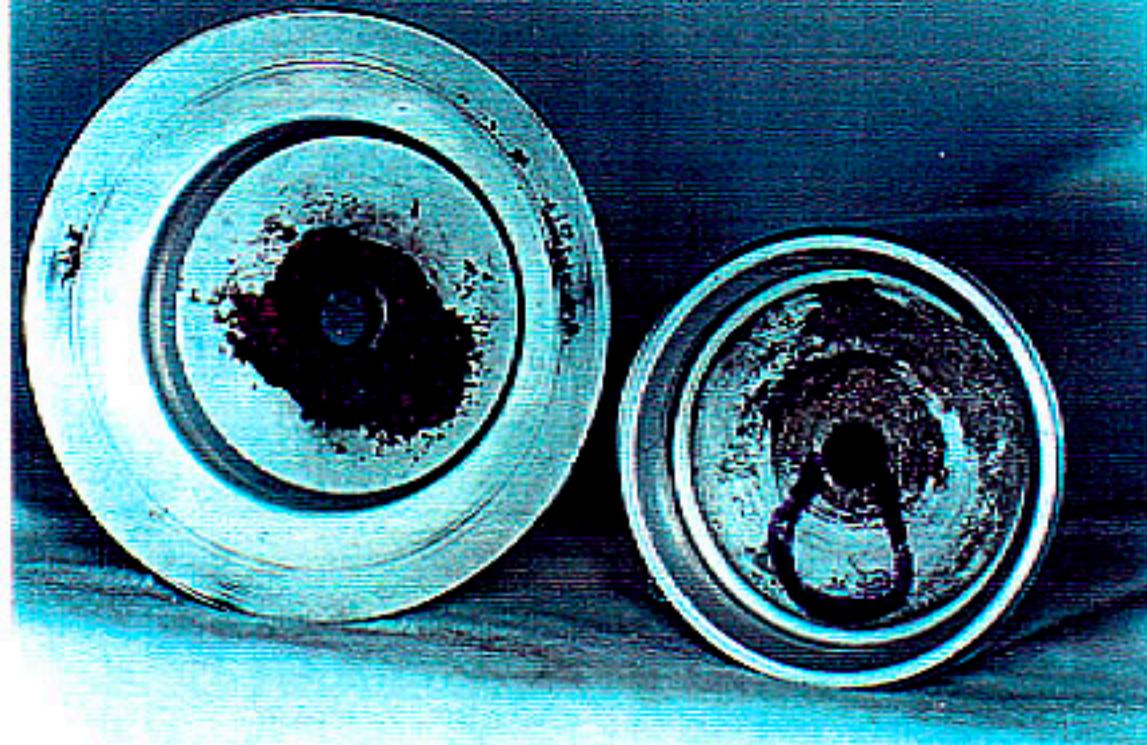
Plate A1

- a very small transgranular crack was present in one retainer;
  - a torque pin from G-VAEL was found to have a large radial crack in its end diaphragm which was considered to have been propagated by a stress corrosion mechanism (Appendix 18, plates A1 and A2);

View on the outer end of the pin and the inner end of the end cap from the No. 5 position on Virgin A340 Airbus registration G-VAEL showing extensive interface corrosion. The position of the radial crack is marked in black ink.

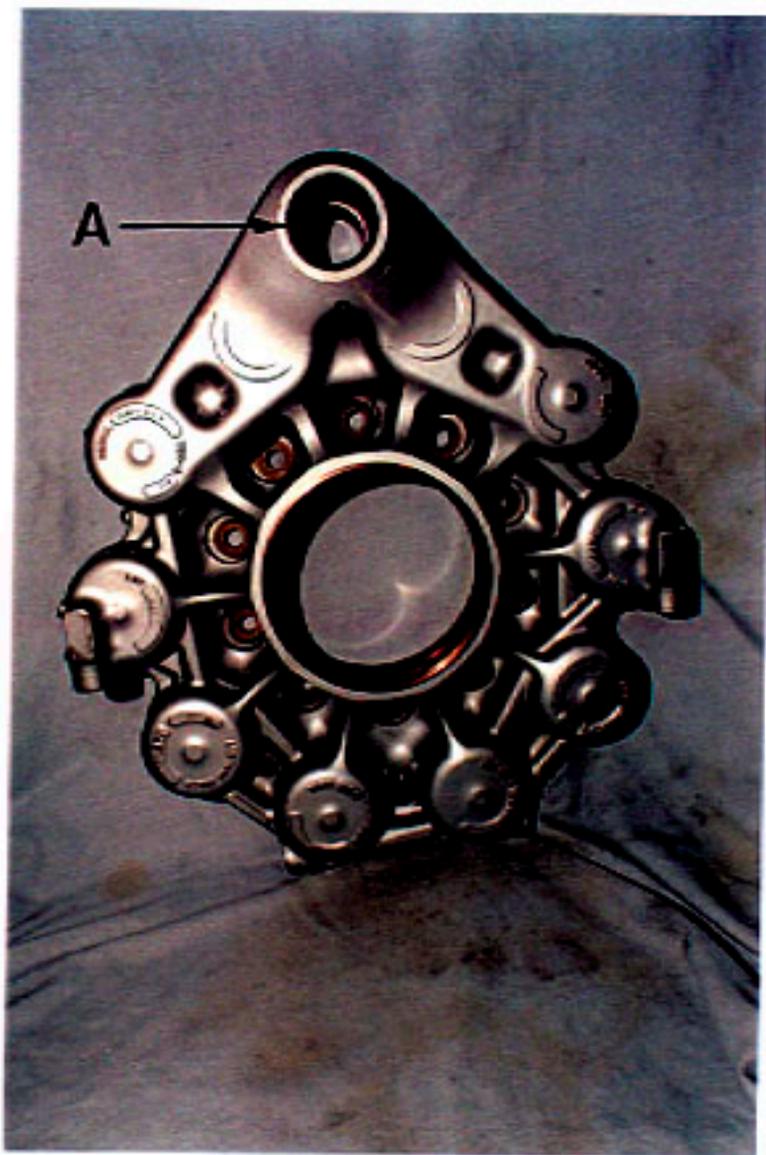
Plate 1

Brake plate reported to be from the position on the left hand main undercarriage on Virgin Airbus G-VSKY from which the brake reaction rod became detached. The Plate was identified Part 5010218-1 ILM, SUBASSY 5010219-1, Serial No. SEP91-0039, TSO-0 26c, AB80-USA, TYPE IVBQ FORG 5010169.

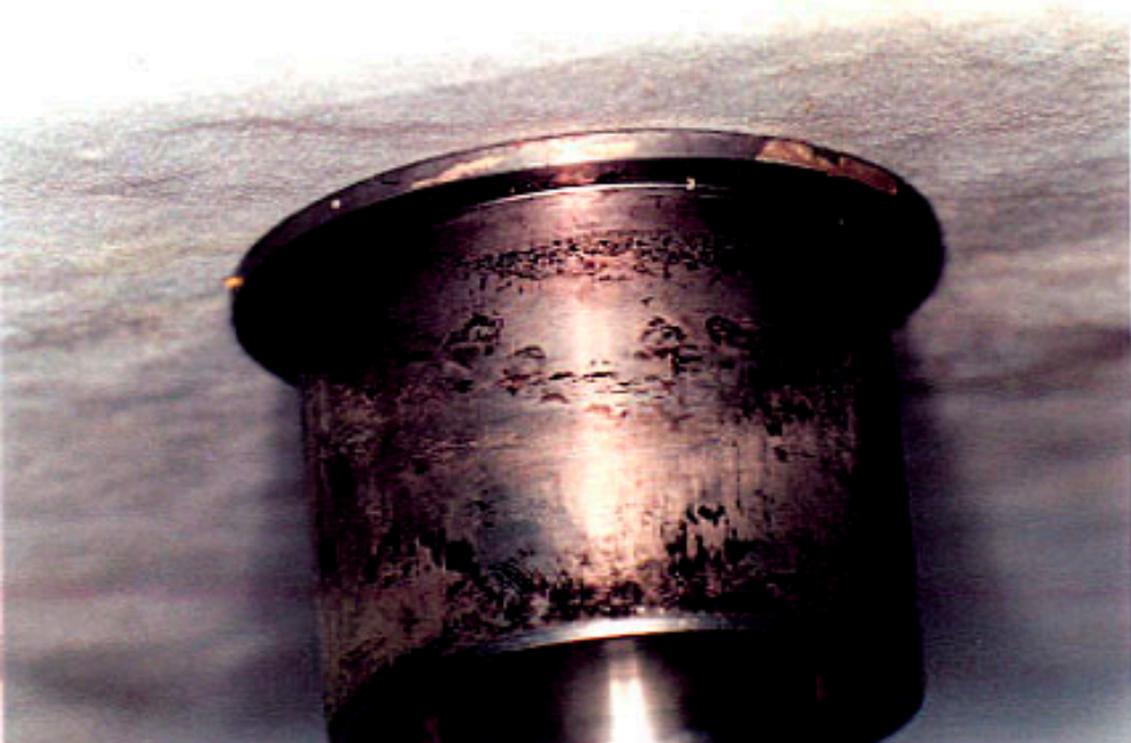
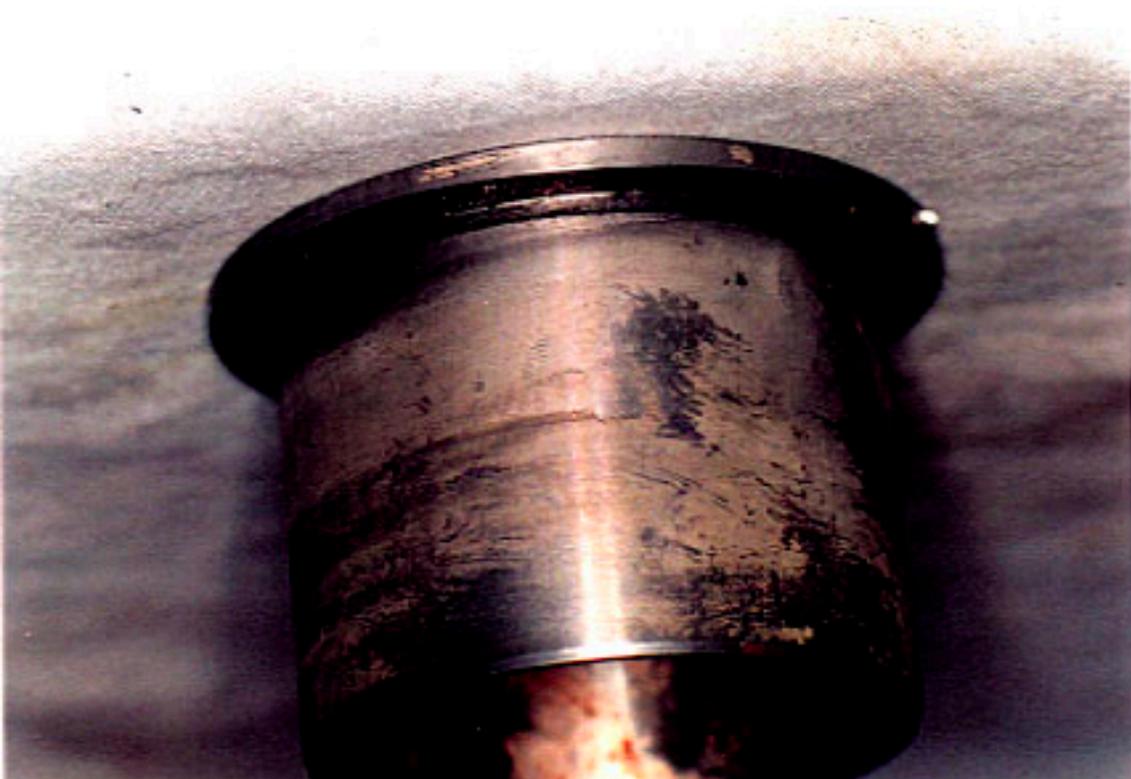
Plate 3

Two views on the bush from position A on Plate 1. The pattern of the debris and marking conforms to the general pattern of the marking within the hole shown on Plates 4 & 5. The marking in the hole is positioned where arrowed on Plate 1.

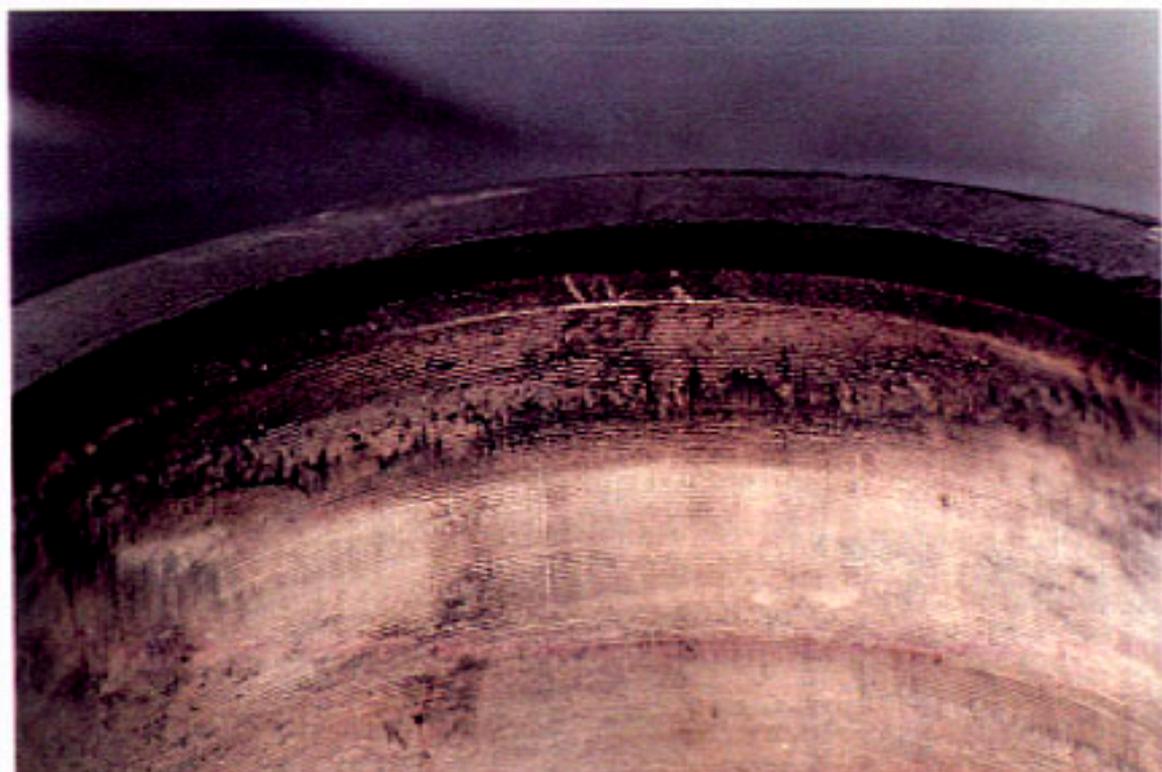
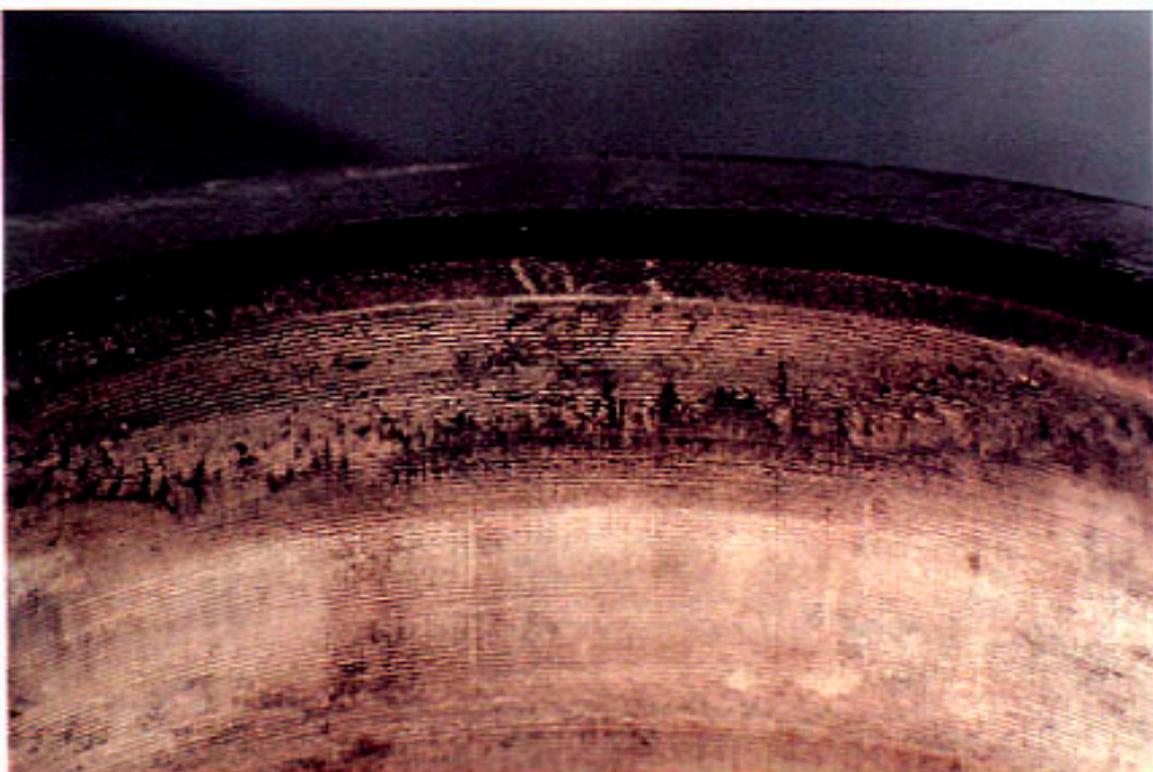
Plate 5

The marking within the hole where arrowed on Plate 1 shown at two different magnifications. It can be seen that the original machining marks have not been removed even though the hole was 0.009 ins oval. The maximum diameter was at this position.

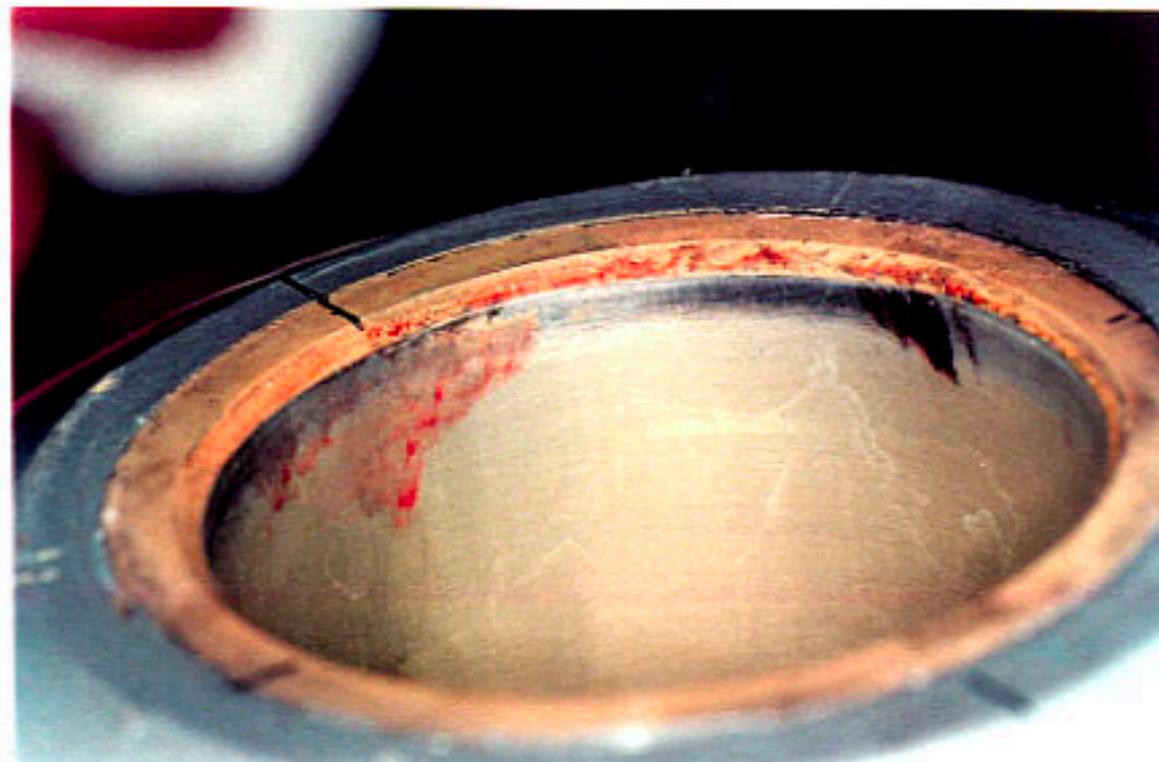
Plate 6

Brake Plate Serial No. 0111 - April ,94 - Hong Kong incident - end of hole remote from brake pack - start of 'compression' mark around rim. Photograph taken at ABS, Slough immediately after removal of bush

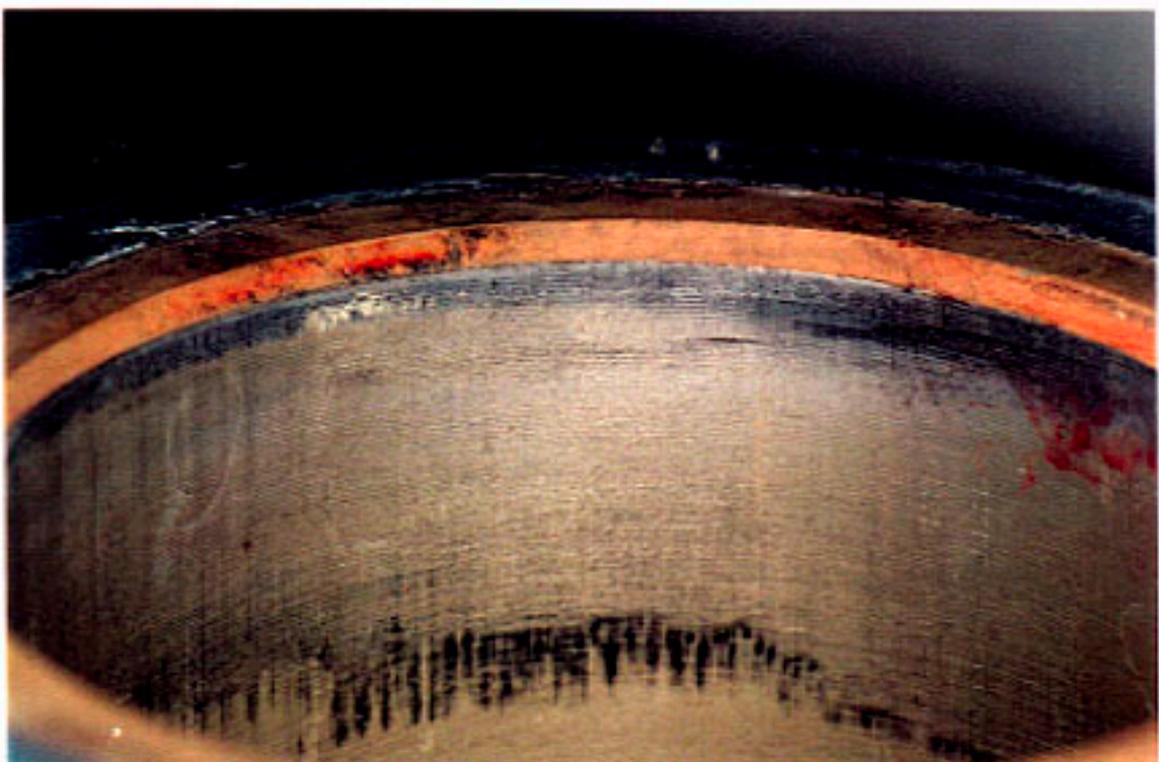
Plate 7

As Plate 6 but further round hole.
