Yaw control problems and runway overrun, Fokker F27-500, G-BNCY

Aircraft Accident Report No: 4/99 (EW/C97/12/1)

Report on the accident to Fokker F27-500, G-BNCY at Guernsey Airport,
Channel Islands on 7 December 1997

Aircraft Type and Registration: Fokker F27 Mark 500, G-BNCY

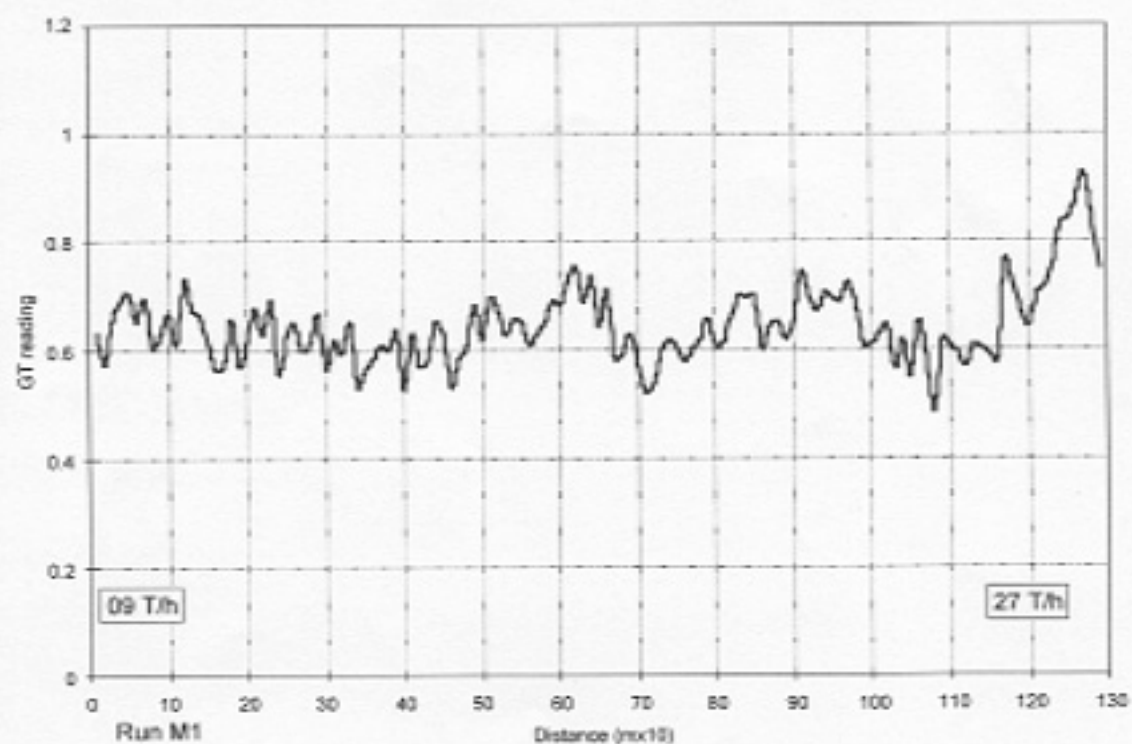
Figure 6 Natural rain. Run 1, 09 direction, 1.5m I of centreline

Table 5 shows the average readings on the runway during rainfall. Typical traces of the runs performed in rainfall are shown at Figure 6 to Figure 8. The same general variability about the mean found in the classification trial is evident in these traces. There are no rapid reductions in friction of the type which would be caused by areas of standing water, except for a very short duration excursion at the 09 threshold in run 8 (Figure 8) approximately 1.5m from the edge of the runway and thus not in a trafficked area.
