Wing strike, Boeing 757-200, G-WJAN

Air Accident Report No 3/99

Report by the Dominican Republic Authorities into the accident to Boeing 757-200, G-WJAN at Puerto Plata Airfield, Dominican Republic on 1 January 1998

Registration: G-WJAN

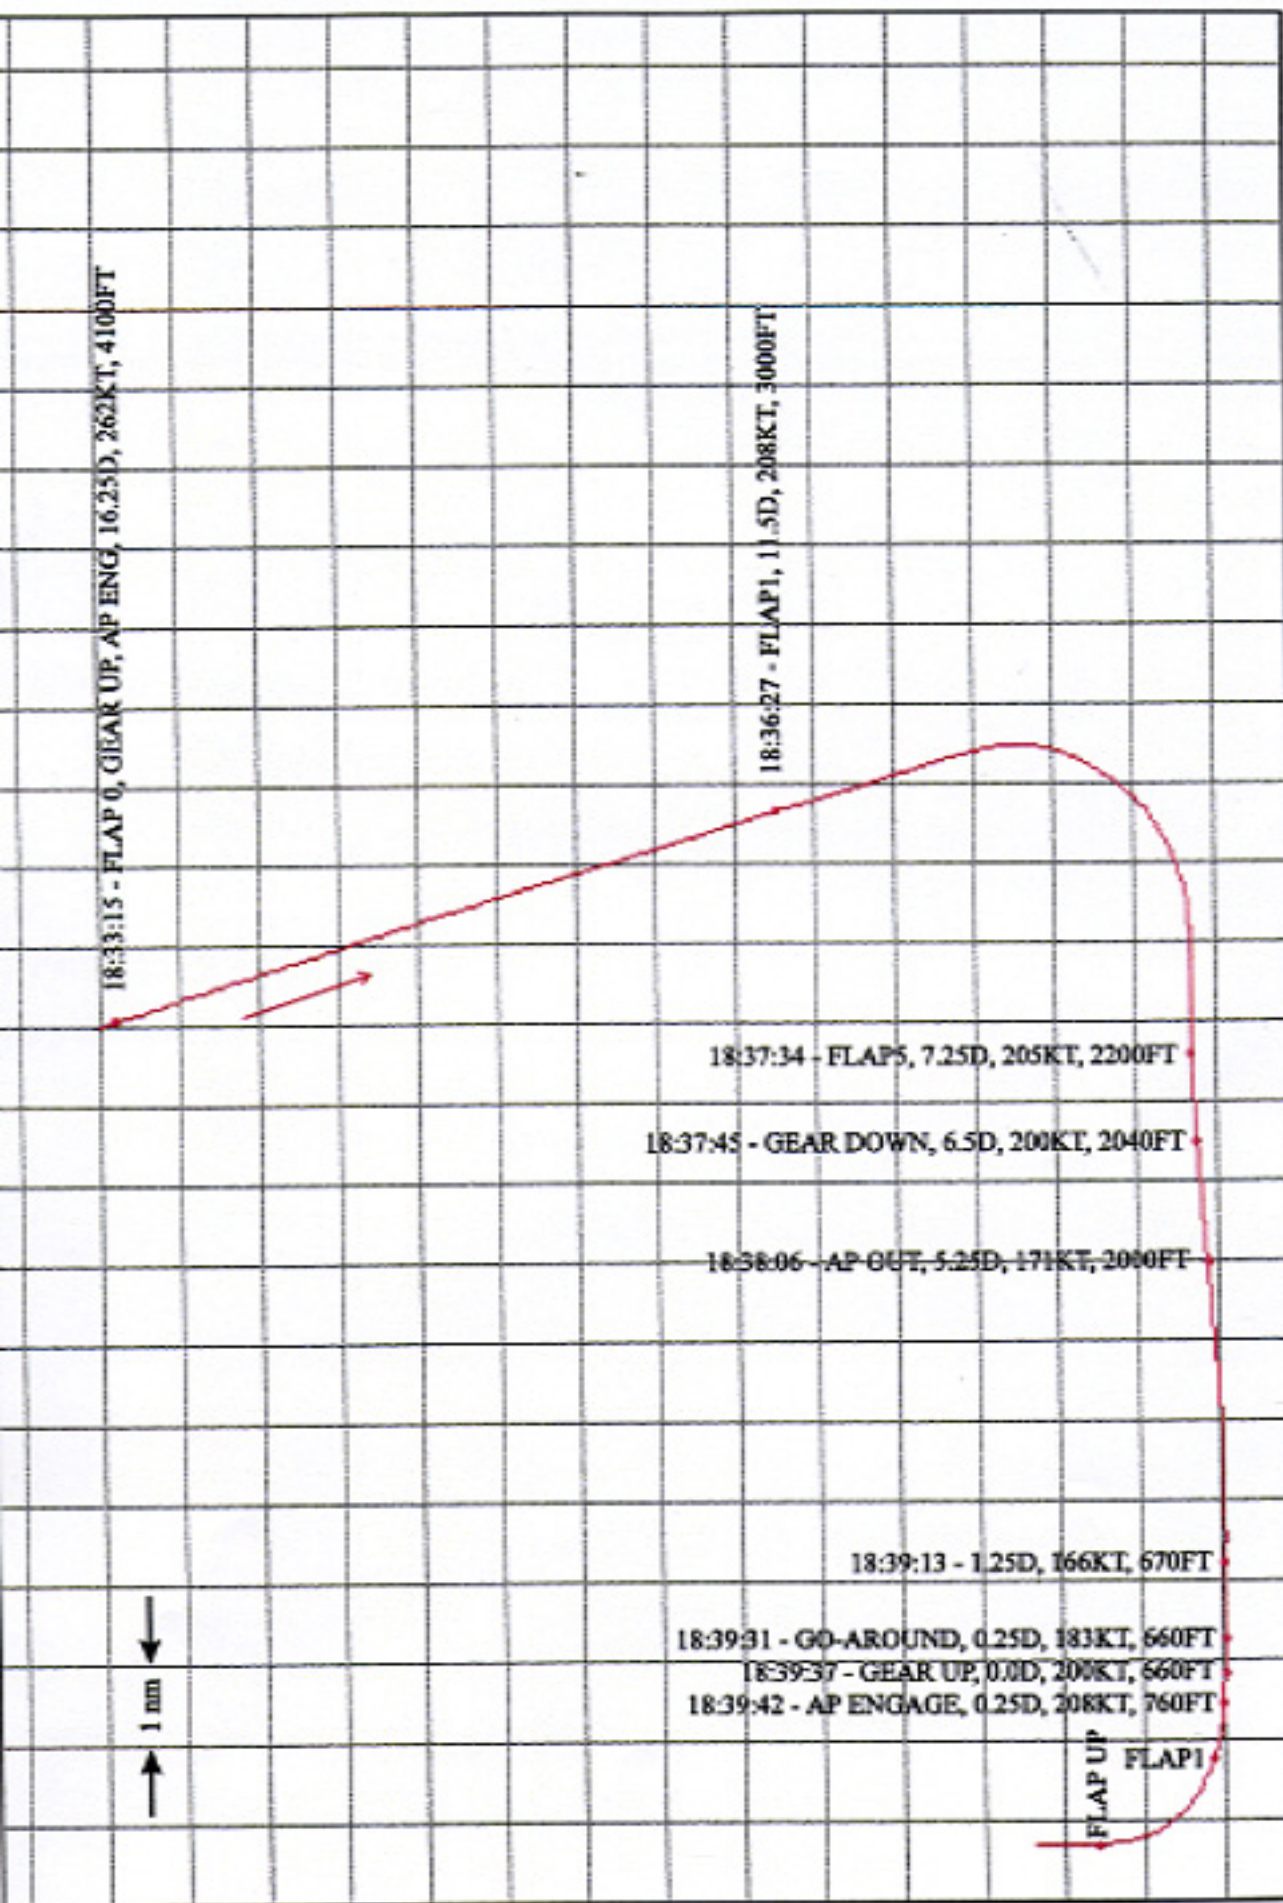
APPENDIX 1

During the right turn onto the inbound track of 263° flaps 1 was selected and the final descent commenced. Once established on the inbound radial, and at a range of 7.25 DME, flaps 5 was selected whilst at 2,300 feet and 210 kt, the gear was selected down at 6.5 DME. The aircraft was still at 2,000 feet at 5.25 DME when the pilot disconnected the autopilot (AP) and commenced the descent to the published Minimum Descent Altitude (MDA) of 660 feet. The aircraft reached the MDA at 1.25 DME and then briefly flew level at this altitude but no visual contact was established with the ground until just prior to commencing the go-around (GA) which was initiated at 0.25 DME by engaging the go-around switches. The published Missed Approach Point (MAP) was at 1.2 DME which was 0.3 nm from the runway threshold. An annotated ground track derived from the FDR using recorded heading and drift angle together with a descent profile for this first missed approach are plotted in Appendix 1 and Appendix 2 respectively.

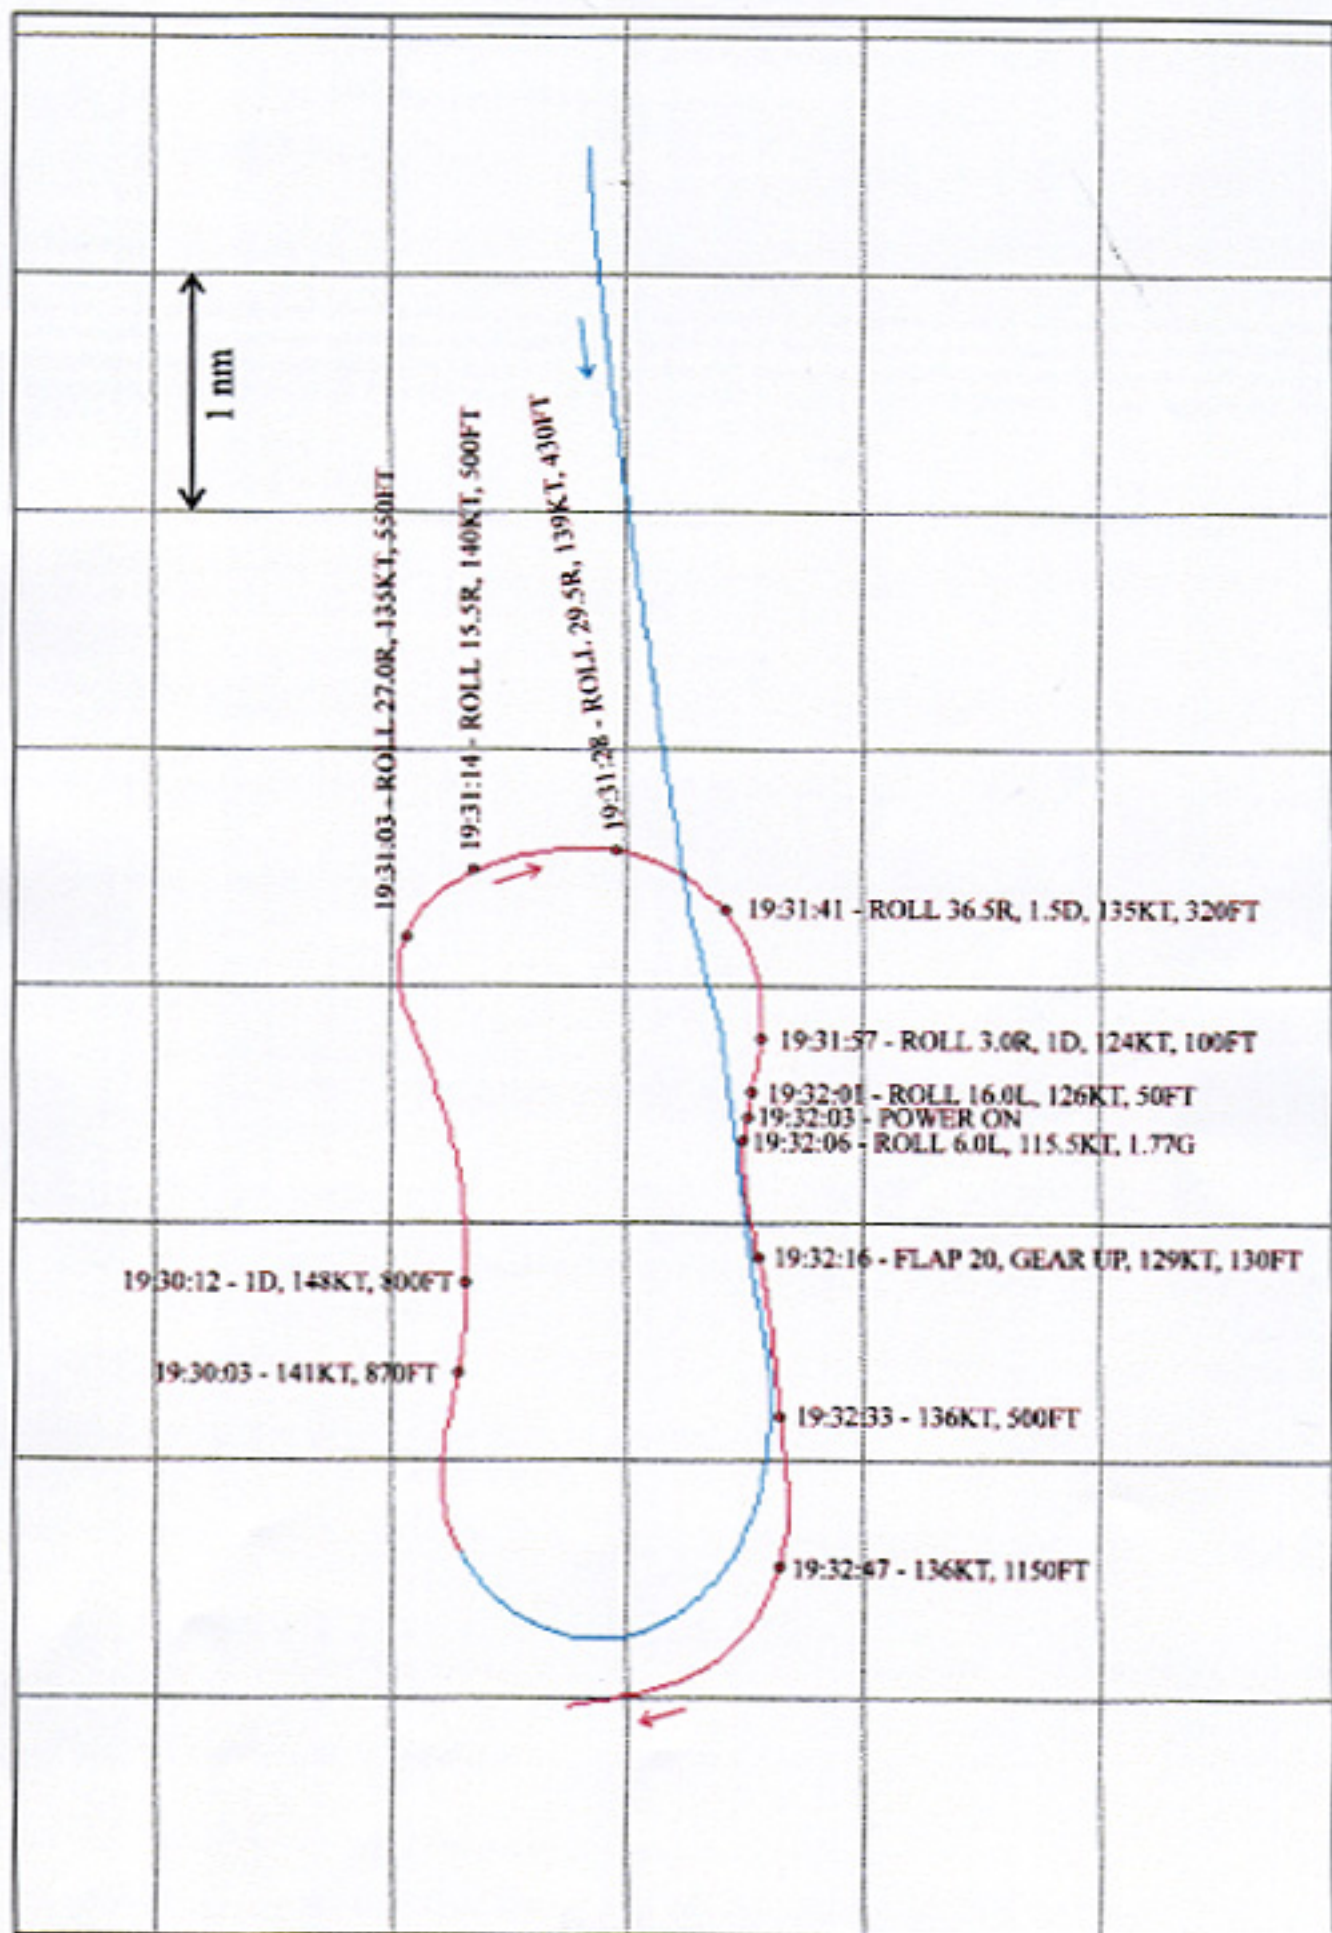
APPENDIX 5

Following the second missed approach the aircraft climbed to 700 feet and commenced a right turn to enter the downwind leg of the circuit. A peak bank angle of 34.5° right wing down was recorded during this turn and the aircraft initially rolled out onto a heading of 097°M and was thus converging with the runway. Whilst on the downwind leg the commander climbed the aircraft up to 800 feet briefly but it went into cloud so he regained 700 feet from where both crew members could clearly see the runway. The aircraft heading was then adjusted left onto 070°M and the FO, in the right seat of the aircraft, was satisfied with the orientation and positioning whilst on the downwind leg. The tower controller passed a surface wind of 090°/10 kt that corresponded with the wind derived by the flight management computer at 700 feet which indicated 100°/13 kt. The commander started his stopwatch abeam the runway threshold and commenced a right turn 25 seconds later from an altitude of 620 feet, he immediately initiated a slight descent. As he entered the turn he had already lost sight of the runway but could see the bay and associated coastline clearly; the FO had good visual contact with the runway and commented that the initial element of the turn looked satisfactory. The commander still had the VOR/DME display selected but was not using it, he had also selected his flight director off. However, the FO selected the runway heading on the mode control panel as the turn was initiated.

The commander reported that about half way round the turn he looked to his right across the flight deck and lowered his head in order to view the runway which he saw was in the expected position. However, as he raised his head, his headset cable caught on the control column, possibly on the map holder, and as he continued to raise his head the left earpiece was pulled from his head and his glasses were dislodged. He was distracted for a period of a few seconds and when he had replaced

his glasses he realised that the angle of bank had reduced to about 15° and that an increased bank angle would be required in order to gain the extended runway centre-line. The FDR data indicated that during the descending turn an initial steady bank angle of 26° was established but, as the aircraft was turning through 120°M, the angle of bank reduced over a period of 11 seconds to 15.1°. Over the next 7 seconds the bank angle varied with values of between 19.3° and 14.7° being recorded, at the end of which the aircraft had descended to 460 feet and was turning through 163°M. The remainder of the right turn, which lasted a further 36 seconds, showed average bank angles of between 22° and 30° but with a peak of 36.5° during the latter stages when the height was 320 feet. The recorded DME at that point was 1.5 nm and the airspeed during the turn had slowly reduced from 140 kt to 130 kt.

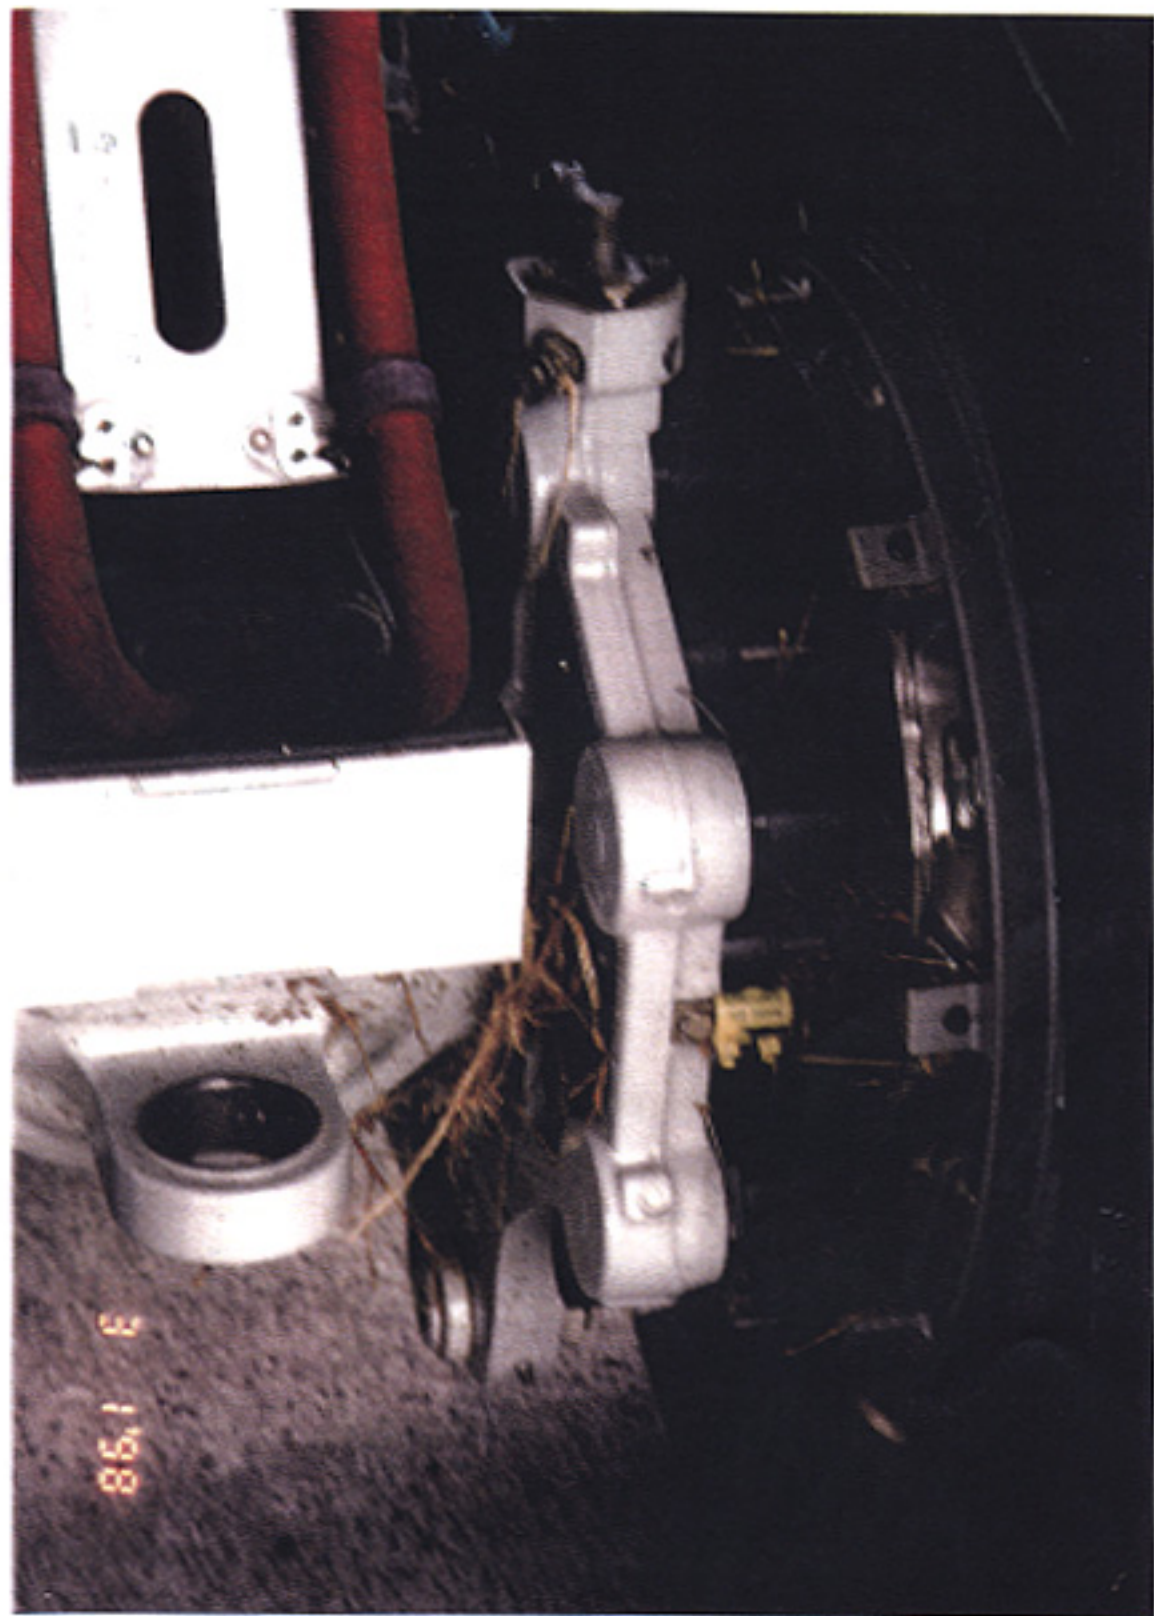
Figure 1 View of left main gear

The aircraft touched down in scrub land to the right of the runway surface, the left main gear and the tail area received the brunt of the impact. The left main gear struck the ground 5.3 metres beyond the right-hand edge of the runway surface. Vegetation was subsequently removed from the left main gear. Significant damage was readily apparent in the tail area and the APU access doors were badly distorted. The ground impact occurred whilst the engine power was increasing towards the go-around setting. Stones and other debris disturbed by the contact made by the left main gear were propelled by the left engine efflux onto the left horizontal stabiliser which received significant dents and punctures. An inspection by the aircraft manufacturer, conducted at Santo Domingo, determined that the aircraft was not airworthy and a repair team completed the subsequent repairs on the airfield.

The left main gear struck the ground 5.3 metres beyond the right-hand edge of the runway surface. Evidence of the tailstrike on the airfield had been obliterated by subsequent prolonged, moderate rain.

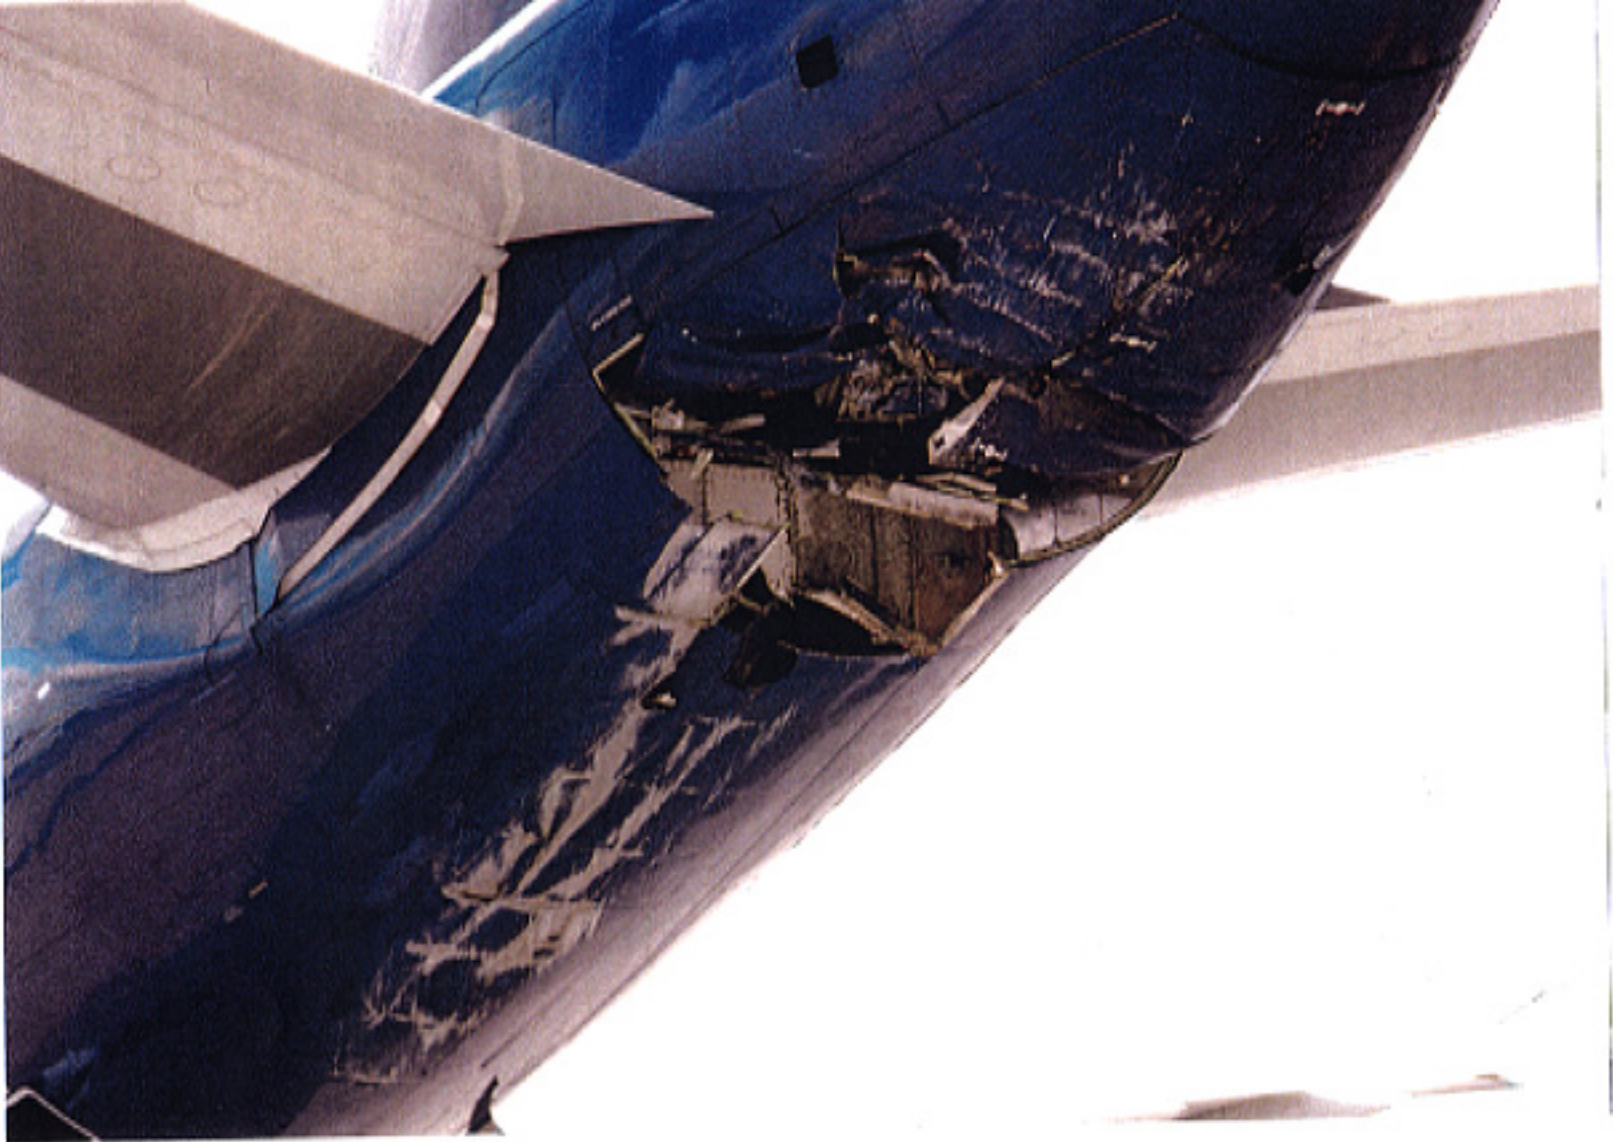
Figure 3 View of damage to rear fuselage

The fuselage underside was scraped and crushed from aft of the rear pressure bulkhead (Frame 1720) to the rear of the APU bay doors, the damage being biased towards the left side. The leading edges of the APU bay doors were crushed rearwards and upwards into the bay and the APU fuel supply line had been ruptured at the firewall that had been crushed and torn. Fuselage distortion during the impact left some wrinkling of the skin panels on the left side aft of the wing root fairing but no permanent twisting of the fuselage was detected.
