## Instrumentation problems on takeoff, Airbus A320-231, G-OOAB, 18 April 1998 at 2200 hrs

# Airbus A320-231, G-OOAB, 18 April 1998 at 2200 hrs

**AAIB Bulletin No: 8/2000**      **Ref: EW/ C98/4/4 Category: 1.1**

**Aircraft Type and Registration:**      Airbus A320-231, G-OOAB

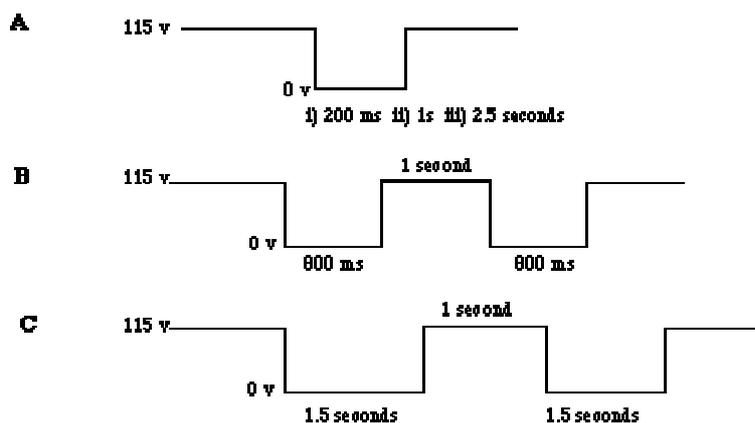
Figure 1 shows the time history of relevant recorded DFDR parameters during the attempted take off. In order to assist an understanding of the DFDR time history an arbitrary time (T) of zero seconds is ascribed to the time when the power levers (as represented by thrust lever angle, TLA) were moved forward at the beginning of the take-off roll.

As the aircraft accelerated along the runway, nose down elevator gradually decreased in response to inputs provided by sidestick 1, indicating that P1 (the commander) was the handling pilot. At T+33 seconds, as the aircraft accelerated through 143 kt, the synchronisation of the recorded data was lost for a period of about 1.5 seconds. The most plausible reason for this loss of synchronisation was due to a temporary loss of electrical power to the DFDR, consistent with a malfunction of AC bus 1.

After synchronisation was re-established, the aircraft was still accelerating. At T+36 seconds, as the aircraft speed reached 150 kt the thrust levers were retarded, reverse thrust was selected, the spoilers deployed and the aircraft began to decelerate. The 'engines' ECAM page remained selected. The DFDR showed that maximum autobrake had been selected before the take-off roll and the deceleration (average - 0.4g) confirmed that maximum autobrake was used.

At T+37 seconds the ECAM page changed to 'wheels', and at T + 37.5 seconds a Master Warning was recorded for a period of 1 second. The source of the Master Warning could not be determined from the time histories of the other recorded parameters.

The DFDR recorded no change in status of the electrical supplies, the DMCs, the SDACs or the FWCs before or after the throttle levers were retarded. It is important to note that this status data was obtained from the appropriate aircraft data bus, and as a consequence the status of the flight deck displays was transparent to the DFDR time history. Furthermore it is possible that data sampling rates and transport delays in the data acquisition and recording functions permitted some short duration (possible spurious) faults to be unseen by the DFDR.
