Right MLG failure on landing, Douglas (Boeing) MD-83, EC-FXI

S3/2001 - Douglas (Boeing) MD-83, EC-FXI

AAIB Bulletin No:
S3/2001

Aircraft Type and Registration:	Douglas (Boeing) MD-83, EC-FXI	
Serial Number:	49630	
Year of Manufacture:	1989	
Date & Time (UTC):	10th May 2001 at 1232 hrs	
Location:	Liverpool Airport, UK	
Type of Flight:	Public Transport (Passenger)	
Persons on Board:	Crew - 6	Passengers - 45
Injuries:	Crew - none	Passengers - none
Nature of Damage:	Major damage to right wing flaps, slats and skin, punctures in fuselage skin, some ingestion damage to the right engine	
Commander's Licence:	Airline Transport Pilot's Licence	
Commander's Flying Experience:	4,990 hours (of which 4,015 were on type)	
Information Source:	AAIB Field Investigation

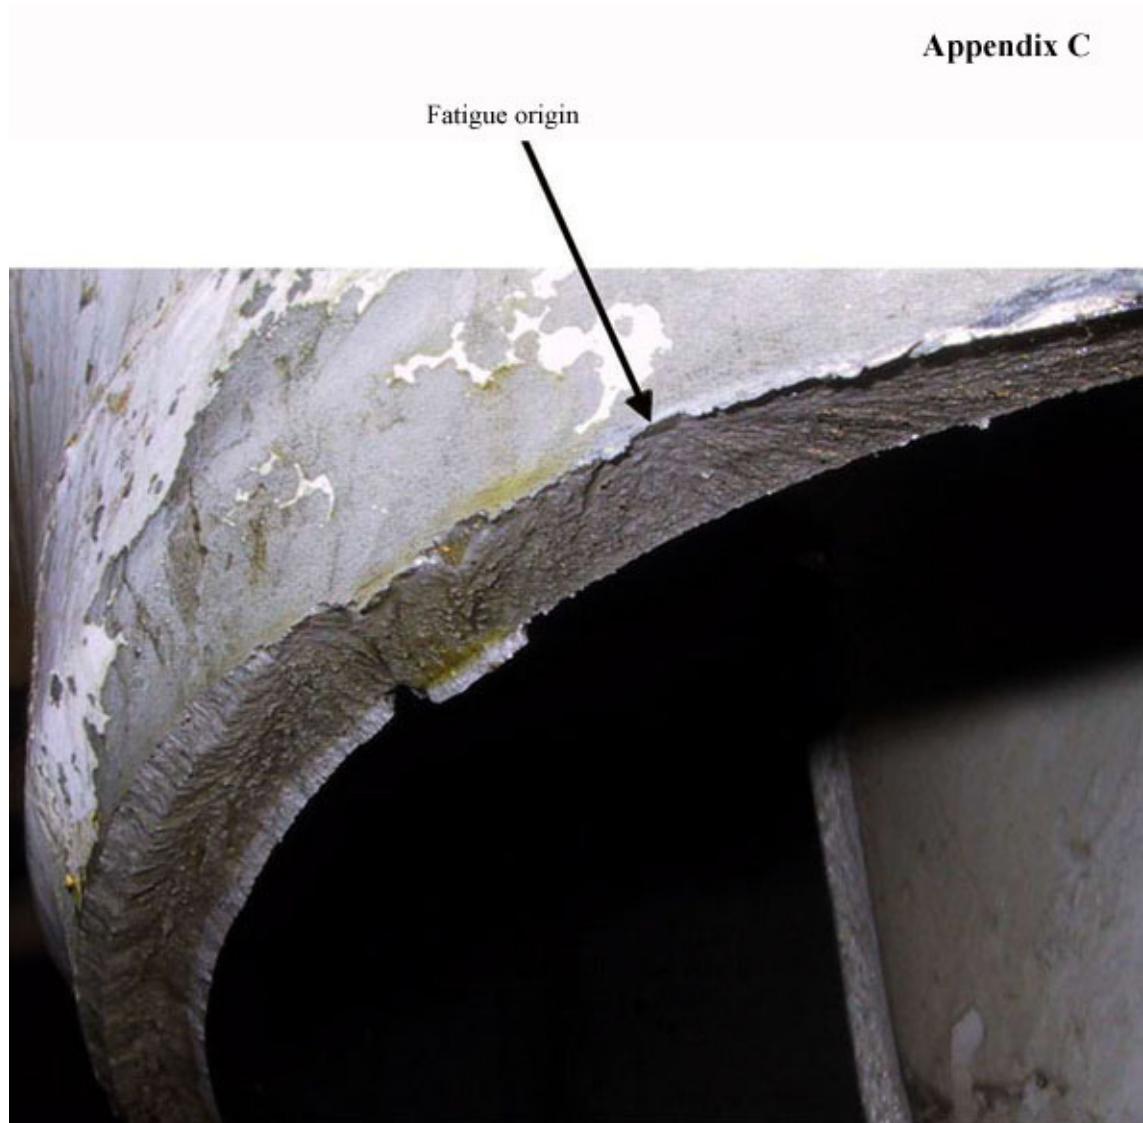
Appendix C: 'As found' picture of upper half of fractured MLG cylinder showing the major fatigue crack

The right wing was raised using airbags, allowing closer inspection of the cylinder fracture face. As with G-DEVR, the vast majority of the face bore signs of fast, ductile rupture, with distinctive 'chevron' features pointing towards an origin at the front face of the cylinder (Appendix C). Here, a small fatigue crack could be discerned, again similar in location and dimensions to the one observed on G-DEVR

The lower half of the fracture face was despatched for metallurgical examination in the United Kingdom under AAIB supervision. The upper half was despatched to BCA for independent examination. Both subsequent reports agreed on the presence of a fatigue crack measuring 1.0 mm deep and 3.2 mm wide at the cylinder surface in the area identified on-site. There were multiple initiation sites within this major crack and, additionally, smaller fatigue cracks were identified either side of the major crack over a chord length of about 40 mm.

'As found' picture of upper half of fractured MLG cylinder
showing the major fatigue crack (arrowed)

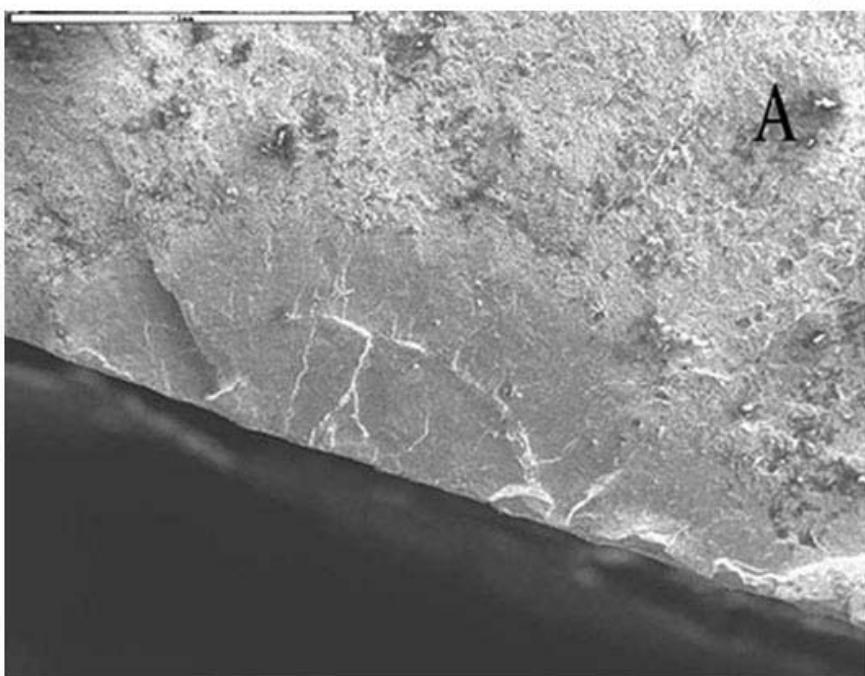
Scanning electron microscope secondary image of major crack

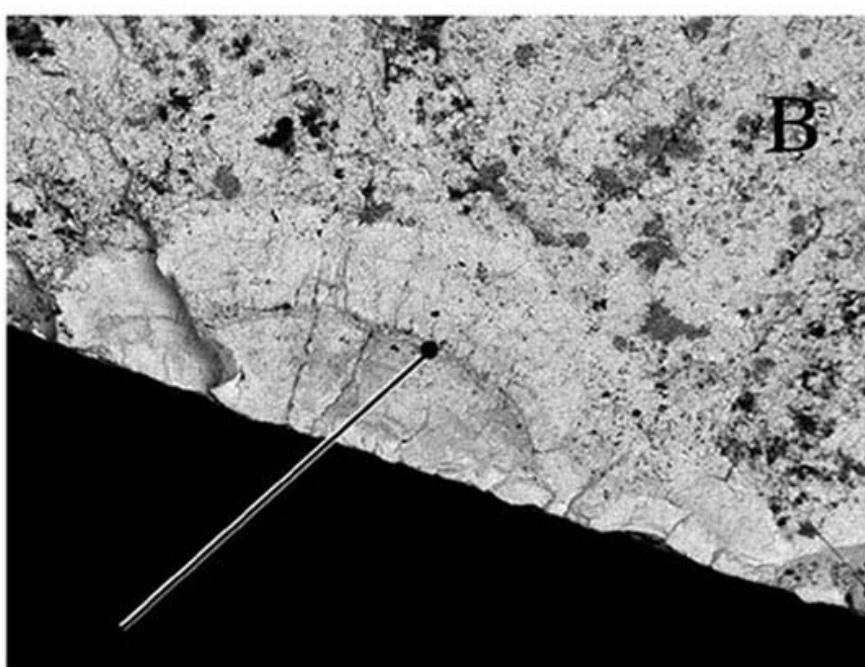
One feature which was noted was the presence of a growth band (visible as a distinct ridge) across roughly half of the crack depth (Appendix D). Analysis of this area using Energy-Dispersive X-ray showed the presence of quantities of Cadmium in the inner boundary of this area which were not present outside it.

Scanning electron microscope backscatter image of major fatigue crack

Note clearly visible growth band (arrowed)
within which high levels of Cadmium were found

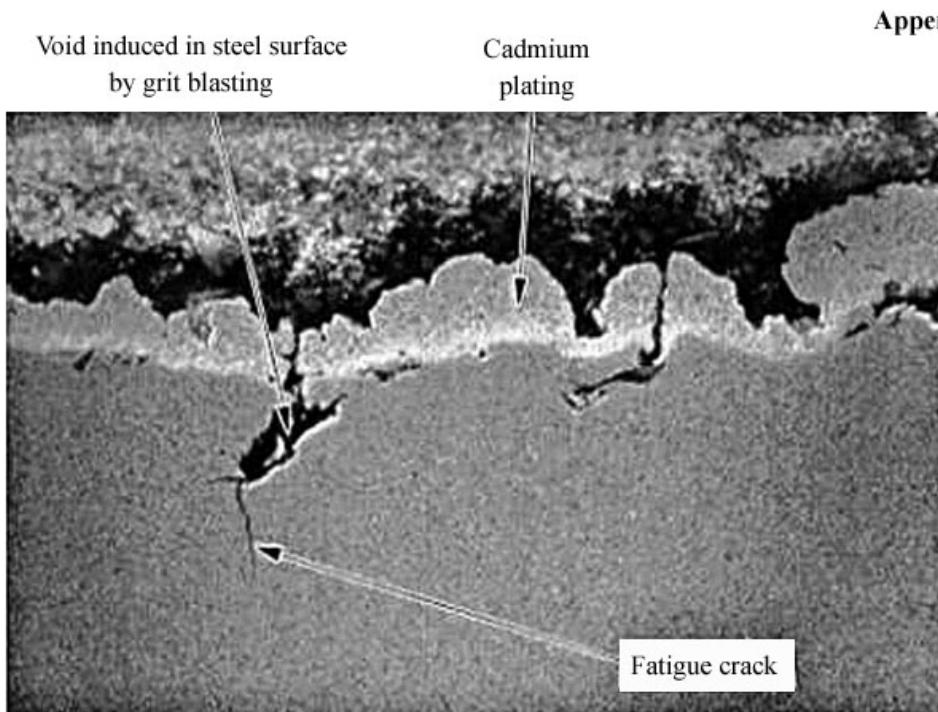
SEM photograph of the surface finish of the failed cylinder from G-DEVR
Note embryonic fatigue crack growing from imperfection

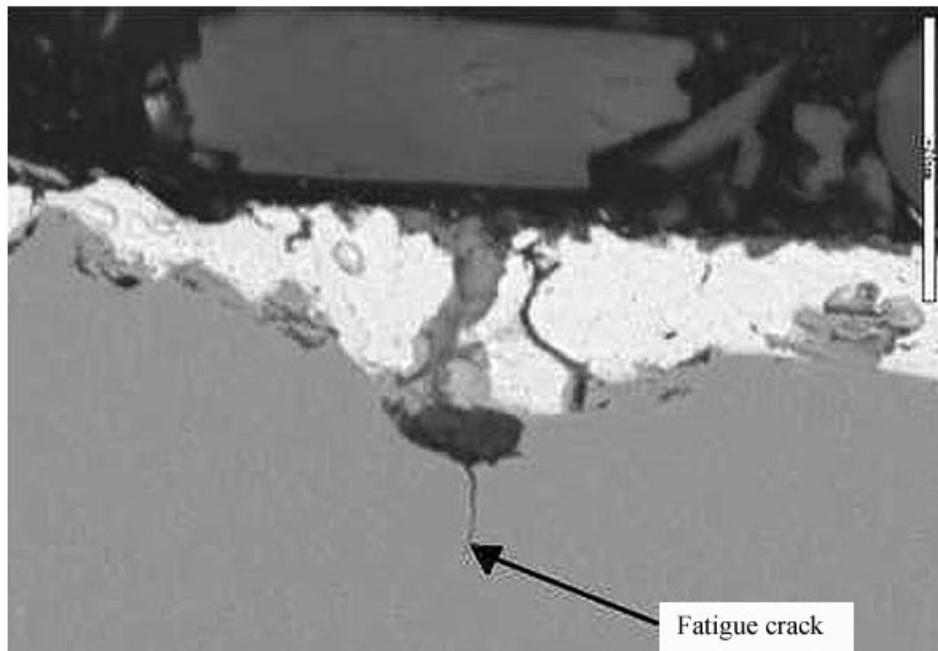
Microsections of the material revealed a similar surface finish to that observed on the cylinder from G-DEVR, with the same smearing of the shot-peened finish caused by grit-blasting resulting in microscopic fissures, some containing embedded particles of alumina grit (Appendix E). These fissures were a maximum of about 20 microns in depth. The Cadmium plating was present but it was clear that the original paint finish had been removed (for previous crack checking) and that the re-applied finish was flaking-off in places.

SEM photograph of the surface finish of the failed cylinder from EC-FXI
Note embryonic fatigue crack growing from imperfection
which is an embedded particle of Alumina grit
