Tailstrike on landing, Boeing 747-267B, TF-ATD

Boeing 747-267B, TF-ATD

AAIB Bulletin No: 8/2003 Ref: EW/C2002/10/01 Category: 1.1

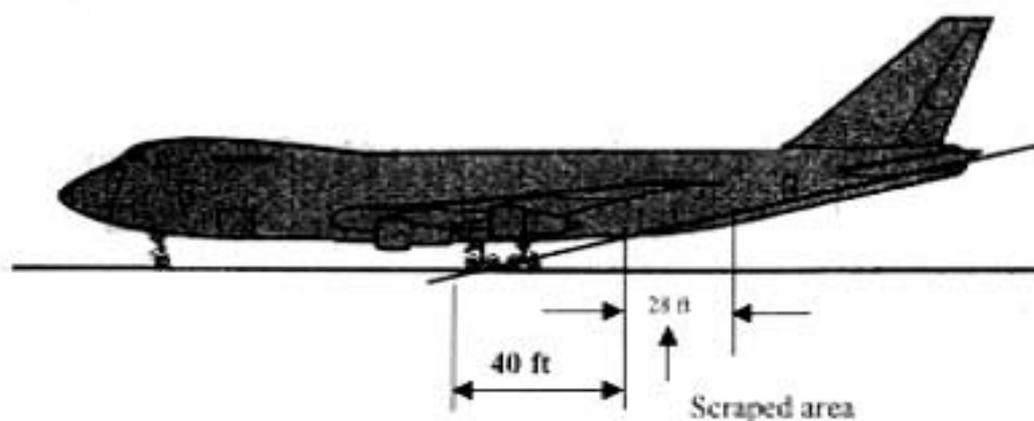
The underside of the rear fuselage had suffered abrasion damage, severe enough to expose the edges, in a few places, of two fuselage frames. The rear toilet drain mast had been flattened to the fuselage and the left-side cabin outflow valve, located aft of the damaged area of the fuselage, and which stood proud of the skin, had been ground away on its lower corner. The right cabin outflow valve had escaped damage however, which confirmed the left roll attitude at touchdown.

The damage to the fuselage underside extended over an area approximately 28 feet in length, as indicated in the above illustration. The aft limit was immediately ahead of the rear pressure bulkhead, which is at Fuselage Station 2360. (Note: Fuselage Station numbers refer to the distance in inches aft of a defined datum ahead of the aircraft nose.) A subsequent inspection inside the fuselage, under the floor in the aft cargo area, revealed some minor damage to some of the fuselage frames. The forward limit of damage was approximately 40 feet aft of the wing gear. Thus the 'slant distance', (ie with the aircraft in its touchdown attitude) between the rear pair of wing gear landing wheels and the aft limit of fuselage damage was around 70 feet, or 21.5 metres. Since the distance between the start of the scrape mark on the runway and the first of the tyre marks was 28 metres, or around 90 feet, as noted earlier, it follows that the rear fuselage contacted the ground fractionally before the wheels.

The 'grounding line,' as shown in the illustration, which would vary slightly with oleo compression, is around 12° ; this compared favourably with the DFDR data, as discussed later in this report.

The scratches on the fuselage underside were angled relative to the longitudinal axis of the aircraft, which, when measured, indicated that the aircraft was yawed 8.25° to the left of its ground track.

The aircraft was flown, unpressurised, to Amsterdam where it was repaired over a period of several weeks. During this time, the operator, at the request of AAIB, conducted a test on the aircraft's pitot/static systems. The results indicated leaks in each of the two auxiliary static systems. However these are connected to aircraft systems that are unrelated to the altimeters and airspeed indicators, which are supplied from the main pitot/static systems. No leaks were found in the latter, with the

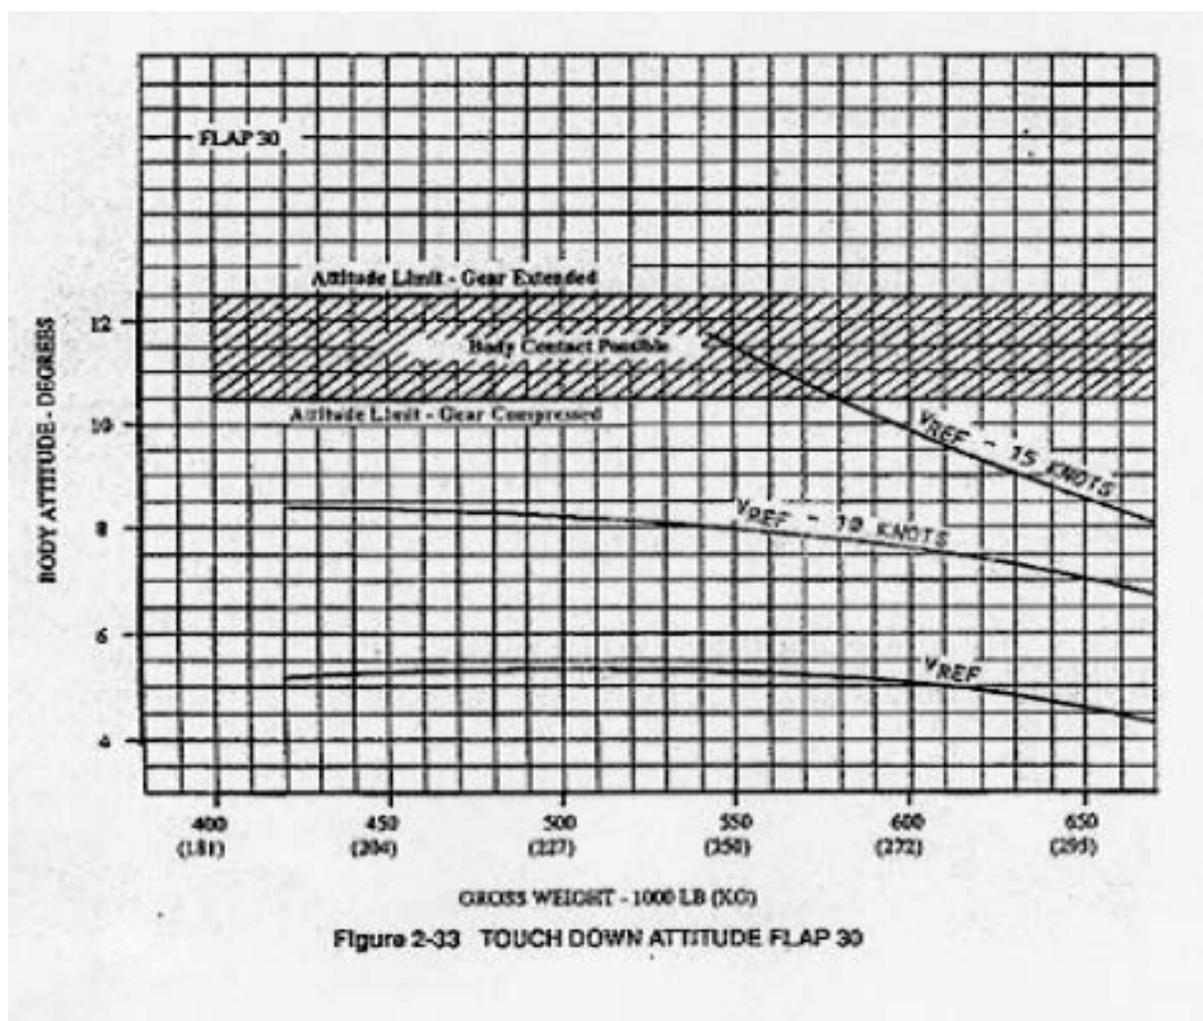
The graph shown below illustrates the relationship of body attitude and speed for the gross weight of the aircraft, which on the accident flight was 254.3 tonnes. The aircraft was 20 kt below V_{REF} at touchdown.

From the 'Touch Down Attitude Flap 30' chart supplied by the manufacturer and included in the Recommended Landing Technique section above, the relationship between low airspeed below V_{REF} and the attitude limit with the landing gear compressed is illustrated. At an airspeed of 14 kt below V_{REF} the aircraft is placed in the 'body contact possible' area of the graph.

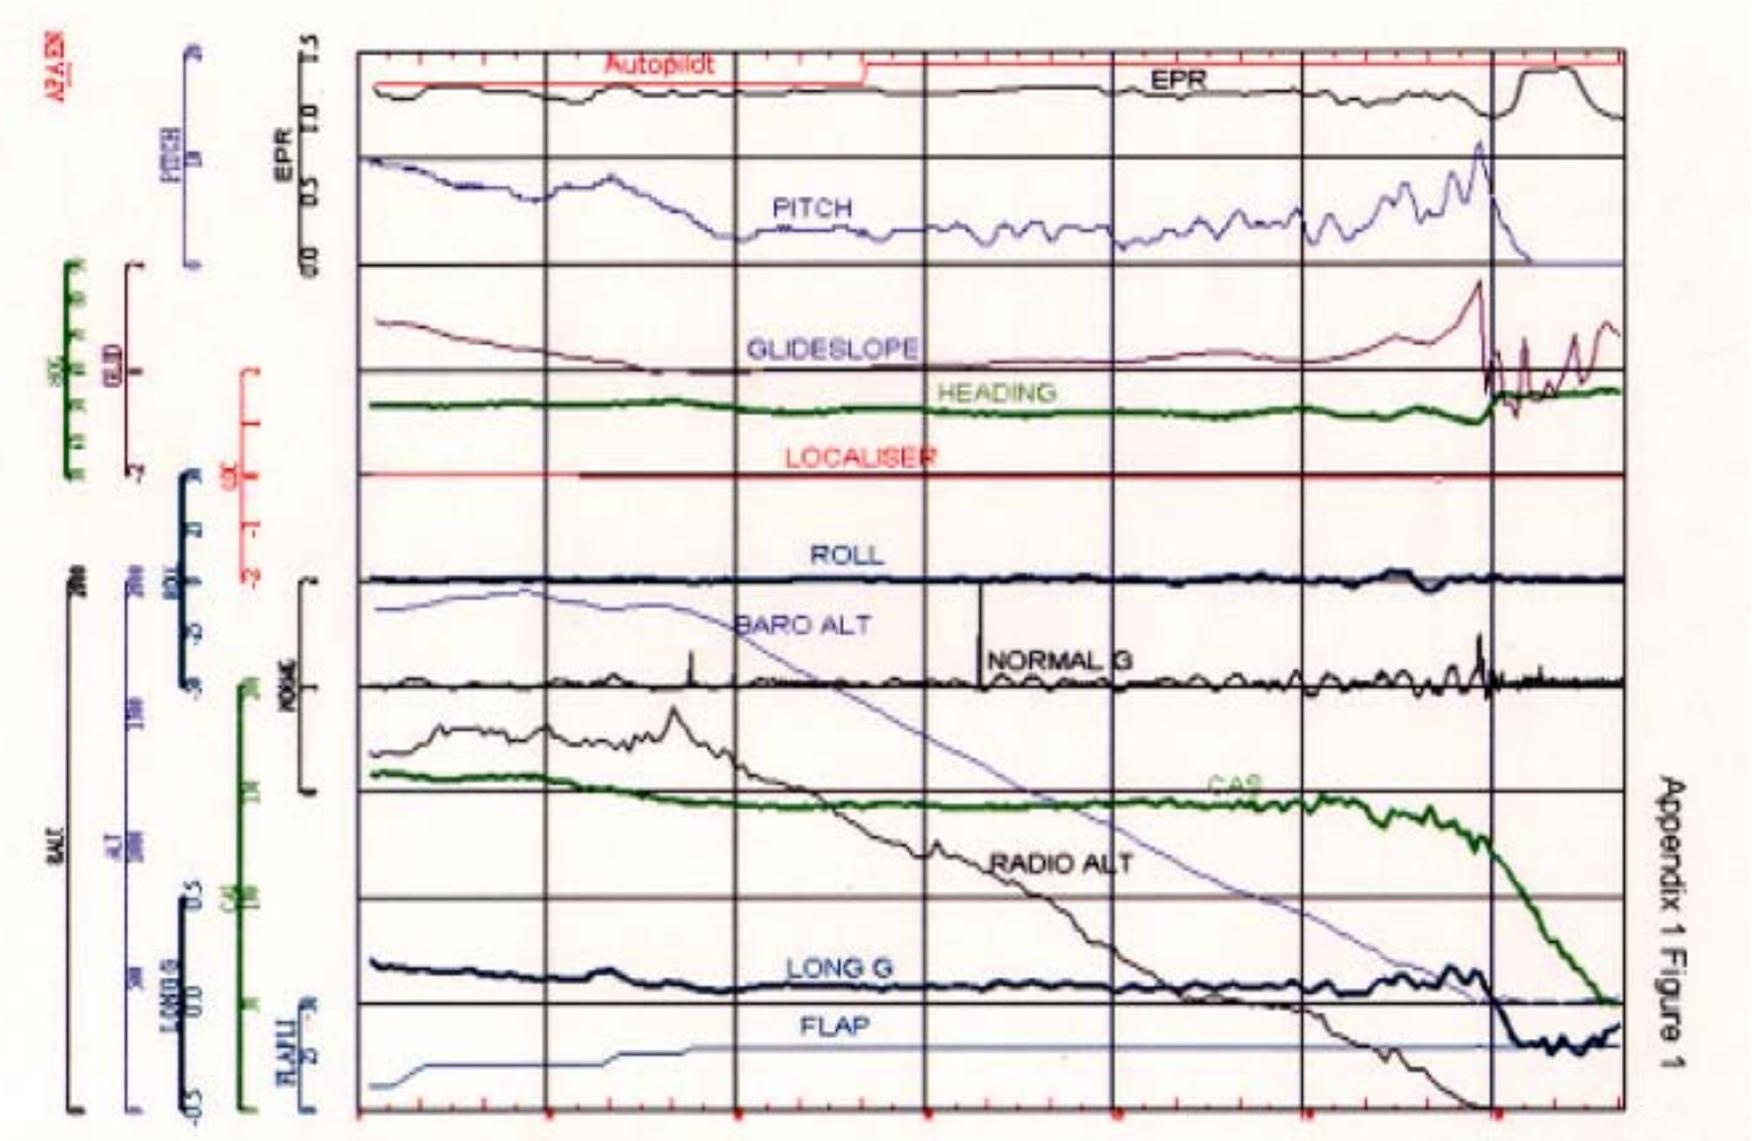
Appendix 1 Figure 1 shows a graphical time history of selected FDR parameters beginning three minutes before landing. Figure 2 is an expanded graph of the data with relevant annotations from the CVR recording.

From Figure 1 it is clear that the aircraft was tracking the glidepath and localiser signals until about 400 feet agl. At 400 feet there was a small reduction in engine power, the barometric altitude indicated an increase in rate of descent and the ILS glidepath signal showed the aircraft beginning to deviate below the glidepath. The aircraft remained below V_{APP} , but above V_{REF} until 300 feet when the airspeed increased to 148 kt remaining at around 146 kt to 250 feet. Thereafter, pitch attitude increased and the airspeed started to reduce. Coincident with the flight engineer's 200 foot call the GPWS initiated the first of two Mode 5 aural "GLIDESLOPE" warnings. The aircraft pitch attitude continued to increase and the glidepath deviation stabilised for about 7 seconds at about 1/2 dot 'fly up' demand. As the pitch attitude increased, the airspeed reduced and at 100 feet agl the speed was 136 kt. There was a small increase in power at about 90 feet agl; however, the pitch attitude continued to increase and the airspeed decayed further. Airspeed continued to decay to 129 kt at 36 feet with the aircraft 1/2 scale deflection below the glide-slope and thrust reducing. At about that time the CVR recorded the non handling pilot call "watch the speed". From 20 feet above the runway the fuselage nose-up pitch angle increased rapidly from 7° and at 5 feet above the runway, the airspeed was 121 kt with the thrust set at idle.

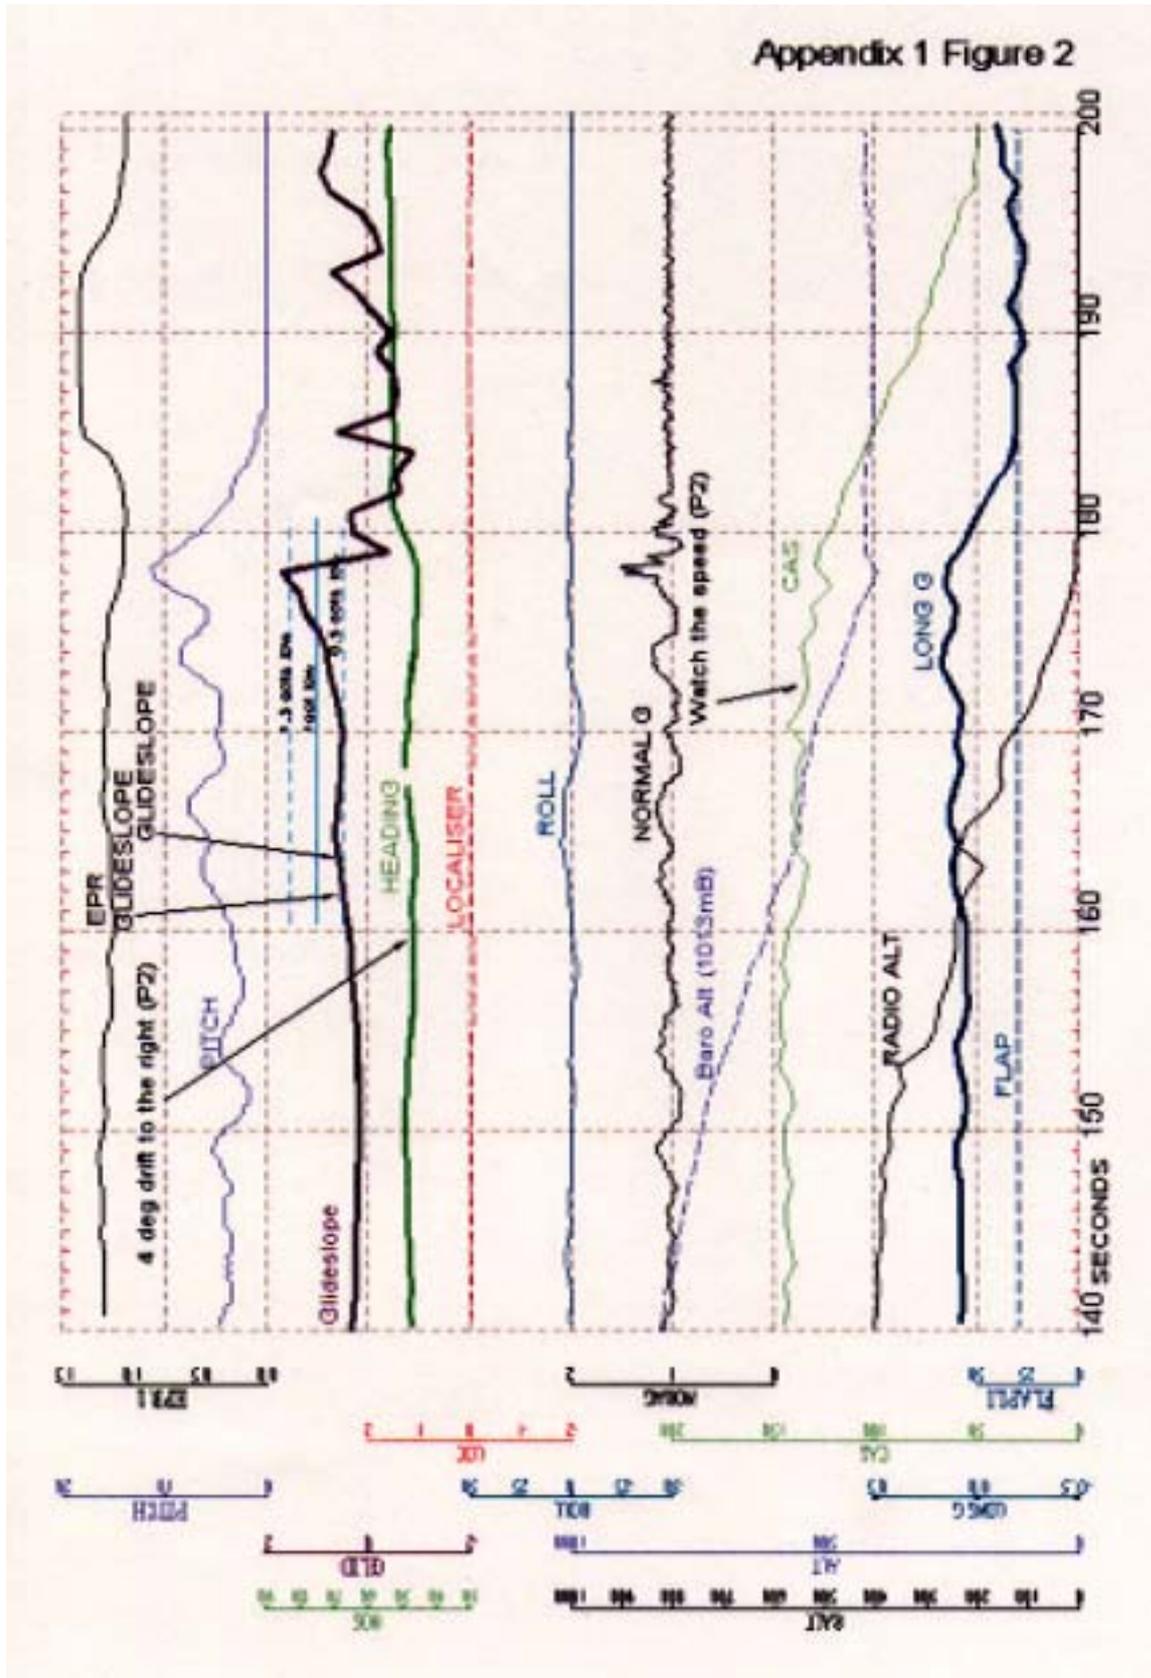
The aircraft touched down with a pitch attitude of 11.5° (nose-up) on a heading of 43° M (about 8° left of runway heading), at a speed of 129 kt (12 kt below V_{REF}). The speedbrake was activated within 0.5 seconds of touchdown and reverse thrust was deployed 2 seconds later. After touchdown the aircraft quickly turned onto runway heading, decelerated normally and stopped within 25 seconds.

Although the recorded body accelerations showed no clear evidence of turbulence on approach, there were a number of fluctuations in recorded airspeed between 150 feet agl and landing. Some of the fluctuations were explainable by pitch attitude changes and ground effects. However some were not. Furthermore, the commander commented on the CVR that he was aware of "a shear" at 100 feet agl.
