Roll impairment due to jammed aileron cables, BAe 146-300, G-OINV

BAe 146-300, G-OINV

AAIB Bulletin No: 7/2004	Ref: EW/C2003/03/04	Category: 1.1
INCIDENT		
Aircraft Type and Registration:	BAe 146-300, G-OINV	
No & Type of Engines:	4 Lycoming ALF 502R-3A turbofan engines	
Year of Manufacture:	1990	
Date & Time (UTC):	2 March 2003 at 1055 hrs	
Location:	In the cruise, near Carlisle, Cumbria	
Type of Flight:	Public Transport	
Persons on Board:	Crew - 5	Passengers - 95
Injuries:	Crew - None	Passengers - None
Nature of Damage:	Fuselage insulation entwined in aileron control run	
Commander's Licence:	Airline Transport Pilot's Licence	
Commander's Age:	34 years	
Commander's Flying Experience:	4,700 hours (of which 3,200 were on type)	
	Last 90 days - 160 hours	
	Last 28 days - 25 hours	
Information Source:	Aircraft Accident Report Form submitted by the pilot and other enquiries made by the AAIB

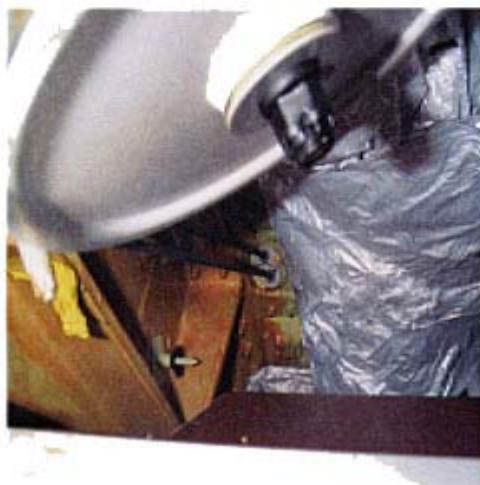
Examination of the aircraft at the operator's maintenance facility showed that a section of insulation on the rear wing spar at Frame 29 on both the left and right sides had become entwined with the aileron cables where they passed through pressure bungs (see Figure 3).

Figure 3 - Photograph showing dislodged insulation bag interfering with aileron cable

G-OINV - Photographs showing (above) dislodged insulation bag interfering with aileron cable and (below) with bag removed, the pressure bungs (note retaining button)

The insulation bags had become dislodged from their retaining buttons but it appeared that the particular zone had not been disturbed during recent maintenance, how long this condition had existed was not known. Other aircraft in the operator's fleet were inspected and loose bags were found, however none were actually touching the cables.

The manufacturer has stated that they intend to revise the Maintenance Manual for the aircraft to include more comprehensive inspection and securing information for insulation in this area.
