Turbulence and hail damage in-flight, Airbus A321-231, G-MIDJ

Investigative Body: Aircraft Accident Investigation Board (AAIB), United Kingdom

Airbus A321-231, G-MIDJ

AAIB Bulletin No: 6/2004	Ref: EW/C2003/05/03	Category: 1.1
INCIDENT		
Aircraft Type and Registration:	Airbus A321-231, G-MIDJ	
No & Type of Engines:	2 V2533-A5 International Aero turbofan engines	
Year of Manufacture:	1999	
Date & Time (UTC):	26 May 2003 at 1543 hrs	
Location:	In the cruise at FL340, 70 nm south-east of Vienna	
Type of Flight:	Public Transport	
Persons on Board:	Crew - 8	Passengers - 213
Injuries:	Crew - None	Passengers - None
Nature of Damage:	Significant damage to radome, flight deck windows, stabiliser leading edges and engine nacelles	
Commander's Licence:	Airline Transport Pilot's Licence	
Commander's Age:	42 years	
Commander's Flying Experience:	11,457 hours (of which 262 were on type)	
	Last 90 days - 184 hours	
	Last 28 days - 49 hours	
Information Source:	AAIB Field Investigation

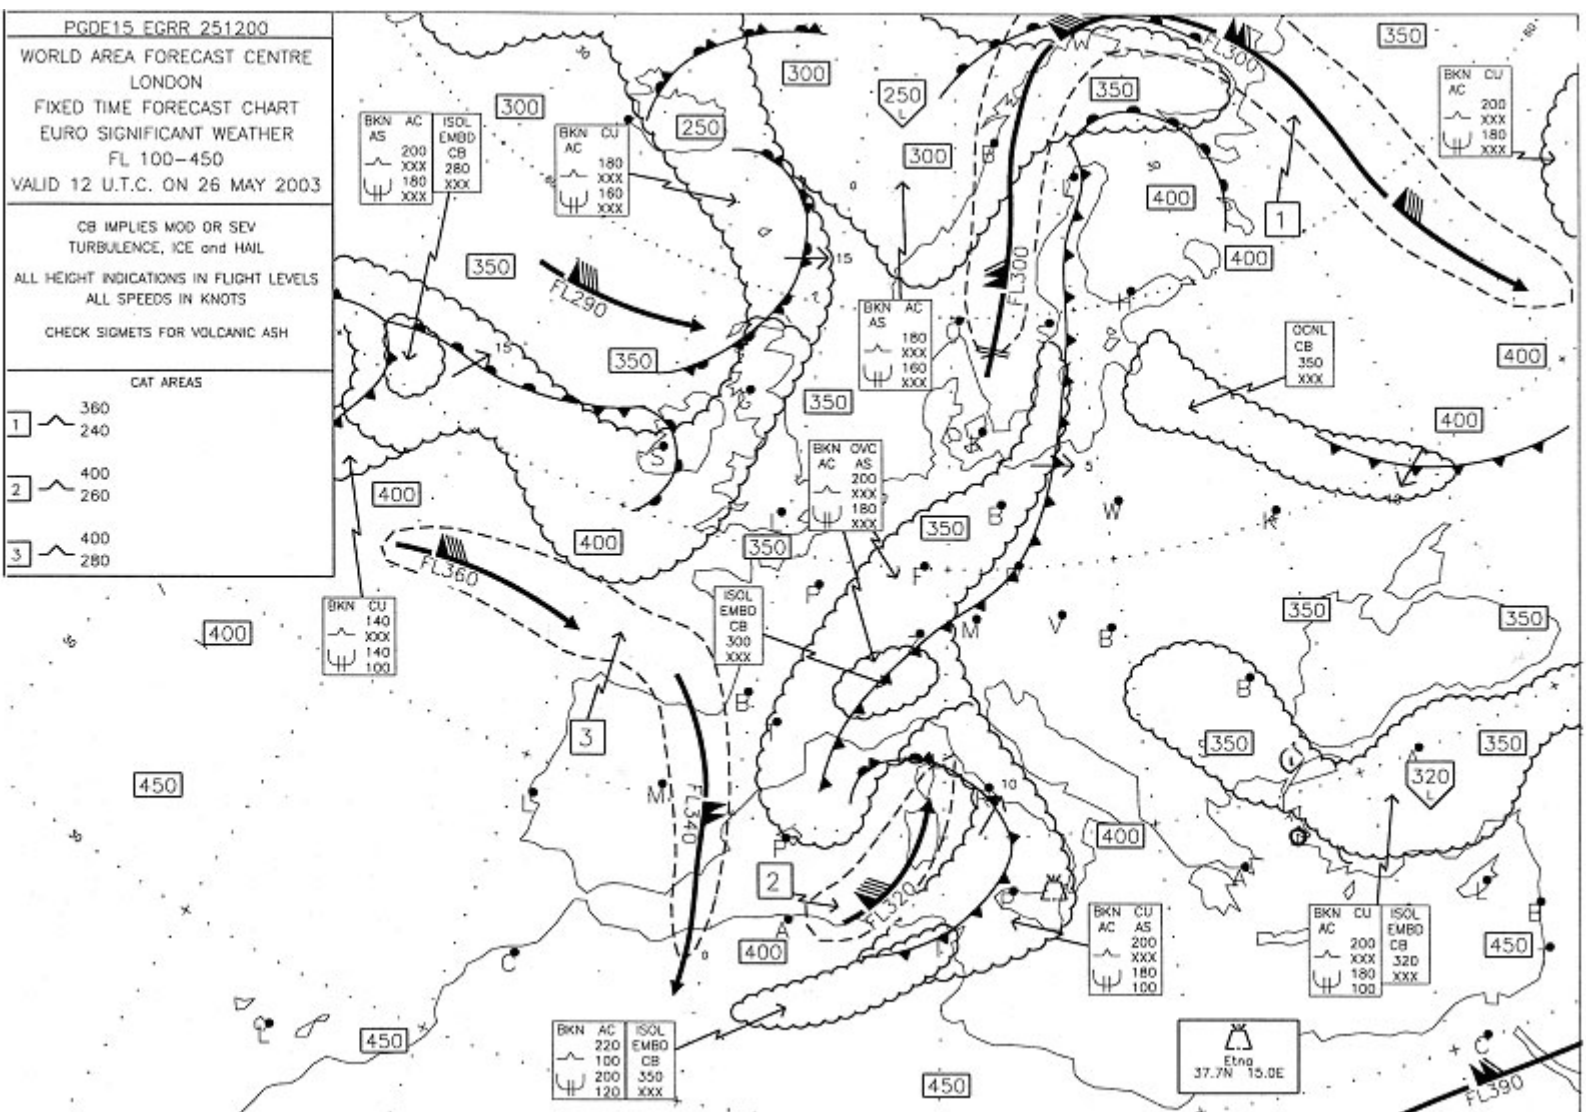
Figure 1

The original written weather forecast, obtained by the crew prior to the flight, was not required to be retained after landing and was not available for scrutiny. A copy of the relevant Significant Weather chart, obtained from the Meteorological Office, however, is shown at Figure 1. This indicates isolated (ISOL) embedded (EMBD) Cb cloud with tops up to approximately FL300 over the Alps. It should be noted that the International Civil Aviation Organisation (ICAO) standard specifies that only EMBD Cb and occasional (OCNL) Cb or more, but not isolated ISOL Cb, should be depicted on the chart.

Figure 1: Significant Weather Chart

Significant Weather Chart

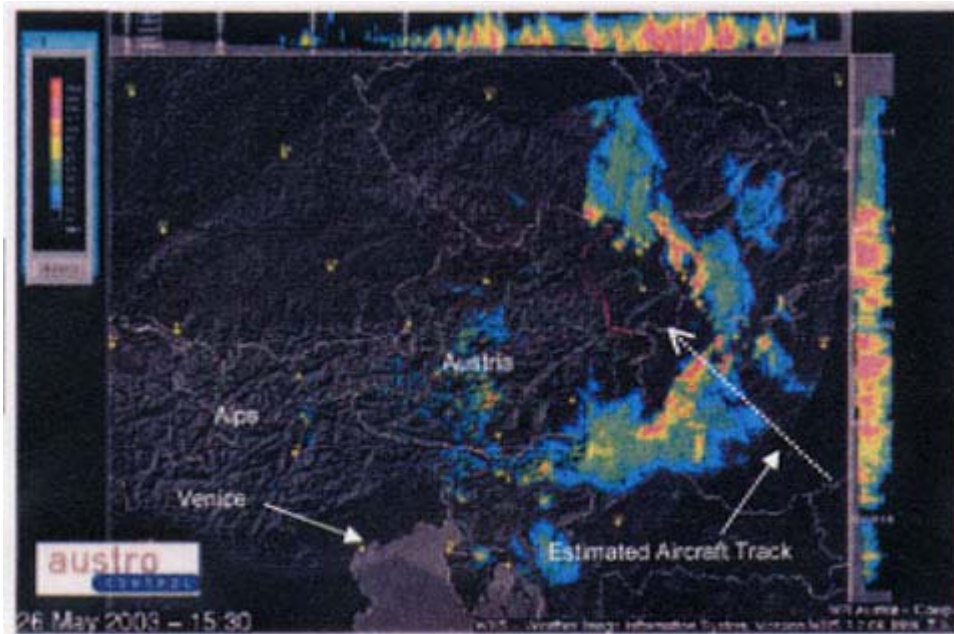
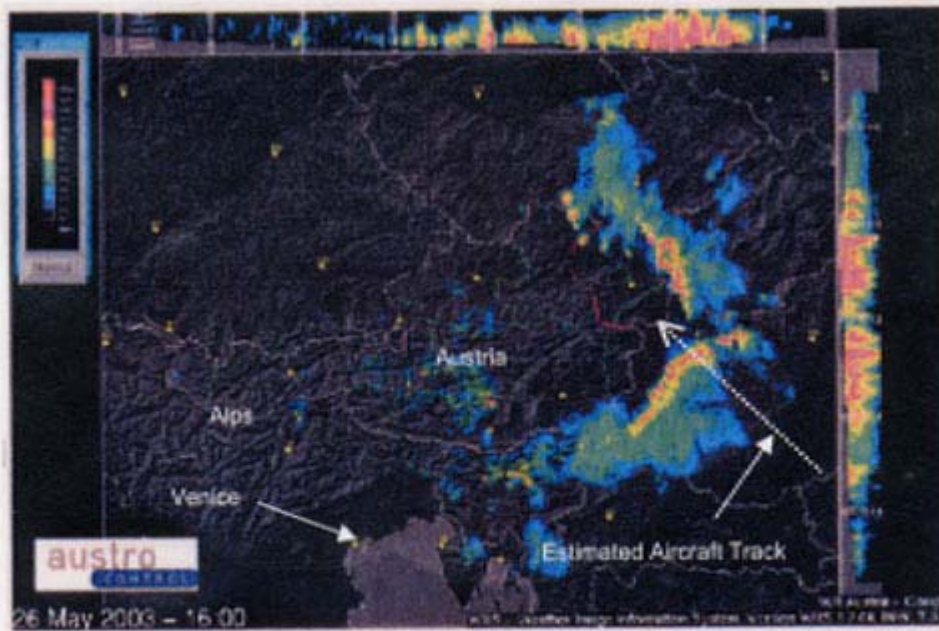
Satellite images of the cold front showing the weather and Cb activity are shown at Figure 2 with the approximate aircraft track indicated.

Satellite image at 1530 hrs

Satellite image at 1600 hrs

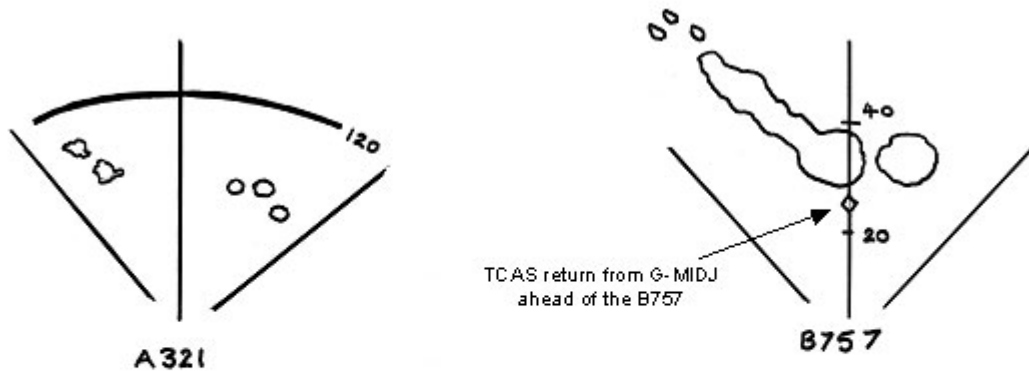
Figure 3: Representative drawing from the crew of G-MIDJ

The actual weather radar picture seen by the crew is not recorded and therefore cannot be reproduced. A representative drawing from the crew of G-MIDJ, illustrating the radar returns they remembered seeing on their display some time before the incident, is shown on the left below. (Note: the crew reported that they thought the tilt was set between 2° and 3° down at this time).

Note: The drawings above depict the weather situation at different times. The left depicts the A321 approximately 80 nm from the weather returns; the right depicts the A321 5 nm from the returns.

The commander of the 757, who had his weather radar and TCAS selected ON and was using the tilt function of the scanner, saw on his display the TCAS return from the aircraft ahead and the weather radar returns. He was able to recollect the display at the time and an illustration of that display is shown on the right above.

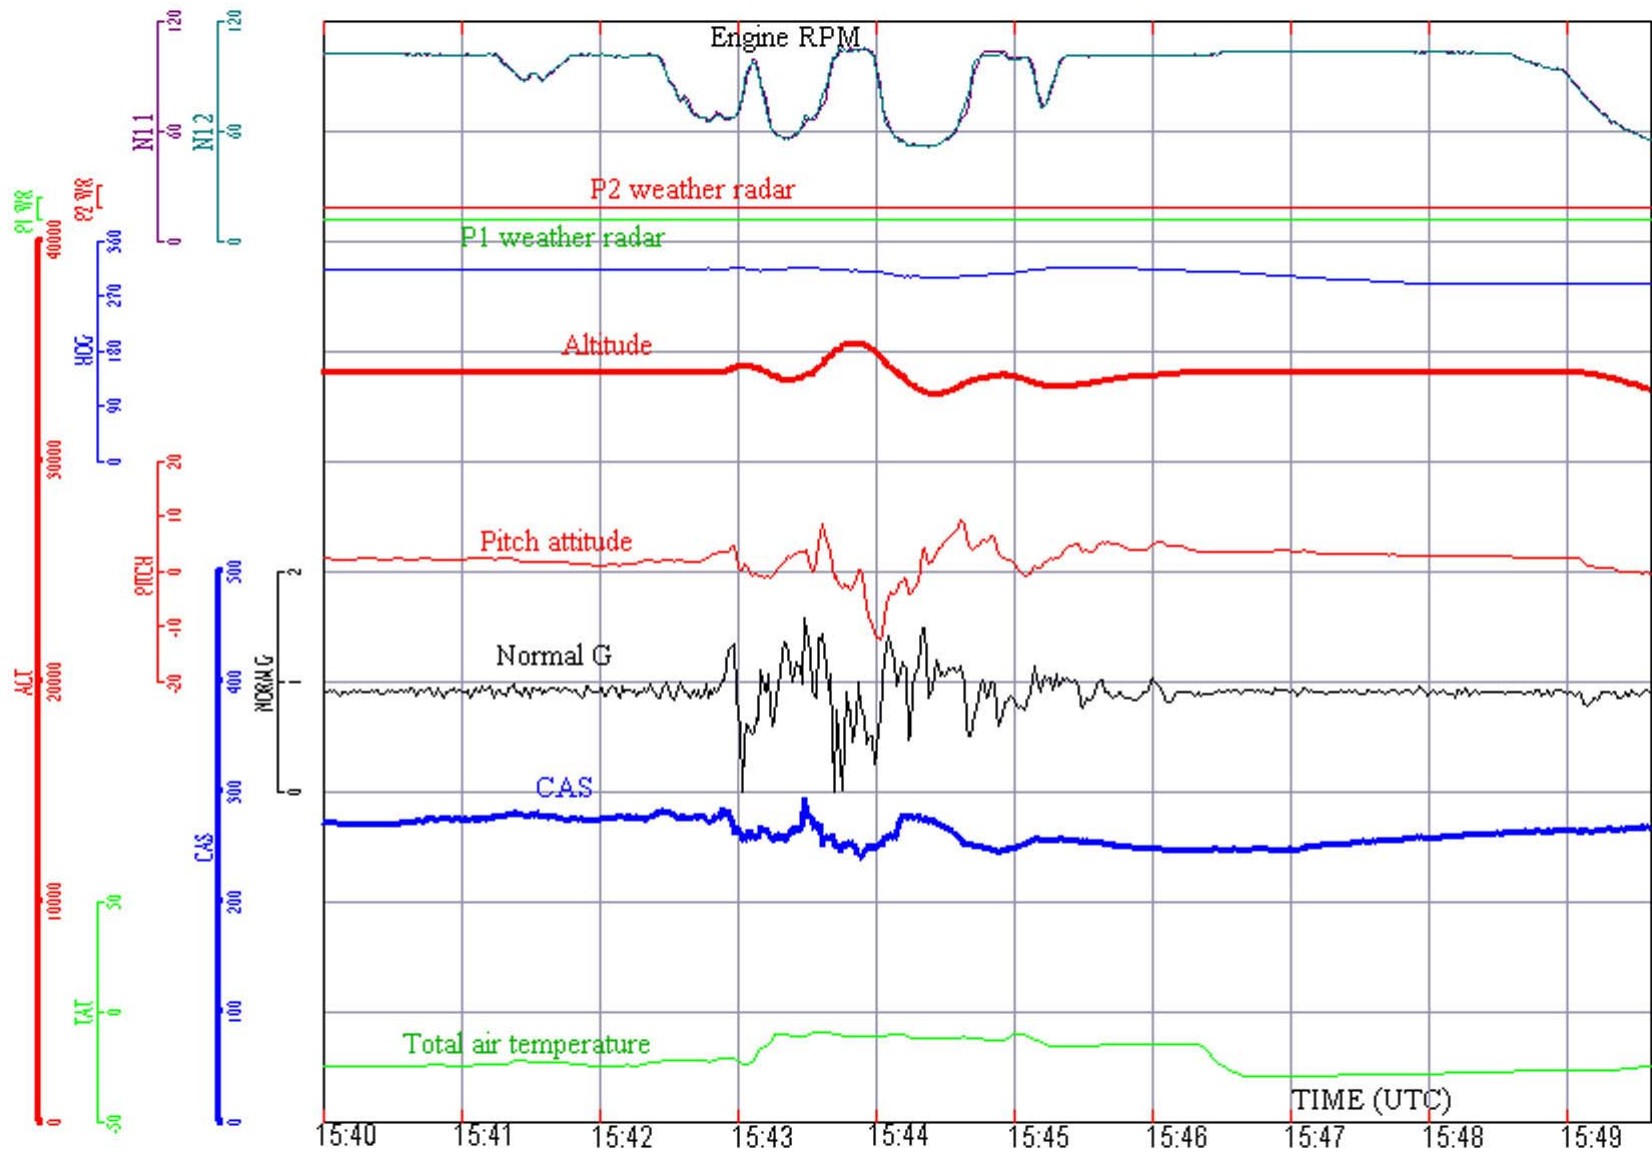
Figure 4: DFDR Trace for G-MIDJ

DFDR Trace for G-MIDJ

Recorded data concerning the use of the weather radar (see Figure 4) showed that it was switched on and displayed to the first officer for approximately 12 minutes as the aircraft climbed from 4,700 feet through 23,600 feet. The DFDR did not record any use of the weather radar during the remainder of the flight.

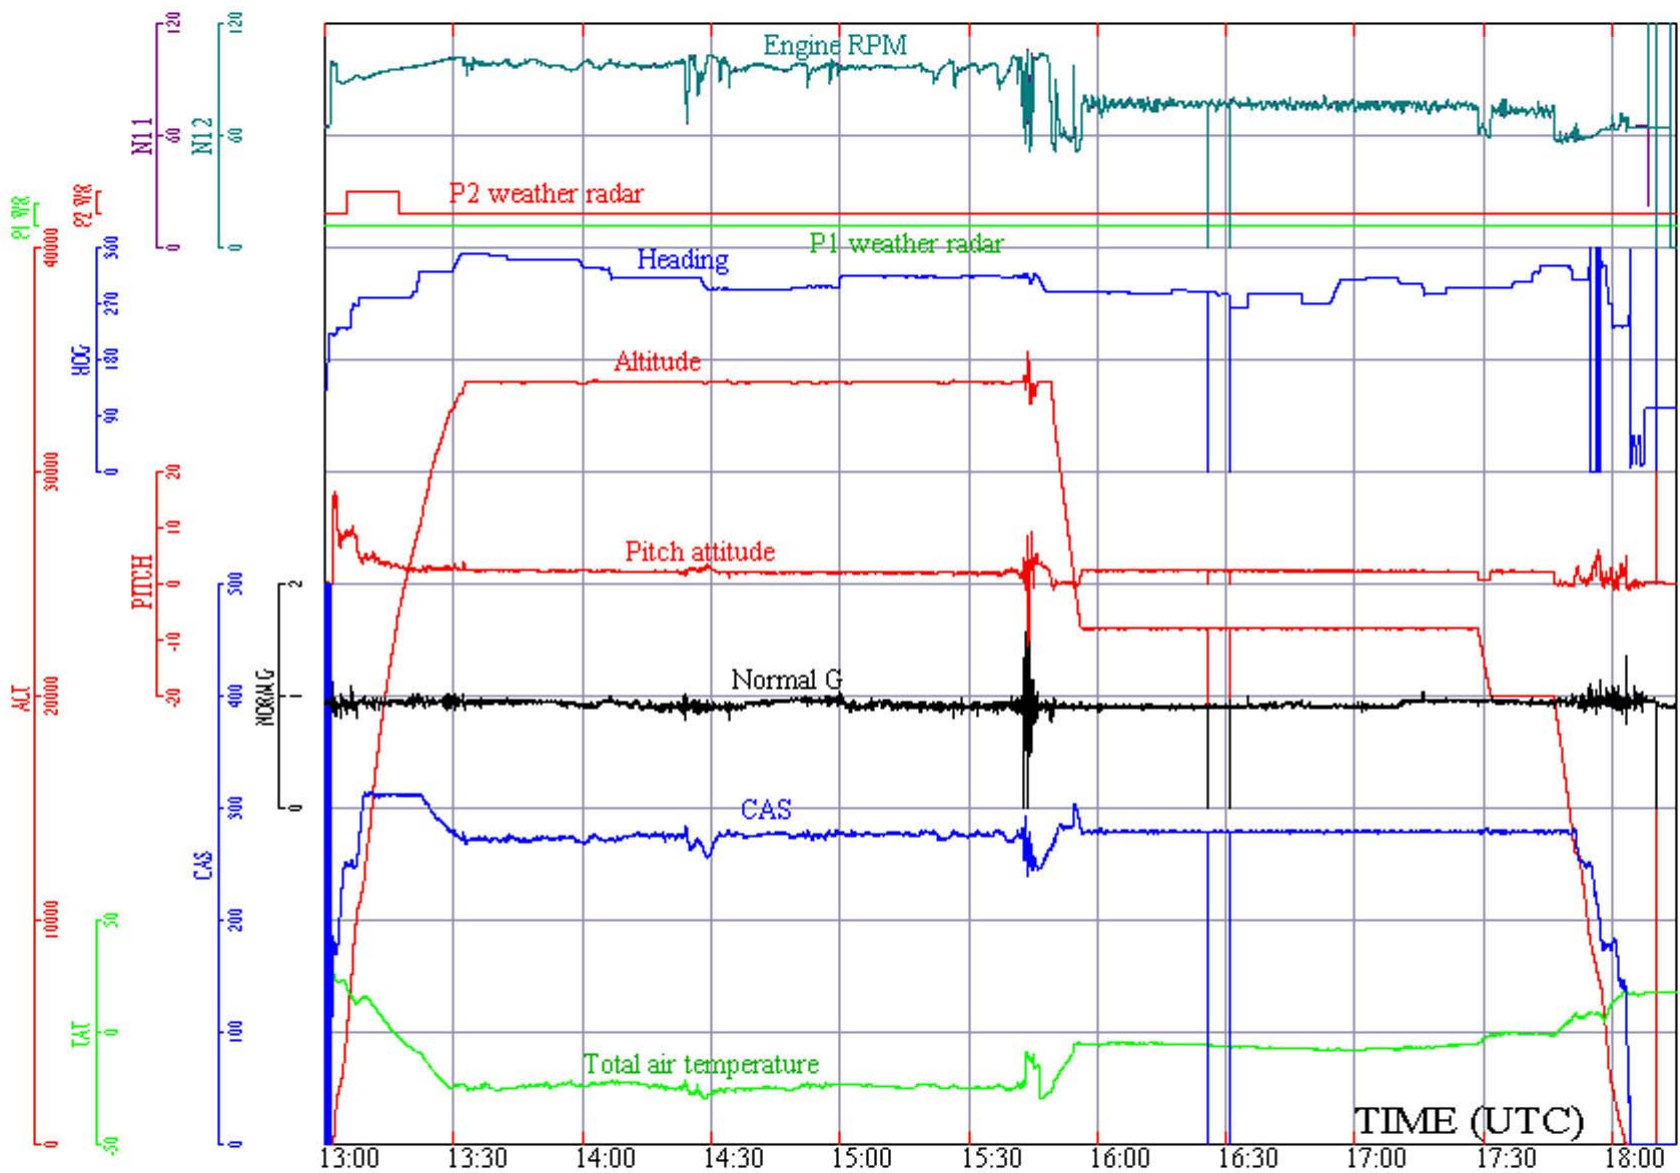
Figure 5: DFDR Trace for G-MIDJ

DFDR Trace for G-MIDJ
